Toronto Inspection Ltd.

May 6, 2003
Project No. 03 LPL 778-02

Re.: Geotechnical Investigation Report
Sanitary Sewer Installation
Highway 10 / 89 and County Road 124
Shelburne, Ontario.

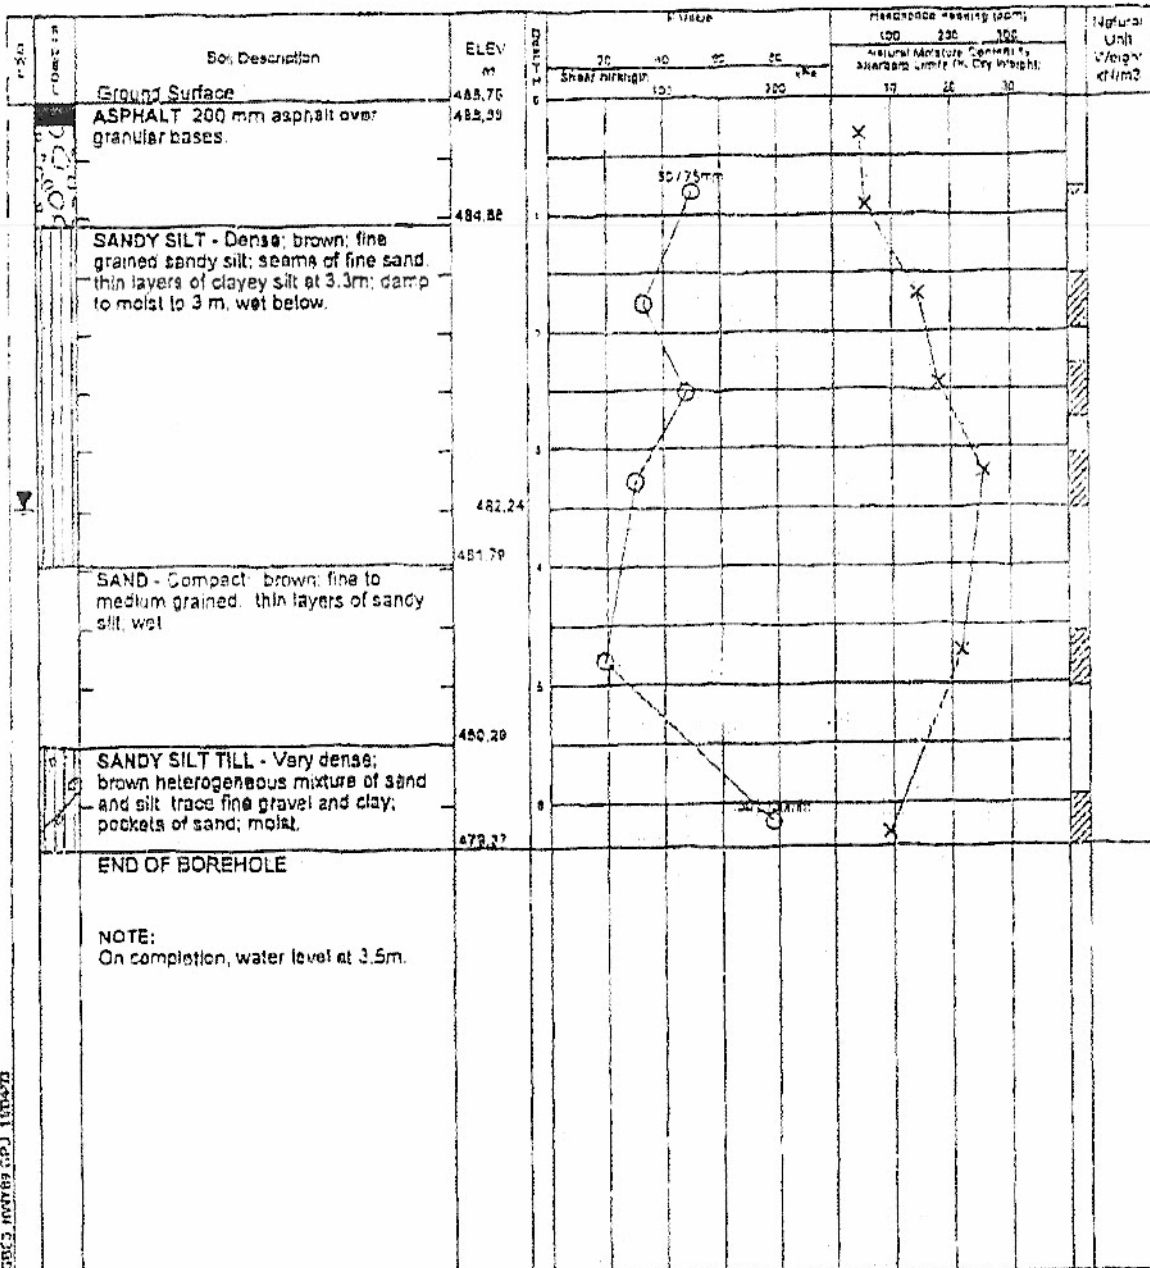
Dwg No 2

Log of Borehole 1

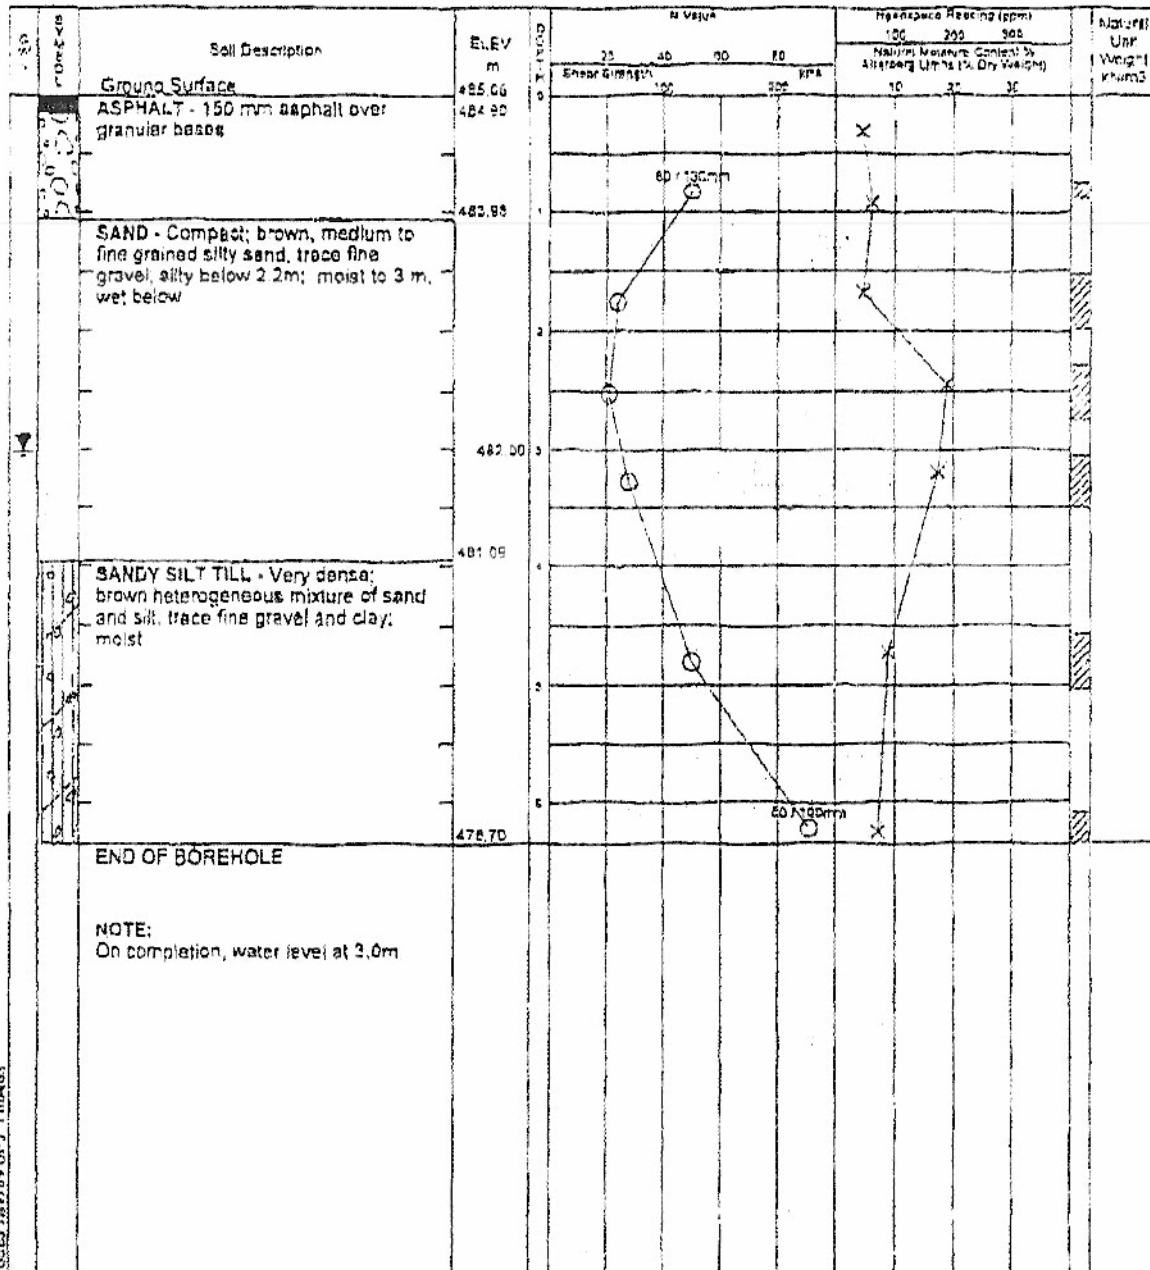
Dwg No 3

Log of Borehole 2

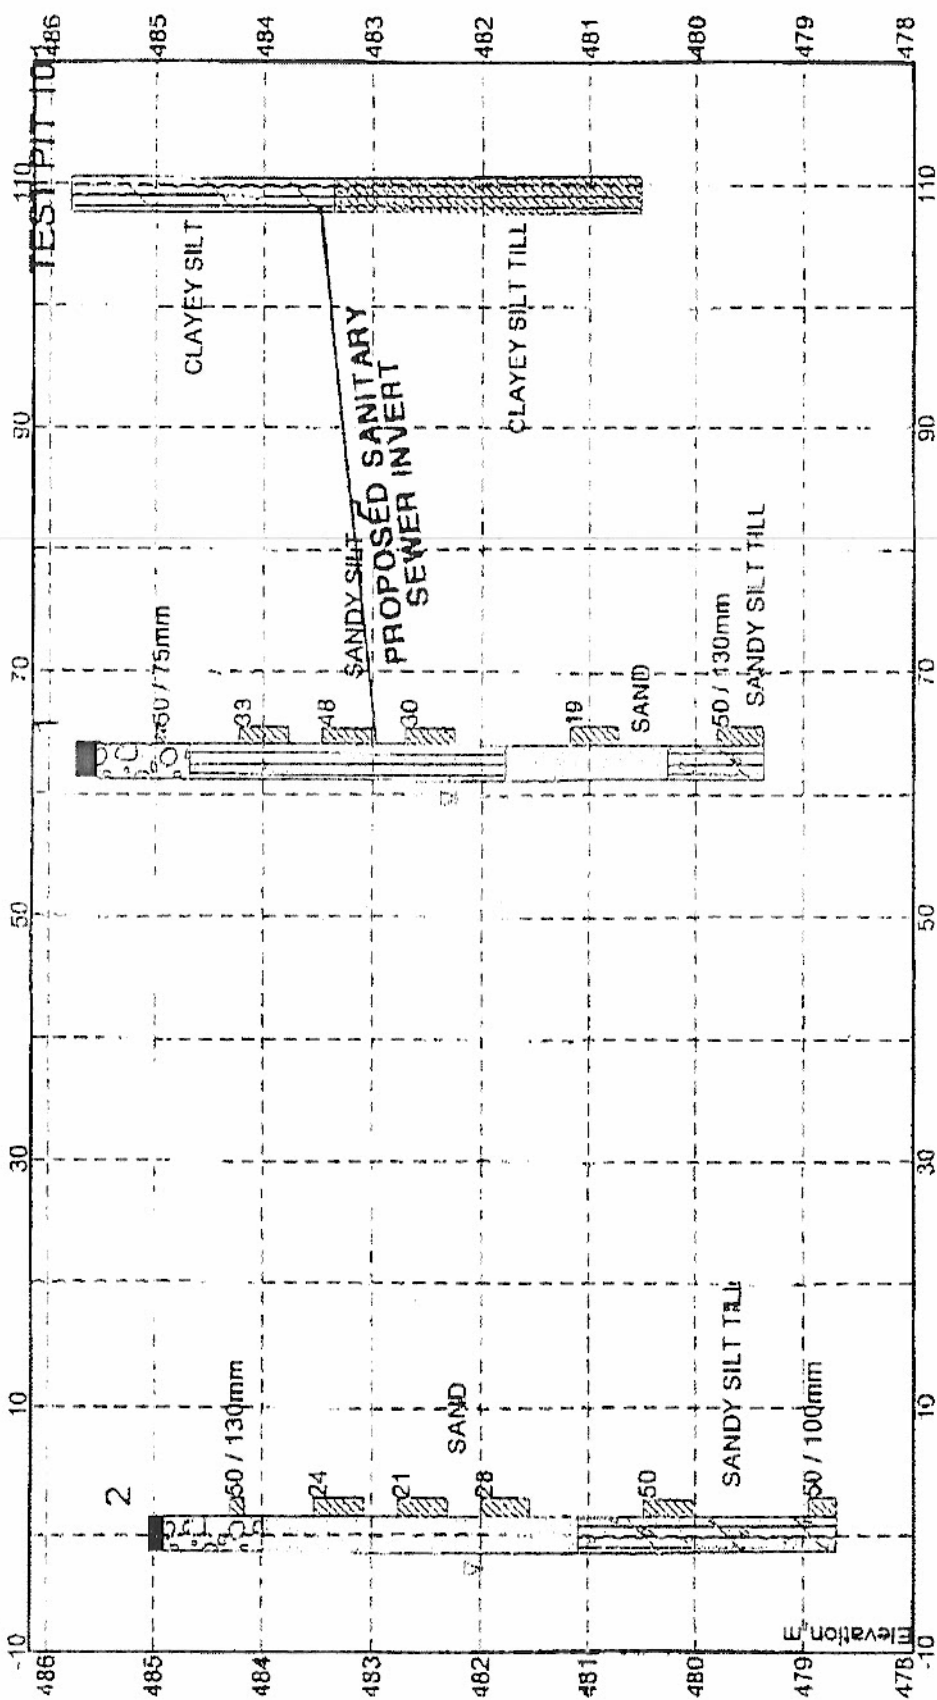
PROJECT #	DATE	DRAWING
03 LPL 778	May 03	5

The subsoil stratigraphic section indicates that the subsoil at and above the proposed invert of the sanitary sewer, under King's Highway 10 and 89, will consist of clayey silt at Test Pit 101 and sandy silt at Borehole 1 locations. These deposits are of low plasticity to non-plastic and will be very sensitive to construction traffic. Unsupported horizontal tunneling in these materials will not be stable and could result in excessive settlement / collapse of the road above the tunnels.

The clayey silt and the sandy silt deposits are in compact to dense state and it might be difficult to jack liners through these deposits. Loosening of the soil by auguring, in advance of jacking, will be necessary.
