Memo to Mr. A. M. Toye, Date December 3, 1959.
Bridge Engineer. Subject FOUNDATION IN VESTIGATION by
From Materials & Research Section. Dominion Soil Investigation, Ltd
Attention: Mr. S. McCombie.

Re: Hwy. #544 & Whitson River Crossing,
Sudbury - Dist. #17 - W.P. 252-59.

REPORT ON
FOUNDATION INVESTIGATION
WHITSON RIVER CROSSING
SECONDARY ROAD NO. 544
NEAR CHELMSFORD
DISTRICT OF SUDBURY

FOUNDATION INVESTIGATION
WHITSON RIVER BRIDGE CROSSING
SECONDARY ROAD NO. 544
W.P. 252-59

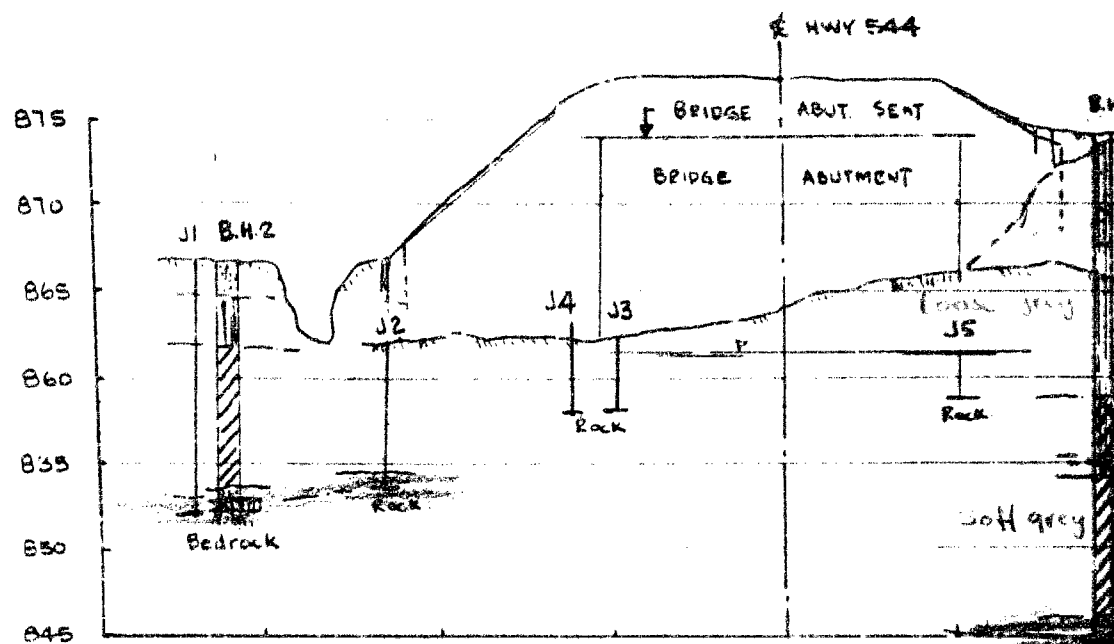
SECTION AT WEST ABUT. - LOOKING

There is a marked difference in the soil at the abutments. At the west abutment a loose silty sand is followed by a loose to medium dense grey silt. Borehole 1 encountered an 8.5 ft layer of silt with thin sand seams extending to elevation 858.7. A firm grey silty clay underlies the silt and extends to bedrock. The clay has vane shear strengths of 900 - 1100 psf with a sensitivity of 5-6. Natural water contents are 42.7% to 60.5% and two unit weight readings are 106 and 116 pcf. The water contents are well in excess of the liquid limit giving a range of liquidity index from 1.4 to 1.8.

Bedrock dips to the north at the west abutment. The difference in elevation is about 7 ft over the normal two lane bridge width. The foundation may be extended to rock by the use of a mass concrete pier or it may be designed to rest on rock at the south end and supported on bearing piles to bedrock beyond the rock support to the north.

Foundations for the proposed bridge may be placed on bedrock. It is recommended that the footings extend a minimum of 1 ft into the rock. A safe bearing capacity of 5 tons per sq ft may be assumed although higher values may be used if required. A mass concrete pier foundation could be used under the west abutment where the bedrock slopes to the north.

The clay strata behind the proposed abutment should be removed a distance of about 5 ft from the foundation, then at a 45 degree slope. This is felt necessary to avoid the possibility of embankment "creep" which would exert a large horizontal force on an abutment. Granular backfill should be used behind the abutments.

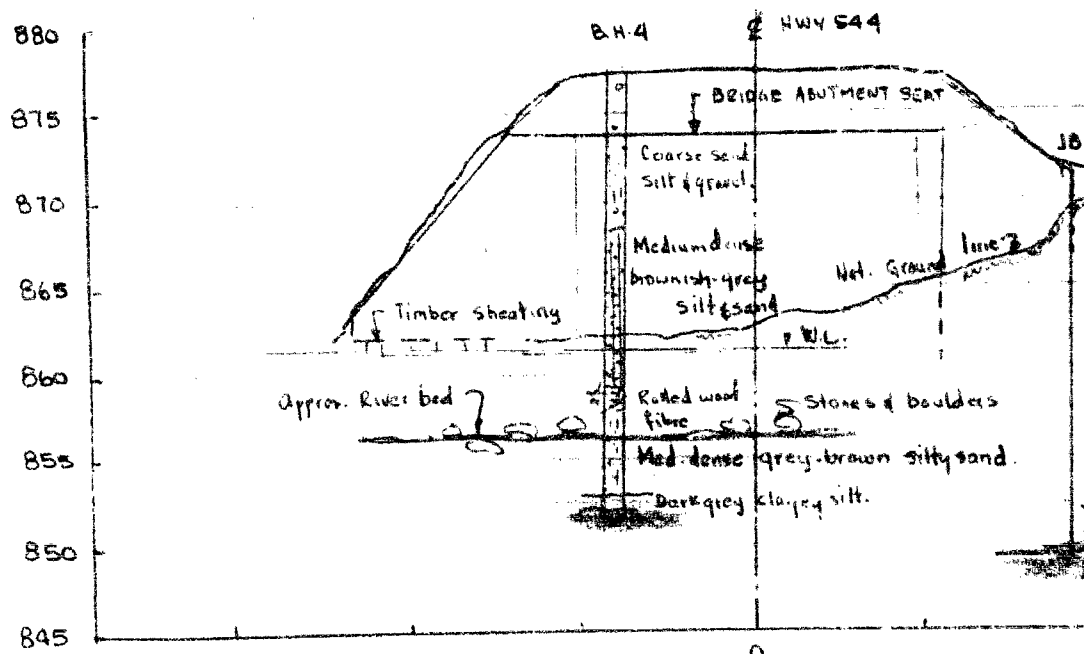
SECTION AT EAST ABUT. - LOOKING

At the east abutment the subsoil was found to be granular throughout. In borehole 3 it was loose throughout. A 1 ft layer of sand with numerous partially rotted wood fibre was encountered at elevation 853. The dark grey clayey silt and decomposed rock mixture followed. Bedrock was encountered at elevation 850.3. Borehole 4 showed granular backfill from the roadway surface to a depth of 10-15 ft. A layer of wood fibre and decayed vegetation was encountered at elevation 858.5. Following the thin layer of blackish clayey silt and coarse sand bedrock was encountered at elevation 852.4.

The east abutment would rest on bedrock. In view of the fractures noted in the top 1 ft of rock, it is advisable to extend the foundations a minimum of 1 ft into bedrock.
