LOCATION ST. JOSEPH ISLAND  
BRIDGE STR. and APPROACHES

CONT. 70-204  
ST. JOSEPH ISLAND BRIDGE  
VP 98-66  
LOCATION OF CORE DRILL SAMPLES  
KING, 1972

SUBSIDANCE OF SOUTH ABUTMENT

SUBJECT: Substructure Excavation,  
St. Joseph Island Bridge,  
Highway #548, District #18,  
W.P. 98-66, Contract 70-204

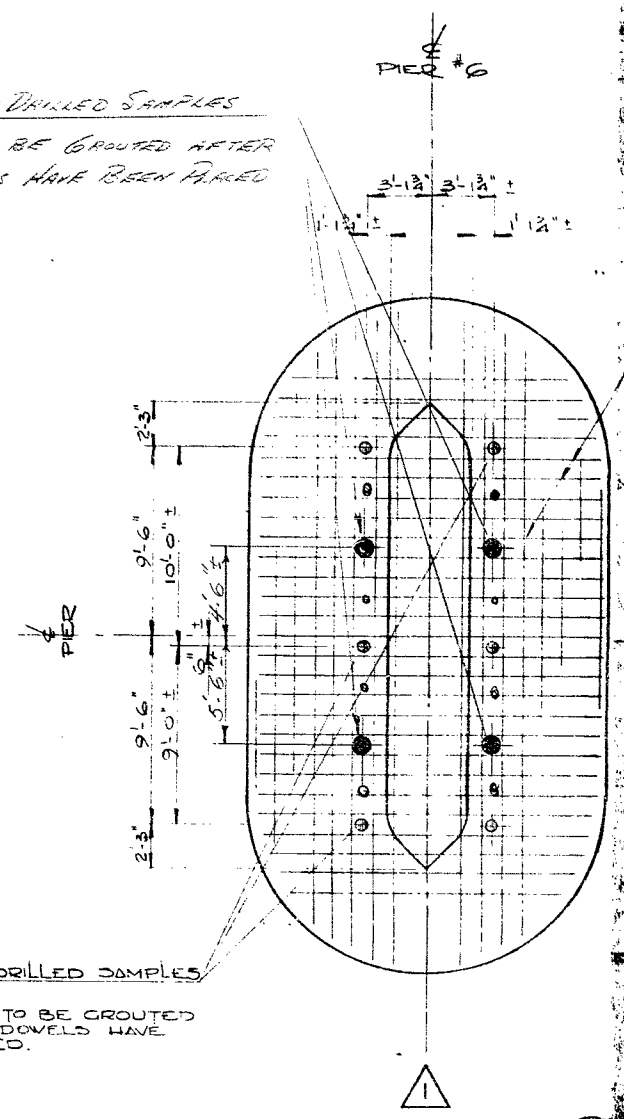
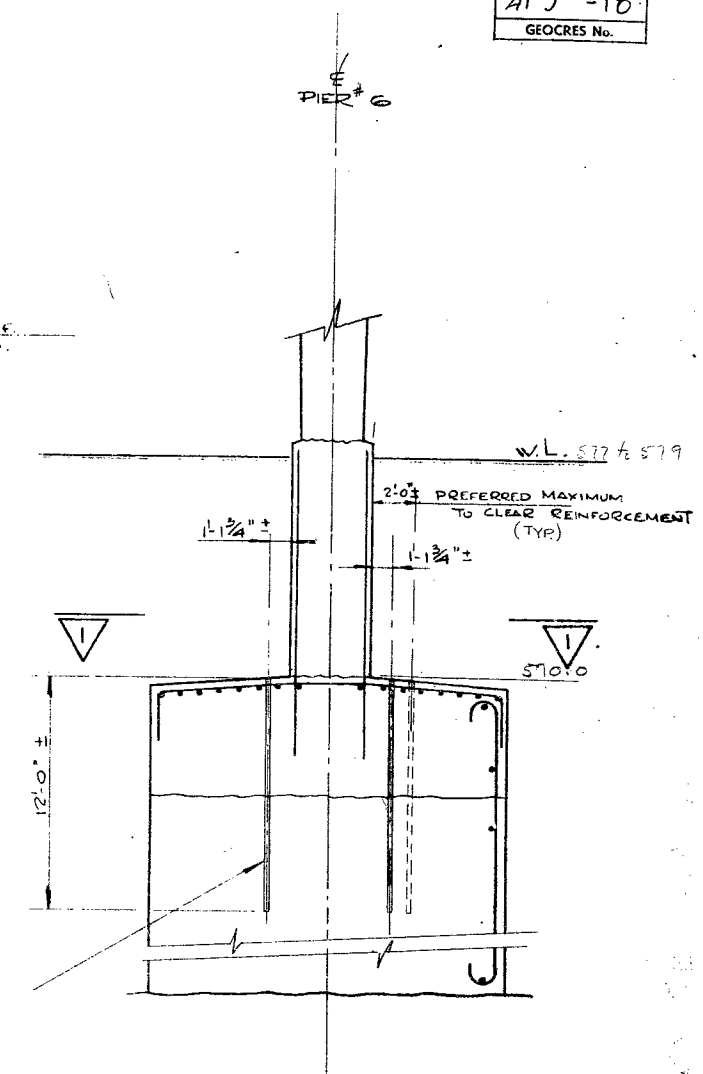
6"  $\phi$  CORE DRILLED SAMPLES  
HOLES TO BE GROUTED AFTER  
#14 DOWELS HAVE BEEN PLACED

3"  $\phi$  CORE DRILLED SAMPLES  
THE HOLES TO BE GROUTED  
AFTER #14 DOWELS HAVE  
BEEN PLACED.

REQUIRED:  
6 / #14 11'-0" LONG DOWELS.

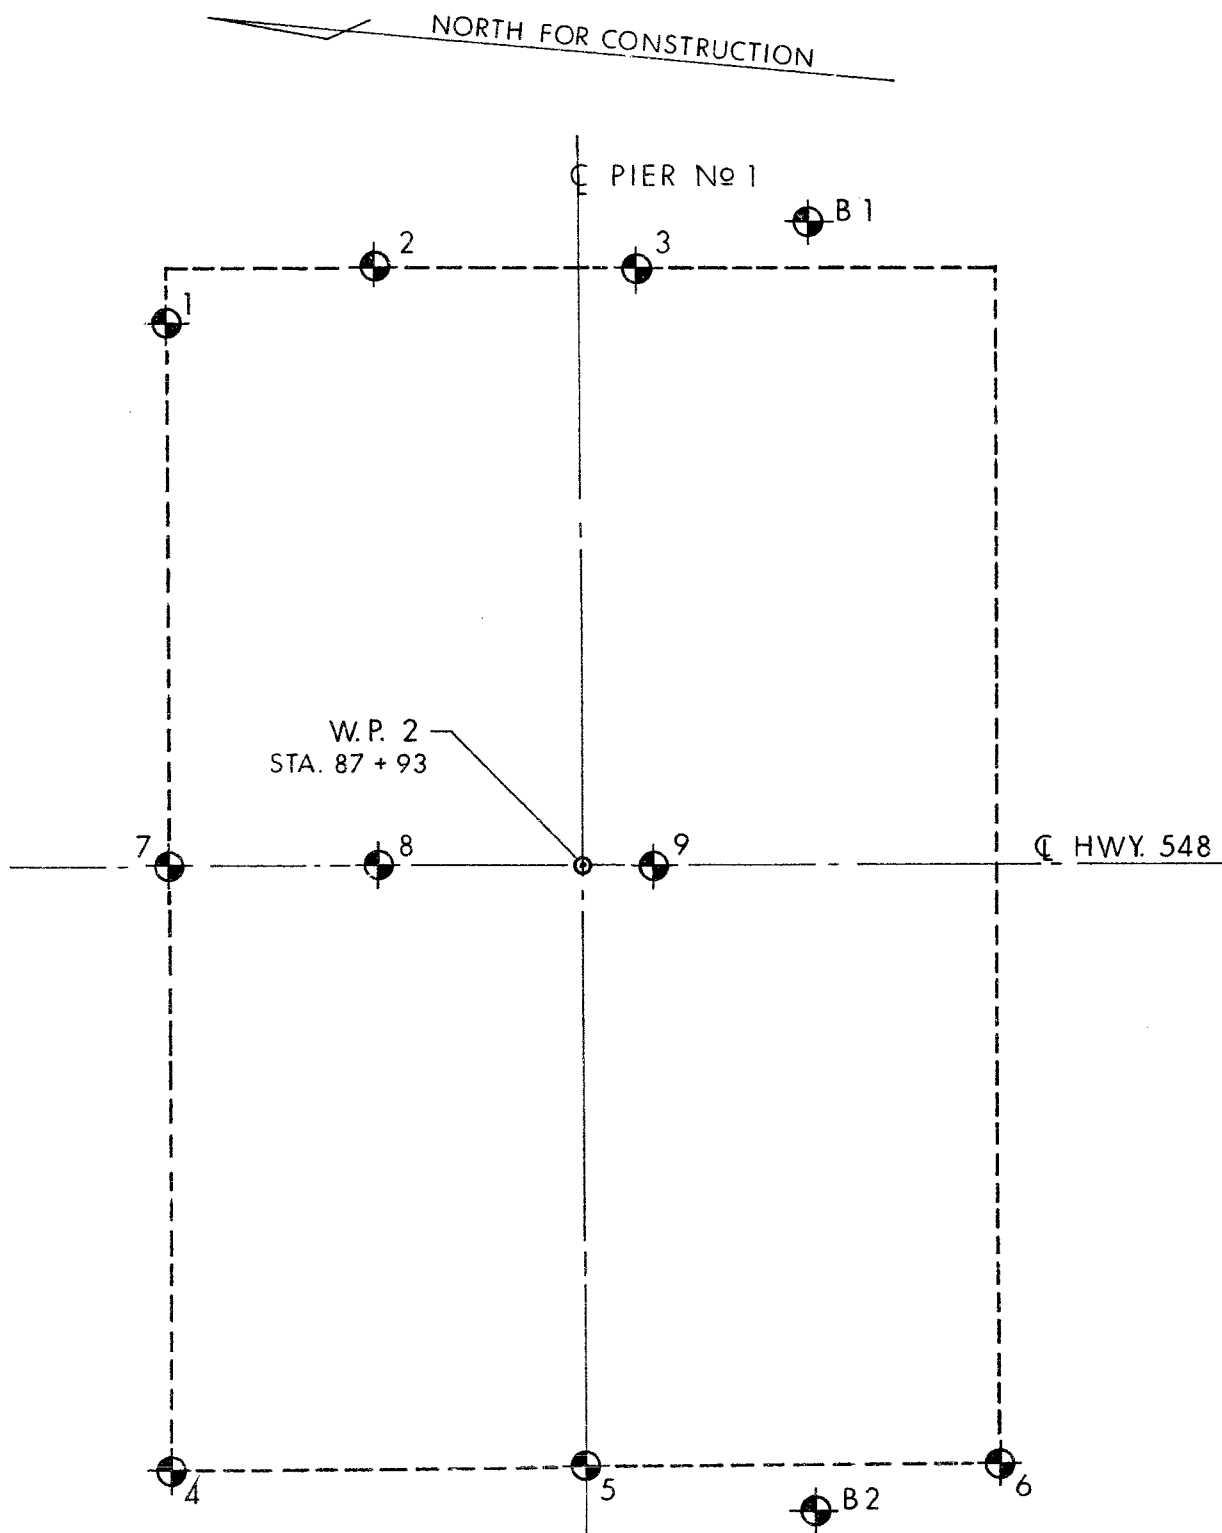
## BORE HOLE LOCATIONS AT PIER No 1 FOOTING

Following are the results of borings recently carried out for No. 1 Pier footing of the abovementioned structure. The locations of the borings are shown on the attached sketch.

The overburden consists of a mixture of clay, sand, gravel and boulders. Between the bedrock surface and the sound bedrock exists a zone of fissured rock partly due to normal weathering and partly due to what appears to be the results of blasting. During the field work, a steel pipe was discovered at the location of B.H.'s #4 and #7. The approximate elevation

It is recommended that all overburden, and loose rock from the fissured zone be removed and replaced with mass concrete (tremied if desired), prior to pouring the main structure foundation.
