EMBANKMENT FAILURE
APPROX. 1.5 MILE WEST OF DESBARATS
(STA. 360+00 TO STA. 370+00)

BORE HOLE LOCATIONS & SOIL STRATA

FOUNDATION INVESTIGATION REPORT
For
Failures of Embankment Between
Station 363+00 and Sta. 369+00
Trans-Canada Highway #17
Contract 67-85
District #18 (Sault Ste. Marie)
W.J. 68-F-34 -- W.P. 904-62

FOUNDATION INVESTIGATION REPORT
For
Failures of Embankment between
Station 363+00 and Sta. 369+00
Trans-Canada Highway #17
Contract 67-85
District #18 (Sault Ste. Marie)
W.J. 68-F-34 -- W.P. 904-62

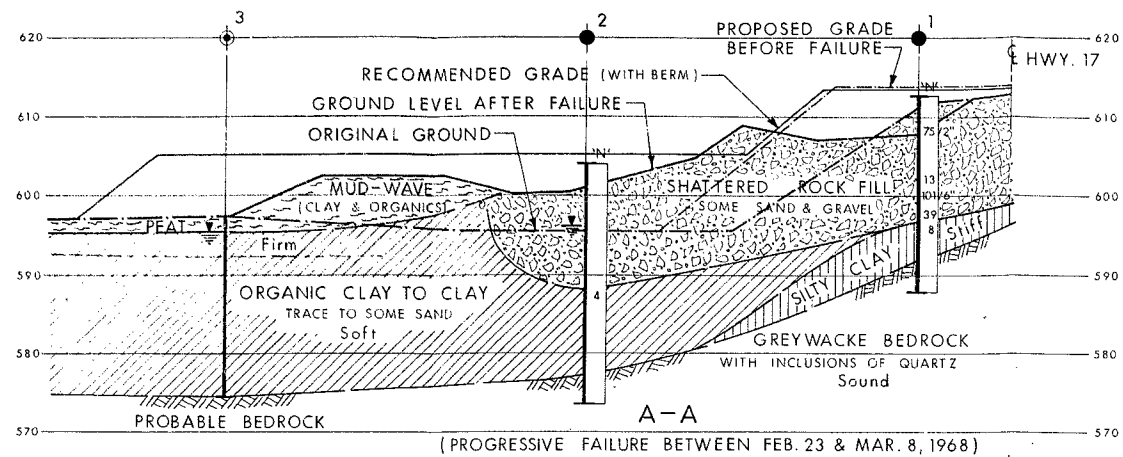
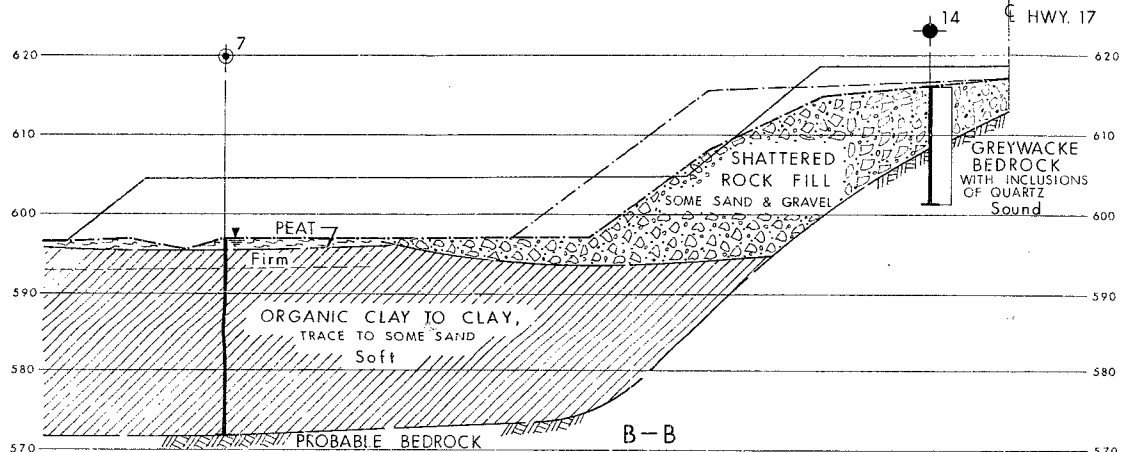
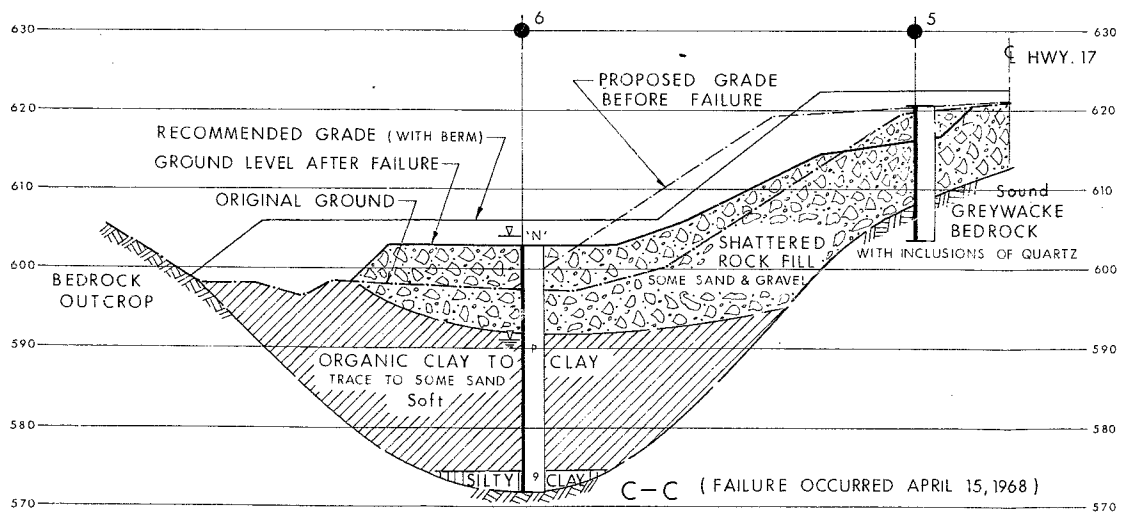
SECTIONS
SCALE
10 5 0 10 20 FT.

A typical cross-section taken following the failure is plotted on Section A-A shown on Drawing 68-F-34A.

i) A mud-wave composed of remoulded and displaced clay and organic material was formed about 80 feet from the centre-line of the re-aligned roadway. The maximum height of the wave is about 5 feet.

ii) The shoulder of the embankment slumped some 8 to 10 feet; the crest of the failed slope was about 3 feet away from the edge of the existing pavement.

Typical cross-sections taken following the failure are plotted on Sections B-B and C-C shown on Drawing 68-F-34A. The following can be noted about the failure:

i) At this location no appreciable mud-wave was formed. The toe of the failure area was probably restricted by the bedrock outcropping immediately south of the creek.

ii) The shoulder of the embankment settled some 5 feet; the crest of the failed slope was about 4 feet away from the edge of the existing pavement.

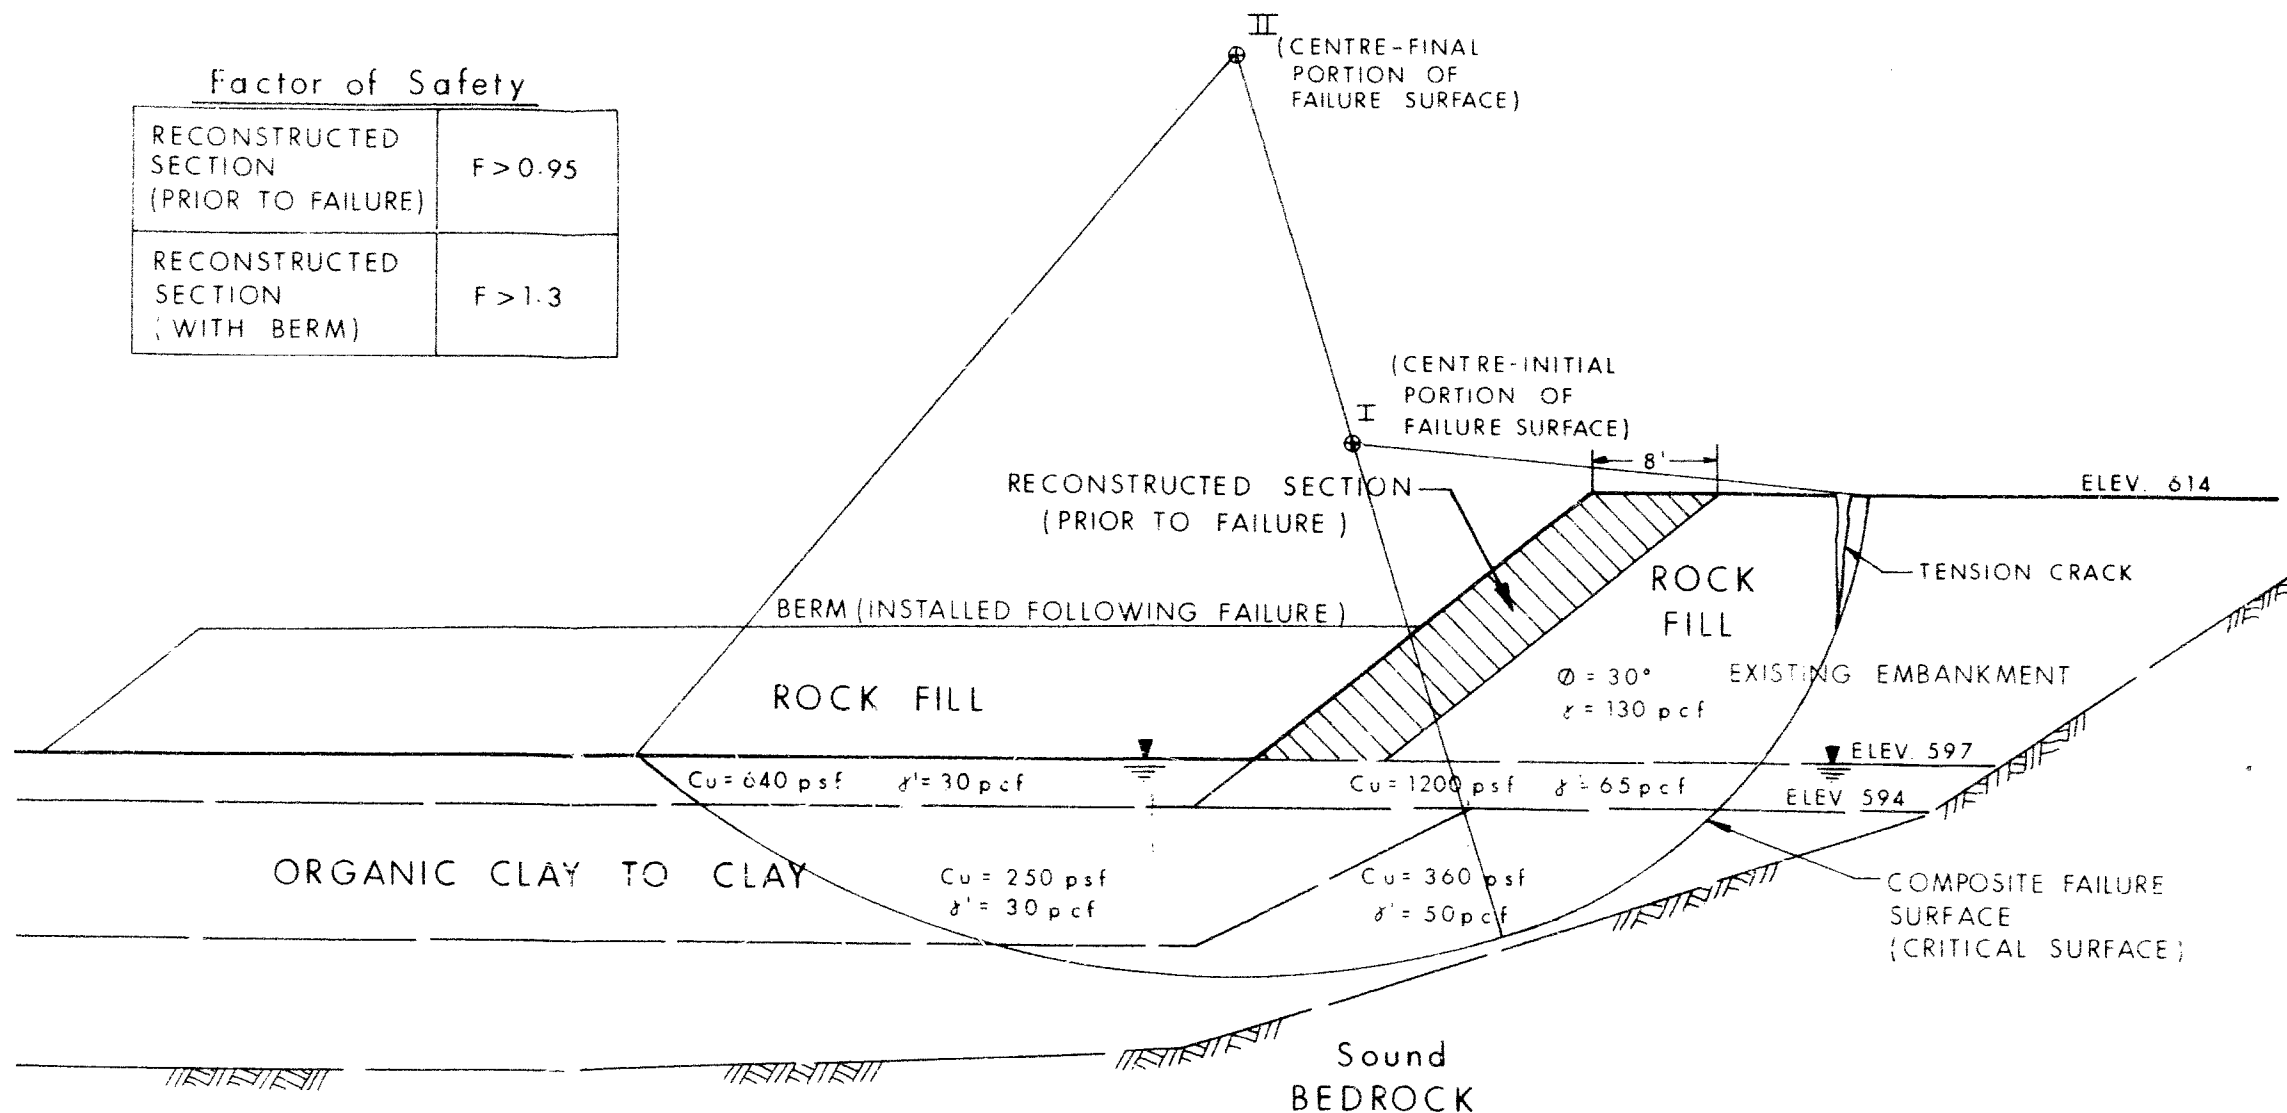
FIGURE NO. 4

The stability analyses carried out indicate that the factor of safety of the reconstructed embankment (prior to failure), was slightly less than 1.0 (about 0.95). The analyses carried out on the section incorporating a berm, however, indicate that the factor of safety was increased by at least 30% - i.e., 1.3 or greater. It is considered that this is acceptable to ensure the long-term stability of the section.

RECONSTRUCTED SECTION (PRIOR TO FAILURE)	$F > 0.95$
RECONSTRUCTED SECTION (WITH BERM)	$F > 1.3$

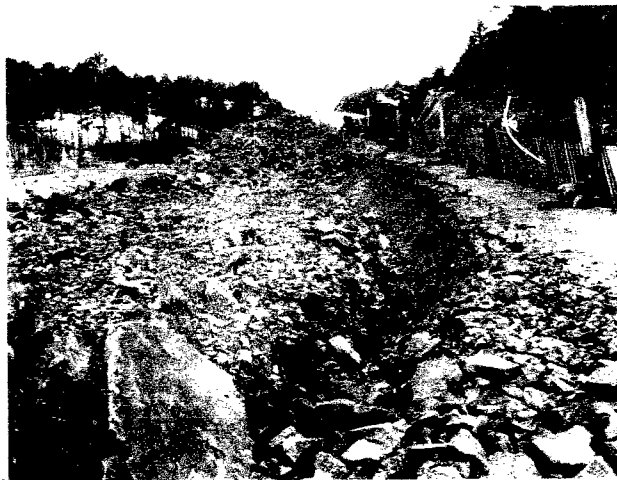
FAILURE OF RECONSTRUCTED EMBANKMENT

SOUTH SHOULDER OF HIGHWAY NO. 17
STA. 363+50 TO 365+00
(MARCH 1968)

i) that a berm be placed between Sta. 363+25 and 369+00. This berm should be placed at the mid-height of the slope and should extend at least 10 feet past the toe of the mud-wave.

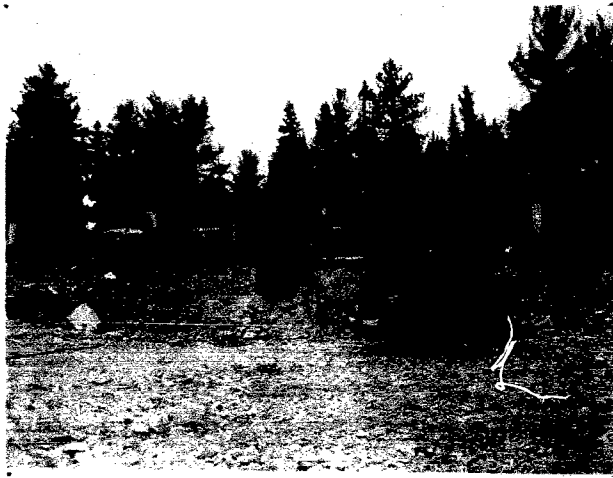
RECONSTRUCTION FOLLOWING FAILURE

DRILL RIG SET UP AT BORE HOLE NO. 1 STA. 364+50
SHOWING RECONSTRUCTED EMBANKMENT AND BERM
STA. 363+00 TO 367+00
(APRIL 18, 1968)

Berm construction commenced on the week of March 25, 1968. The rock fill berm was constructed to within 10 feet of the proposed width between Sta. 362+50 and 369+00; the surface of the berm was at about elevation 604, which is some 2 feet below that proposed. The berm was brought up to final grade the week of April 22, 1968. A sandwich blanket of finely crushed rock was placed between the soft cohesive subsoil and the rock fill in all pertinent areas, as called for in Section 6.2) ii); only a minimal amount of organic matter was removed as per Section 6.2) iii). The proposed finalized sections are plotted on Drawing 68-F-34A.

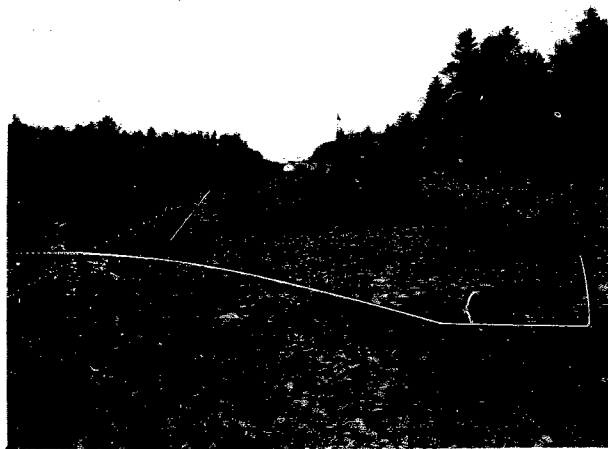
RECONSTRUCTING SOUTH SHOULDER FOLLOWING FAILURE
STA. 363+00 TO 365+00
(APRIL 19, 1968)

The reconstruction of the south shoulder of the embankment, in the failure areas, was started on April 19, 1968. End-dumping of rock fill commenced at about Sta. 363+00 and proceeded in a westerly direction. Reconstruction between Sta. 367+00 and 369+00 was started on April 22, 1968.

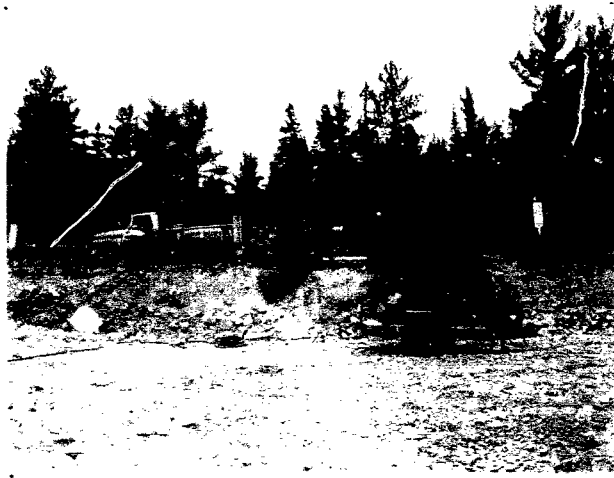
RECONSTRUCTION FOLLOWING FAILURE

DRILL RIG SET UP AT BORE HOLE NO. 1 STA. 364+50
SHOWING RECONSTRUCTED EMBANKMENT AND BERM
STA. 363+00 TO 367+00
(APRIL 18, 1968)

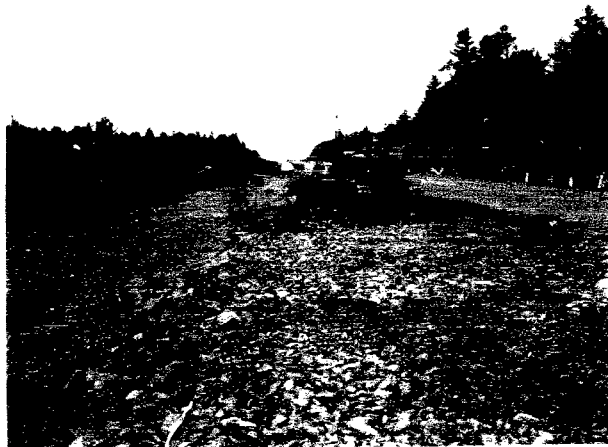
RECONSTRUCTING SOUTH SHOULDER FOLLOWING FAILURE
STA. 363+00 TO 365+00
(APRIL 19, 1968)

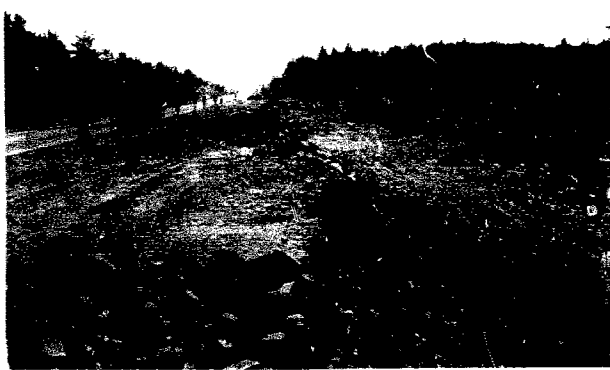
RECONSTRUCTION FOLLOWING FAILURE

During and following the berm construction and south shoulder reconstruction, the failure areas appear to have performed satisfactorily - i.e., up to this date no signs of instability have been evident. During this period the embankment section in the most easterly failure area (Sta. 363+50 to 365+50) has not undergone any appreciable settlement. However, in the failure area between Sta. 367+00 and 369+00, some differential settlement did occur between the old embankment and the reconstructed south shoulder. This settlement, which was of the order of 1 to 1-1/2 feet, primarily occurred immediately following the end-dumping of the fill. According to information provided to us, only negligible settlement has been recorded in this area since April 24, 1968. In summary, at the present time, the remedial measures initiated appear to have stabilized the embankment sections in the problem areas.

SHOWING HIGHWAY NO 17 EMBANKMENT AND BERM
STA 363+00 TO 367+00
(APRIL 22, 1968)

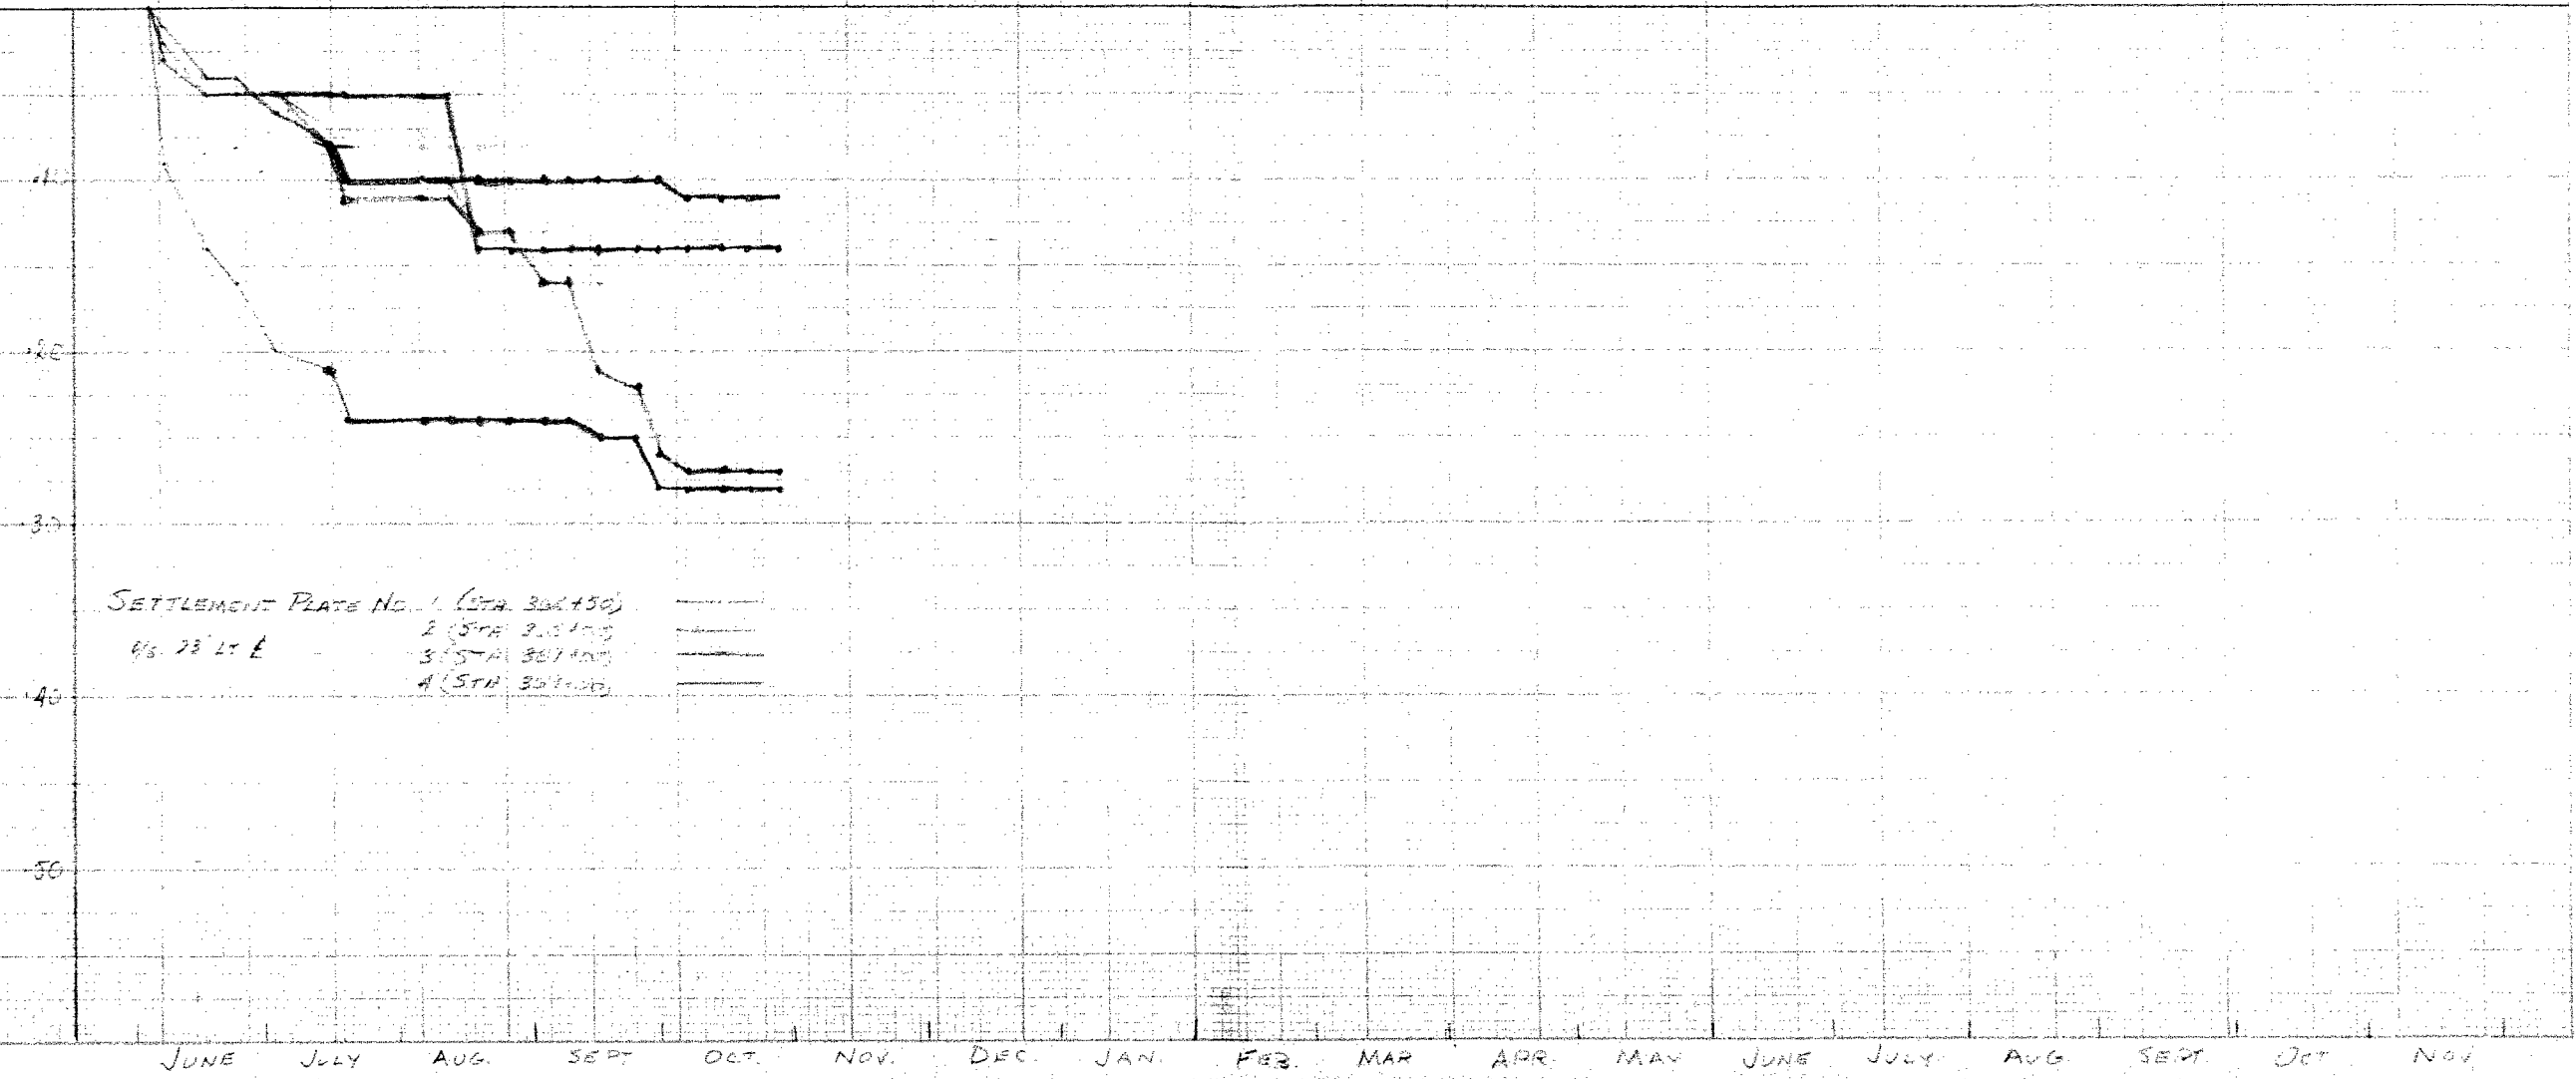
SETTLEMENT PLATE NO. 1 (STA 364+50)
 2 (STA 365+00)
 3 (STA 367+00)
 4 (STA 369+00)

If settlement of the foregoing magnitude occurs, some maintenance of the embankment will be required. To determine the magnitude of the settlement involved, settlement plates should be installed as per Section 6.2) iv). The elevations taken on the plates should periodically be forwarded to the Foundation Section. If appreciable settlement is still taking place, it may be advantageous to postpone final paving as long as possible.
