## **Golder Associates**

MINISTRY OF TRANSPORTATION AND  
COMMUNICATIONS

REVIEW OF RIVER BANK INSTABILITY  
MISSISSAGI RIVER  
IRON BRIDGE TO MISSISSAGI CHUTES  
WP 153-83-00                      DISTRICT 18  
PHASE II

November, 1985

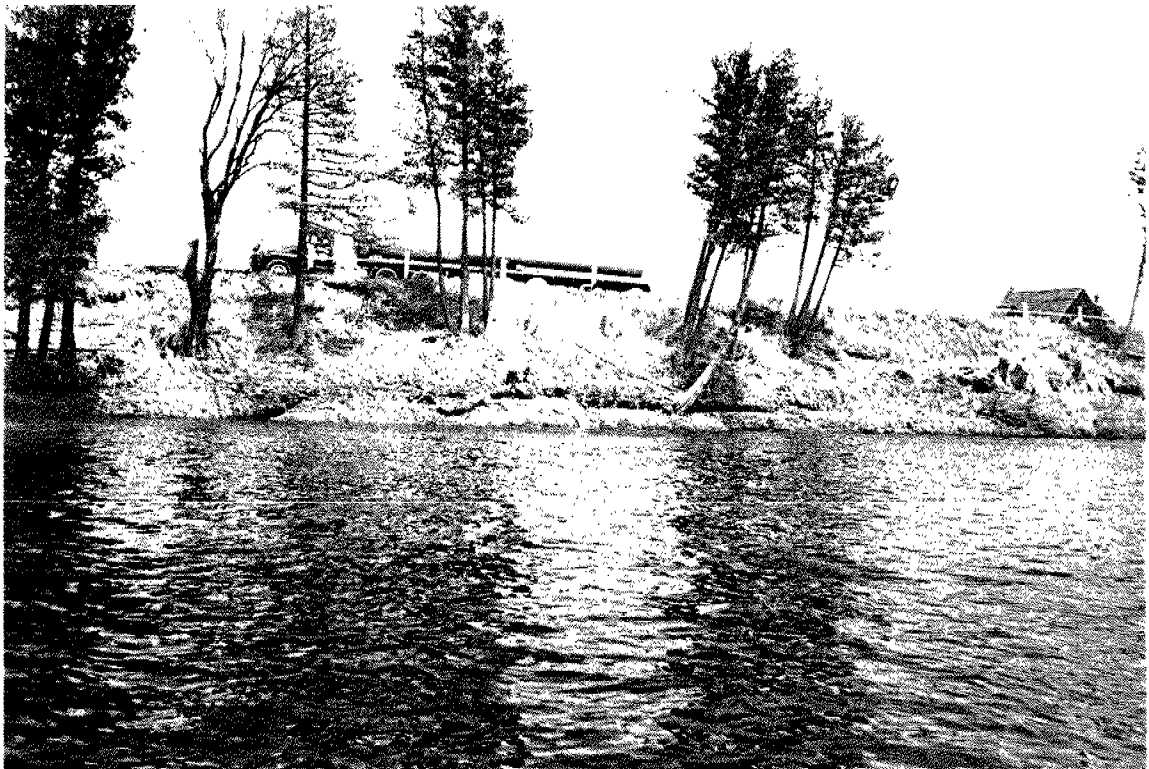
( MTC CHAINAGE 17 + 800 )

Erosion of the materials at the toe of the slope (I) and removal by water flow causes undercutting and steepening of the slope. If the materials comprising the slope consist of sands and/or silts, this undermining process can cause surficial sliding (II) in which the top/surface layers of soil slide in thin sheets down the banks. Where weak cohesive strata are present at or near the toe of the slope, this steepening process along with removal of the stabilizing material at the toe can effect rotational or block failures (III) which occurs along or through the weaker stratum.

PLATE I SHOWING TOE EROSION AND FORMATION OF  
BACK SCARPS

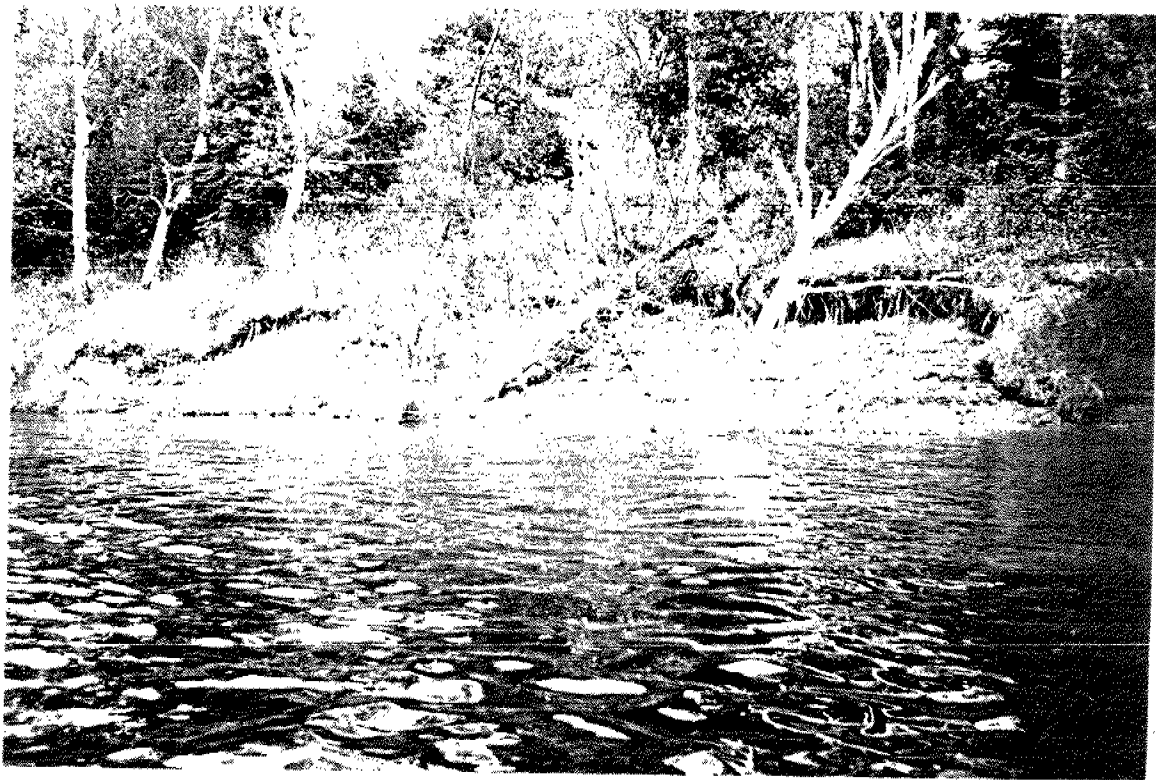
( MTC CHAINAGE 19 + 290 )

- iii) repeated fluctuations aggravate erosion of the slope toe and undermining of the loose granular materials comprising the upper part of the slope thus leading to surficial sliding of these materials.

PLATE II SHOWING SURFICIAL SLIDING

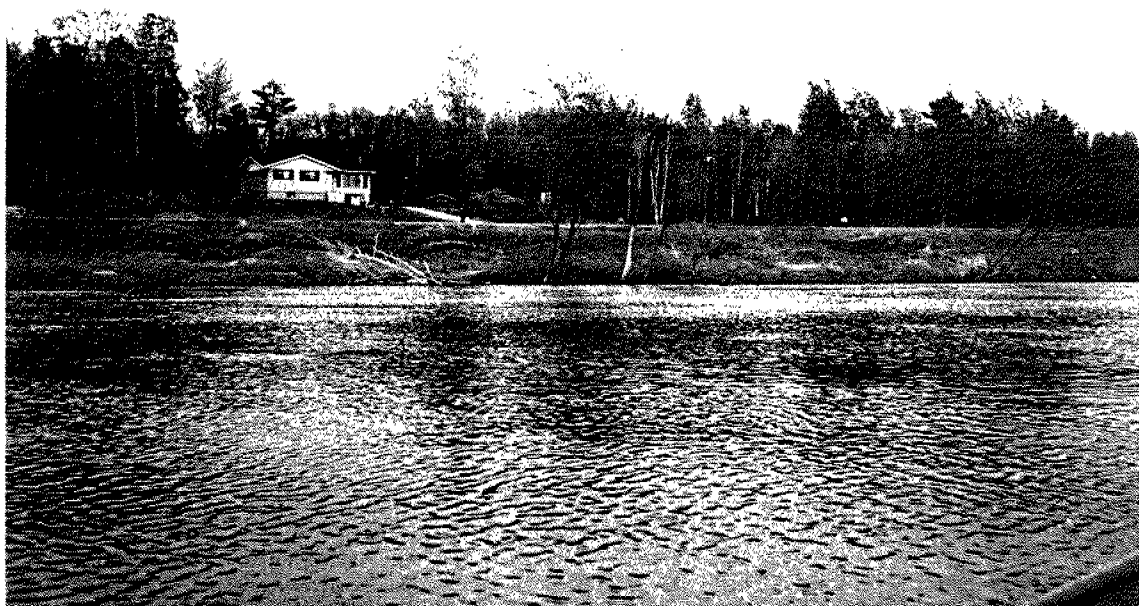
- i) river velocities can change from below to well above critical scour values on a daily basis, thus resulting in increased erosion, both of steep banks in erodible materials and of material resulting from shallow slumps or failures;
- ii) following a large drop in river water level, high piezometric levels exist in the cohesive materials at the toe of the slope causing shallow rotational failures of the bank;

PLATE III      SHOWING ROTATIONAL FAILURES  
( MTC CHAINAGE 21+330 )

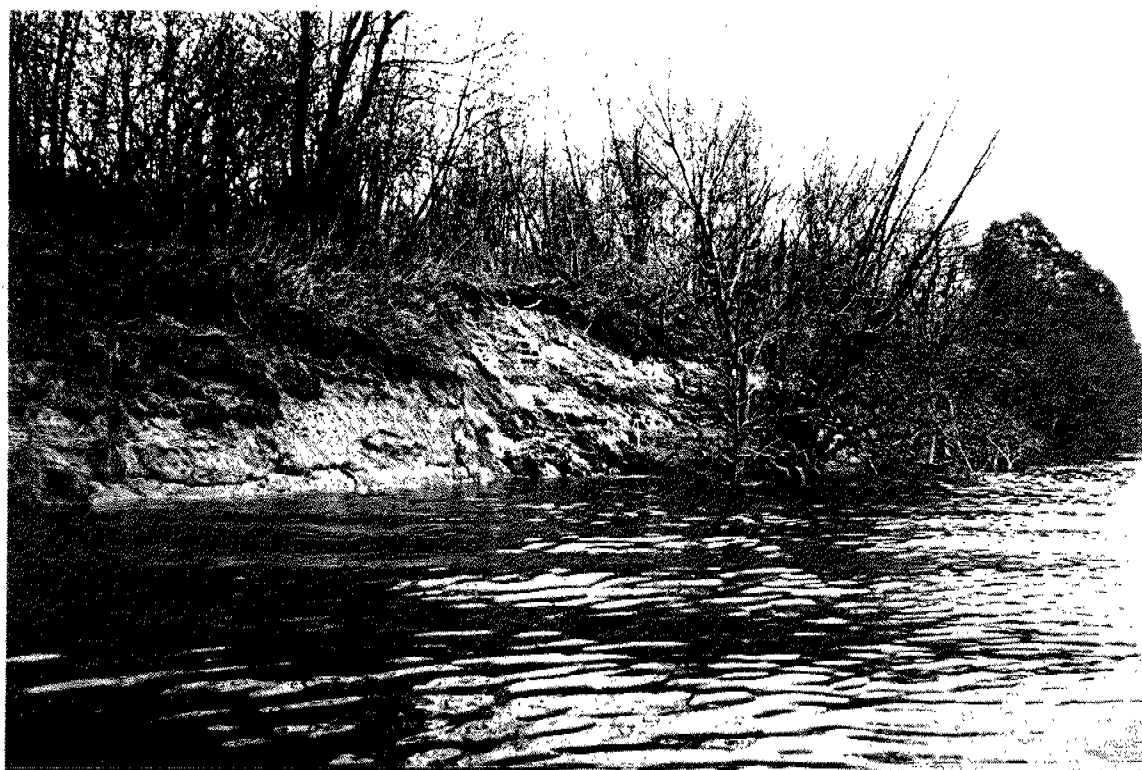
PLATE IV      SHOWING A COMBINATION OF SURFACIAL  
SLIDING AND SHALLOW ROTATIONAL FAILURE  
( MTC CHAINAGE 19+900 )

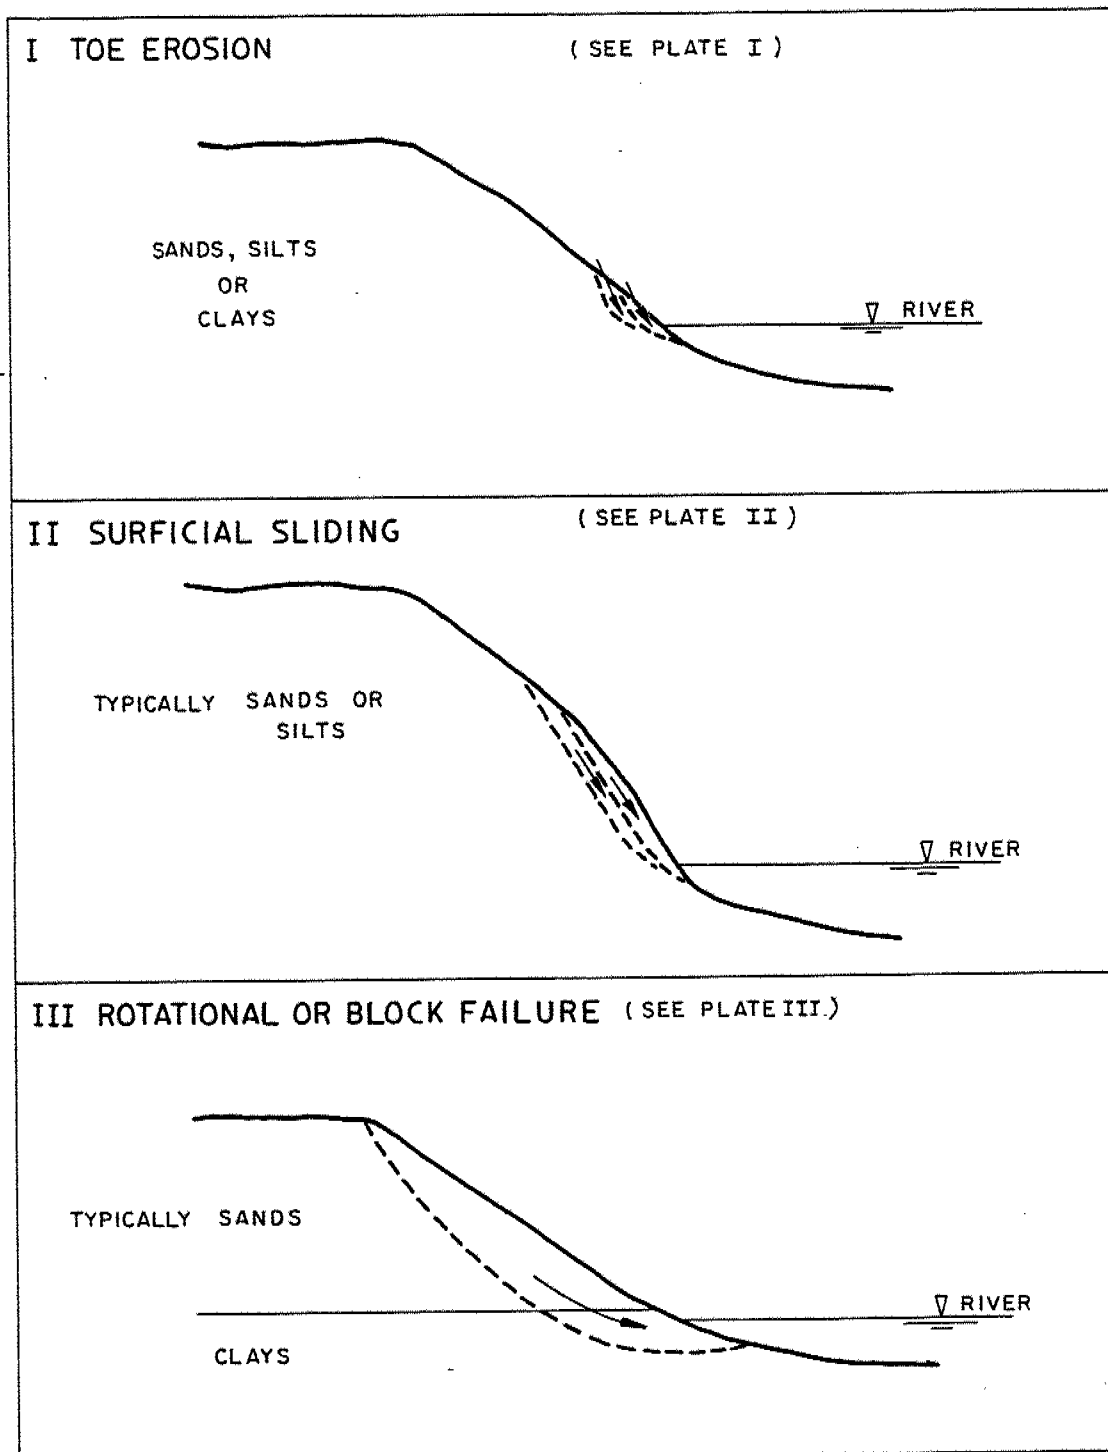
FIGURE 25

There are three types of instability identified along the banks of the Mississagi River; namely toe erosion, surficial sliding and rotational or block failure; these are illustrated schematically on Figure 25 and photographically on Plates I to IV.

SCHEMATICS SHOWING  
GENERALIZED FAILURE MECHANISMS

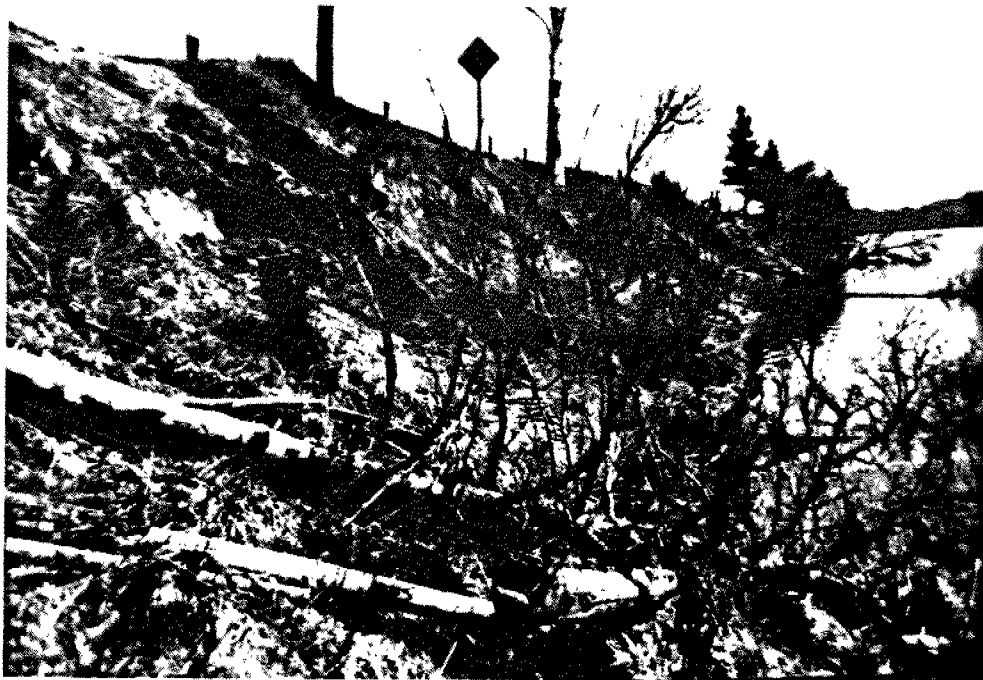
FIGURE 5

1. loss of trees and other vegetation due to slippage into the river (Figure 5)
2. loss of support for guiderail causing potential traffic hazard (Figure 3 and Figure 6)
3. potential danger of complete undermining of Highway 17 (Figure 6 and Figure 7).
