LOCATION Munroe Island Bridge

Foundation Investigation Report
For
Munroe Island Bridge at Highway 548
W.P. 29-88-01, Site 38 S-177
District 18, Sault Ste. Marie

Re Highway 11, Noden Causeway
 Site 45W-75, District 20
 Kenora District, Ontario
 Underwater Inspection Report

This report covers the underwater inspection of the **Highway 548, Munroe Island Bridge, MTO Site 38S-177**, including visual examination of the underwater components of the foundation, underwater videotape recordings of the foundations, determination of scouring conditions, and recommendations for remedial work. The Munroe Island Bridge was inspected previously by our Chief Engineering Diver in 1984.

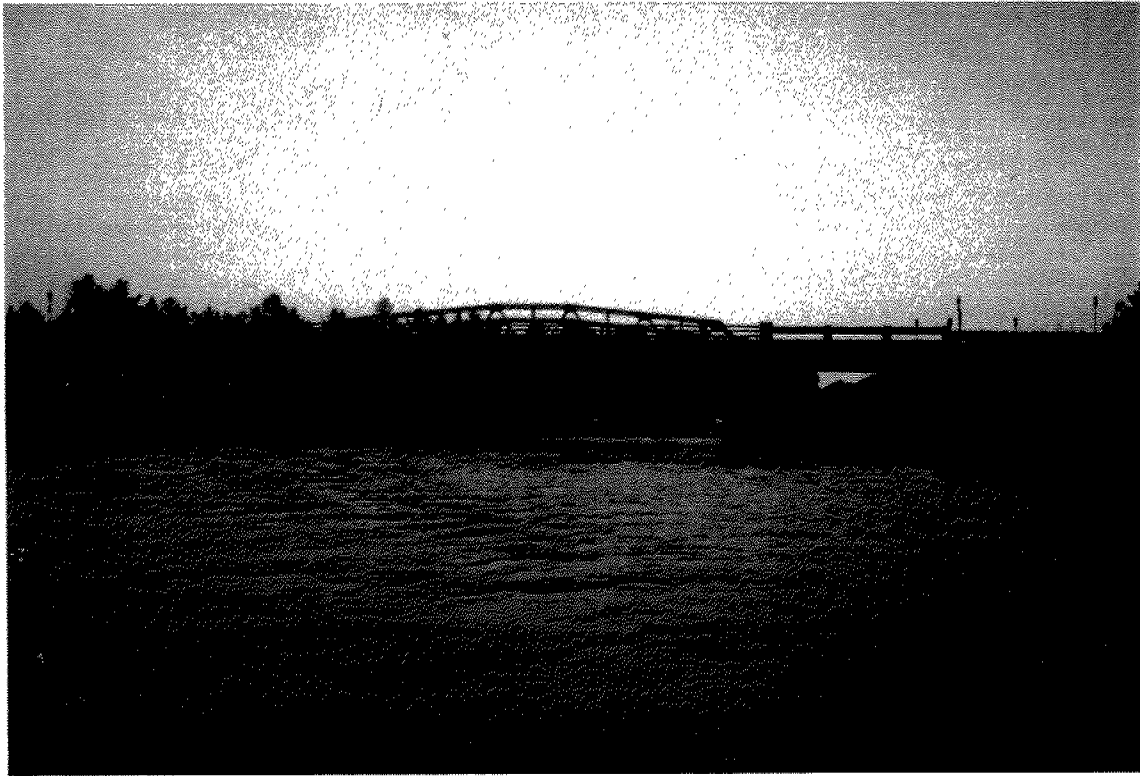
PHOTOGRAPH 1 General arrangement of bridge structure. Photograph taken looking west.

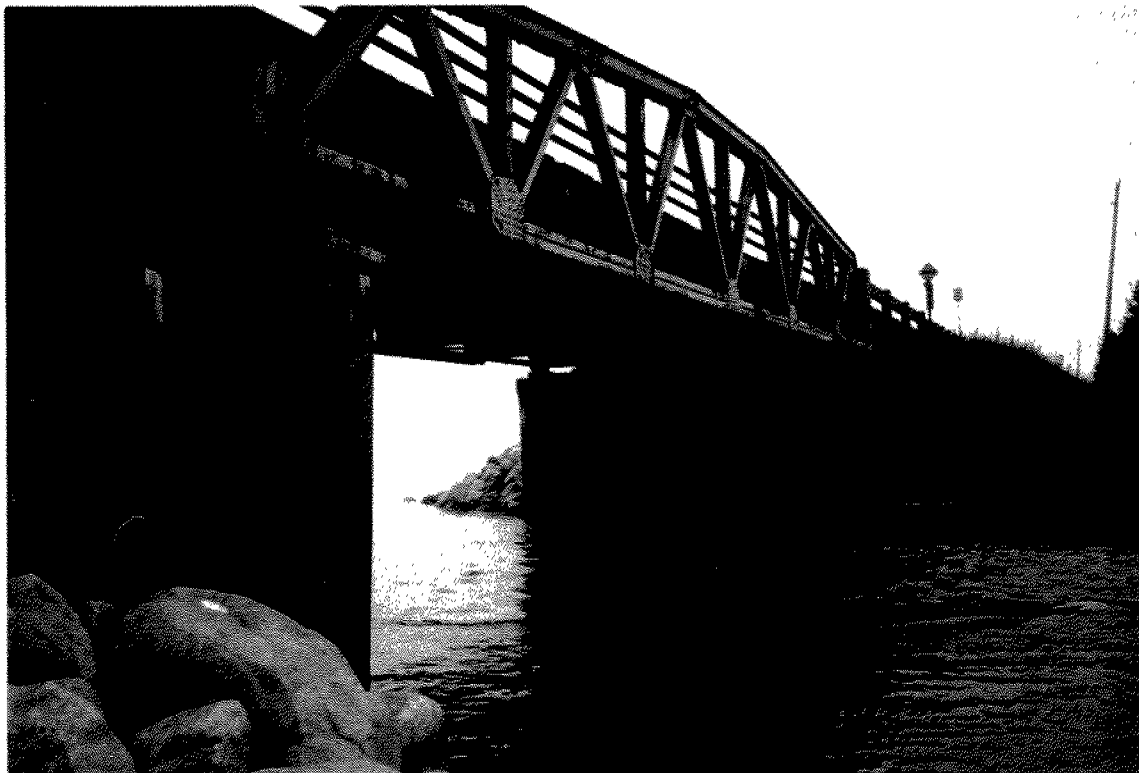
The abutment slope on the north side of the crossing is protected with rip rap and armour stone on the west side and is virtually unprotected on the east side as shown in Photograph 2. The unprotected portion of the slope is steep and bare and unable to sustain any vegetative cover. Lack of topsoil, minor slope failures and surface erosion appear ongoing, thus preventing the development of a protective vegetative cover.

PHOTOGRAPH 2 General arrangement of bridge structure. Photograph taken looking north.

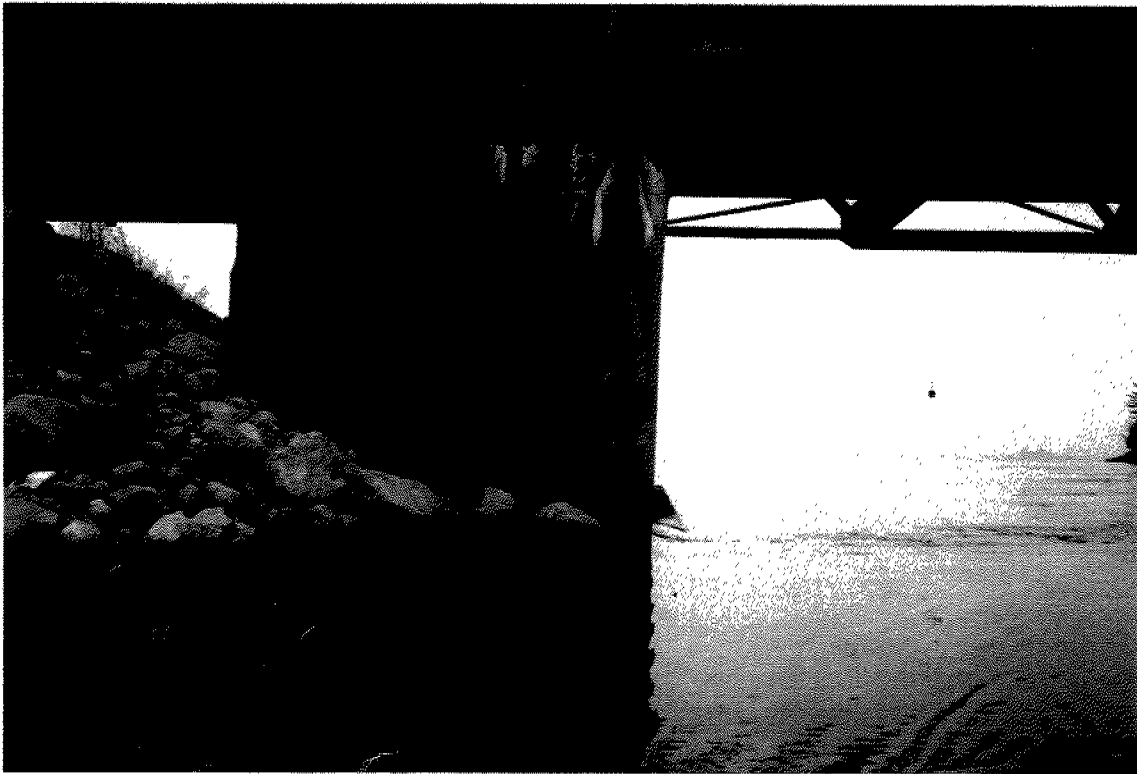
PHOTOGRAPH 8 Upstream face of Pier 1. Note lean of pier toward the channel.

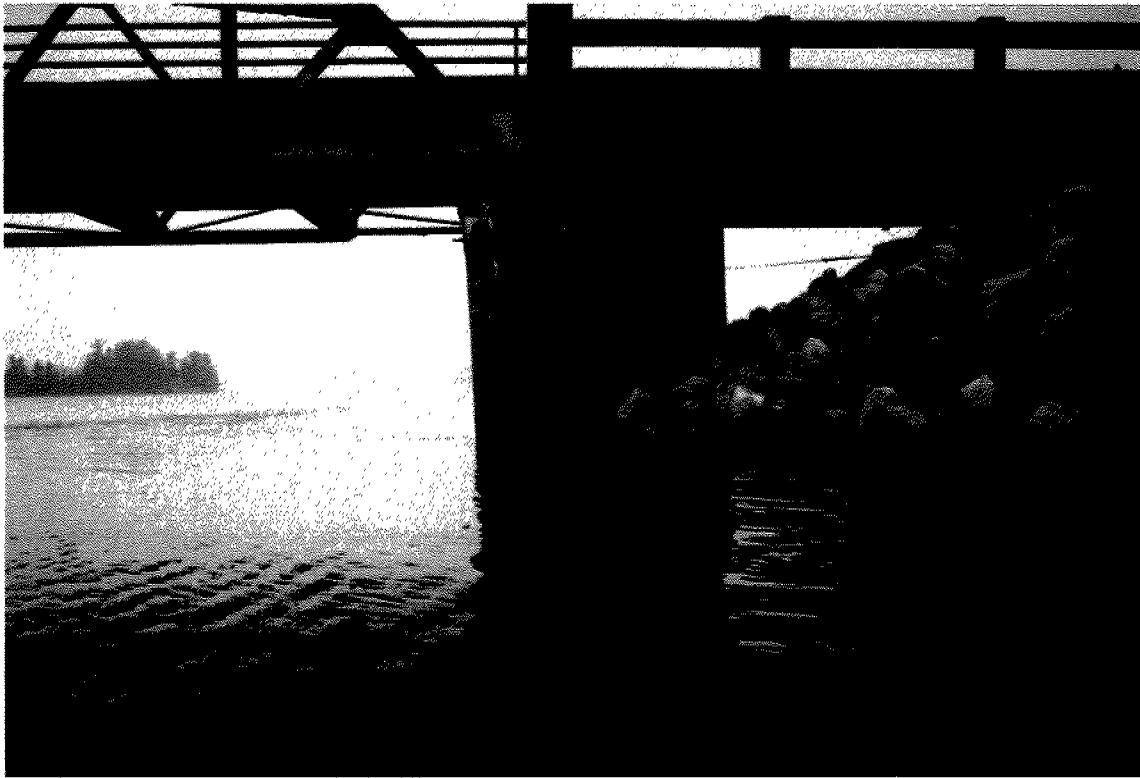
Above the water level, the concrete pier is in poor to fair condition. Photographs 7 and 9 show the general condition of the pier. Cracking of the concrete surface and deterioration at cold joints in the pier concrete is evident at several locations. Efflorescence and rust staining was observed at many of the cracks and cold joints.

PHOTOGRAPH 9 Upstream face of Pier 2. Note lean of pier toward the channel.

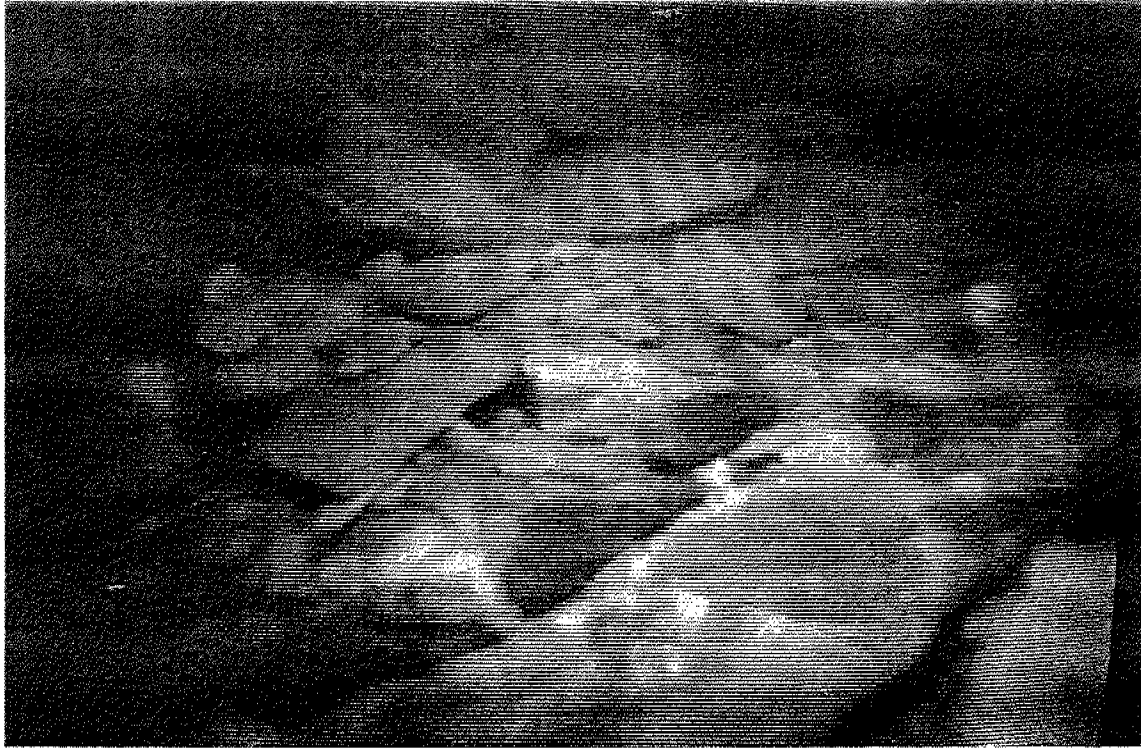
The soil around the pier consisted of loose rock (Photograph 13) and concrete sacks (Photograph 14). A steel rod was used to probe into the river bottom. However, very little penetration was possible due to the coarse nature of the material. Very little debris was noted on the river bottom around the pier.

PHOTOGRAPH 13 Loose rock and concrete rubble located around Pier 1.

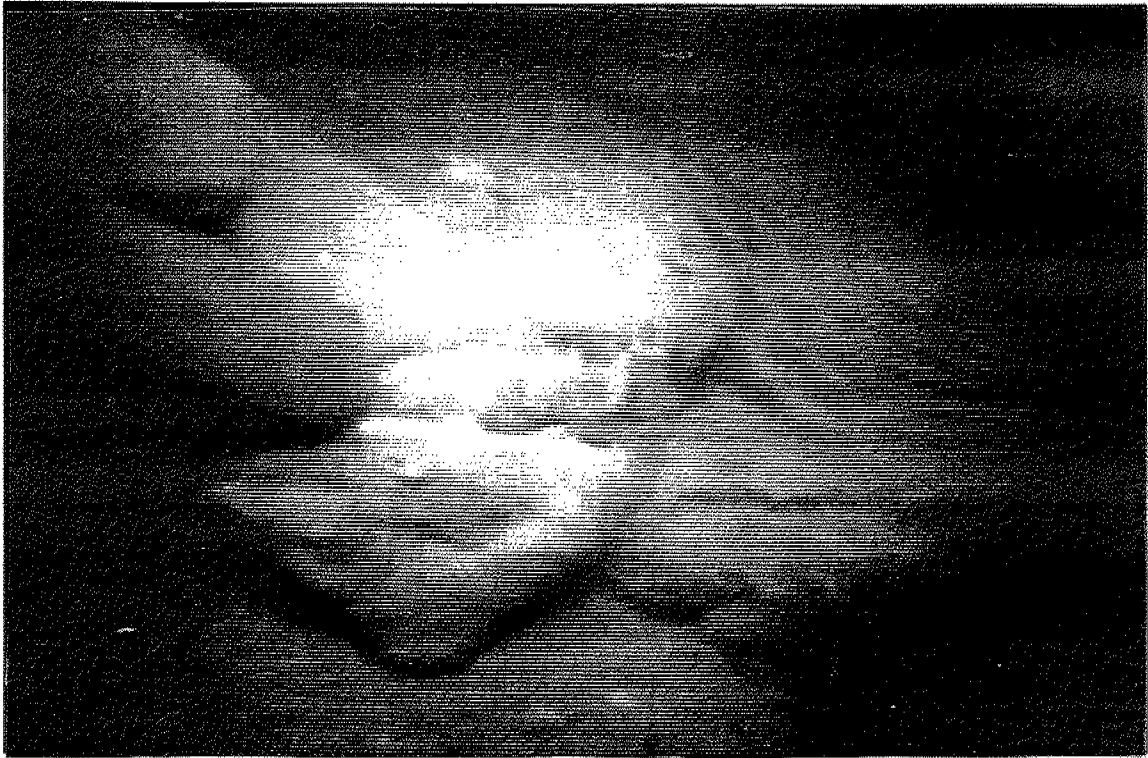
PHOTOGRAPH 15 Concrete sacks located below the footing of Pier 1.

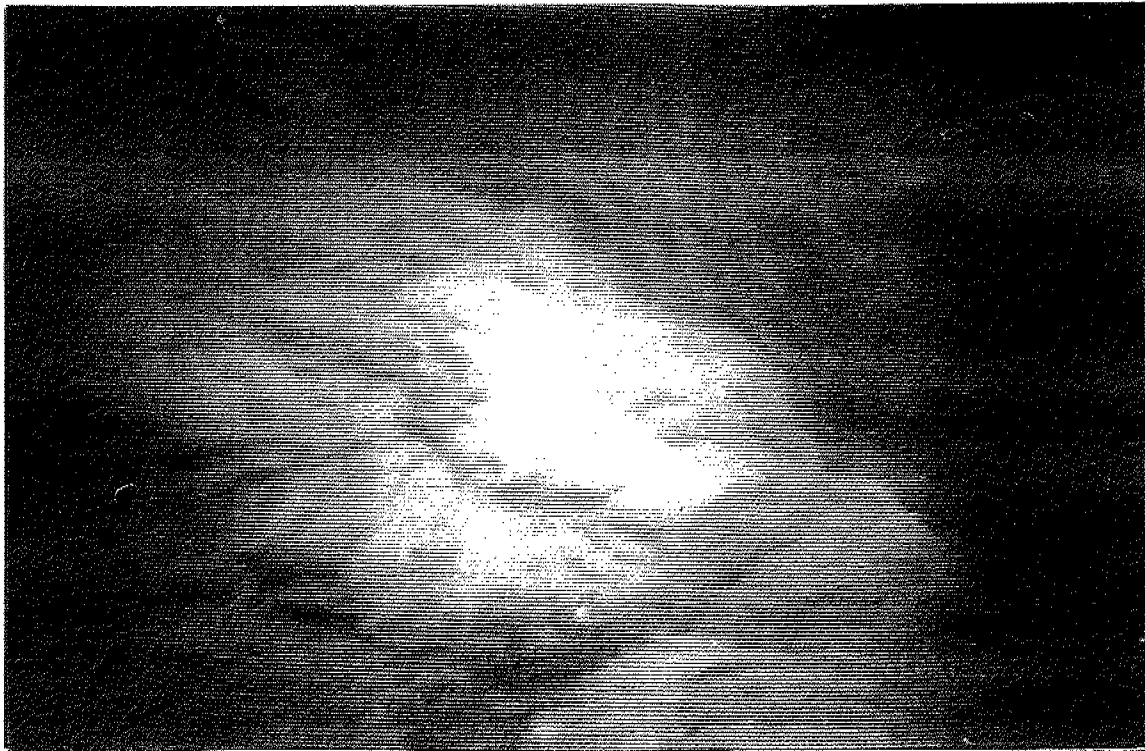
PHOTOGRAPH 16 Concrete sacks located beside the footing of Pier 2.

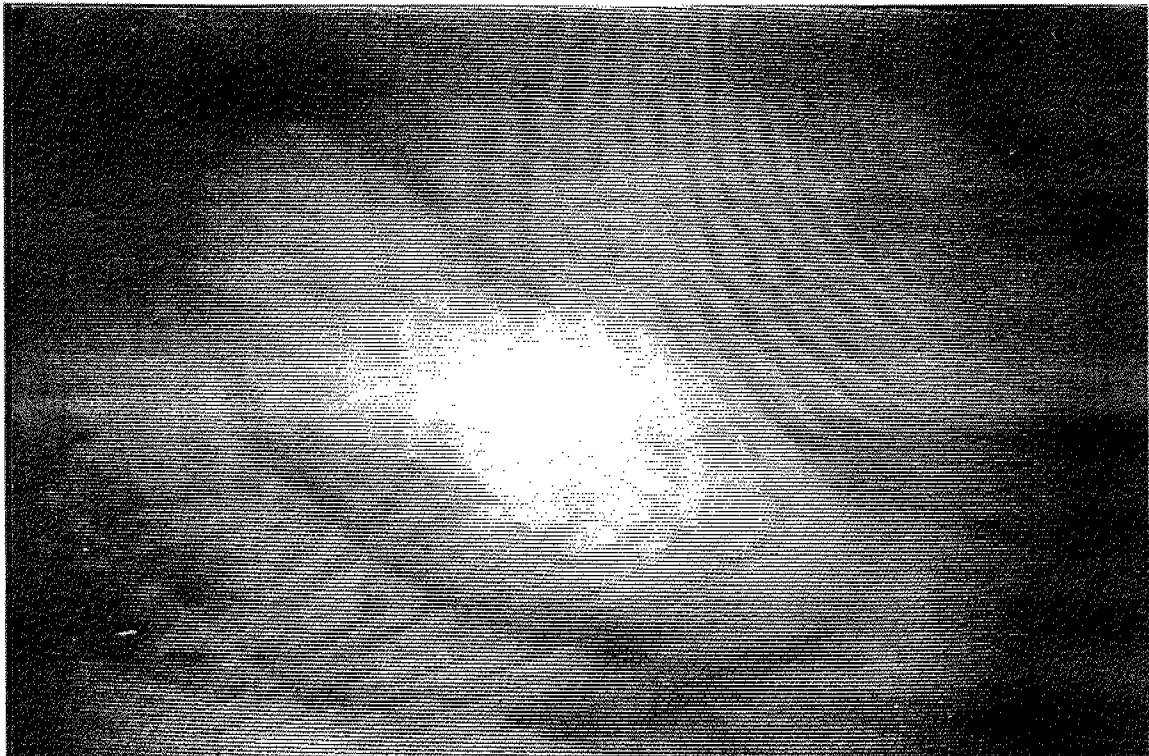
PHOTOGRAPH 17 Concrete sacks located on the riverbed slope below Pier 2.

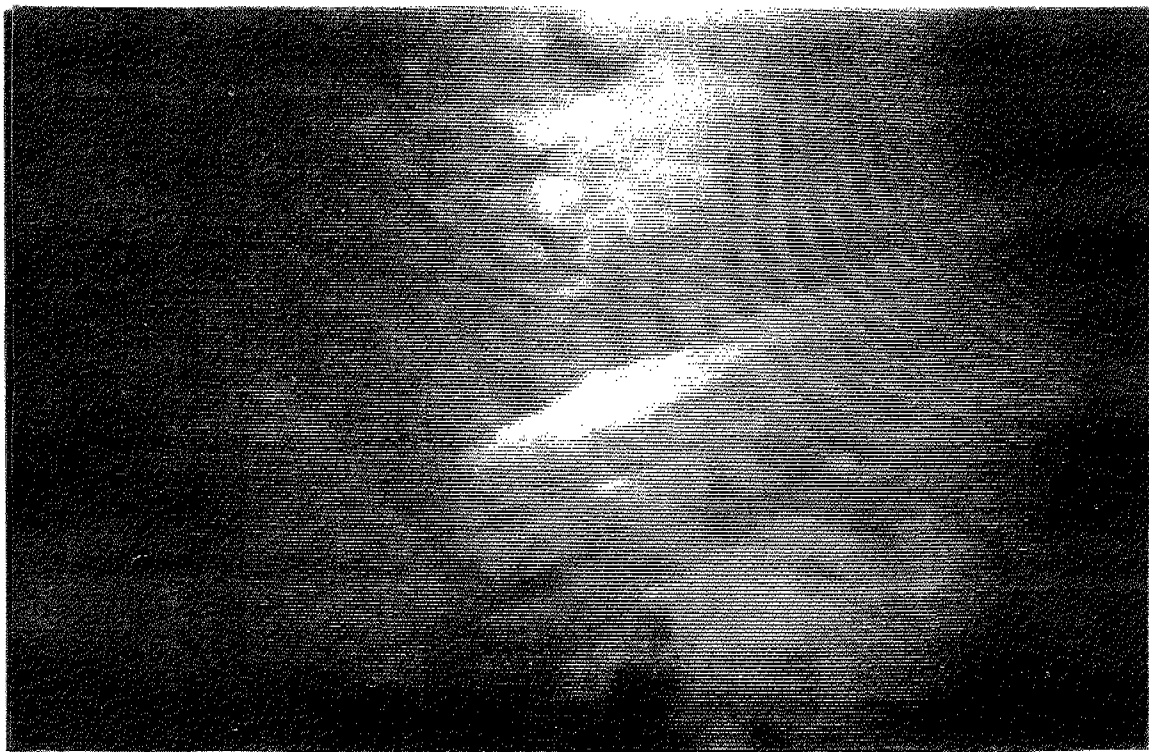
PHOTOGRAPH 18 Remnant 2 x 4 planks from original footing form work near the base of the Pier 1 footing.

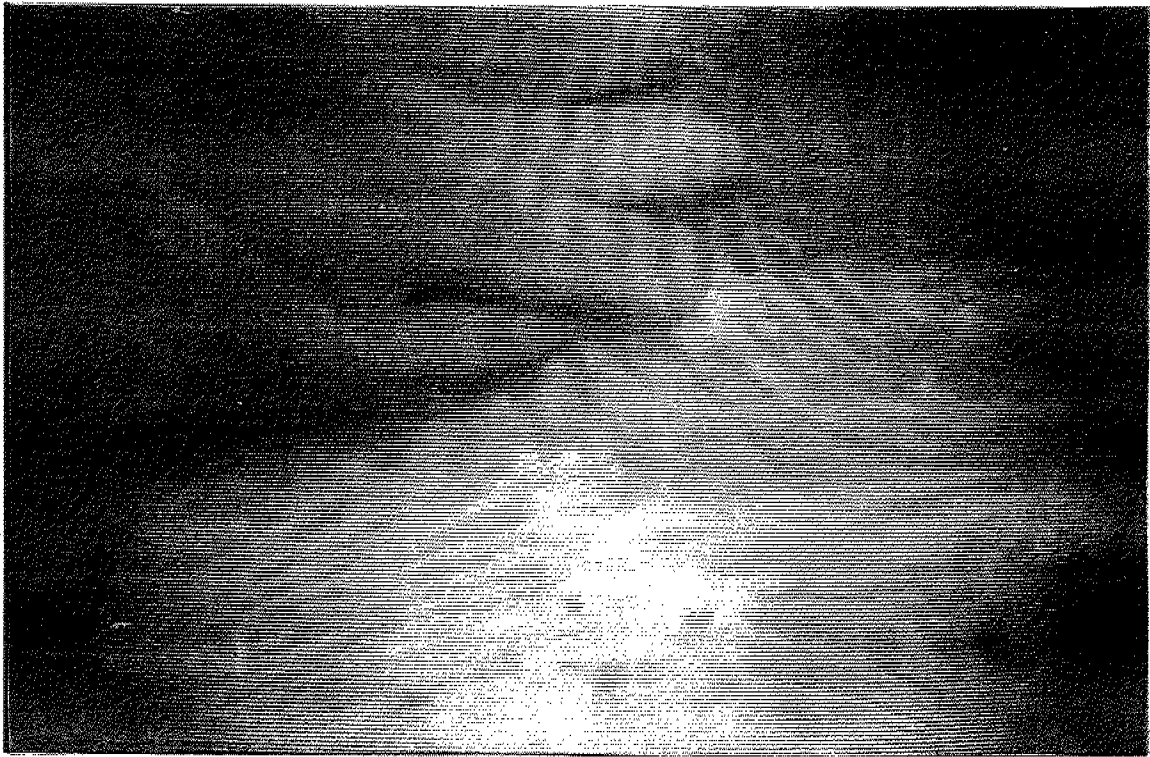
Below the water level, the remaining portion of the pier and the concrete footing are generally in good condition. The joint between the footing and the concrete pier is tight and shows no evidence of significant deterioration (see Photograph 19). The footing concrete surface is eroded and the concrete aggregate in the footing is exposed as shown in Photograph 20 & 21, however, the footing concrete does not exhibit evidence of major cracks or spalls in the exposed concrete surfaces. Exposed reinforcing steel was not observed at any location on the footing concrete.

PHOTOGRAPH 19 Joint between the footing and the concrete of Pier 2.

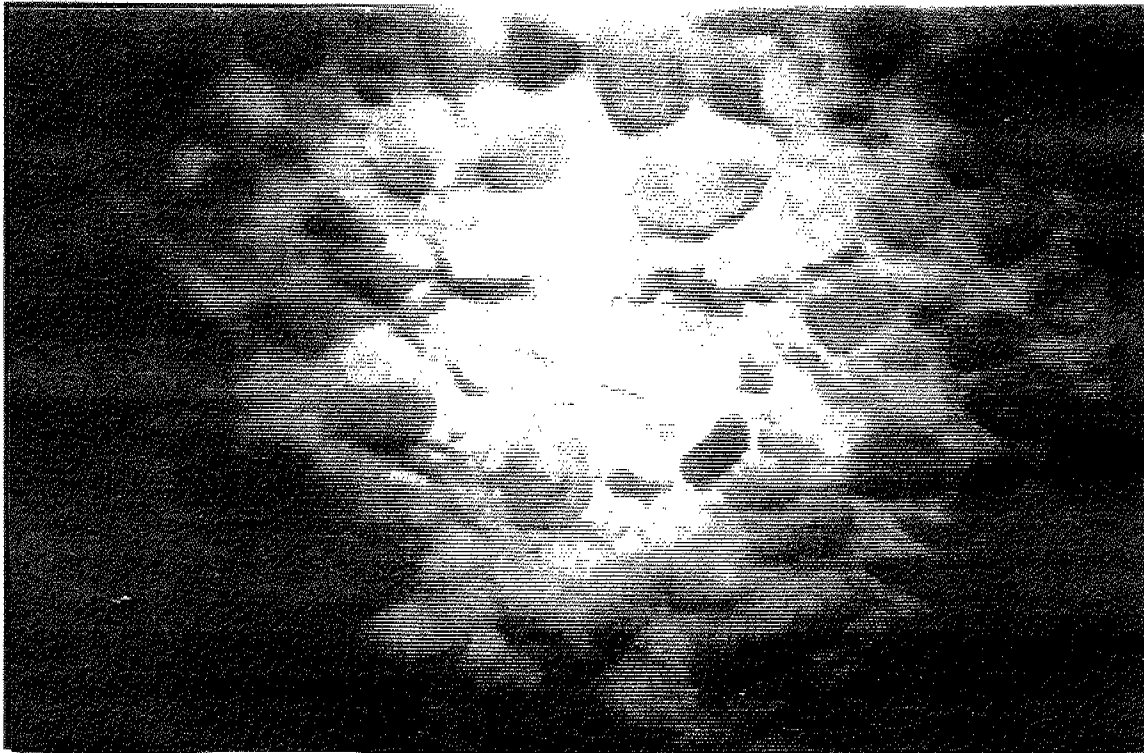
PHOTOGRAPH 21 Concrete surface of footing (Pier 2). Note exposed aggregate 20 to 30 mm in diameter.

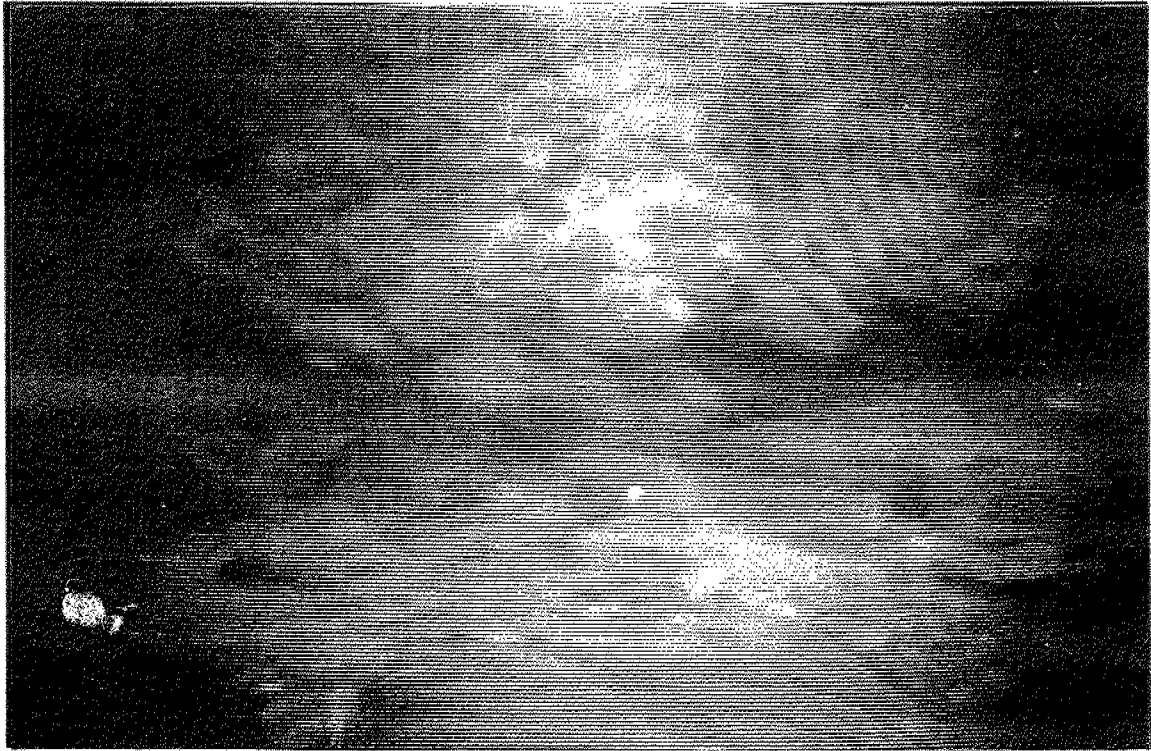
In one area toward the upstream end of Pier 2, a small gap about .75 metres in length, 5 cm high and 15 cm deep, was found between what appeared to be the bottom of the footing and the riverbed. The gap, shown in Photographs 22 and 23, is the result of either localized undermining erosion, or localized slope failure in the riverbed.

PHOTOGRAPH 23 Gap below footing of Pier 2.

Due to the piers being founded on spread footings which have settled and remain susceptible to riverbed erosion, we recommend that the extent of undermining be monitored on a regular basis until such time as an effective repair is undertaken or the bridge replaced.
