WP 263-90-01 DIST 62
HWY 17 STR SITE 48E-46C

Embankment Failure - 0.9 km West Hopper Road
4 Km West of Thessalon (Lake Street)

DATE NOV 15 1995

FOUNDATION INVESTIGATION REPORT
FOR
Sta. 13+900 to Sta. 14+000
Embankment Failure - 0.9 Km West Hopper Road
4 Km West of Thessalon (Lake Street)
WP 263-90-01, Twp. of Lefroy
District 62, Sault. Ste. Marie

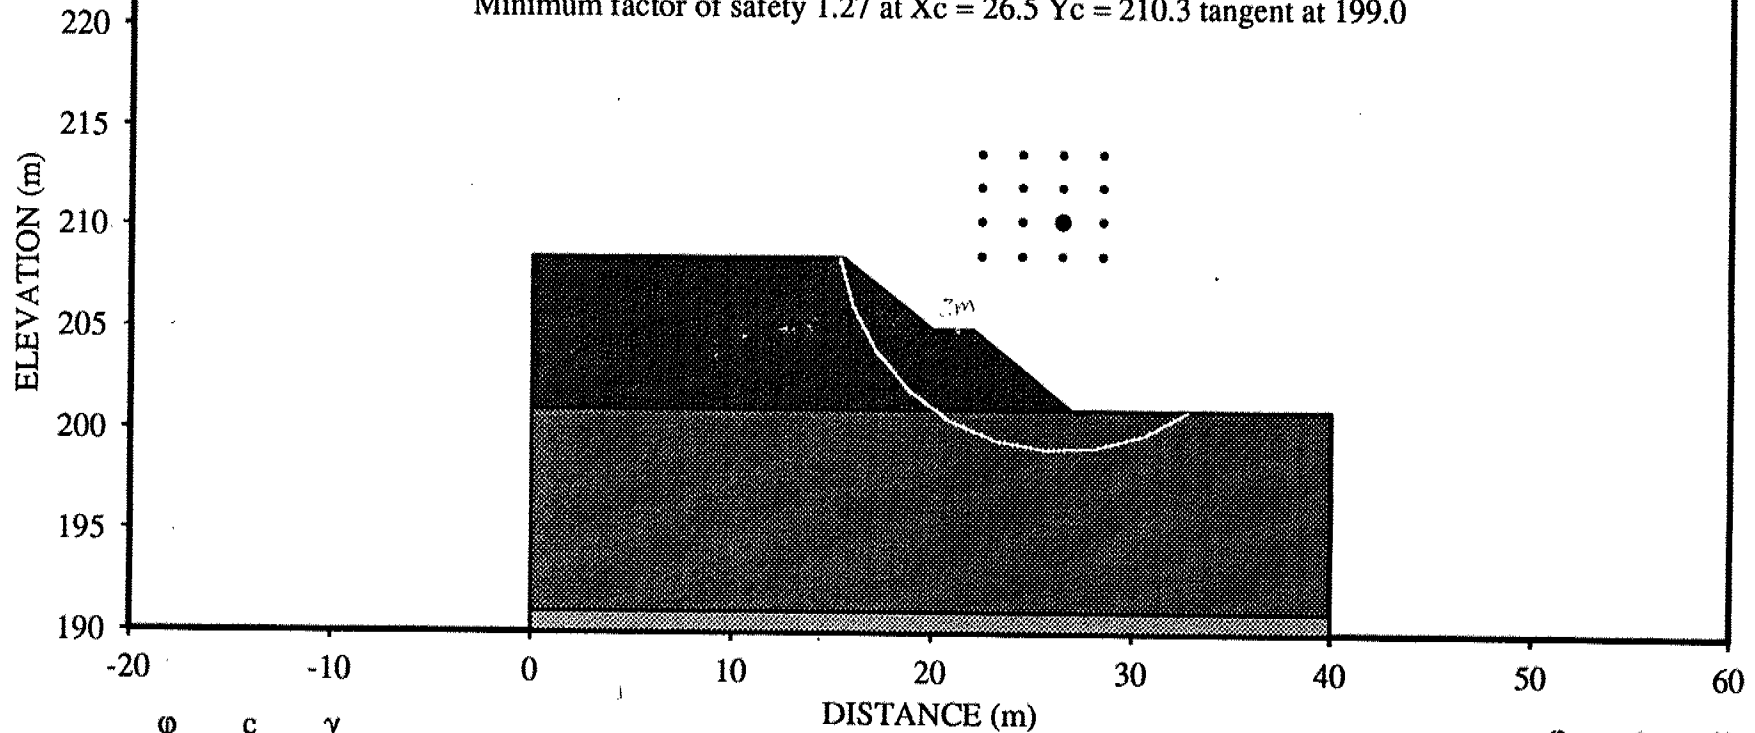
An effective stress analysis was applied for calculations of slope stability of the embankment fills using the Limit Equilibrium Method of stability developed by Sarma (1973, Stability Analysis of Embankment and Slopes, Geotechnique, Vol. 23, No. 3). Checking both deep seated and shallow failures for rockfill embankments of 1.25H:1V slopes, a factor of safety of 1.4 and 1.1 respectively was calculated (Figure 7 and 8). As the minimum Factor of Safety utilized by this office is 1.3, subsequent analysis indicated the need to place a 2 m midheight berm to increase this value for shallow failures to an acceptable level. (Figure 9)

Minimum factor of safety 1.27 at $X_c = 26.5$ $Y_c = 210.3$ tangent at 199.0

To summarize, the failure of the slopes appears to be a combination of shallow slip planes and the infiltration of fines into the voids of the rockfill. The recommendations are to place a 2 m midheight berm together with the placement of crushed stone on the rockfill with a geotextile underneath the subgrade material.

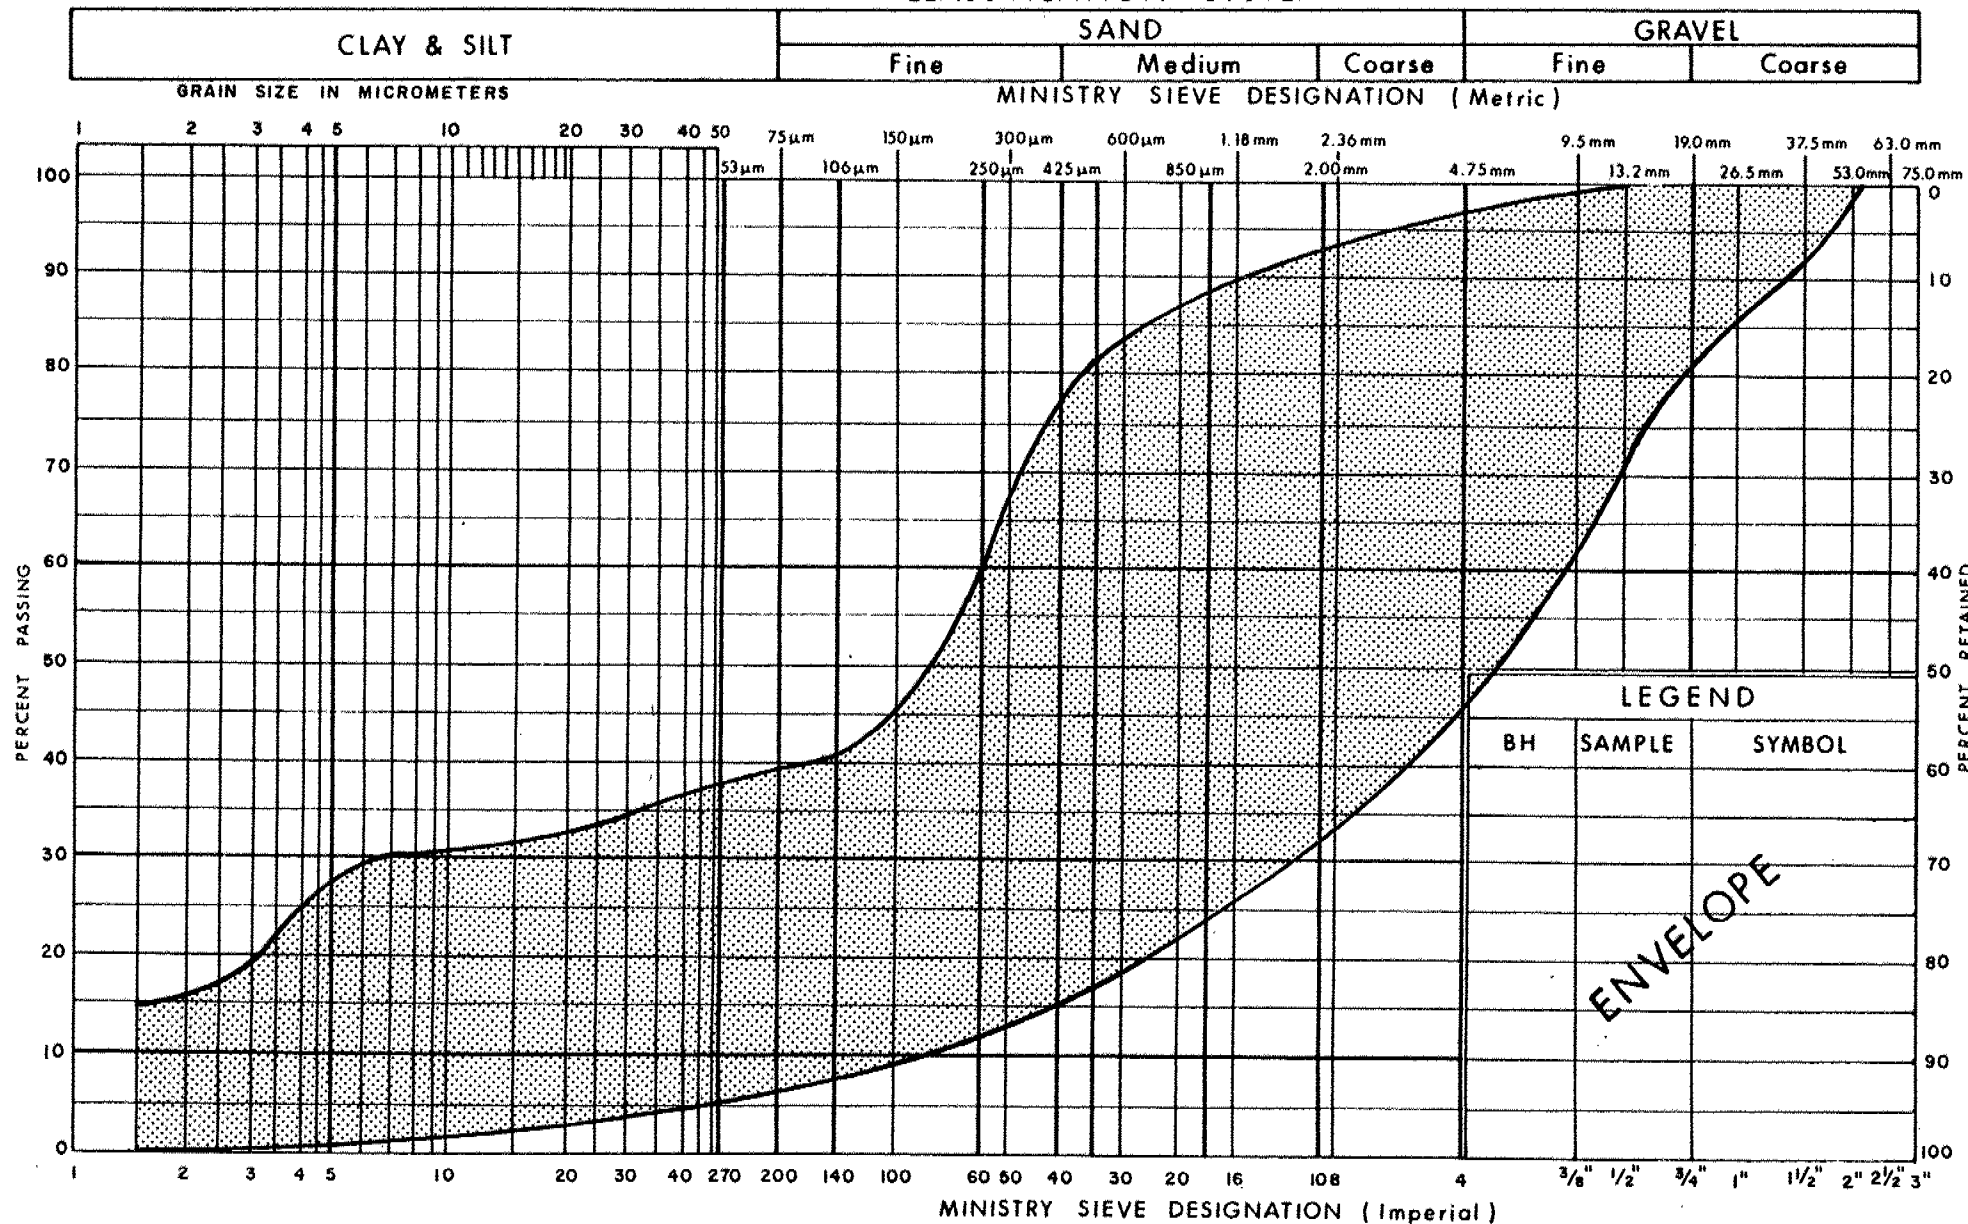
FIG No 1

Results of grain size distribution tests carried out on select samples indicate that the material contains 25 - 54 % Gravel, 40 - 57 % Sand, 5 - 25 % Silt and 1 - 8 % Clay. Figure 1 illustrates grain size distribution curves for this material based on representative samples within this layer.

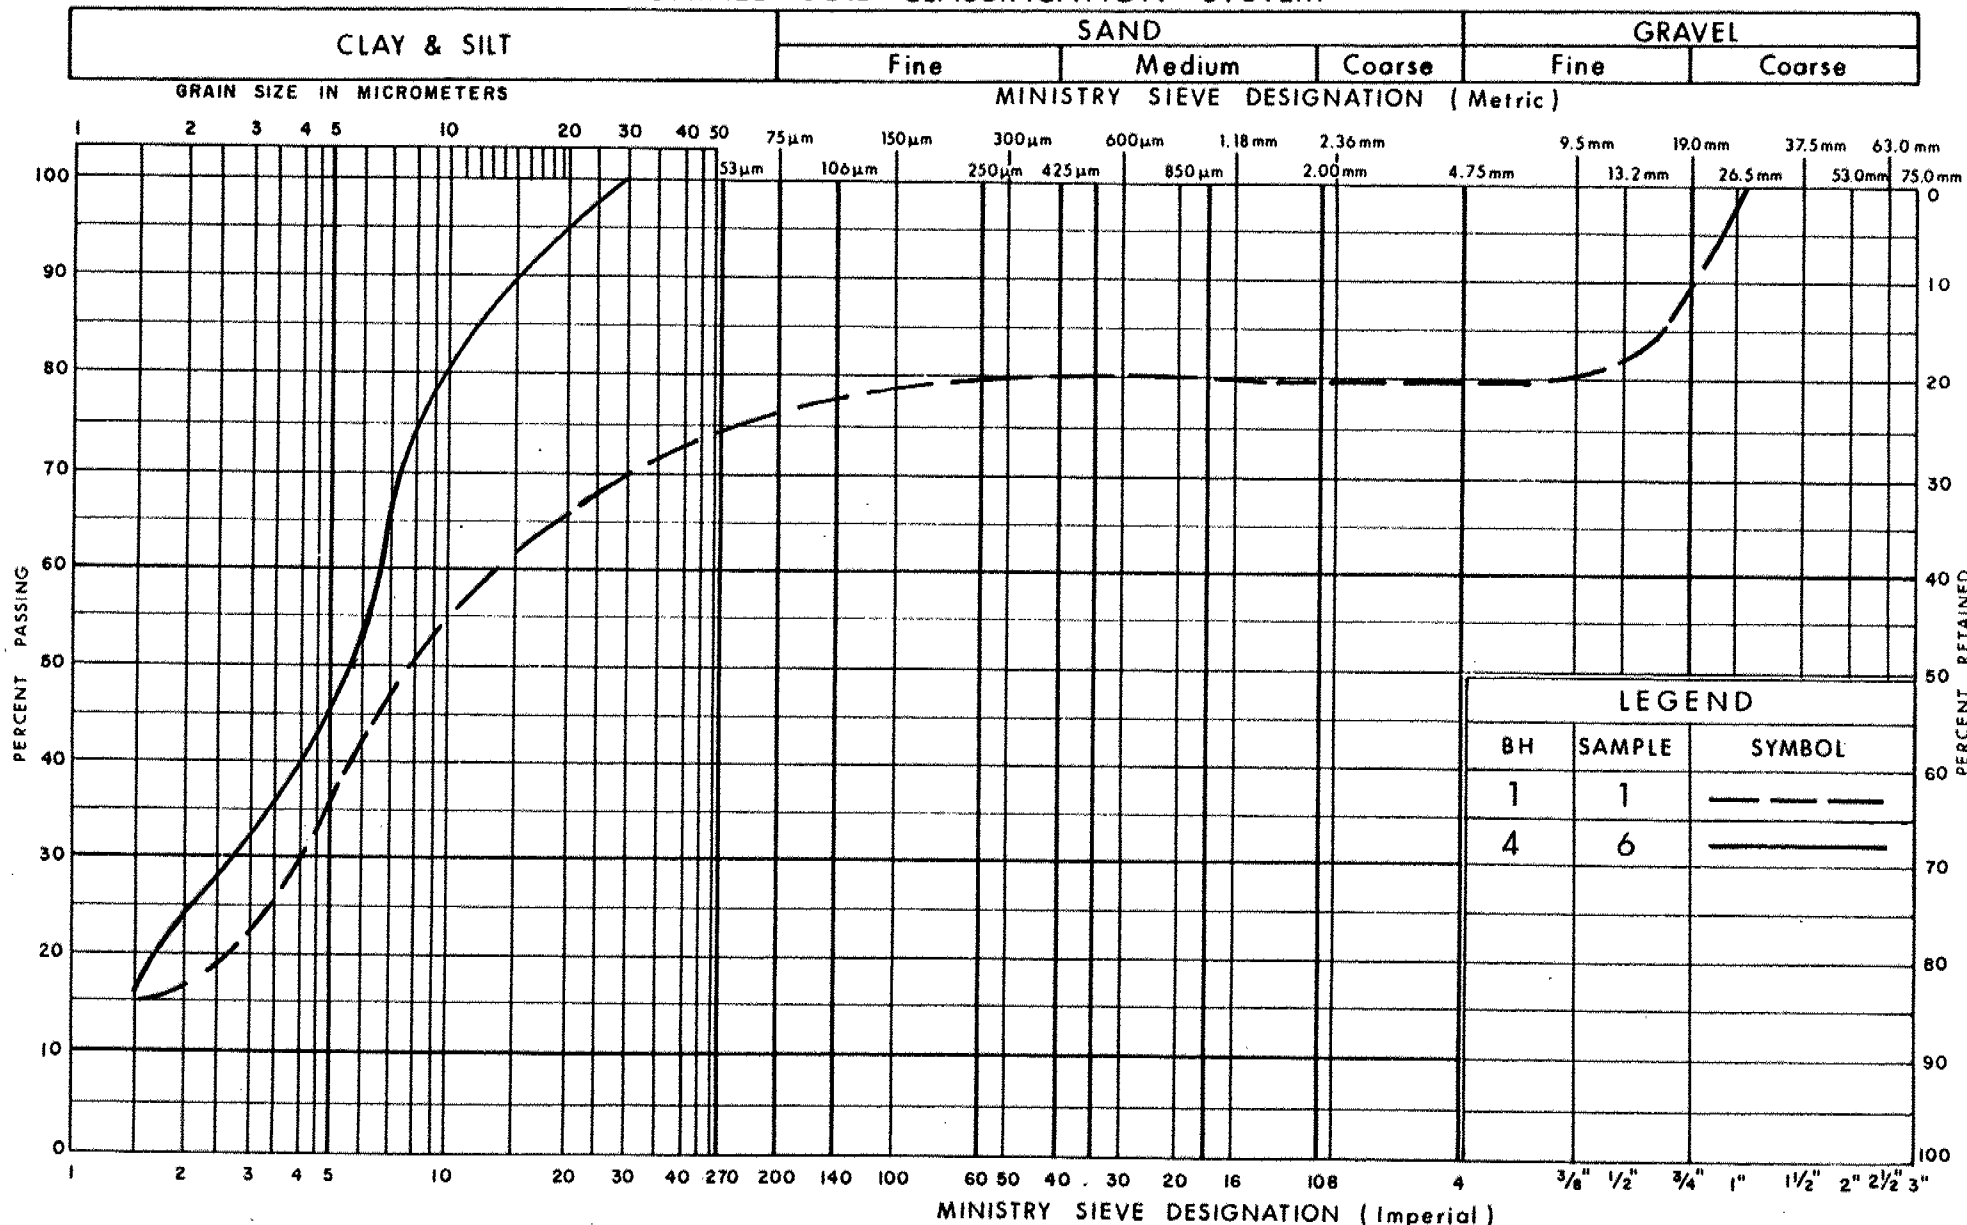
FIG No 2

Results of grain size distribution tests carried out on select samples indicate that the material contains 0 % Gravel, 2 - 16 % Sand, 48 - 81 % Silt and 17 - 36 % Clay. Figure 2 illustrates grain size distribution curves for this material based on representative samples within this layer.

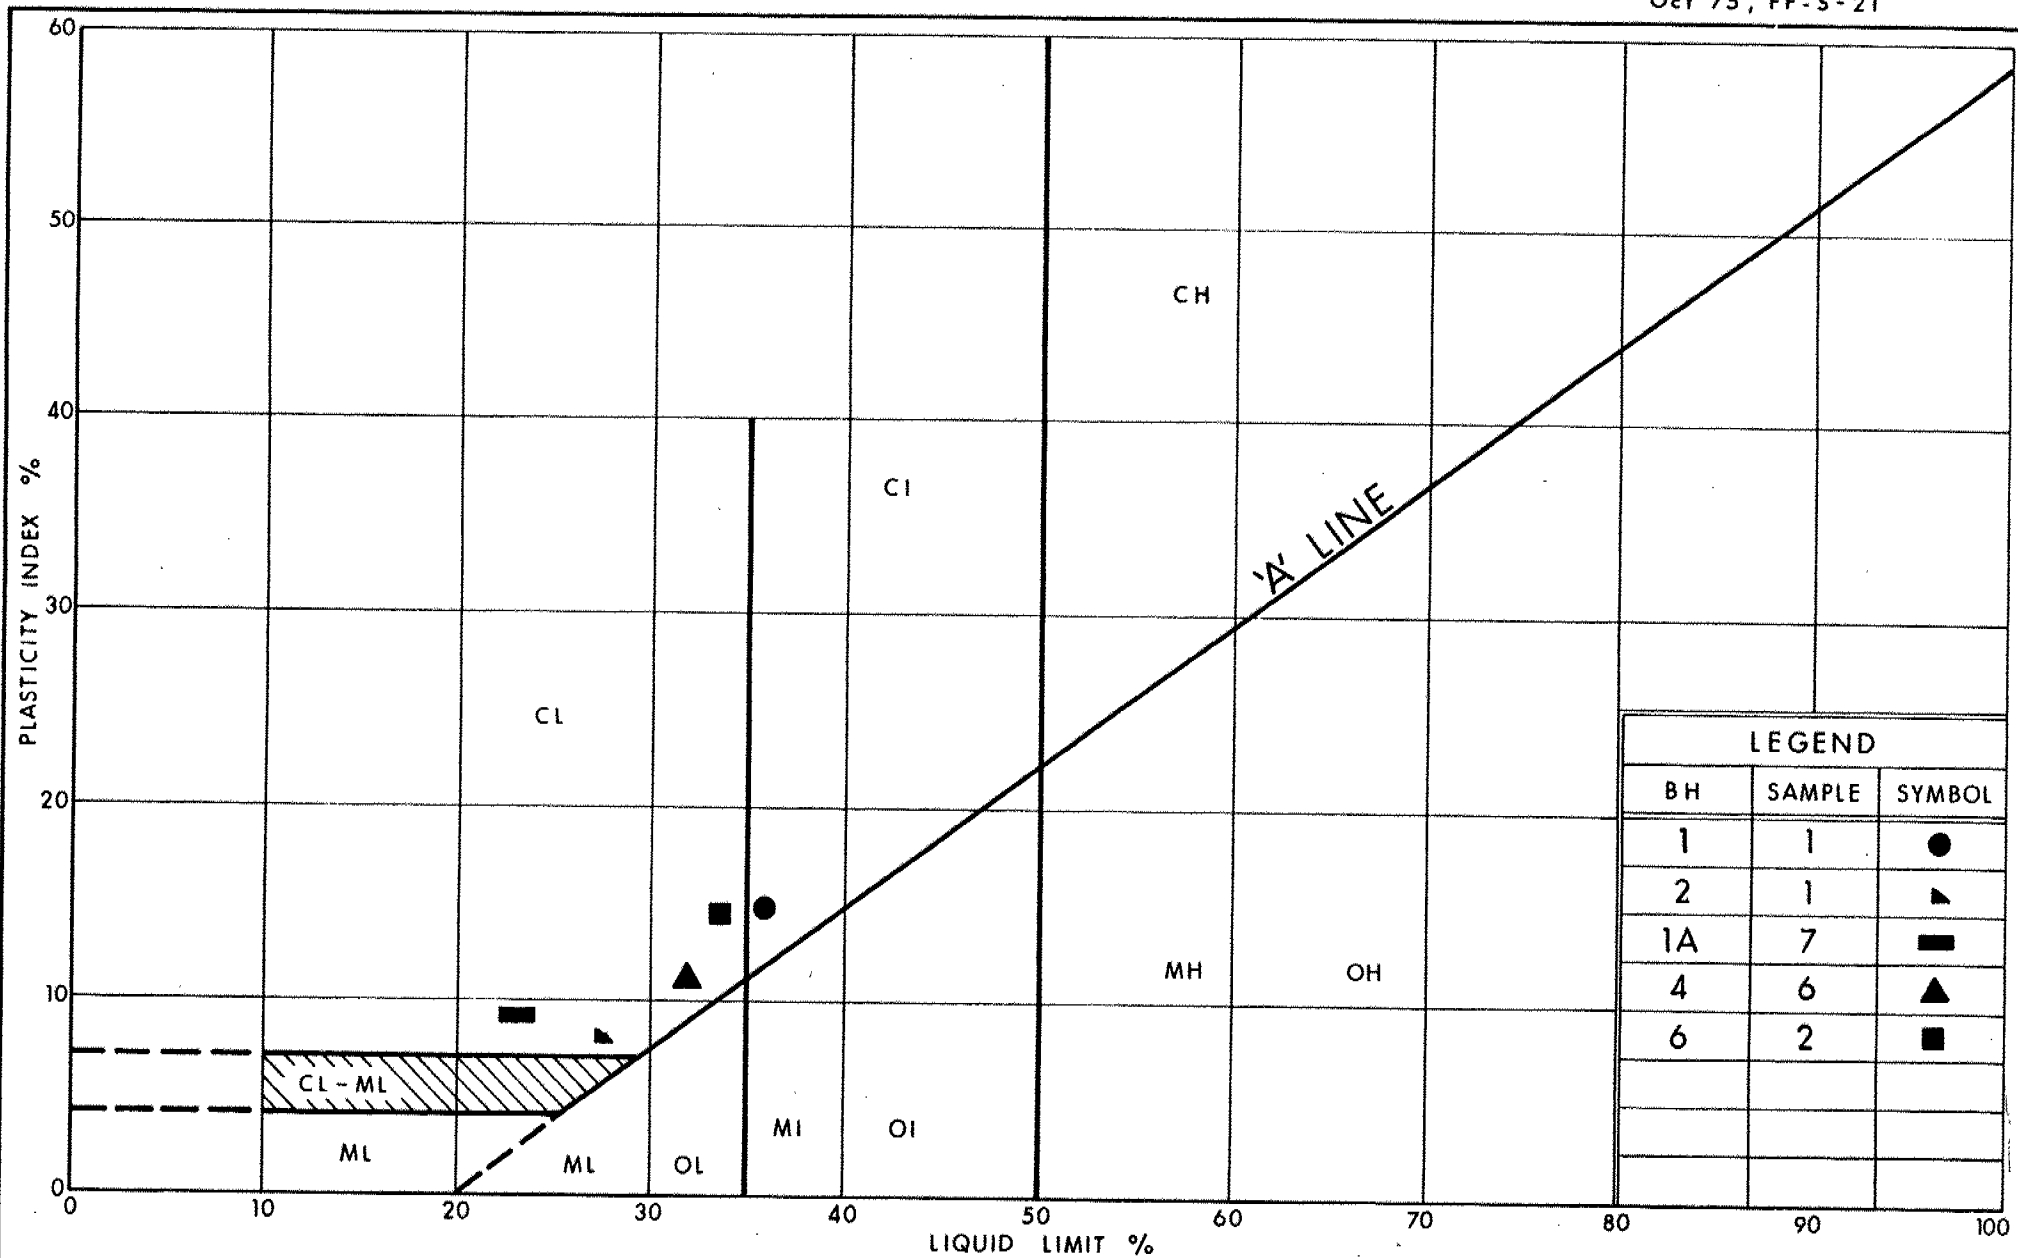
FIG No 3

Figure 3 illustrates the plotted plasticity chart for this material based on representative samples. It indicates that the material is of a low plasticity. The field vane shear strengths were very high greater than 100 kPa. Based on this the consistency is considered Stiff to Hard.

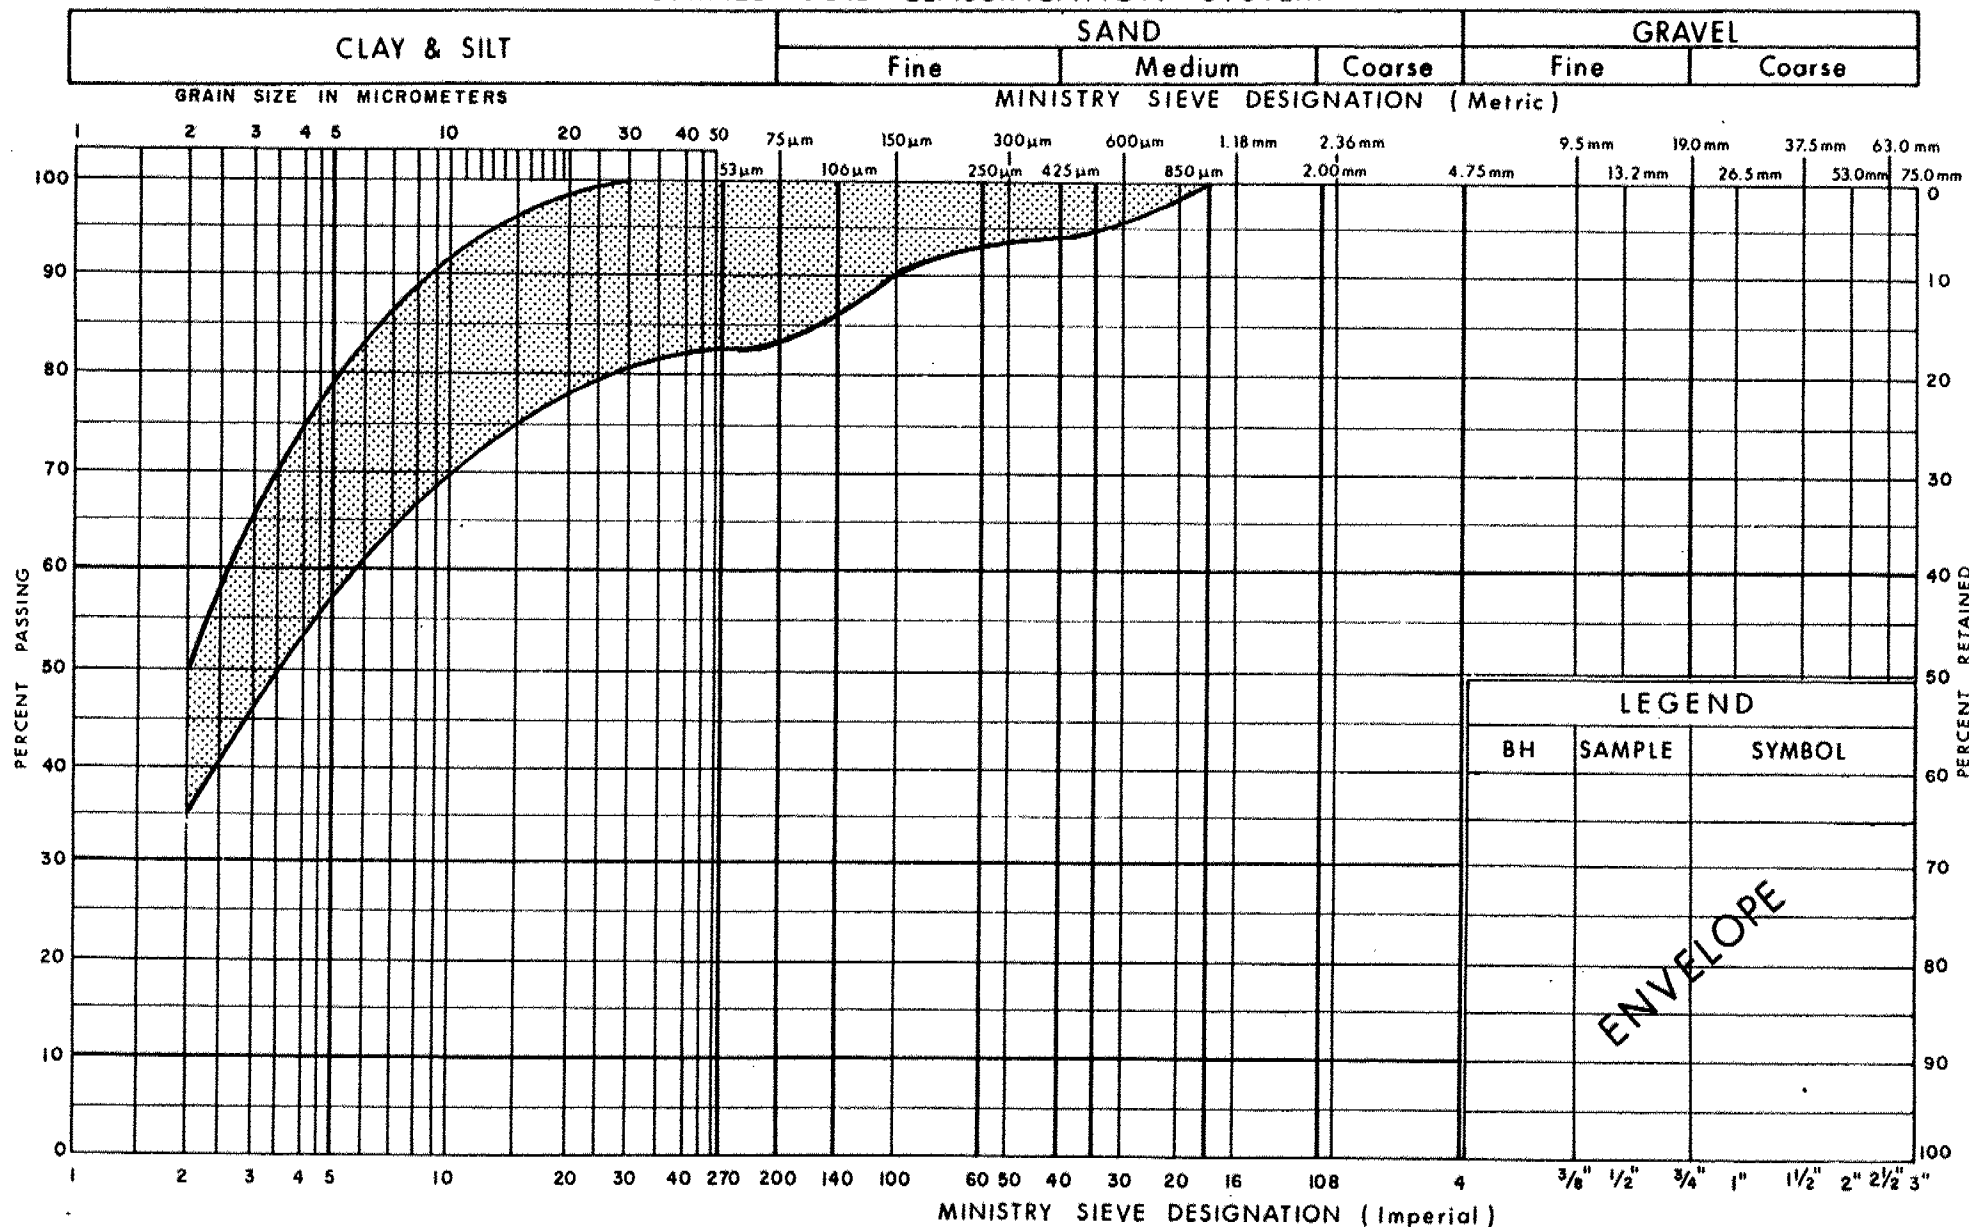
FIG No 4

Results of the grain size distribution tests carried out on select samples indicate the material contains primarily Silt and Clay. Figure 4 illustrates grain size distribution curves for this material based on representative samples within this layer.

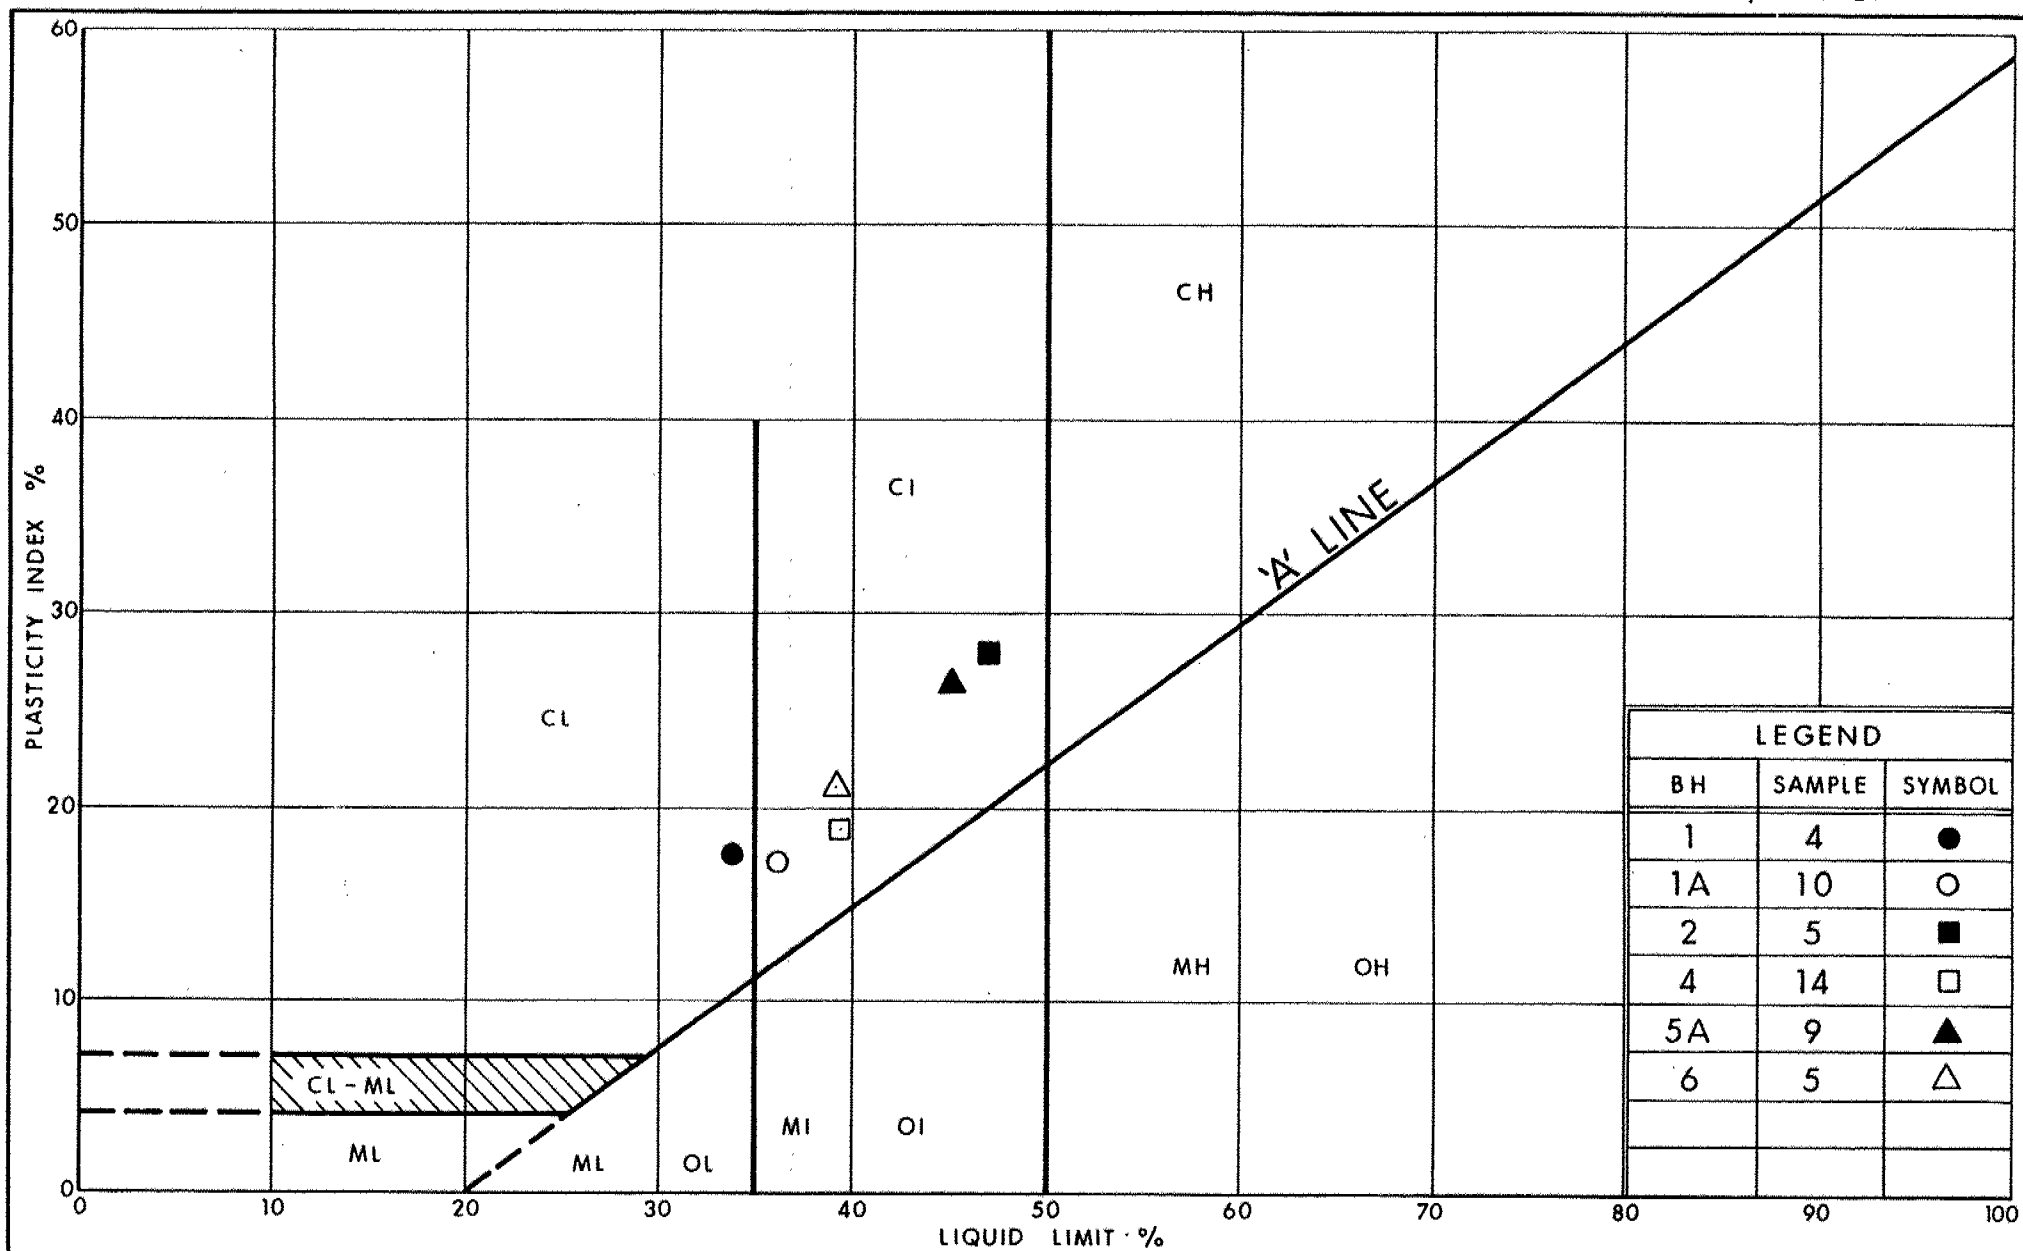
FIG No 5

Figure 5 illustrates the plotted plasticity chart for this material based on representative samples. It indicates that the material is of an intermediate plasticity. The field vanes shear strengths varied between 59 to > 100 Blows/0.3 m and can be considered to have a stiff to hard consistency.

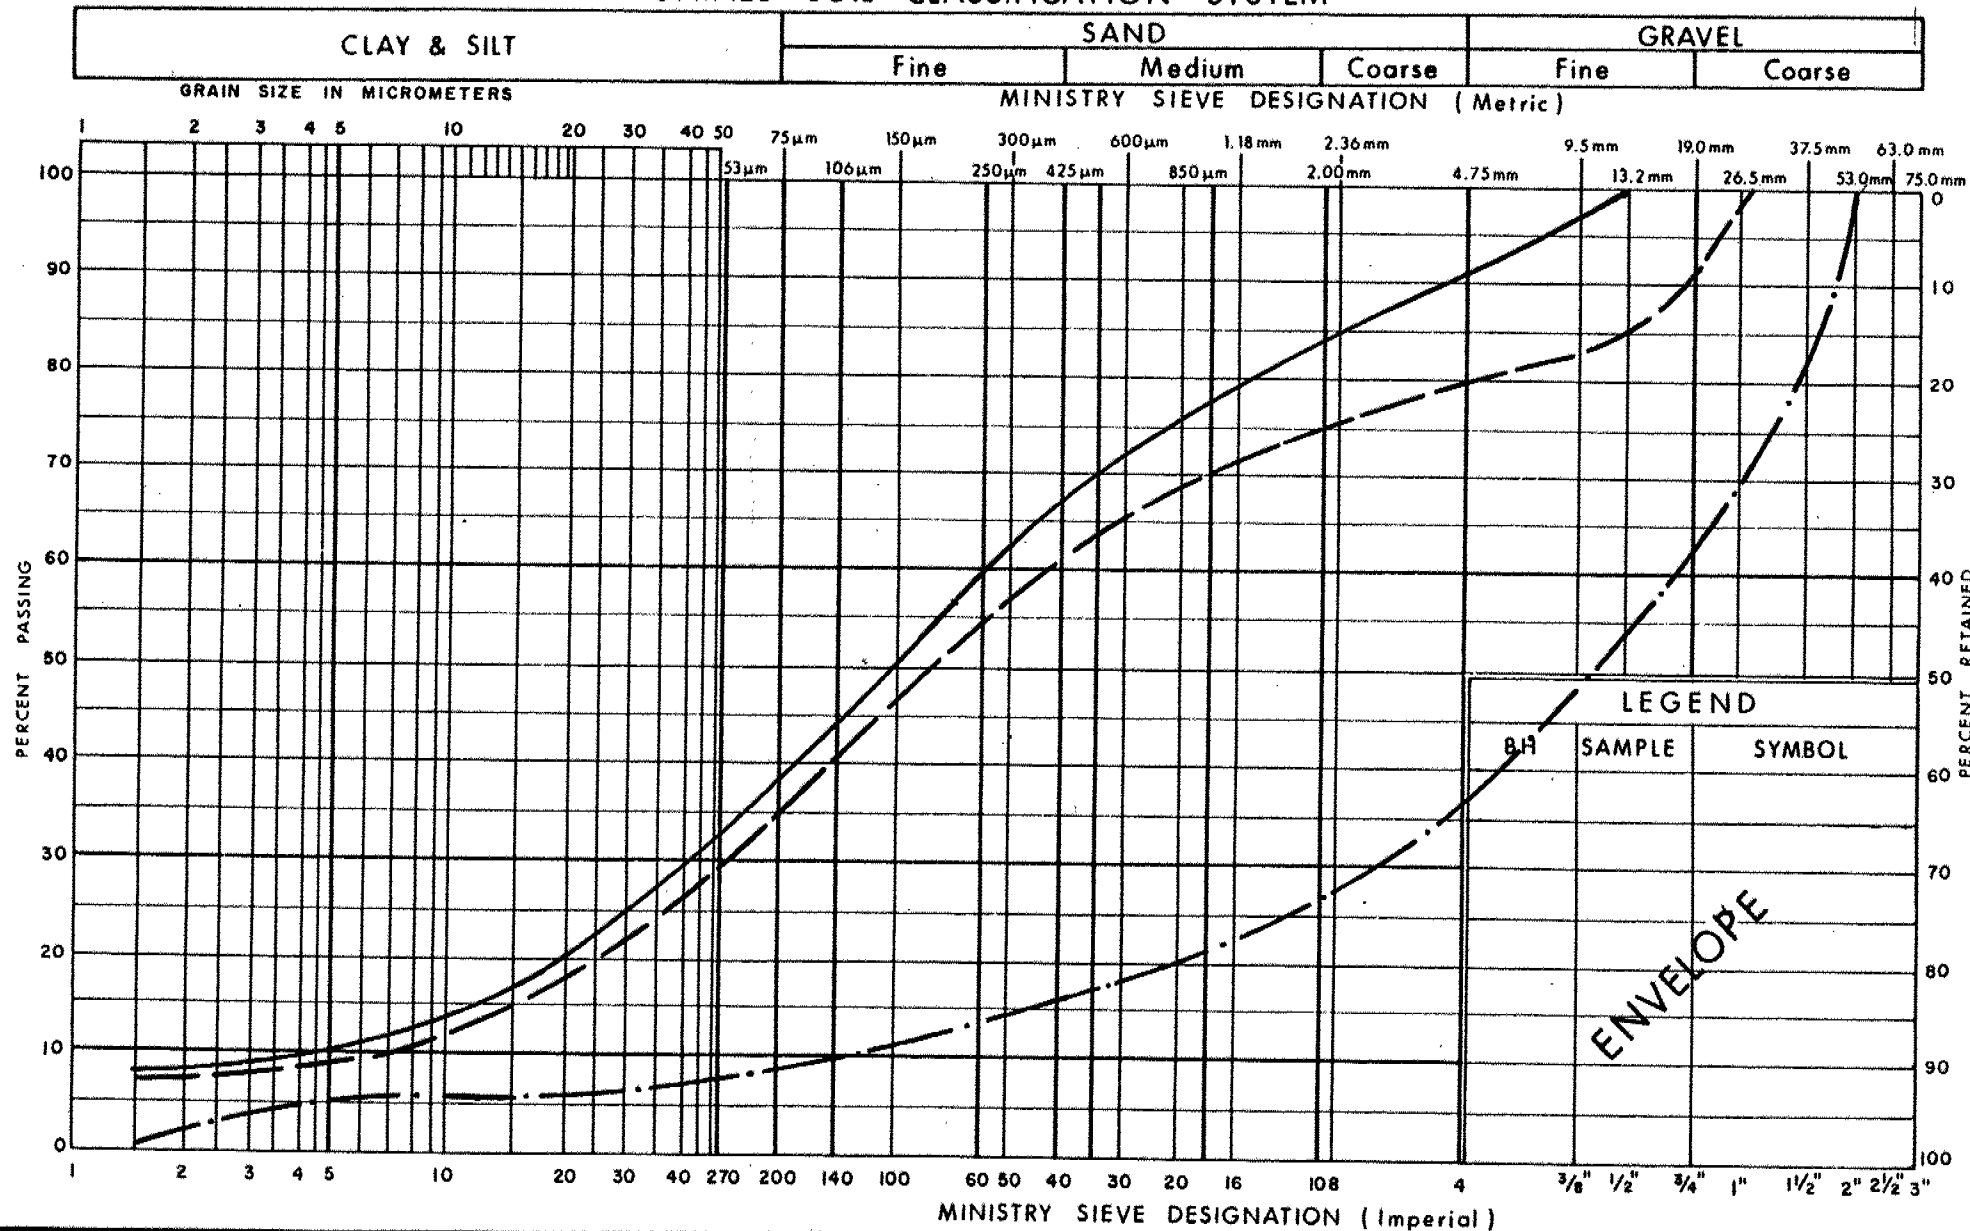
FIG No 6

Grain size distribution tests carried out on select samples indicated 9 - 65 % Gravel, 26 - 53 % Sand, 8 - 38 % Silt, 1 - 4 % Clay. Figure 6 illustrates the grain size distribution curves for this material. A large amount of auger grinding indicated the presence of cobbles and boulders.

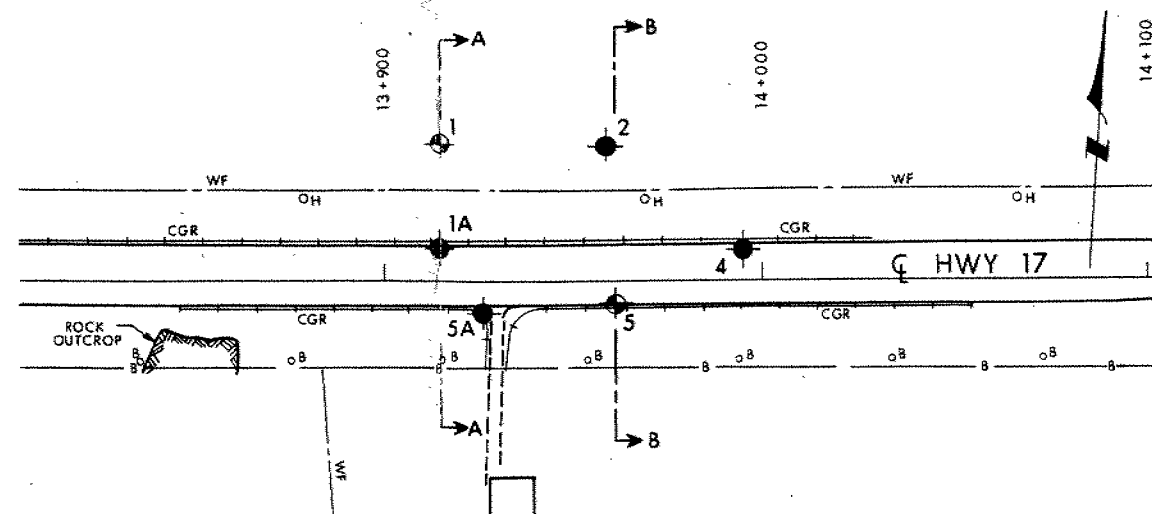
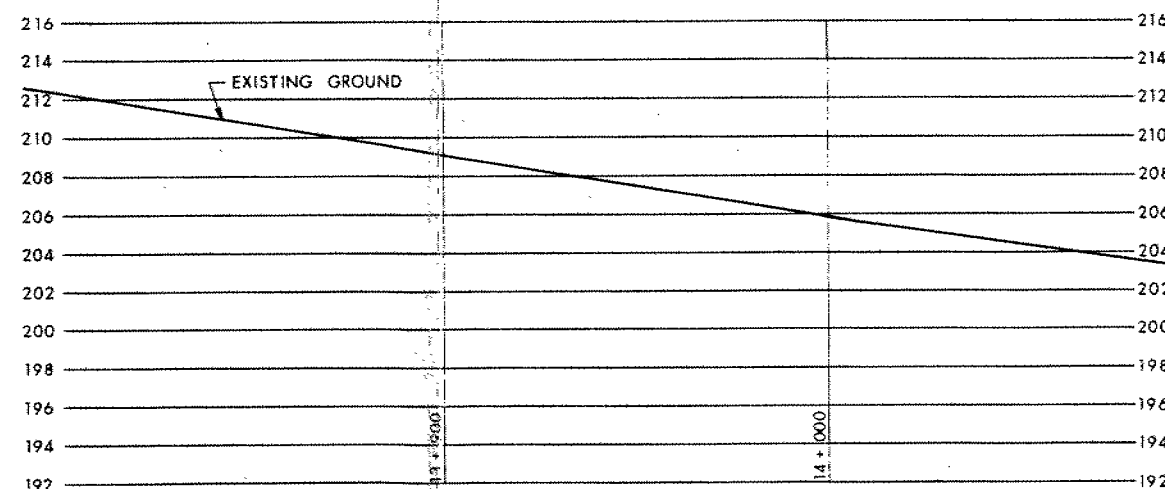
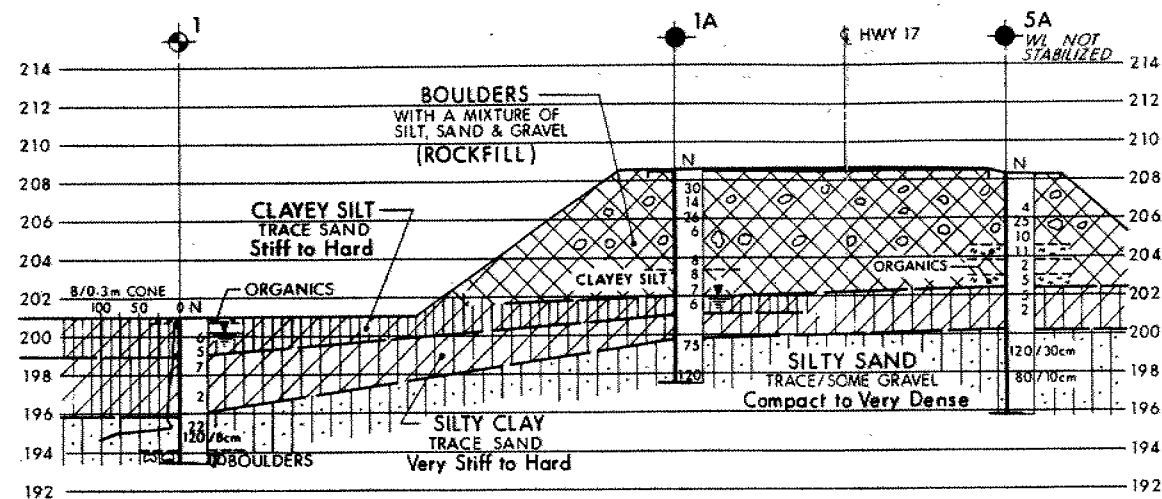
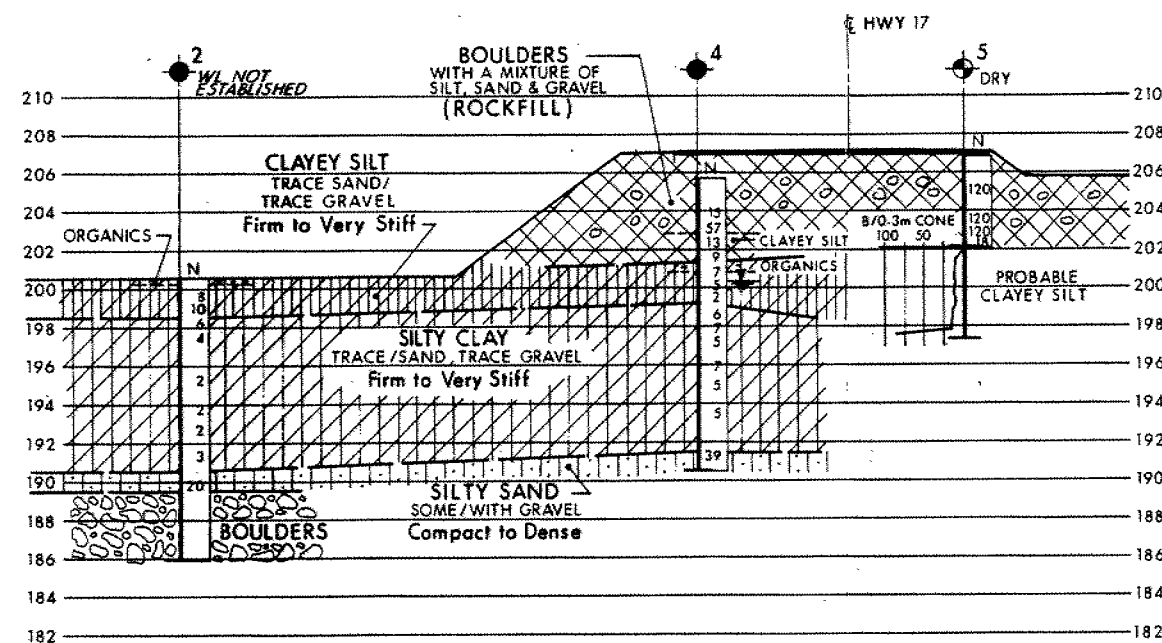
EMBANKMENT FAILURE
STA 13+900 to STA 14+000
0.9km West of Hopper Rd
BORE HOLE LOCATIONS & SOIL STRATA

The locations of borings are shown on Dwg. No 2639001-A in the attached appendix of this report. The field and laboratory test results are plotted on the record of borehole logsheets.
