Subject: Hwy 546 Slope Failure  
Sta. 16+675 to 16+875  
Township of Nouvel  
W.O. 94-11002  
District 18, Sault Ste Marie

# HIGHWAY 546 FAILURE

STATION 16+825

W.O. 94-11002

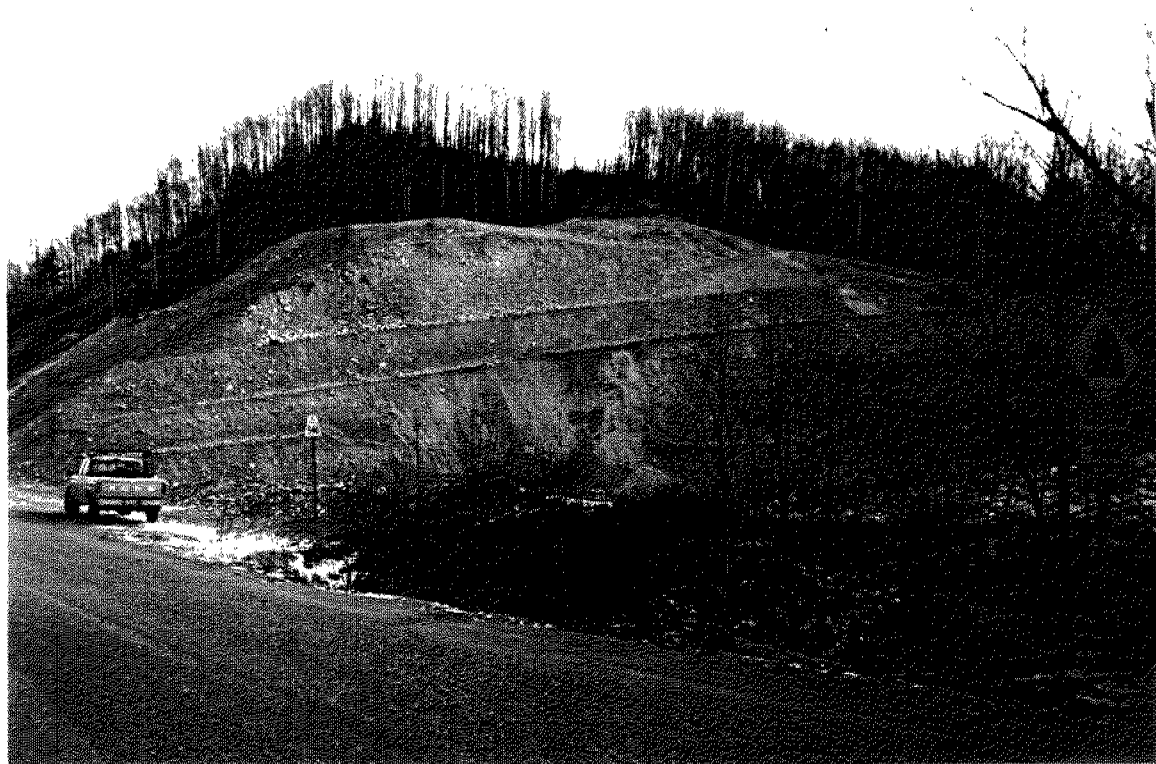
AREA WHERE  
WASHOUTS CLOSE  
ROAD.
