Observations and Recommendations regarding the Goulais River Bank Slump of October 13, 2003

**MNR Northeast Region Engineering Unit
Field Service Division,
Ministry Of Natural Resources**

October 27, 2003

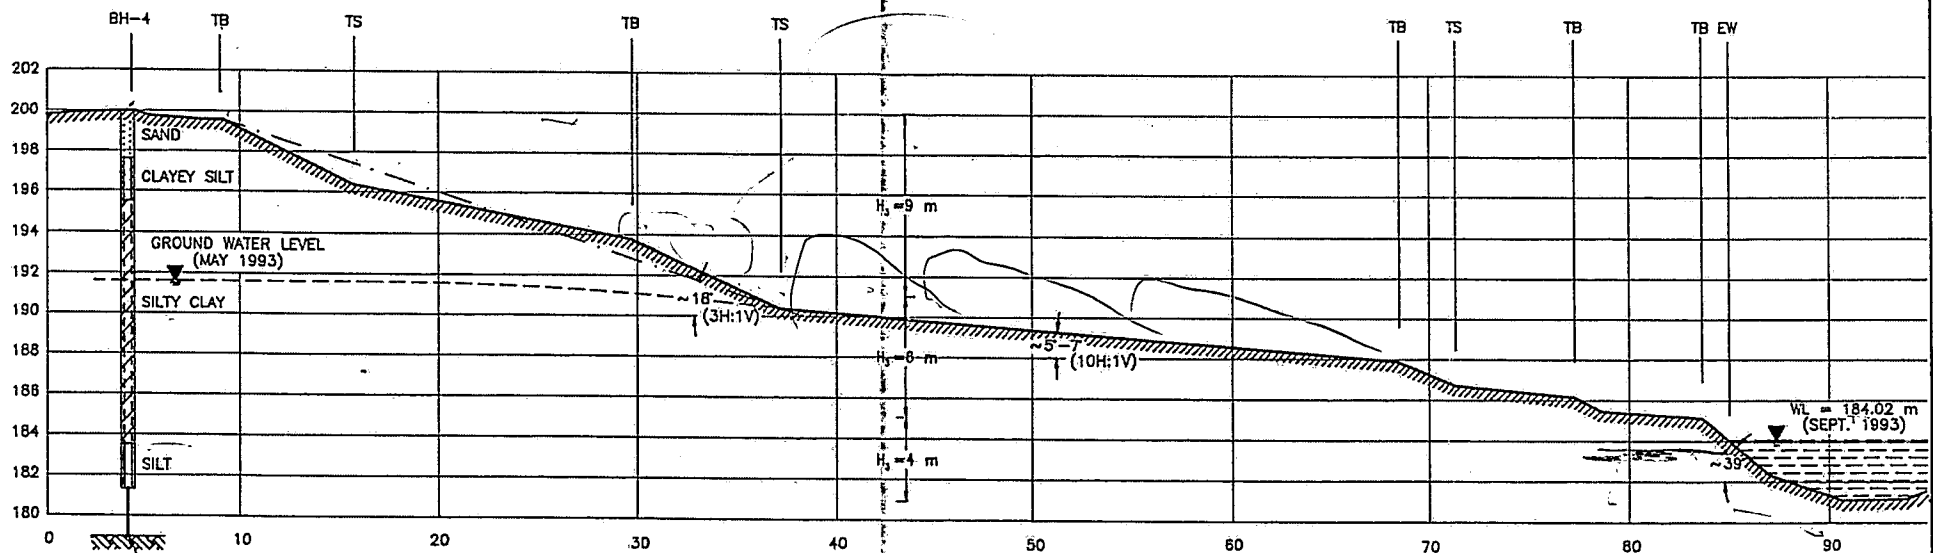
Figure 3: Trow Goulais River Geotechnical Investigation – Post-Failure Embankment Profile.

As part of the 1994 Trow investigation, a post-failure surface profile was to be developed at four locations, one of which was immediately adjacent to the recent slump (Figure 3). The profile sections commenced at the boreholes and extended down to the river. The post-slump bank configuration was found to comprise the following three distinct slope or inclination zones:

- i. An upper zone (for all material located above the groundwater level and comprised of sands and the clayey silt). This zone was observed to stand at approximately 18° or 3H:1V (horizontal to vertical);
- ii. A lower zone (below the groundwater level but above river level and comprises the silty clay). This zone was found to stand at a relatively flat angle of approximately 5° or 10H:1V;
- iii. An underwater zone (below the normal river water level and can comprise silty clay and silt). This zone was measured at a relatively steep slope of approximately 39° or 1.25H:1V.

Note that the above description is for the location at or near the 1988 and the 2003 slump locations only. The description for other sites were found to vary in some cases significantly and can be possibly attributed to post-failure configuration versus a present metastable condition. A metastable condition is one where the existing embankment

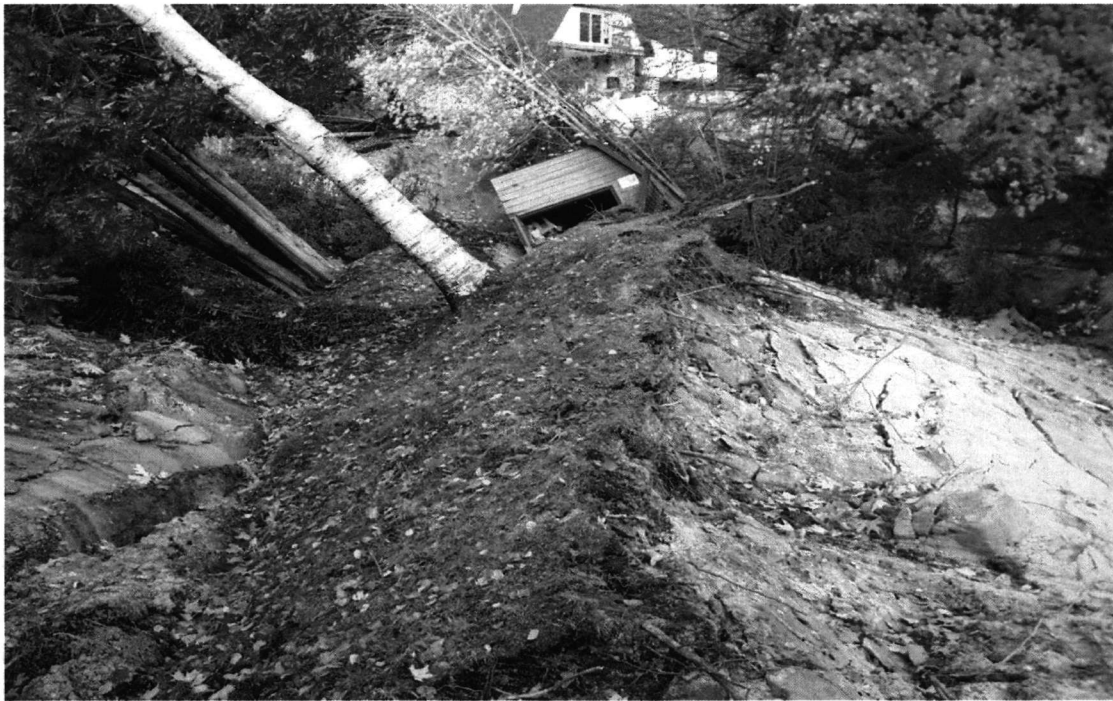
The slump was observed to have semi-circular and concentric slips dipping back towards the main scarp in a typical rotational failure pattern (Photo 1), giving the appearance of backward sloping steps moving away from the location of the back or main scarp. (A main scarp is defined as a steep face on undisturbed ground at the upper edge of the slump). The main scarp was estimated to be between 2 and 5 metres in height and approximately 200 metres in length (Photo 2). The failure or slump area was measured using a hand held GPS unit and found to be slightly less than 2 ha. in size, measured approximately three days after the event. The overall post failure slope profile of the embankment was determined to be at approximately 7.5H:1V (horizontal to vertical). It should be noted that the area is still experiencing ground movements and as such the overall slope is likely to flatten further.

Photo 1 – Sectional View of Compound Failure. Note concentric slips dipping backwards.

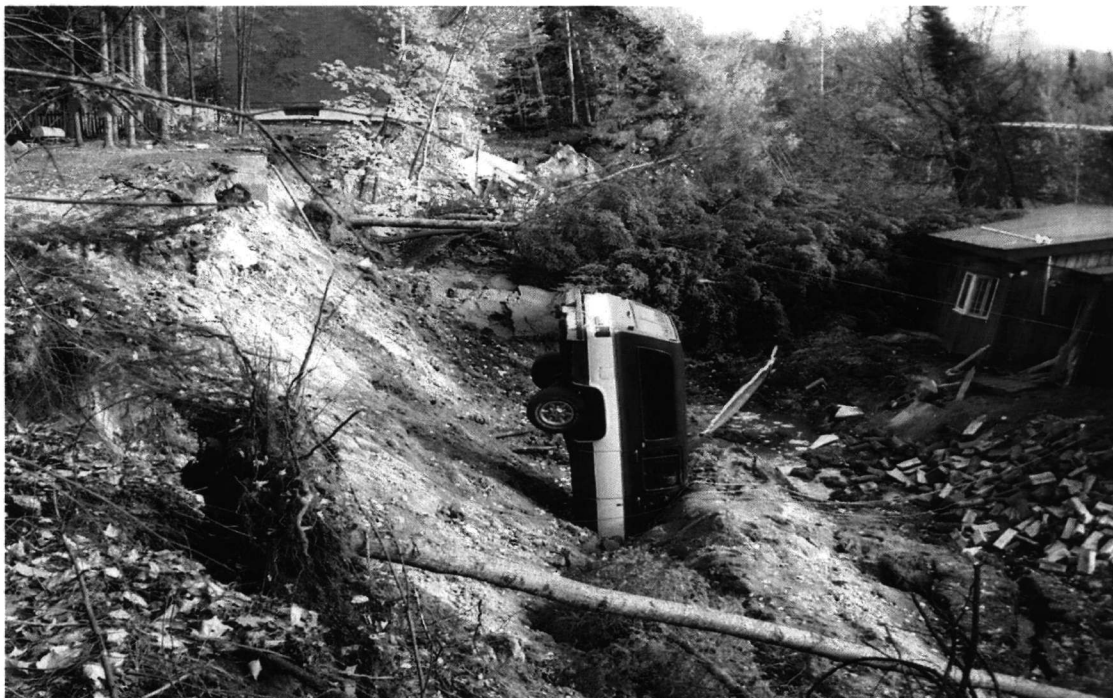
As a result of the embankment slump one home has been shifted from its original location and moved toward the river and down into the slump area (Photo 2). A second home, located less than 20 metres from the 1988 slump, was observed to be severally undermined and is on the verge of tumbling into the slump area as the main scarp runs under a portion of the house (Photo 4). Due to the extent of undermining of this house and the continued ground movements, it is highly probable that this house will eventually fall into the slump area. The third home that was observed to be impacted by the slump is located less than 20 metres from the main scarp. What the effect will be on this home is uncertain, given continued ground movements experienced and the proximity to the steep main scarp.

Photo 2 – Sectional View of Main Scarp. Note house on right within slump area.

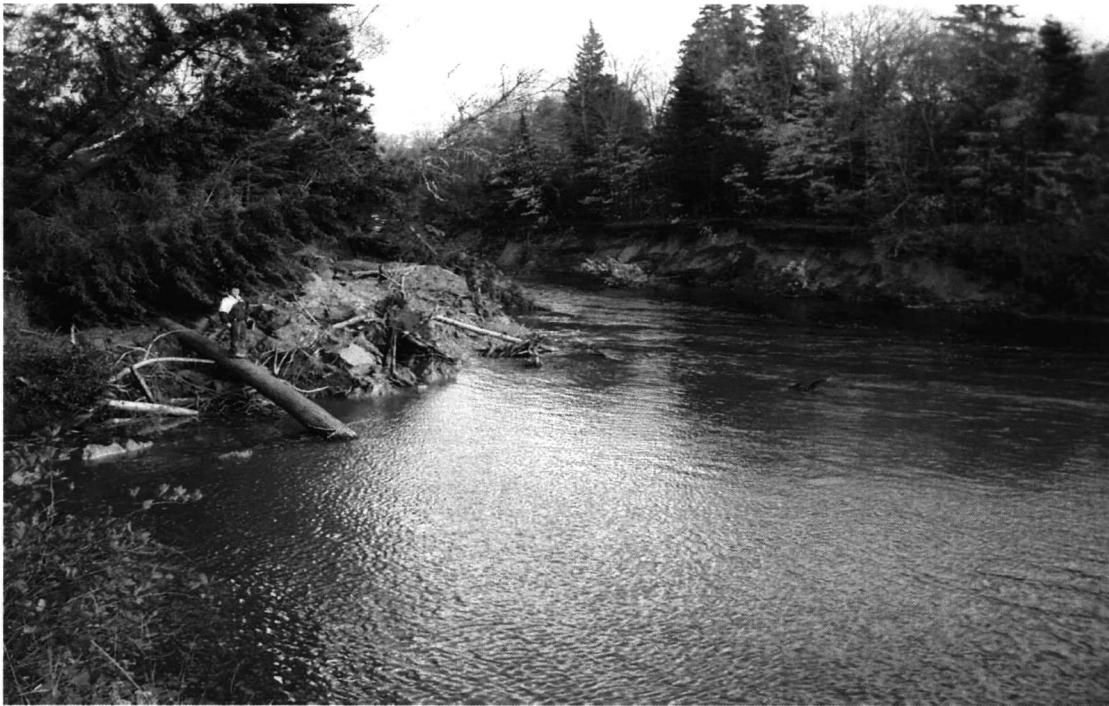
The toe of the slump area was observed to be protruding into the Goulais River and has subsequently reduced the normal waterway opening width from approximately 50 metres to approximately 15 metres over a distance of more than 100 metres (as measured along the axis of the river). The toe of the slumped embankment material that is within the original waterway path was observed to be partially covered with trees and other stream bank vegetative matter (Photo 3). It was not possible to determine whether the remaining open river section below the slump has been altered below the water surface (i.e., has the river bottom been heaved upwards but still remains below the surface of the water). The bank, directly across from the slump area, was observed to be eroding and this can be attributed to the significant reduction in the cross-sectional area of the river and increased velocities of the water at the slump location.

Photo 3 – Toe of slump at Goulais River. Note large trees within normal waterway opening area.

A large section of the Goulais River has been impeded upon and nearly closed off due to the slump. The area of the slump contains large trees, brush, etc. and is located within the normal watercourse area (Photo 6). The larger material, if not removed prior to the spring freshet, may contribute to an ice or debris jam. This is of importance as the Goulais River generally experiences ice and debris jams during the spring freshet. These jams often result in flooding of developed areas. This material should therefore be removed from the watercourse to the greatest possible extent.

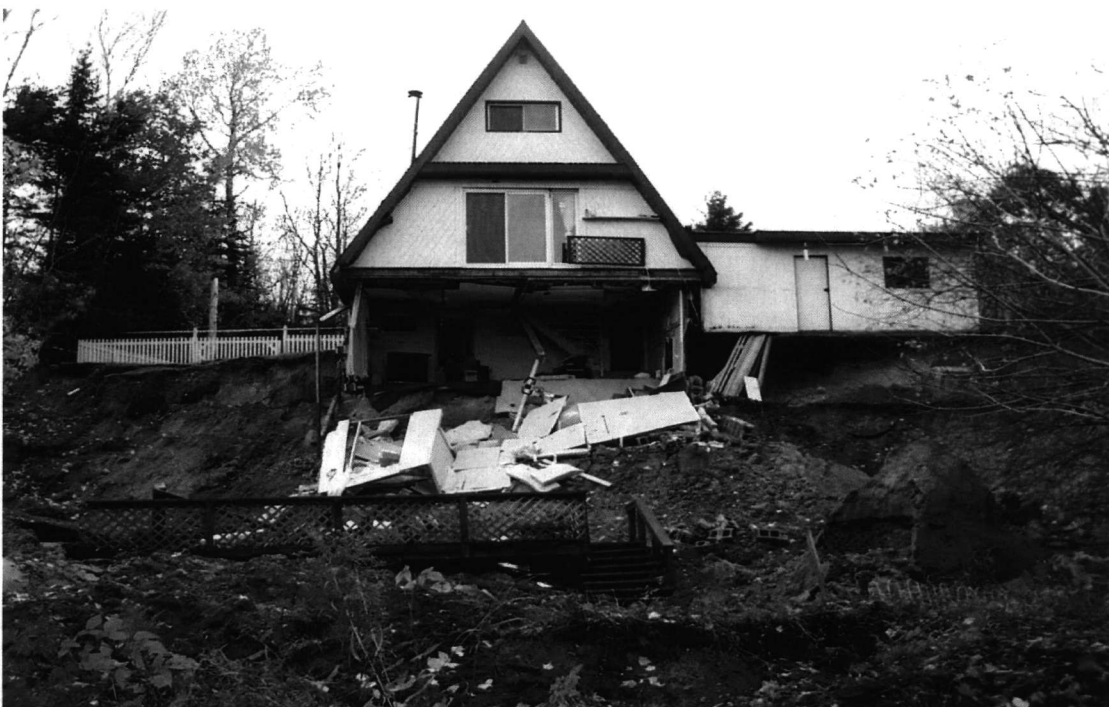
Photo 4 – Home severally undermined and on verge of tumbling into slump area.

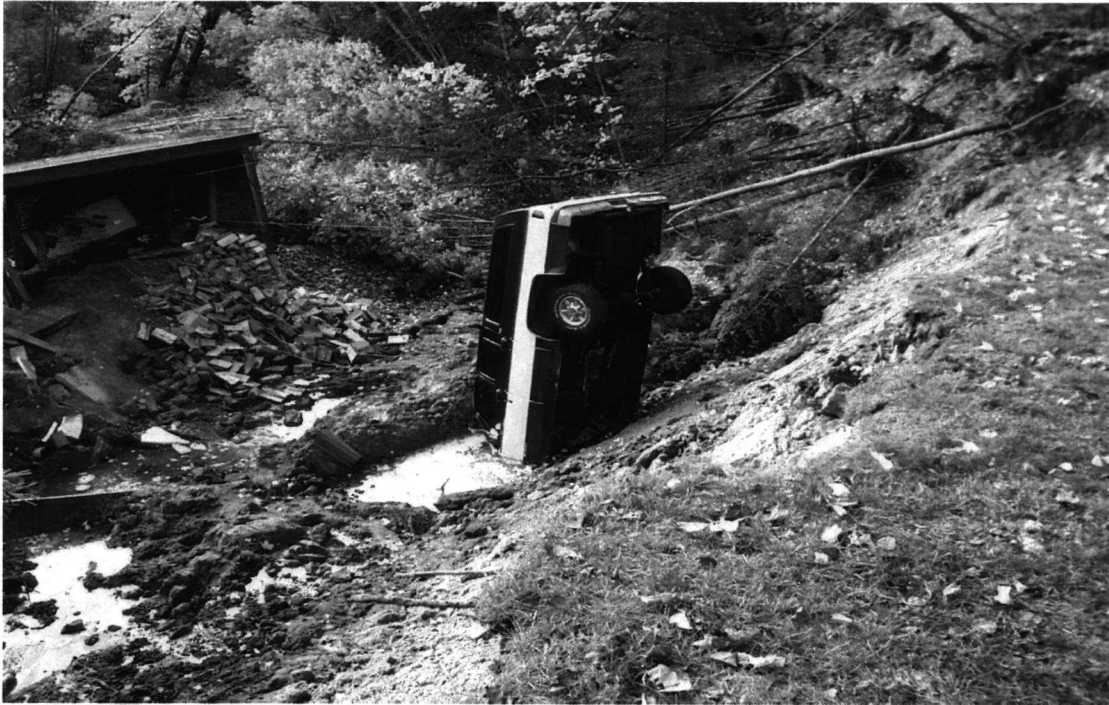
The three homes immediately affected by the slump pose an immediate risk to the environment. Specifically, septic systems for two of the homes have been damaged or destroyed and have been observed leaking effluent (Photo 5). With unrestricted site access, exposed raw sewage not only poses a risk to the environment but to the people as well. In addition, home fuel oil tanks have not been drained.

Photo 5 – Note Groundwater and effluent at base of slump.

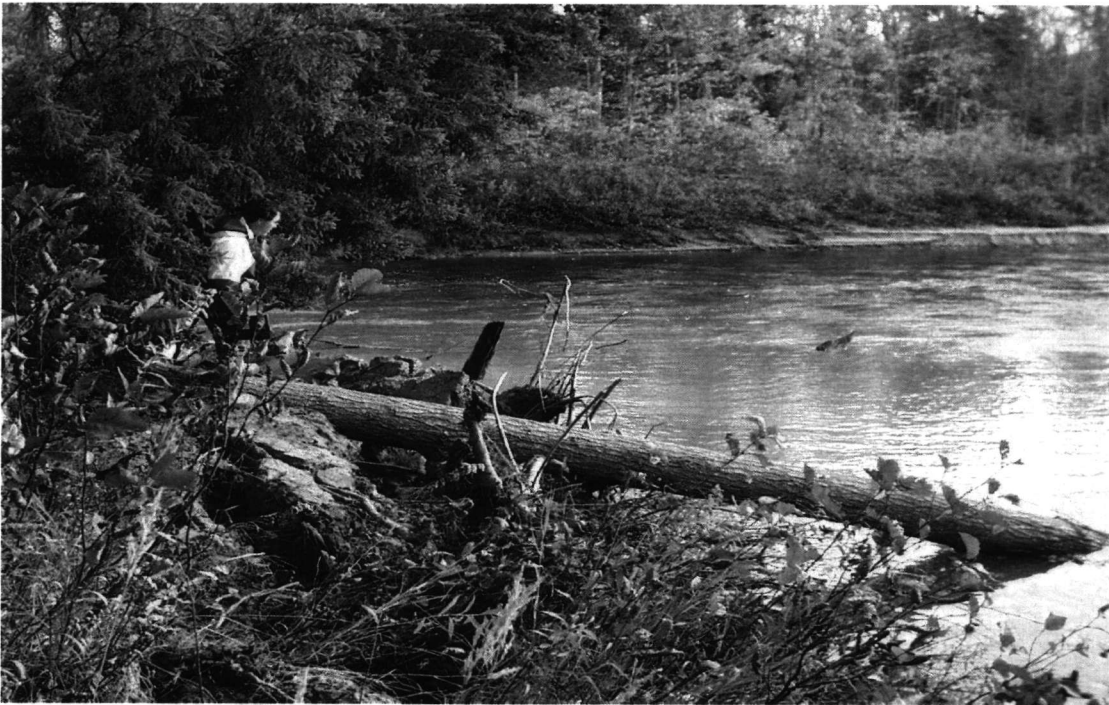
Photo 6 – View of toe of slump at river. Note large trees and other woody debris now within the waterway opening.
