#60-F-291-C

HWY. #17

HAVILLAND BAY CAUSEWAY

907 REPORT ON HAVILLAND BAY CAUSEWAY - HIGHWAY 17 T.C.H.

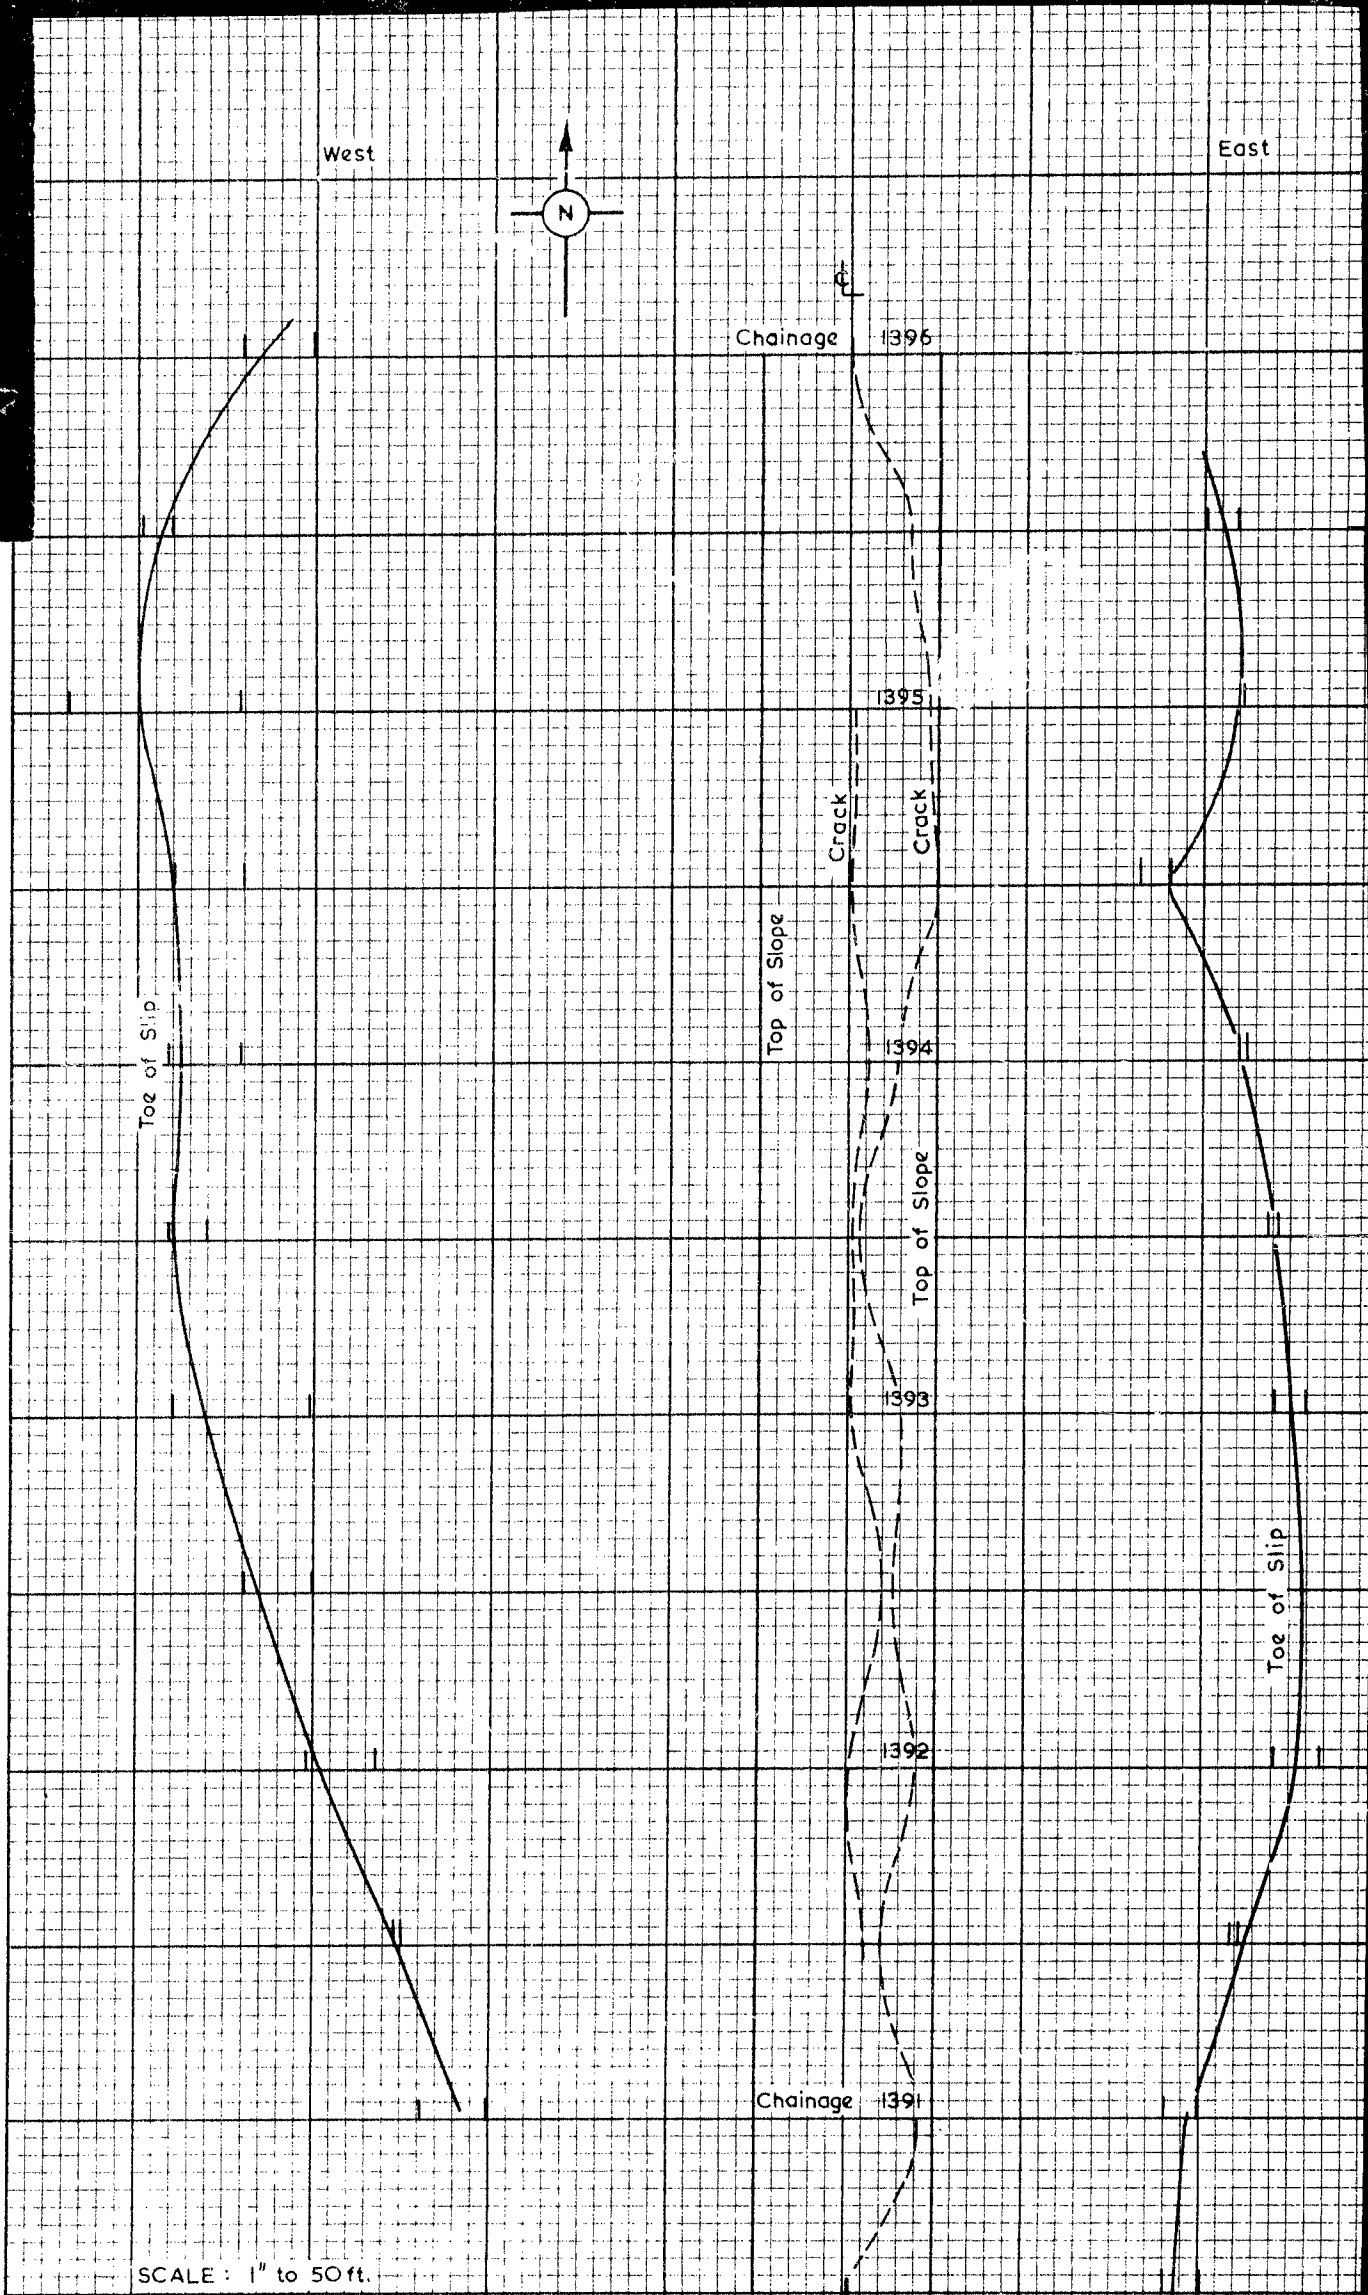
FIG. 1

A very careful survey of the area of the failure was made by the site and District staff of the Department of Highways. This consisted of profiles at 50 foot intervals across the bank for the whole of its length and extending some 200 feet on either side of it. From these profiles the plan and sections shown in figures 1 and 2 have been prepared.

This information indicates quite clearly the cylindrical nature of the second failure and the positions of the ends of the failure surfaces. It also shows that failure took place to both sides at once, the surface of failure extending somewhat further on the lake side, where the water and the clay is deeper, than on the land side.

PLAN OF SLIPPED AREA.

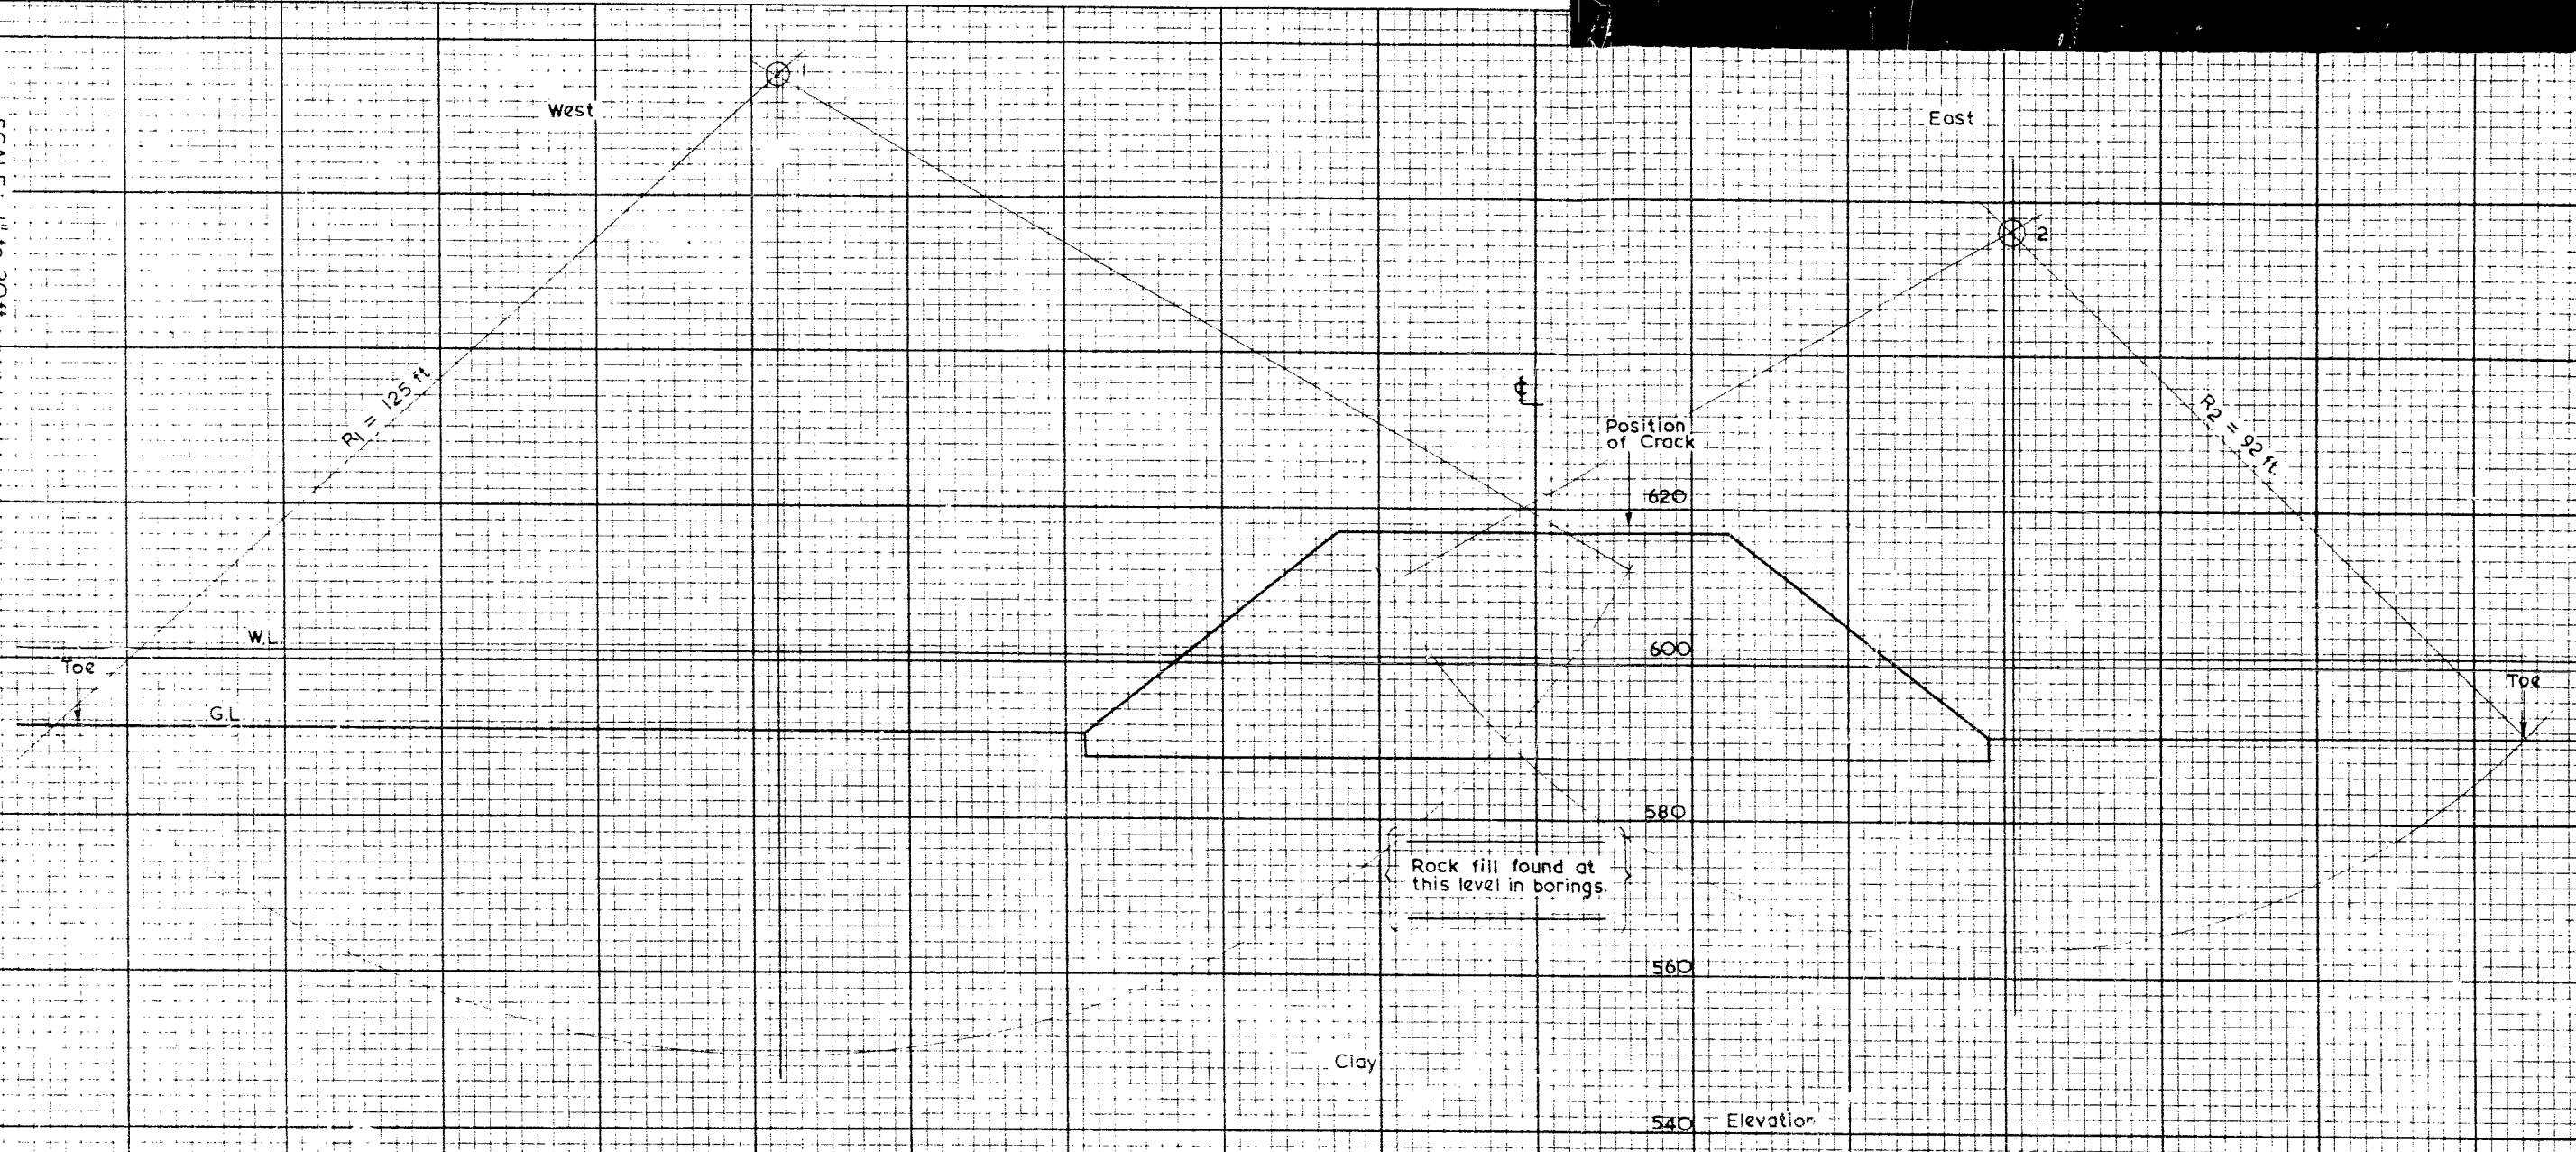
FIG. 2

Borings showed that the rock had moved downwards to about level 570 in places as shown in figure 2. The borehole logs made by the Department of Highways, and the results of the in-situ vane tests and laboratory compression tests are given in Appendix I. They indicate a shear strength for the clay of about 600 lb/sq.ft.

SECTION THROUGH SLIP
