T.C.H. BRIDGE

FOUNDATION INVESTIGATION FOR A PROPOSED
TRANS-CANADA HIGHWAY BRIDGE ACROSS THE EAST BRANCH
OF THE BALDHEAD RIVER, NEAR STATION 833 + 00,
ALGOMA DISTRICT, ONTARIO.

Racey, MacCallum and Associates
Limited

21 March, 1958

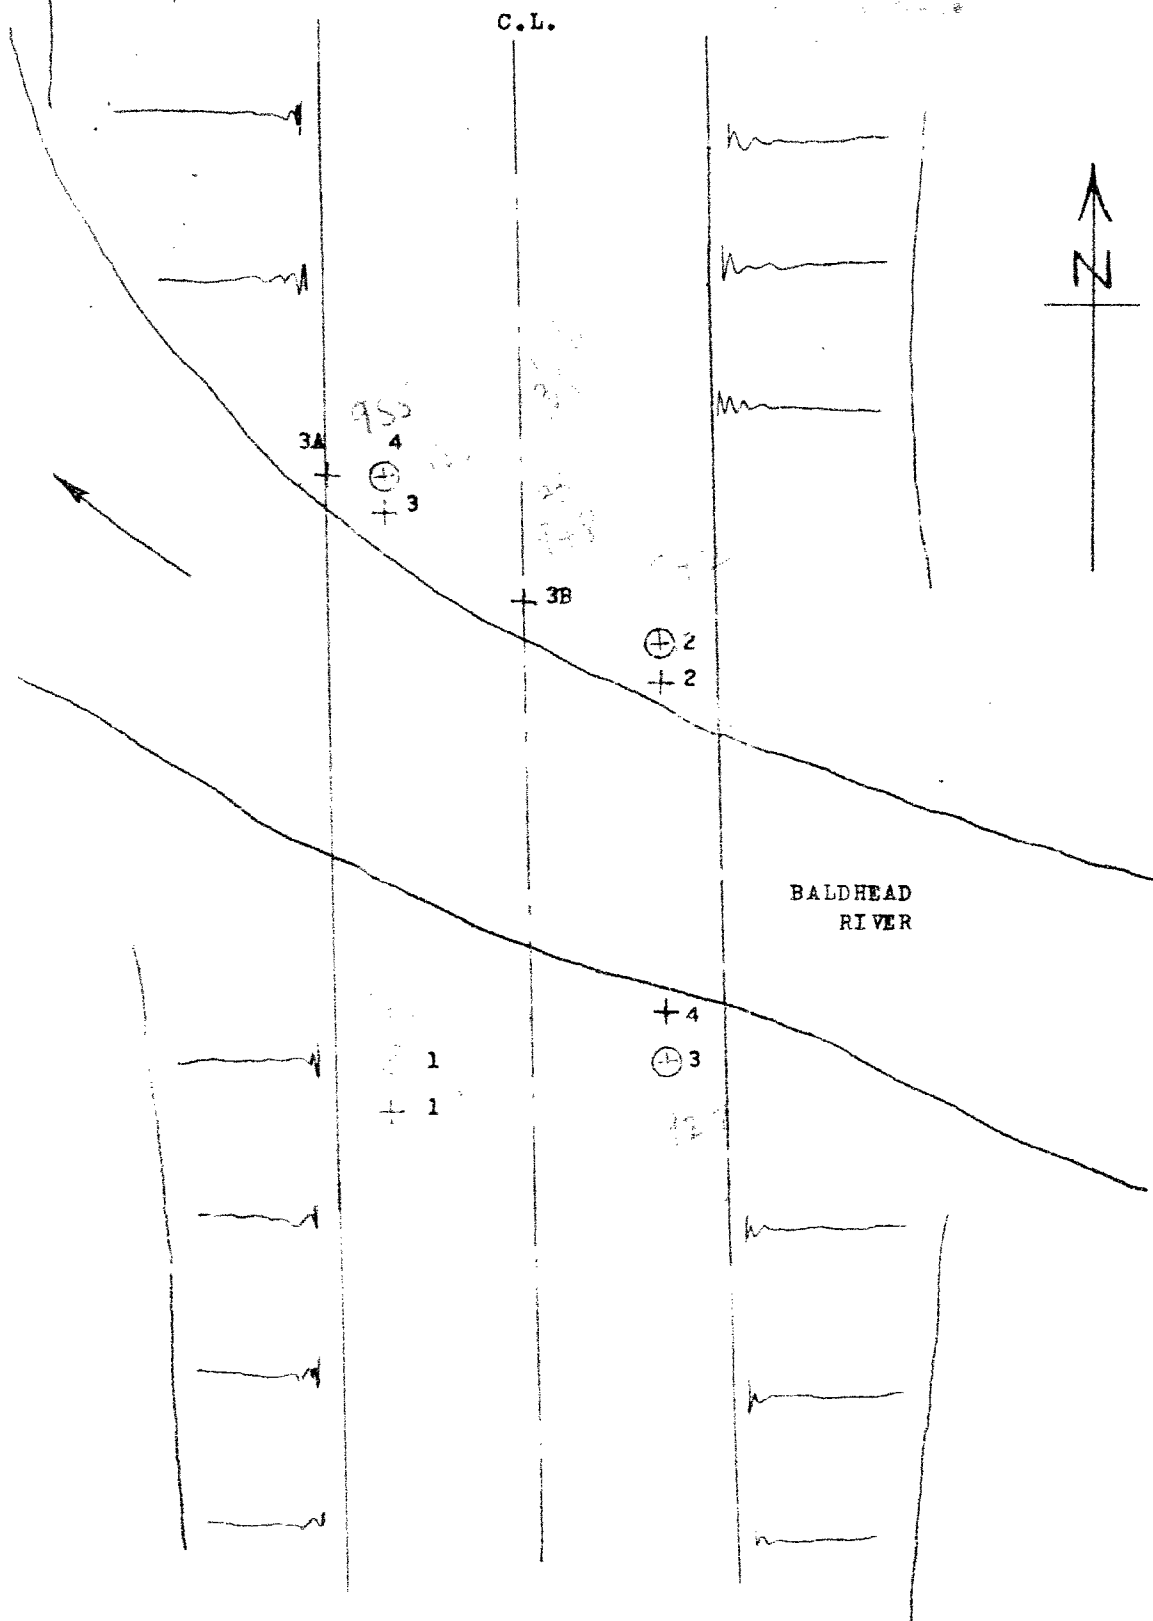
SITE PLAN
BALDHEAD RIVER BRIDGE,
NEAR STATION 833 + 00
SCALE : 1 inch = 20 feet.

The site plan, Enclosure No 2, shows the location of the boreholes and cone penetration tests actually carried out at Station 833 + 00. It was originally intended to carry out four boreholes and penetration cone tests at the bridge site, but drilling conditions proved so difficult that it was felt desirable to cut down the amount of work performed.

A cone penetration test was attempted at Location 1, shown on Enclosure No 2, but it was found possible to drive the cone test only to a depth of about 3 feet. At each of several sites the numerous boulders in the underlying soil prevented the driving of the cone further than this depth without severe damage to the point. However, it was found possible to advance a borehole at Location No 1, and the soil strata encountered are shown in the Engineering Data sheet, Enclosure No 3.

Refusal was encountered in this hole at a much shallower depth than was the case in either of the first two boreholes, and a further cone penetration test at the location shown on Enclosure No 2 as 3A was performed. This gave results substantially identical to those obtained with the cone test No 3. At this stage it was decided to carry on and drive a penetration cone at Location 4 in the diagram; it proved impossible to penetrate the dense boulder layer at this location. Consequently a borehole, No 3, was also attempted but it, too, proved almost impossible and succeeded only in penetrating to a depth of 3 feet, where the hole was terminated in case of damage to the equipment. Since an examination of the site conditions seemed to indicate that those existing at location No 2 on the north bank of the river were poorer than those on the south bank of the river, it was decided to attempt a further borehole at the location shown as Borehole No 4 on the diagram. The results obtained from Borehole No 4 are shown on the Engineering Data sheet, Enclosure No 7, and substantiate those of the cone penetration tests 3 and 3A. In order to check the elevation of bedrock, which apparently changed between locations No 2 and No 3, it was decided to carry out a further cone penetration test, No 3B, on the centre line of the road. The results of this cone test are shown on Enclosure No 6, and indicate that a uniform gradient of the bedrock apparently exists from cone No 3 location down to location of Borehole No 2.

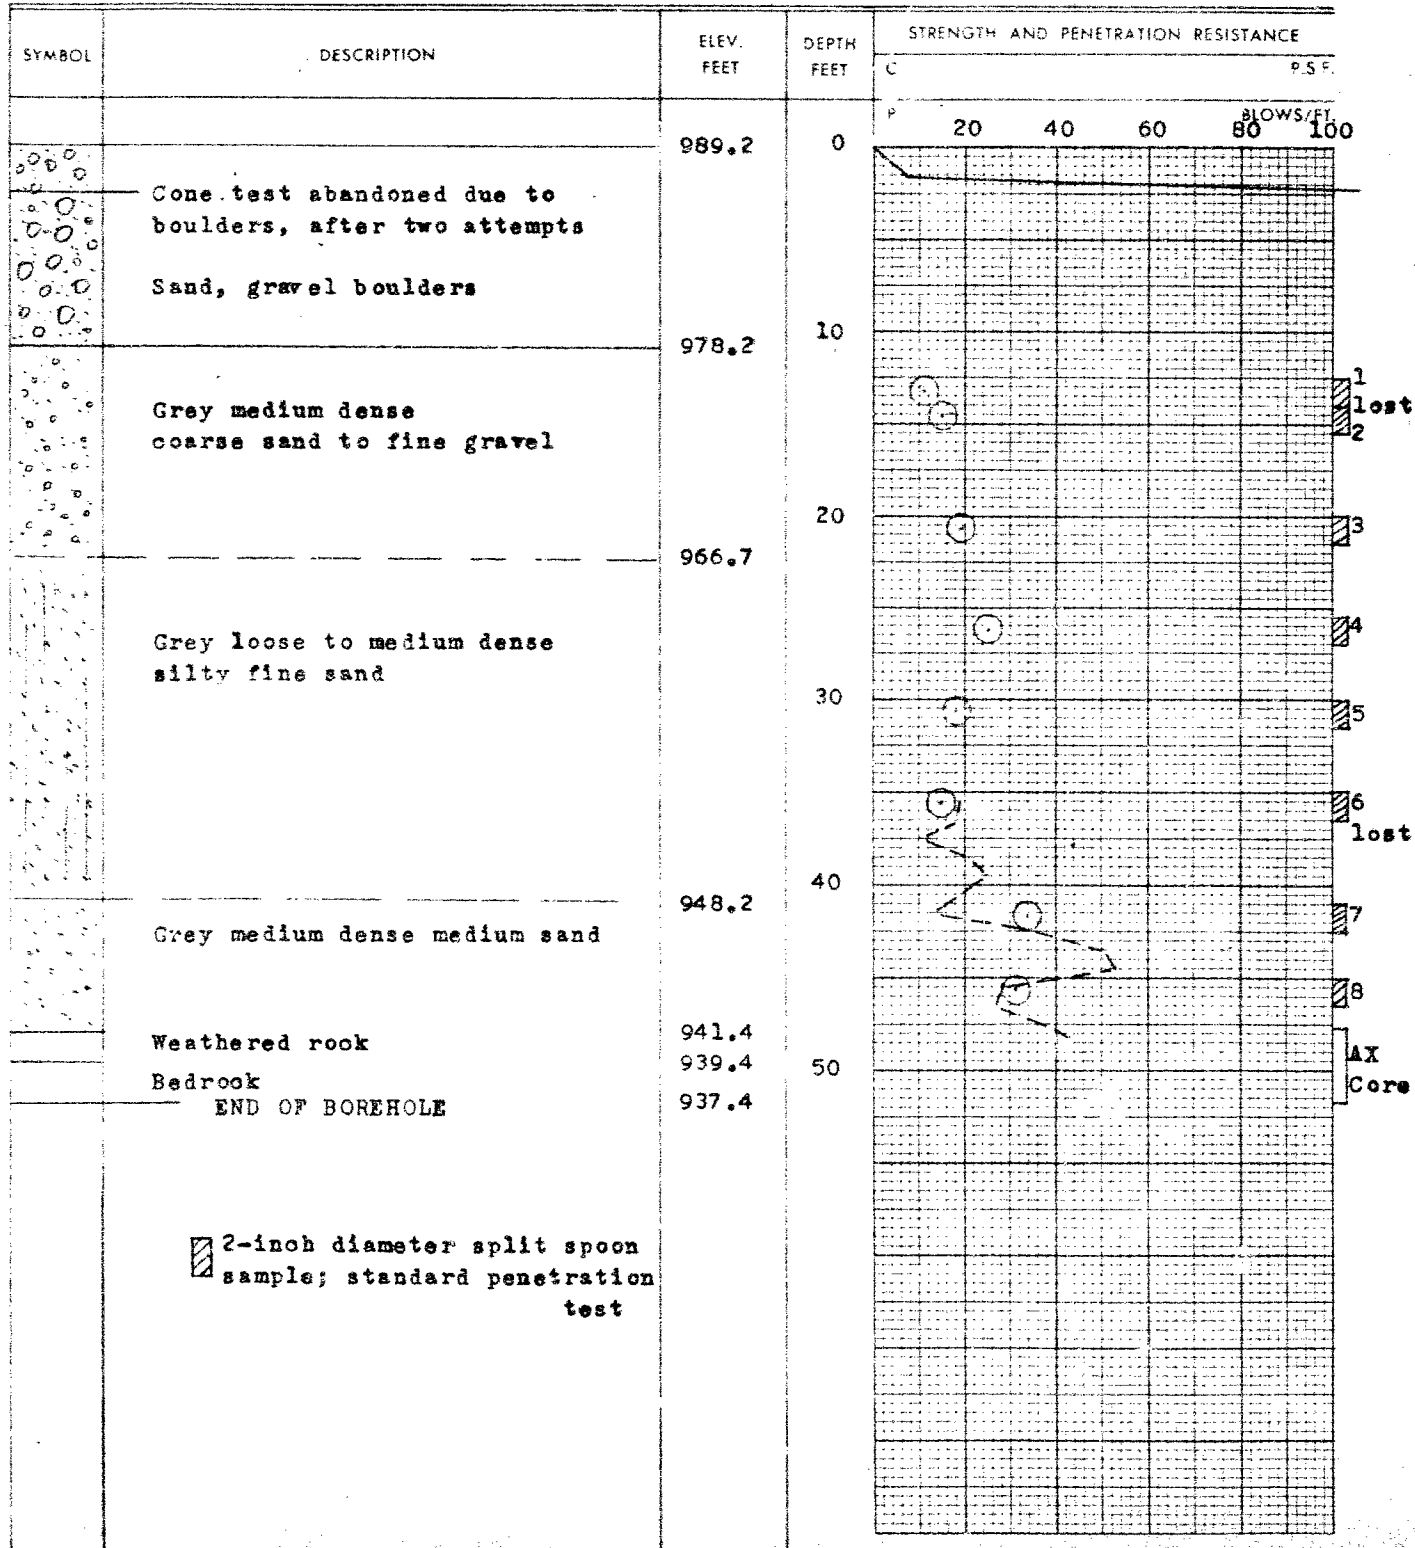
Engineering Data Sheet for Borehole: 1

The soil conditions appear to be quite similar at all three completed boreholes, with a surface layer of approximately 10 feet of coarse sand, gravel and boulders underlain by a 15 foot layer of loose to medium dense coarse sand containing some fine gravel. Underneath this latter layer is a zone of loose to medium dense silty fine to medium sand, which varies in thickness in the different boreholes. In Borehole No 1 this material has a thickness of approximately 20 feet, while in Borehole No 2 only 5 - 10 feet of fine material is encountered, and approximately 10 feet in Borehole No 4. Below this, again, is a grey medium dense fine to coarse sand containing some gravel in all three boreholes immediately overlying bedrock, which consists of a granite. A similar pattern of density is apparent in all of the boreholes, with extremely dense material at the surface which probably represents that portion of the soil profile which is disturbed by periodic floods of the river and has, therefore, been moved and compacted to a high degree. The layer immediately underneath this, of thickness 15 to 20 feet, appears to be in a very loose to medium dense condition and does not constitute a reliable bearing material for foundations. Below a depth of 40 feet in Borehole No 1, the soil begins to become more dense again and this density increases until bedrock is reached. In Borehole No 2 a gradual increase in density occurs from a depth of 25 feet down to about 35 feet, but the density once again falls off as bedrock is approached. In this borehole the material between a depth of 9 feet and a depth of 25 feet is in an extremely loose condition. In Borehole No 4 the soil appears to be in a loose to medium dense state from a depth of 10 feet down to a depth of 25 feet in the medium sand immediately overlying bedrock. The soil encountered in all boreholes is a grey material and all the fragments appear to be angular, indicating that they have not been subject to a great deal of movement or attrition.

The indications are that, in Borehole No 1, it would be necessary to drive piles to bedrock at Elevation 940 approximately, while in Borehole No 2 on the other side of the river the piles can probably be driven to Elevation 942 approximately. It is possible that the last 10 or 15 feet of driving in this hole may be quite hard. Borehole No 4 indicates that a much shorter length of pile will be required, and that the limit of penetration will be reached at approximately Elevation 956. No unusual difficulty should be encountered in driving piles at this location. The maximum allowable loads for H-piles can be used in these circumstances, since the piles will in each case probably rest upon sound, hard bedrock.

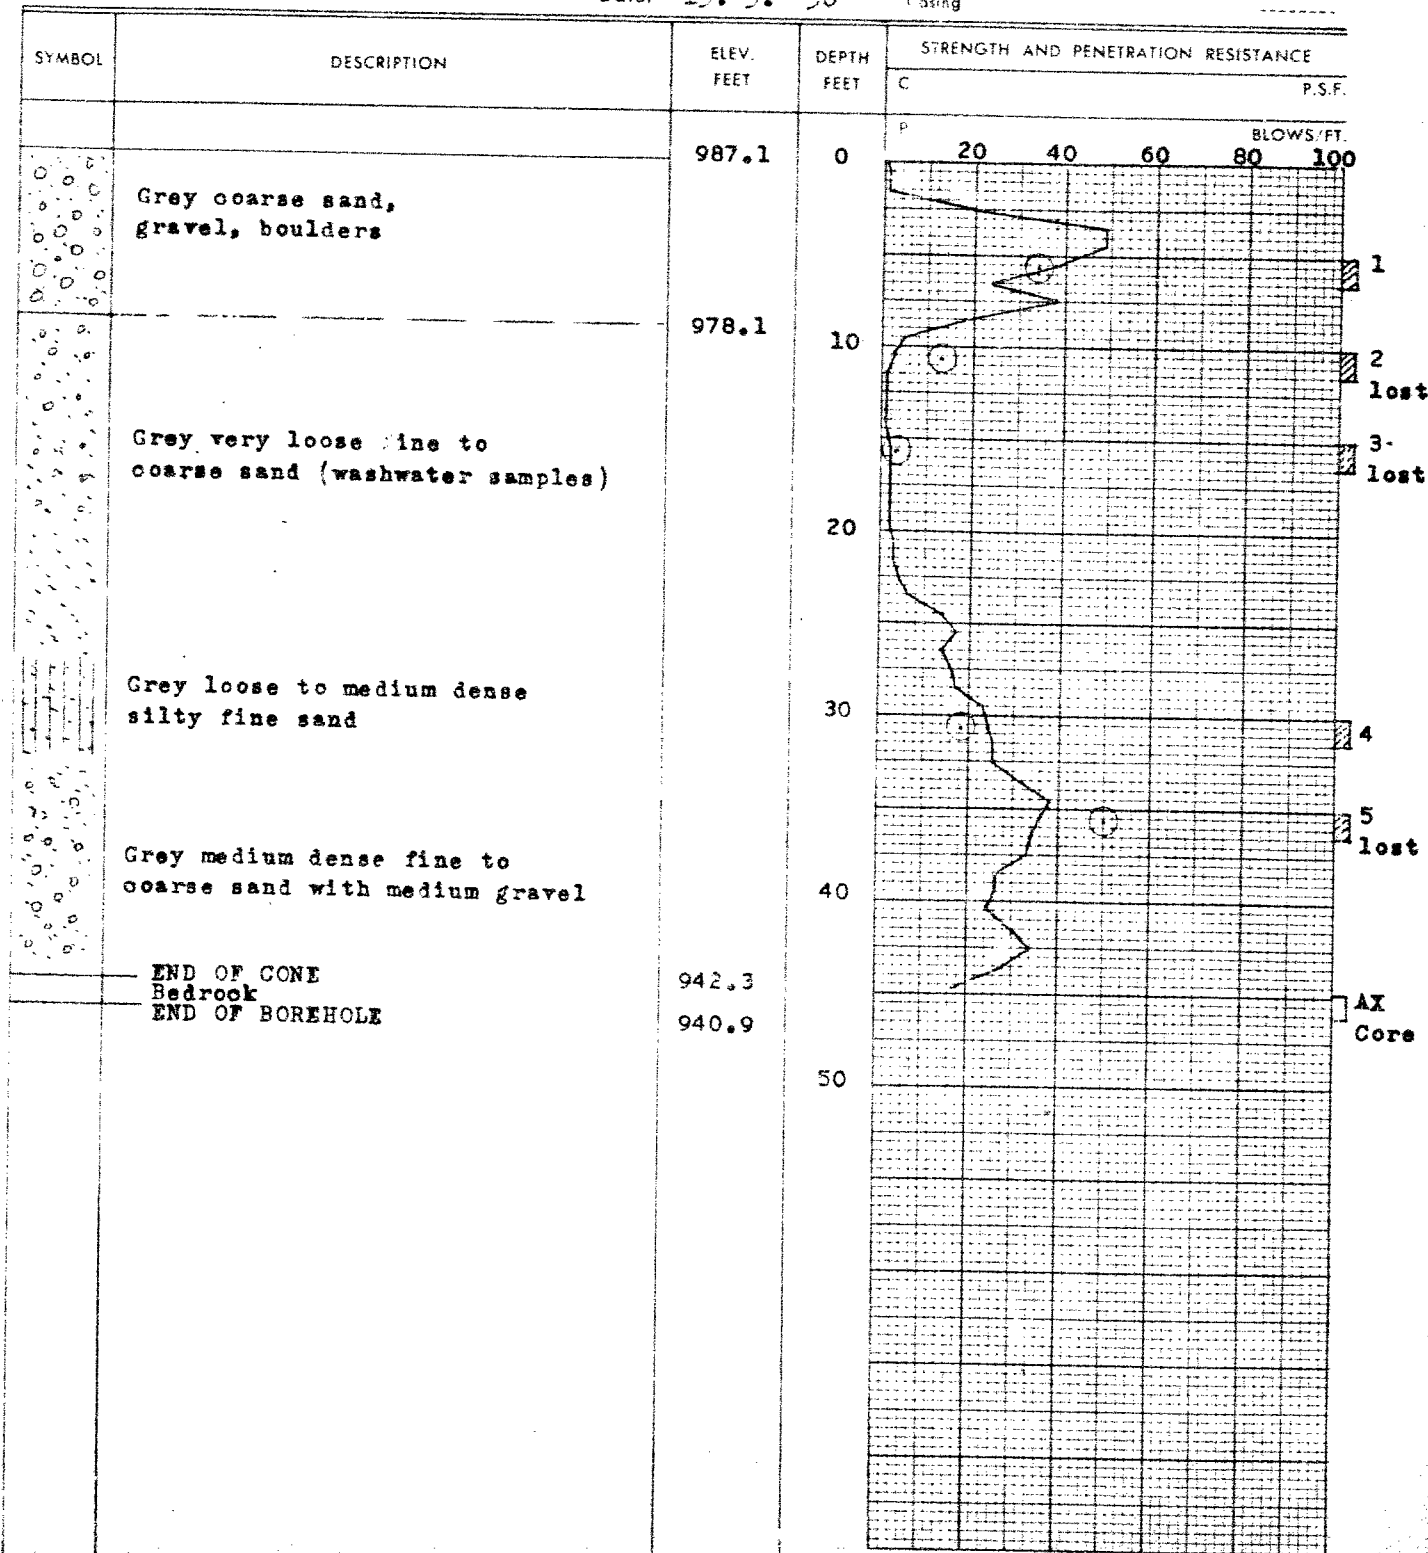
Engineering Data Sheet for Borehole: 2

The drill was then moved to Location 2, where it proved possible to carry out both the cone penetration test and a borehole, with the results shown on Enclosure No 4. Apart from the difference in depth to bedrock, the results seem to be quite similar for both boreholes. Consequently it was felt advisable to carry out only a cone penetration test at Location 3, and accordingly cone penetration test No 3 was driven.
