57-F-237C  
W.P. 952-57  
Hwy. # 17  
BARRETT RIVER

SOIL SITE INVESTIGATION  
AT  
PROPOSED CROSSING FOR  
BARRETT RIVER  
FOR  
DEPARTMENT OF HIGHWAYS - ONTARIO.  
OUR JOB No. 5792 DATE: 22 JAN '58  
CLIENTS PLAN No. E-3332-1 PER. C.F.F.

**SOIL SITE INVESTIGATION**

**BARRETT RIVER CROSSING**

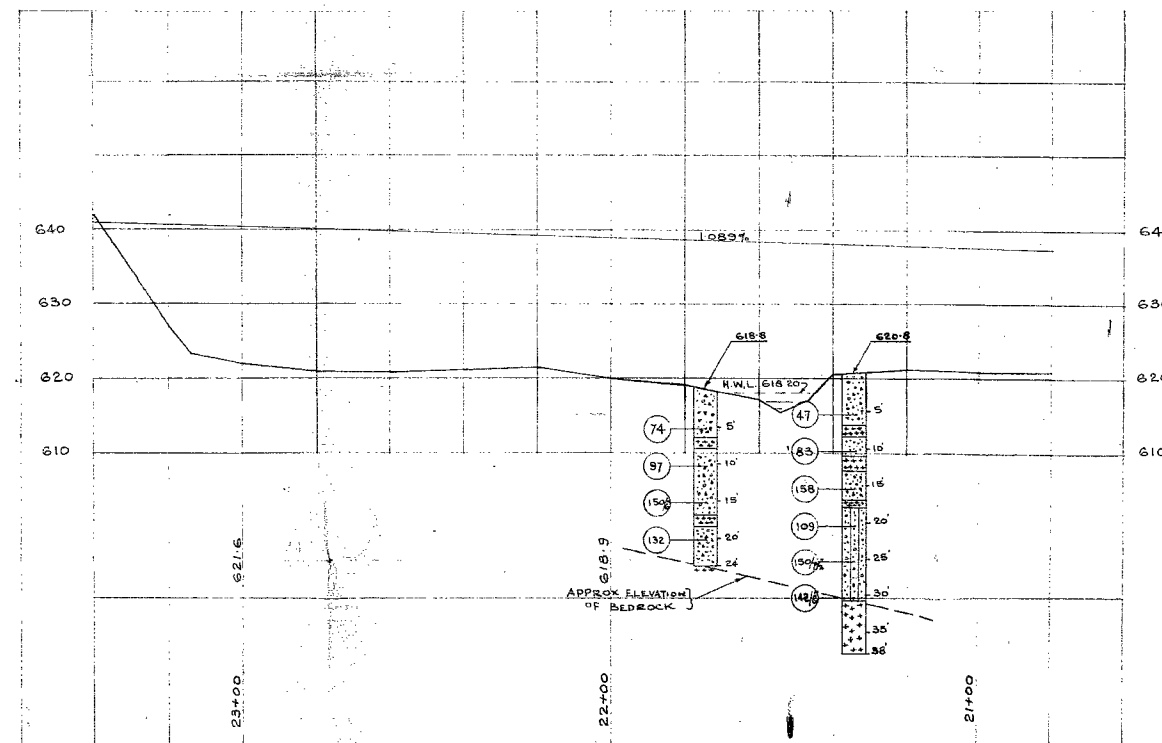
## PROFILE

Soil conditions at the river crossing are quite uniform, and are generally good for foundation purposes. The only soil type encountered was a grey-brown to grey very fine to very coarse sand with gravel and boulders. This material is quite heterogeneous in composition, as are nearly all glacial deposits of granular material. The rock fragments and boulders are of igneous origin. The sand and gravel is very dense, even though saturated. The number of blows in the standard penetration test varied from a low of 47 to a high of well over 150 blows per foot. Some of this variation may well have been due to the interference from large stones and boulders encountered in this deposit. The bedrock elevation indicated on the profile has been shown as approximate, since the rock core recovered was badly fragmented, and may have been the result of drilling through a series of boulders overlying bedrock.
