#62-F-124

WAWA EASTERLY

SUBJECT: Re: Stability of Rock Fill Embankments,  
Highway #101 Wawa Easterly,  
Contract #62-178.

Re: EMBANKMENT FAILURE HWY #101  
6 MILES EAST OF WAWA CONT. # (2-178)

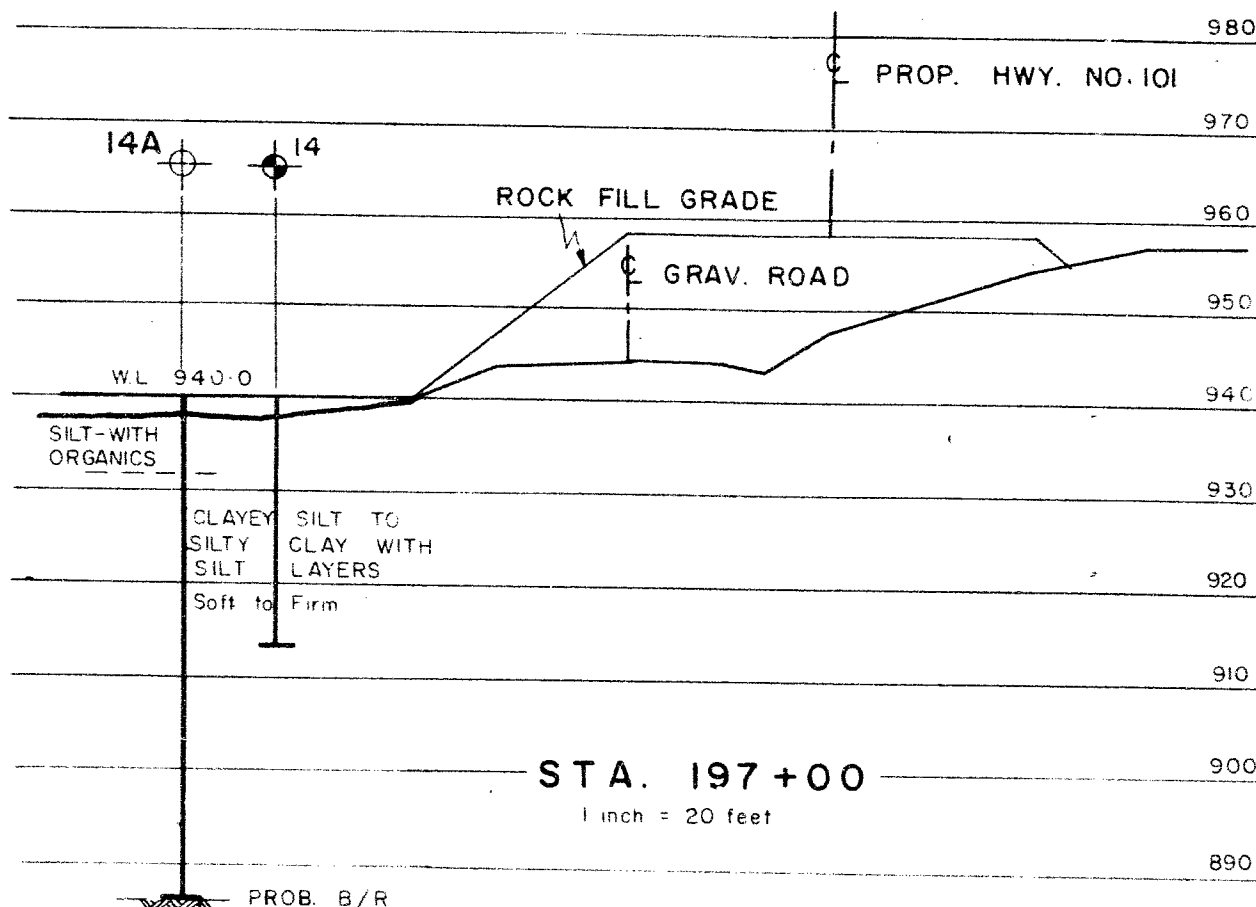
HWY. NO. 101 - WAWA EAST  
PROPOSED EMBANKMENT  
AT STA. 197+00

Lake depth here is 2' to 3'. Subsoil consists of at least 24' of soft to firm clayey silt to silty clay containing stratified layers of fine sandy silt.

As a result of our investigations it is apparent that some failures of the proposed embankments might occur during construction. The most critical locations appear to be between Stations 132+00 and 135+00, 196+50 and 197+00, 201+00 and 204+00, and 270+00 and 290+00. However, it is felt that it would be unwise at this stage to propose expensive remedial measures based on the very limited number of borings carried out. We therefore recommend that construction be carried out according to the original design proposals. If failures occur at specific sections this office should be informed as soon as possible and we will advise the district of the remedial measures to be taken.

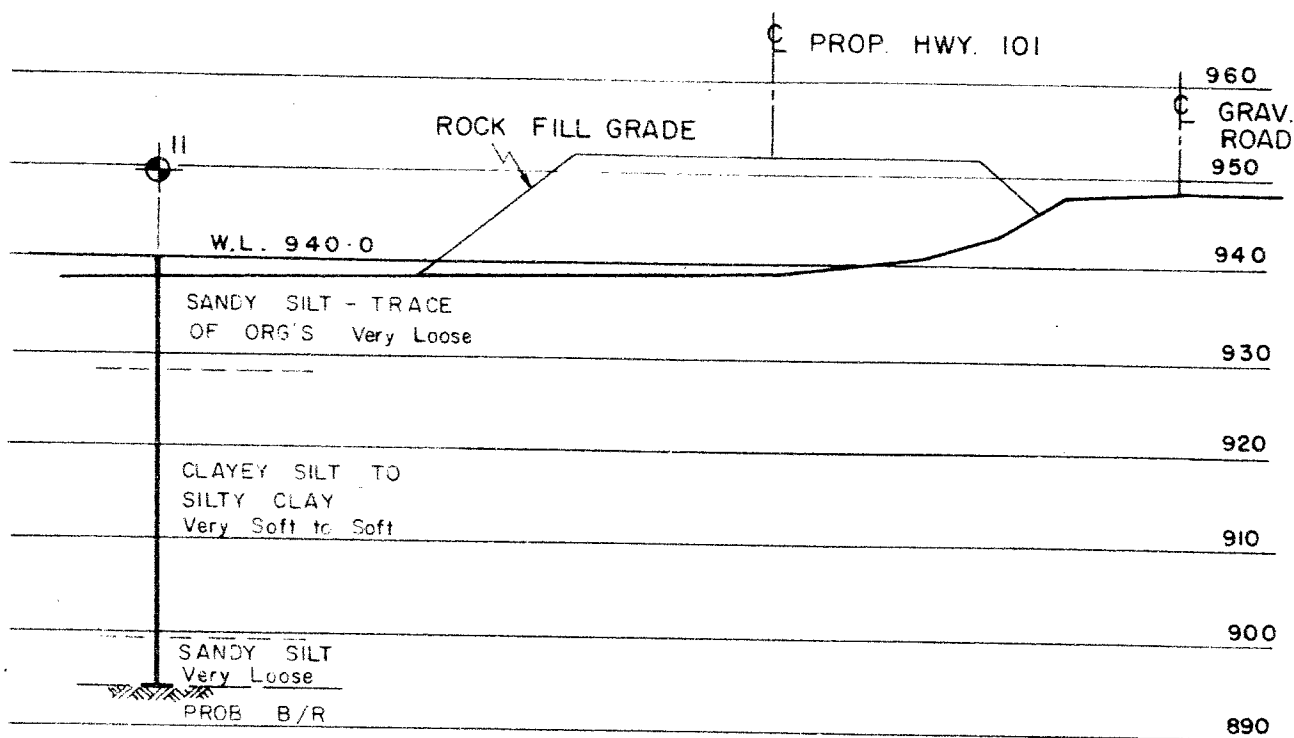
HWY. NO. 101 - WAWA EAST  
PROPOSED EMBANKMENT  
AT STA. 202+00

Lake depth here is 2' to 3'. Subsoil consists of about 10' of very loose sandy silt with organics followed by about 30' of very soft to soft clayey silt to silty clay.

Between Stations 196+50 and 205+00, our borings indicate the subsoil at the left toe of slope to consist of up to 10' of loose silt with organics, followed by up to 50' of soft to stiff clayey silt to silty clay. It is probable that construction difficulties due to failures will occur across this entire section and, therefore, it is our recommendation that stabilizing berms be constructed on the lake side of the fill sections. The dimensions of these proposed berms are shown on the accompanying sketch. Notes regarding construction procedures to be followed are also given on the sketch. If subsoil conditions at some locations appear to be more favourable than the borings indicate, the berms at these locations may be dispensed with and a transition as shown on the sketch, may be employed.

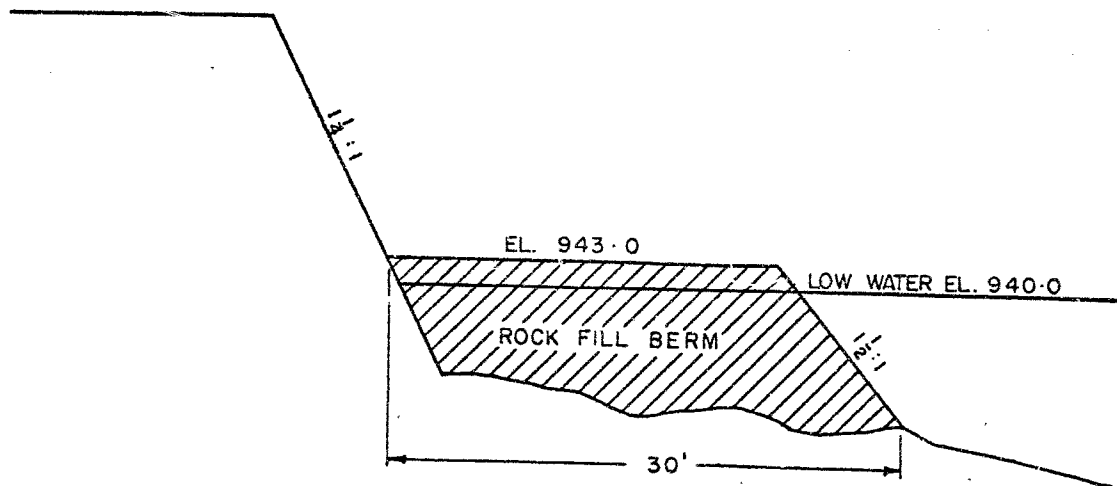
Recommended Berms - Sta. 255+70 to Sta. 256+75

During construction of the rock fill embankment between Stations 255+00 and 262+00, a failure took place at Sta. 256+25. The fill was just up to grade at that point - i.e., about 22' high. The outer 7' (measured back from the toe), slid down into the lake. The length of the failed area was about 30'. The fill was then rebuilt to grade and failed again in the same manner. It was again rebuilt to a height two or three feet below grade and it failed once more. These events took place during October, 1962. The Foundation Section were requested to investigate the situation by Mr. E. R. Saint on 25th October, 1962.

It is our opinion that remedial measures should be taken, not only at the failure zone, but also along the toe of the existing fill between Stations 255+00 and 260+00. These recommendations are as follows:-

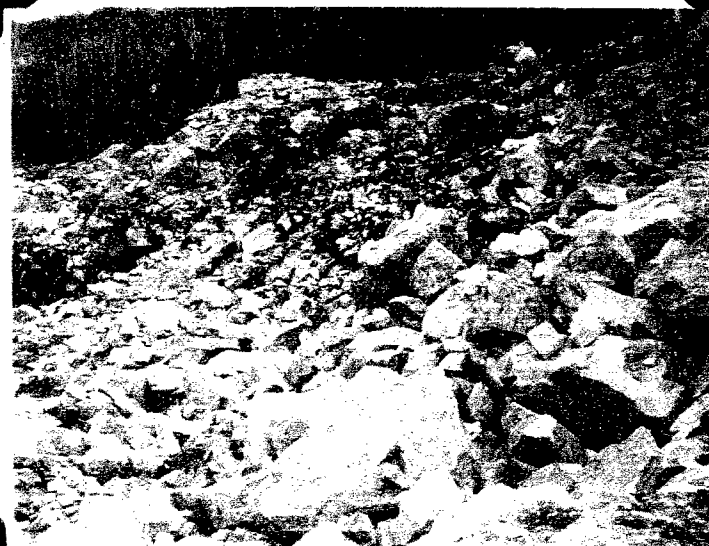
CONT. 62-178  
HWY. \*101  
WAWA.  
STA. 262-255  
(LOOKING WEST)

CONT. 62-178  
HWY. \*101  
WAWA  
FAILURE AT  
STA. 256+25  
LEFT OF C
