HWY. No. 65LOCATION Slope Failure - 17 km N of
Elr. Lake at Hwy 65No of PAGES -

Re: Embankment failure at Hwy. 65
approximately 18 km south of the Junction of Hwy. 65/66
W.O. 96-11002, Hwy. 65, District 53, New Liskeard

Re: Embankment failure at Hwy. 65, approximately 18 km south of the Jct. of Hwy. 66/65.

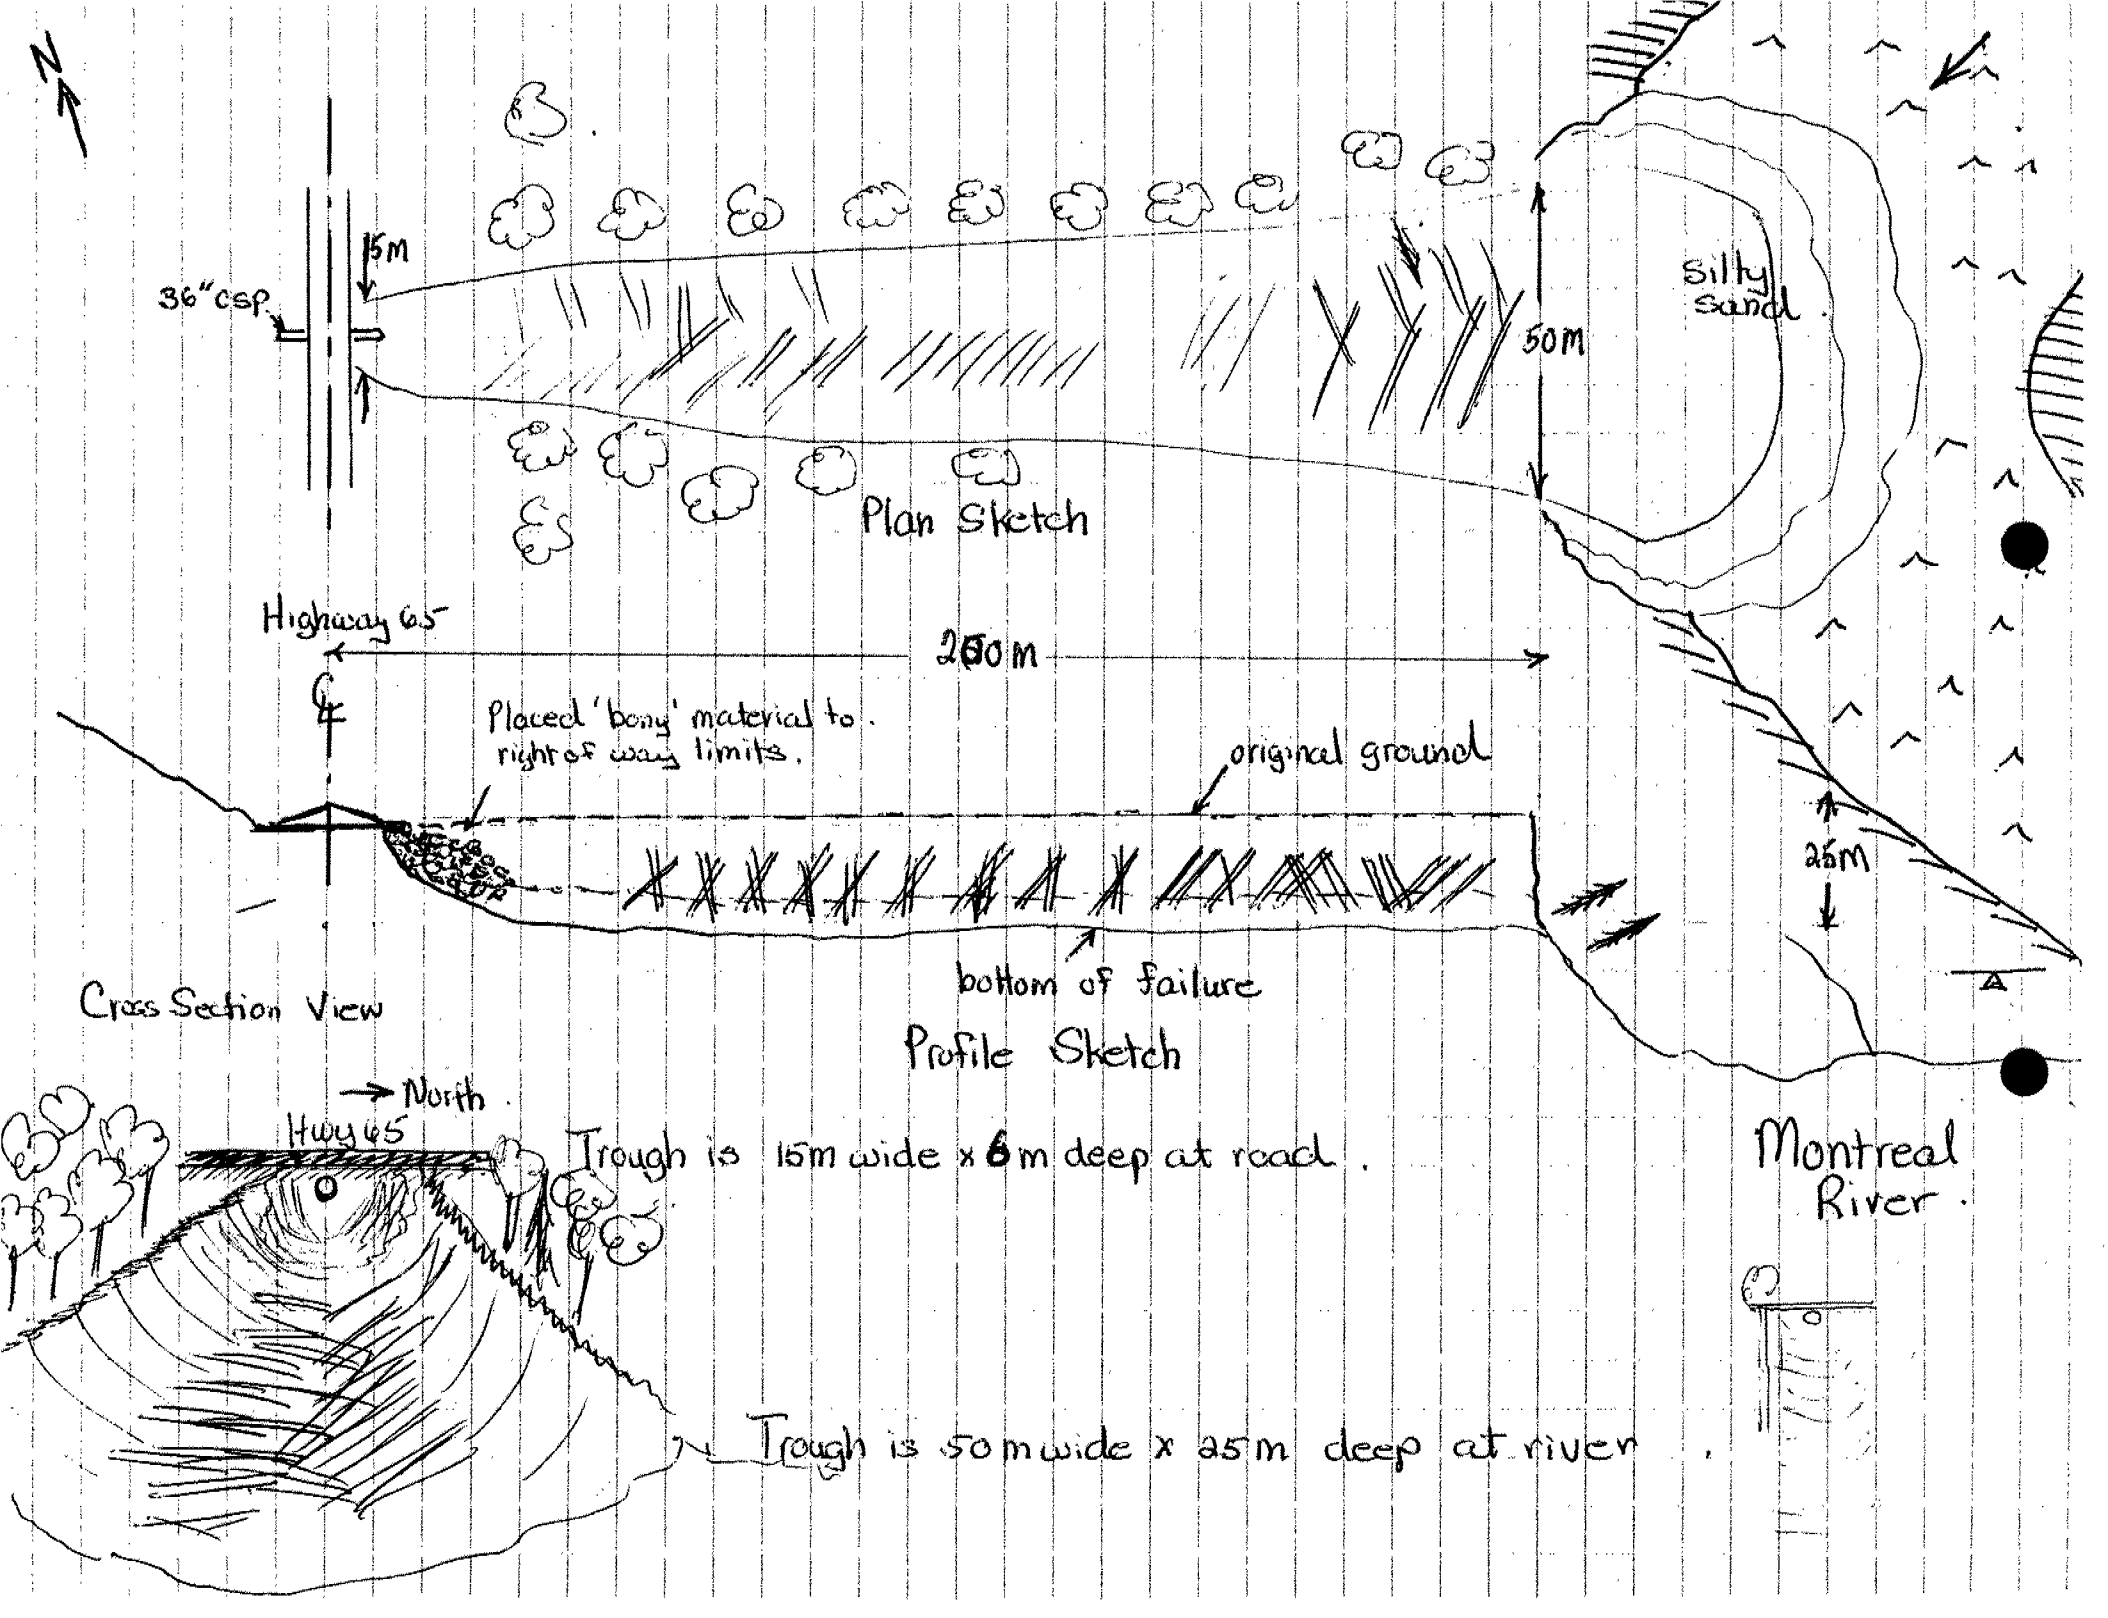
Plan Sketch

The failure appeared to be from natural causes. The erosion from the river at the embankment toe; undermining of the embankment from underground water sources; and saturation of the embankment material during the spring thaw were all contributing factors.

Silty sand

Placed 'bony' material to right of way limits.

Trough is 15m wide x 6m deep at road.

Trough is 50m wide x 25m deep at river

① 8'x6'
CSPA
② 36" csp
site of
failure
