**David F. Wood**

**Report to**  
**Proctor & Redfern Limited**  
**on Rock Mass Conditions at Chabanel Twp.**  
**Highway 101, Wawa, Ontario**

November 7, 1997

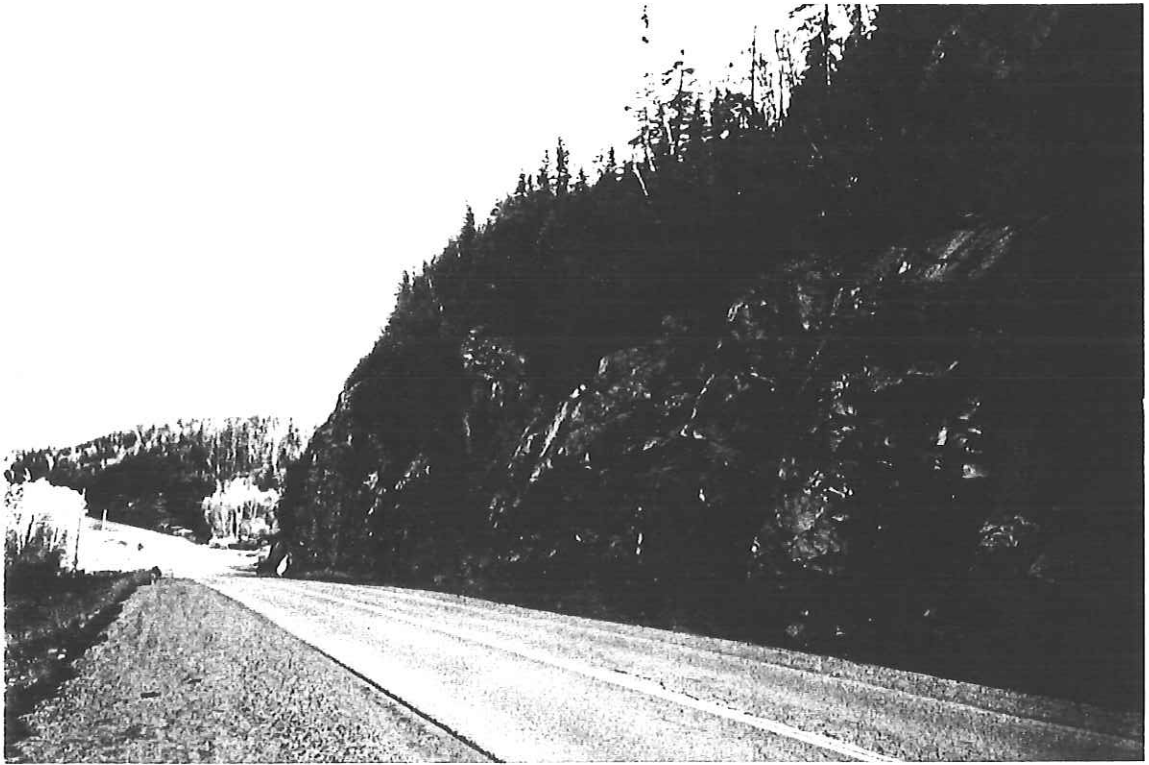
This site, mostly on a tangent alignment of the highway on a downhill grade heading east, Figure 1 in Appendix 1, was constructed using some form of controlled blasting using vertically oriented drill holes, Figure 2. The face was estimated by FGL to be in the 8–14 metre range, although the MTO drawings show a rock cut up to 18 metres high. Without the aid of detailed surveying, the face was estimated to be 15–16 metres high at the crest. Many of the original blast hole traces are visible in this south excavated face, attesting to the competence of the rock mass in general, Figure 3. There are, however, some noticeable zones of more highly fractured, or in some cases faulted, rock where freeze-thaw action is likely to generate fragments of rock which are prone to ravelling, Figure 4.

Figure 1: Overview of Site P from PA, 16+760. Note wet face PE-PF

The realignment of the highway at Site P will certainly give a long term solution to rock hazard, provided that the final design has a well-developed ditch. Realignment towards the north may not require the placement of fill in Wawa Lake if bedrock conditions continue to the shoreline as anticipated, Figure 5. Further east, the lake shore is shallow and fill may be required, Figure 6.

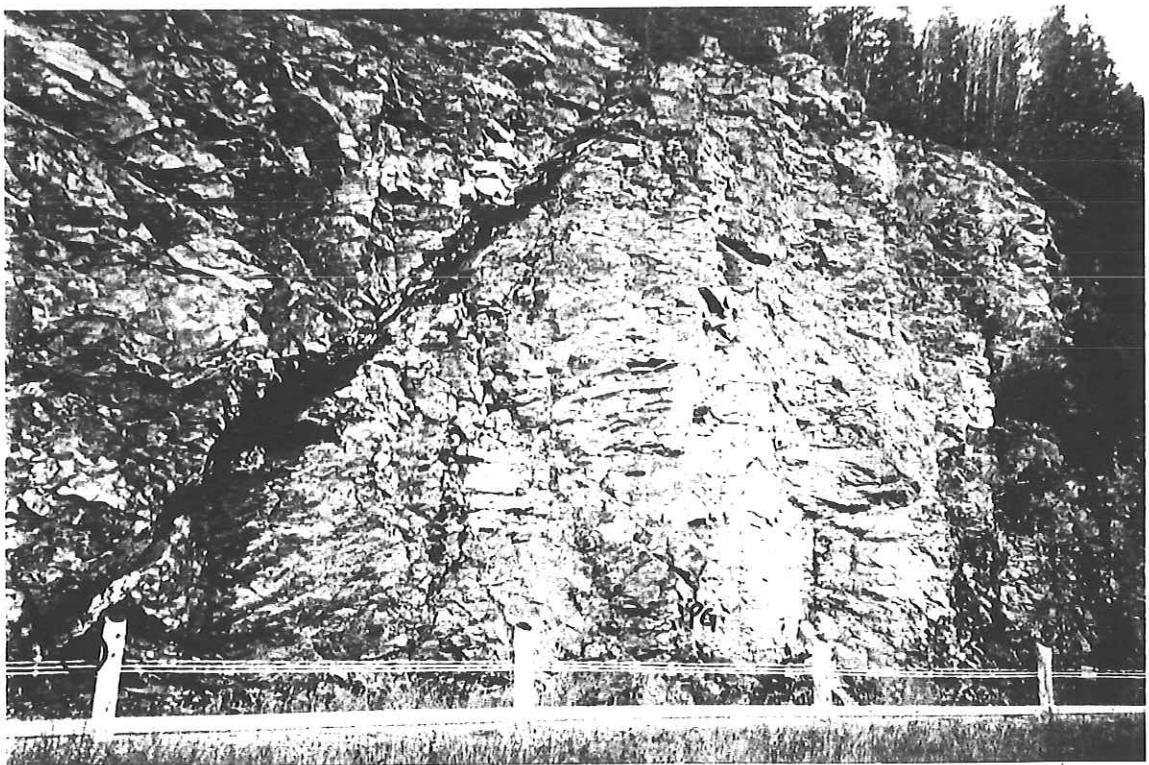
Figure 2: Site P, PF-PH, 16+840-16+875. Note FGL mark PH at left

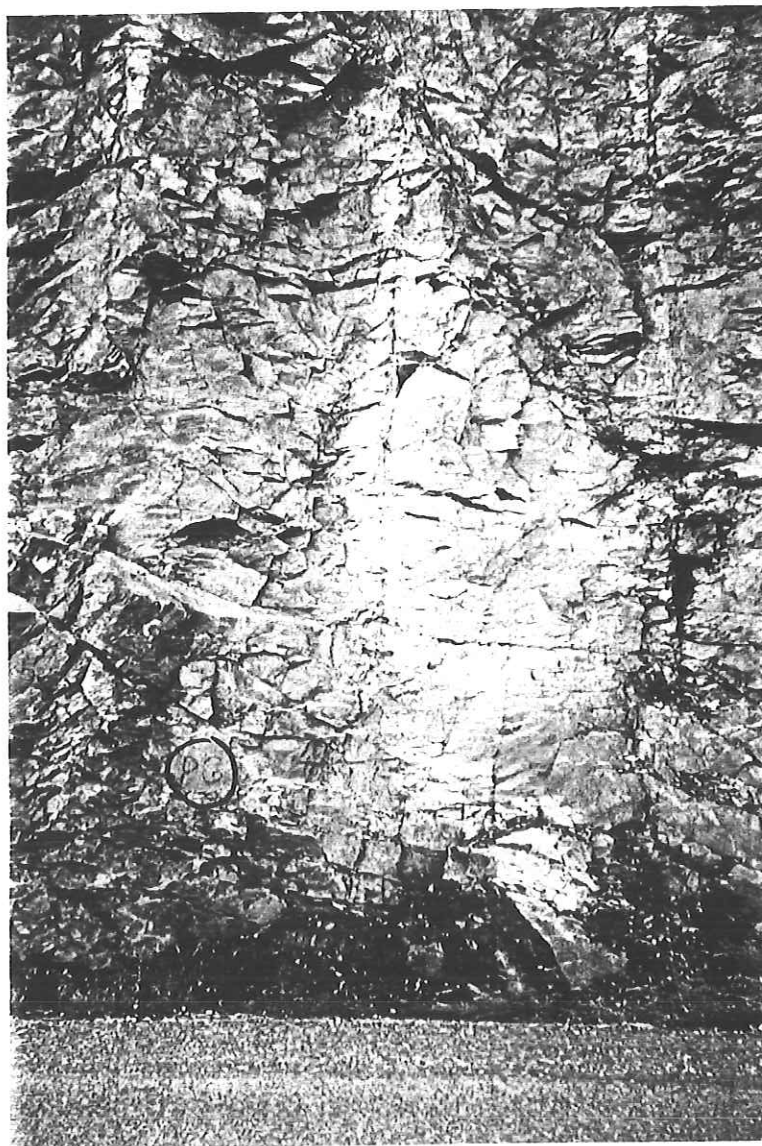
Figure 3: Close-up of PG showing drill hole half barrels, minor loose in ditch

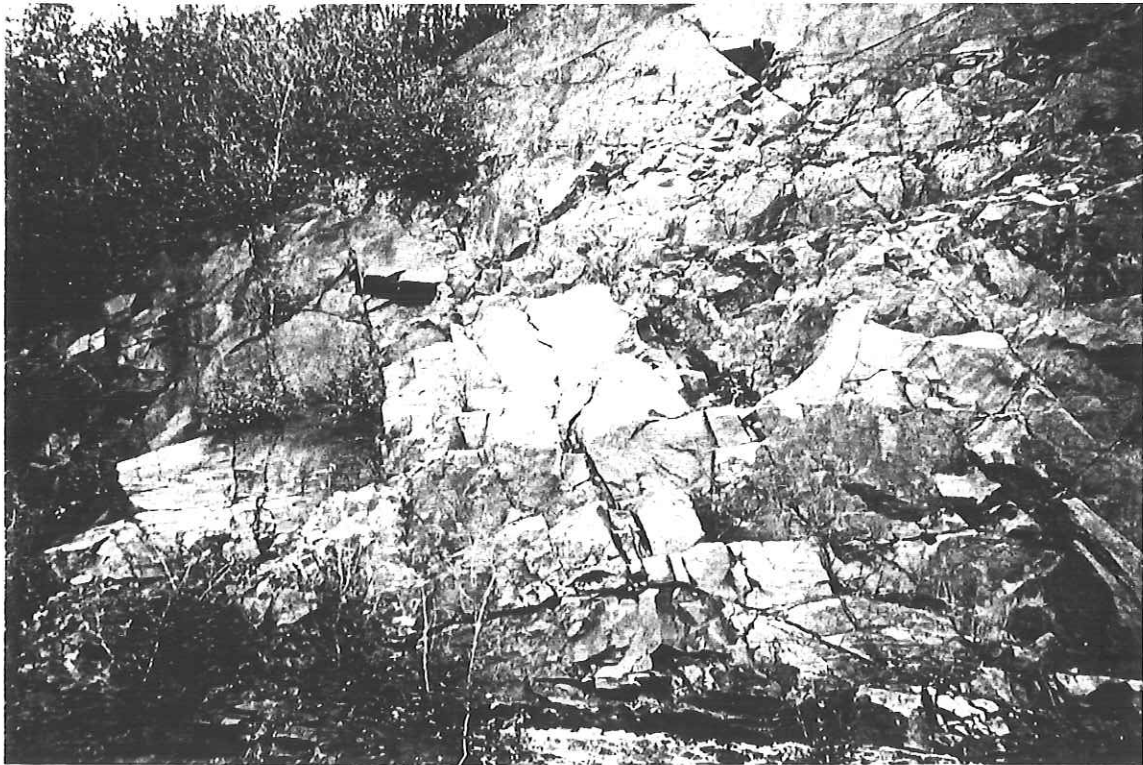
Figure 4: Rock mass above PJ, 16+910, showing blocky ground

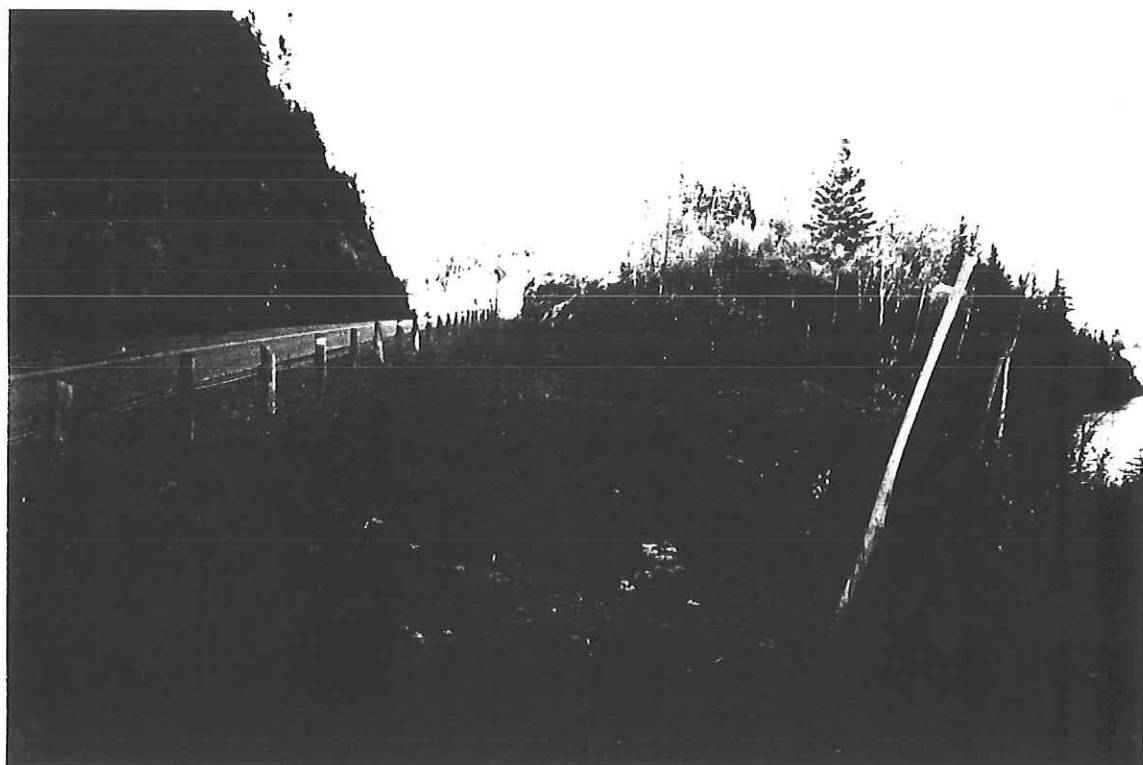
that the bench to the north of the highway at this location, adjact to the shoreline of Wawa Lake, is in bedrock rather than rock fill. If the highway grade is not plaaned on being at a higher elevation, it may not be necessary to add fill to the lake.

Figure 5: Bench to north of highway opposite 16+900, founded on bedrock

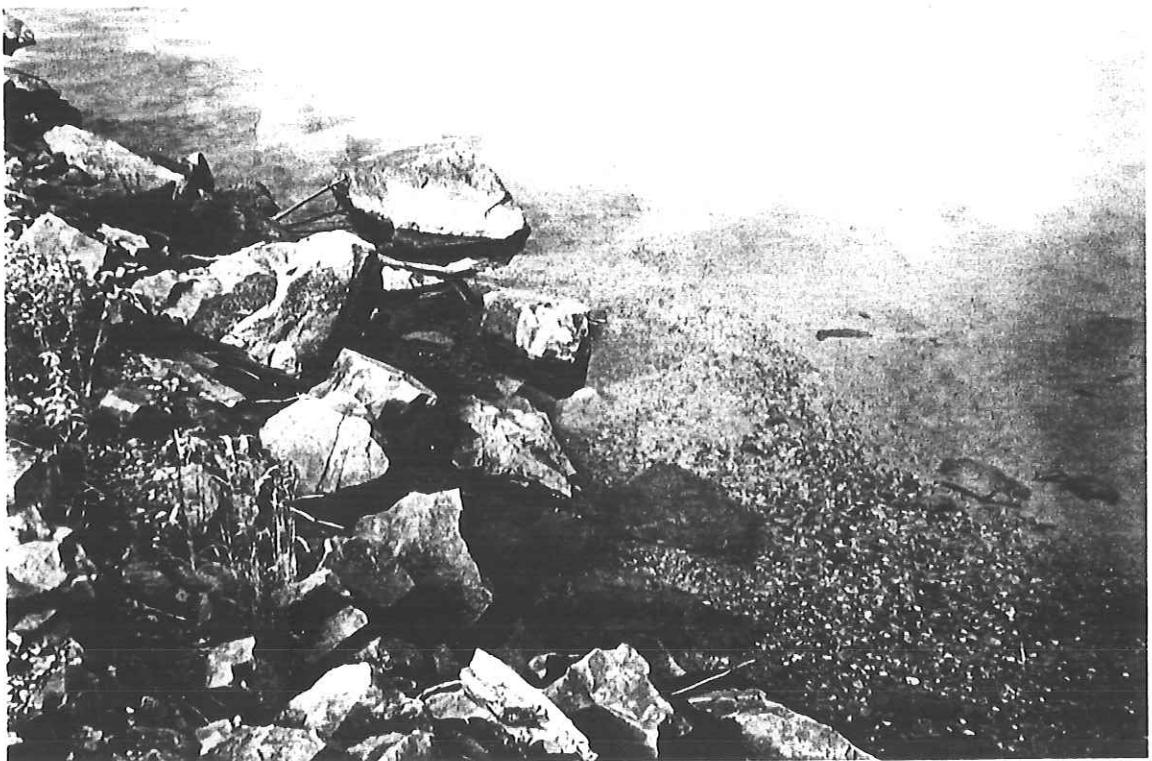
Figure 6: Shoreline of Wawa Lake opposite 17+050 in shallow water

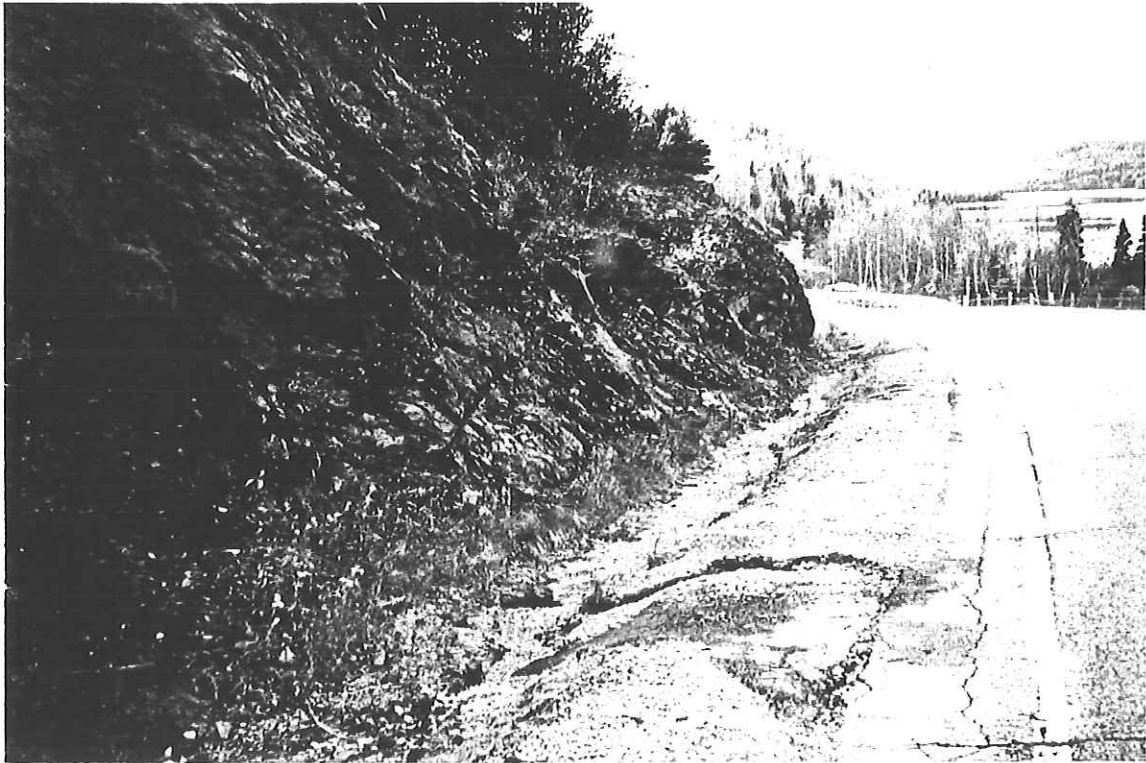
The exposed rock mass in this vicinity is immediately adjacent to the eastbound lane of Highway 108 with limited ditch allowance. The road is on a right hand curve eastbound. Figure 7 is looking west and shows a knob of rock which is close to the travelled portion of the road and may impair visibility. Further, the loose condition of the rock mass in certain segments may lead to rock fall activity which could impinge upon the travelled portion of the road. The cut face is approximately 9 metres high up to a local maximum of almost 12 metres, and about 90 metres long.

Figure 7: Site Q, lower slope and ditch, showing poor visiblity at 21+650

Since part of the work at Site Q also requires trimming of the ditch line and removal of about 7.5 cu m of rock at the western end of the site at ditch level, Figure 7, hoe-ram work at the highway level could proceed in advance of scaling. It is estimated that the complete work at this site could be carried out in two days, including moving equipment in and out from the main construction area.

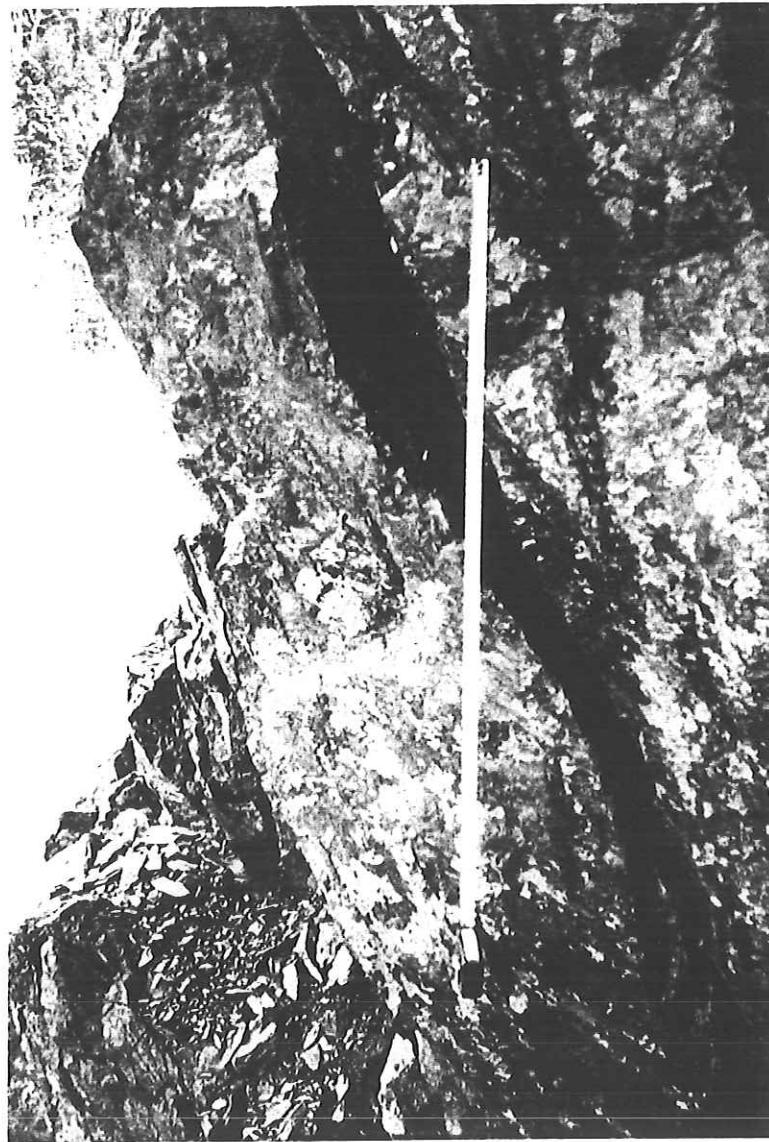
The rock mass, as observed, may be described as slightly weathered; tabular and blocky; dark greenish grey; fine to medium grained; medium strong; metavolcanic rock material. Some shearing and faulting is visible which locally gives a highly fractured rock mass. There are two steeply dipping joints sets that are highly persistent, widely spaced, with very narrow apertures close to the exposed surface probably reducing to tight apertures at depths of 3 metres or so, clean to iron stained, planar, and rough. There are other randomly oriented joints which dip in the 45 to 60° range. The rock mass has medium-sized, tabular shaped blocks with fair surface condition. There is a strong toppling potential for the larger blocks at this site, shown in Figures 8 and 9.

Figure 9: Close-up of crest at QA showing toppling. Machine scale

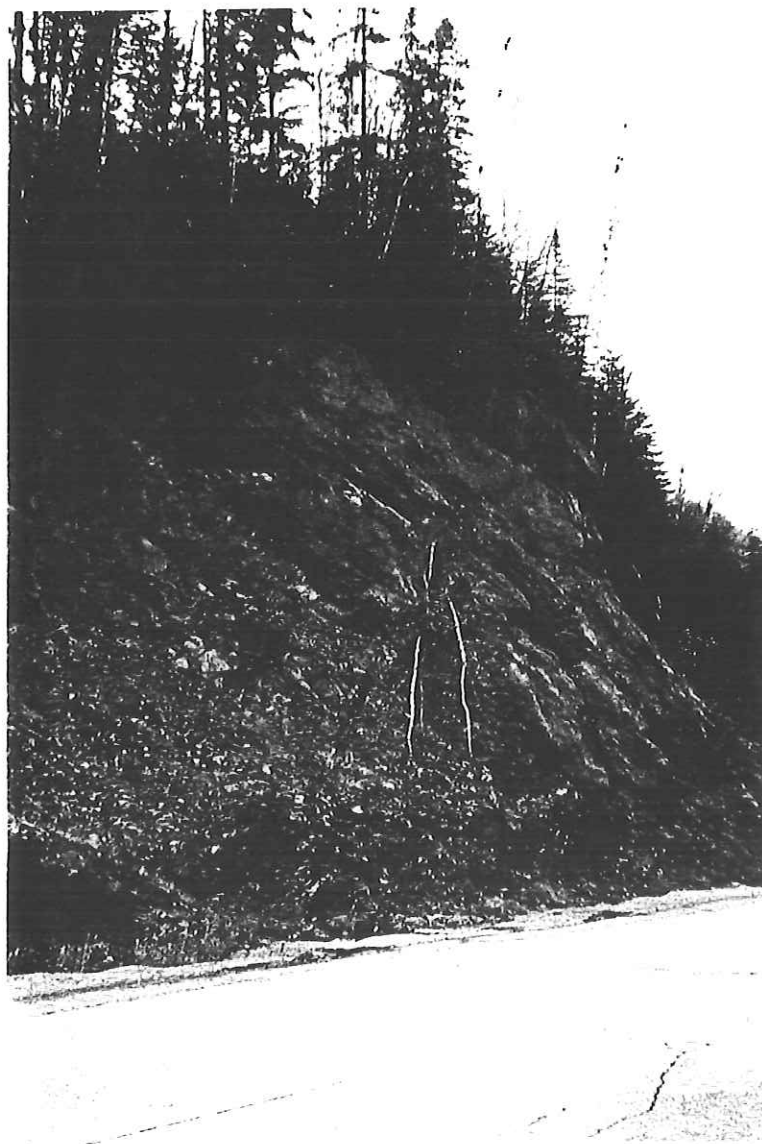
Figure 10: Site Q showing QB from 21+700, toppling rock at top right

Top right of QB about 6 m above road, overhanging block on shaly joint becoming loosened by ice jacking. Probably low risk but as well to remove this by long reach hoe-ram or by local hand wedging when the work team are in the area. Trim and remove about 3 m<sup>3</sup> in 0.3 m<sup>3</sup> pieces. Top left of QB various small to medium sized blocks to be scaled by hand or by hoe-ram. Uphill of QB the height of cut is only 2 to 3 m above road with a gentle slope back through the trees. Some small rock fragments may be rolling through the trees. Enlarged ditch would take care of this.

The rock mass requires local scaling, see Figure 8, and would be accessible from highway level with a long reach hoe-ram. The scaled rock will probably be contained in the existing ditch. The segment identified by FGL, and marked on the rock face, extends from approximately Ch. 21+650 to 21+680, some 30 metres. To the west and east of these limits the rock face decreases in height or is set back from the roadway, Figure 10.

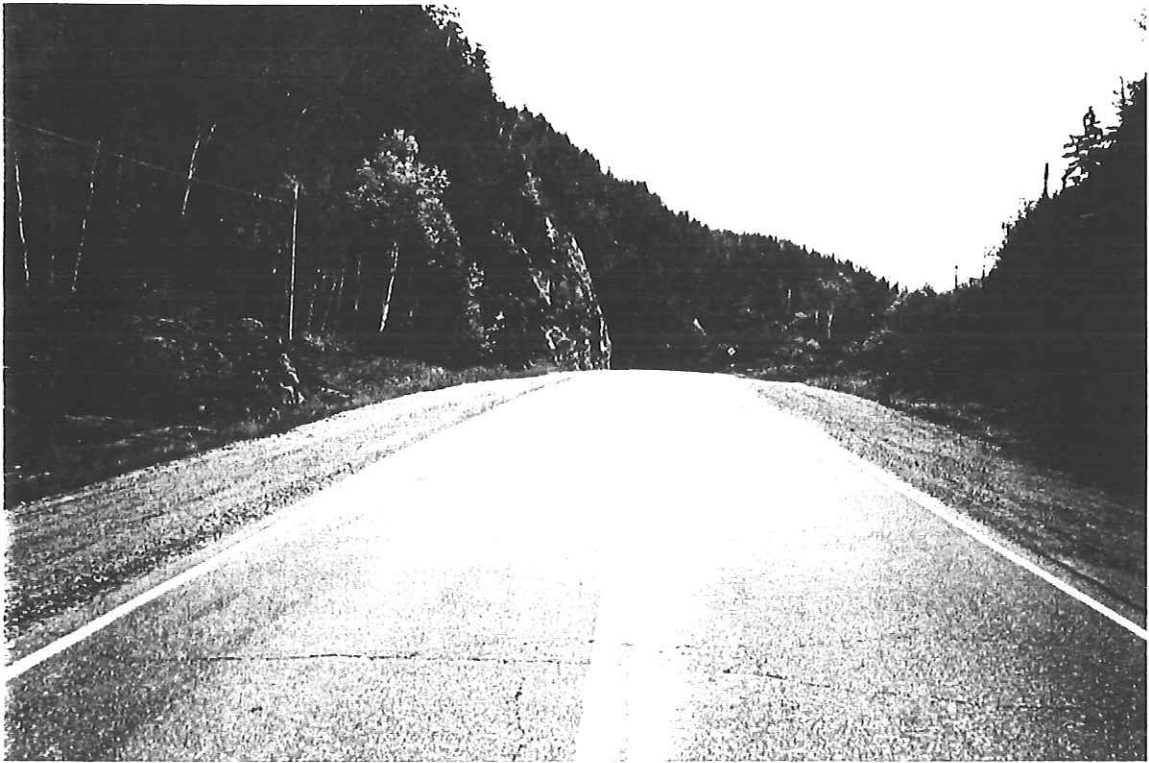
The exposed rock mass in this vicinity is immediately adjacent to the westbound lane of Highway 101 with very limited ditch allowance, Figures 11, 12 and 13. The road is on a slight right hand curve eastbound close to the crest of the hill, but the proximity of the rock face to the travelled portion of the road is unlikely to impair visibility. The loose condition of the rock mass in certain segments may lead to rock fall activity which could impinge upon the travelled portion of the road, Figure 14, even though part of the highway shoulder is protected by the installation of restraining mesh hung over part of the slope from 21+196 to 22+037.

Figure 11: Approach to Site R (left side) at 21+800 looking east

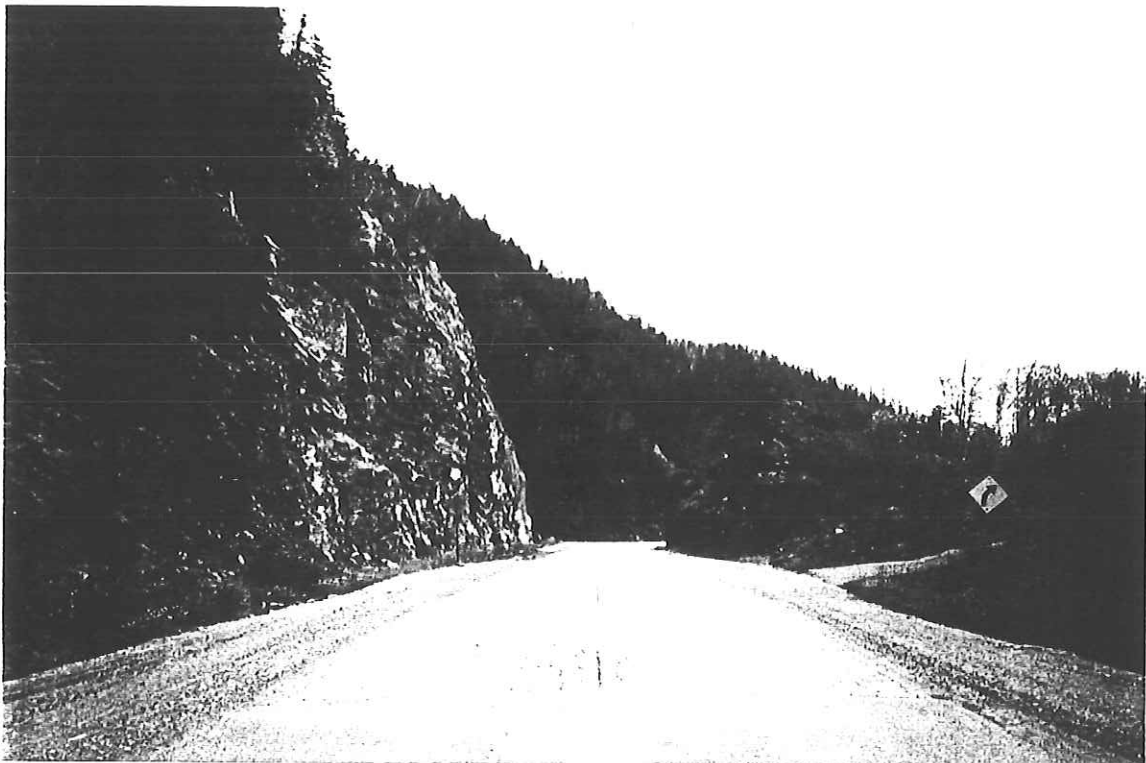
Figure 12: Approach to Site R (left side) at 21+900. Note limited ditch

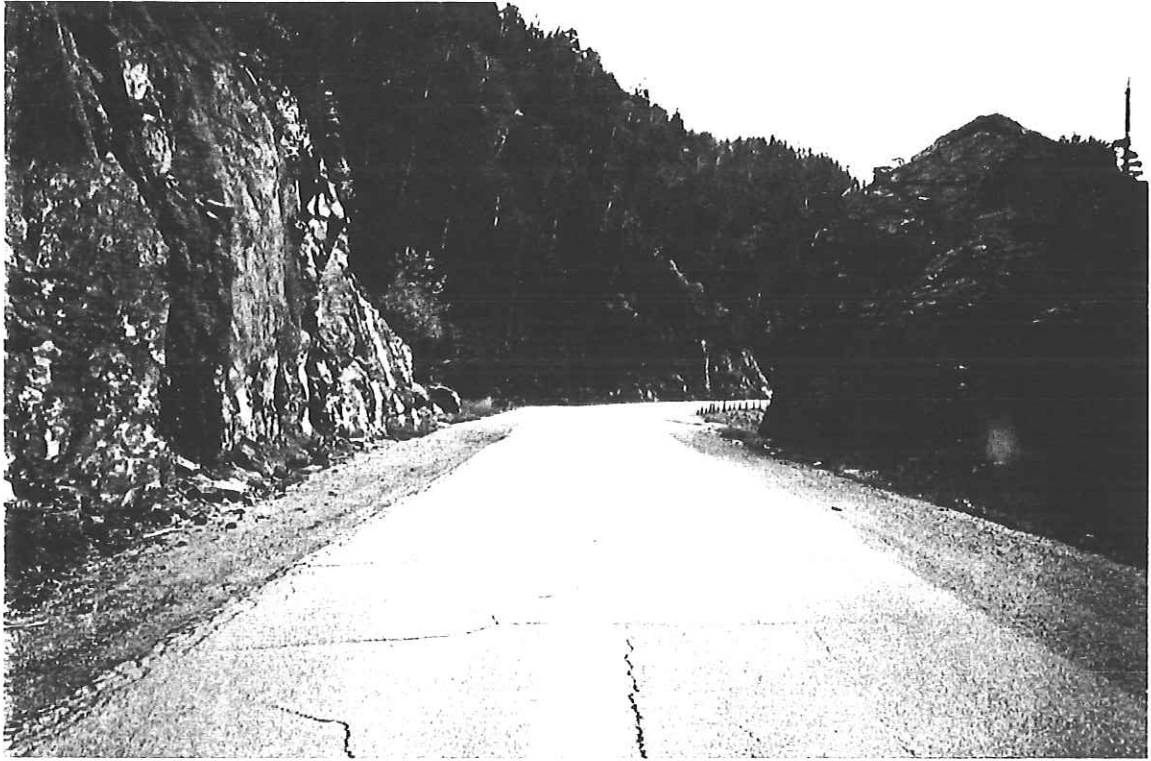
Figure 13: Site R, centreline at 22+000, mesh from 21+196 to 22+037. Note rock in ditch

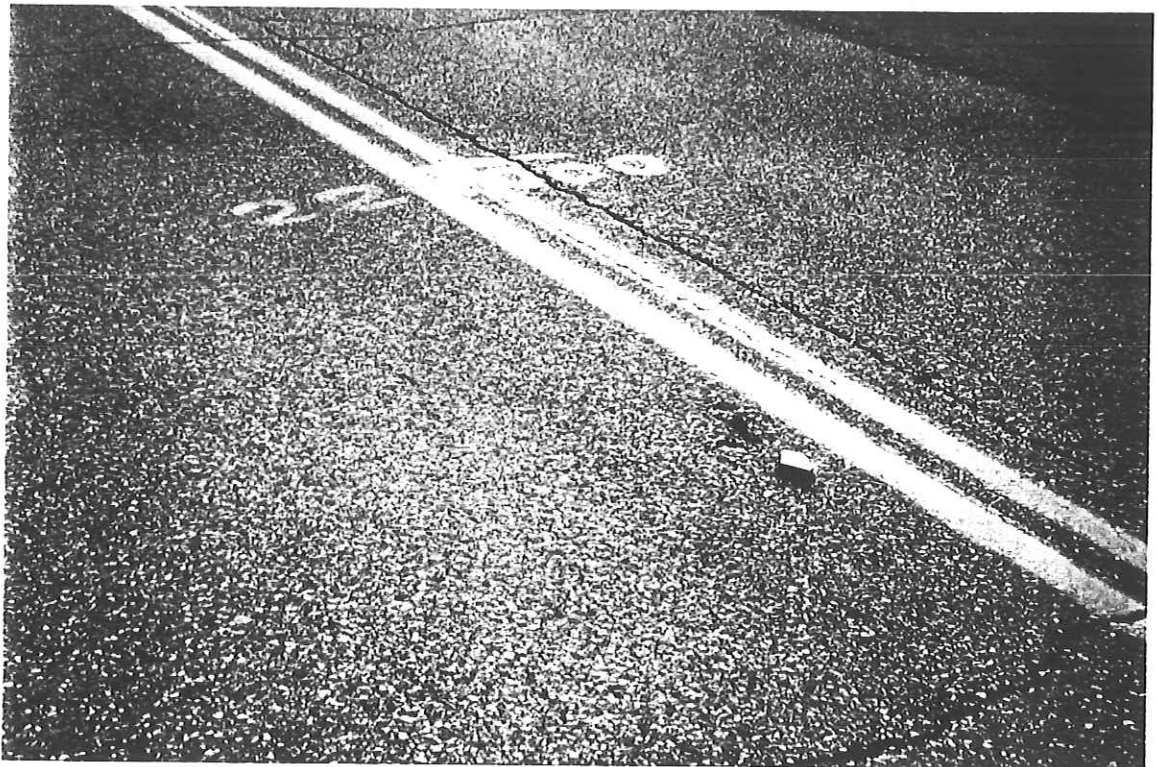
Figure 14: Close-up of impact mark near centreline at 22+000

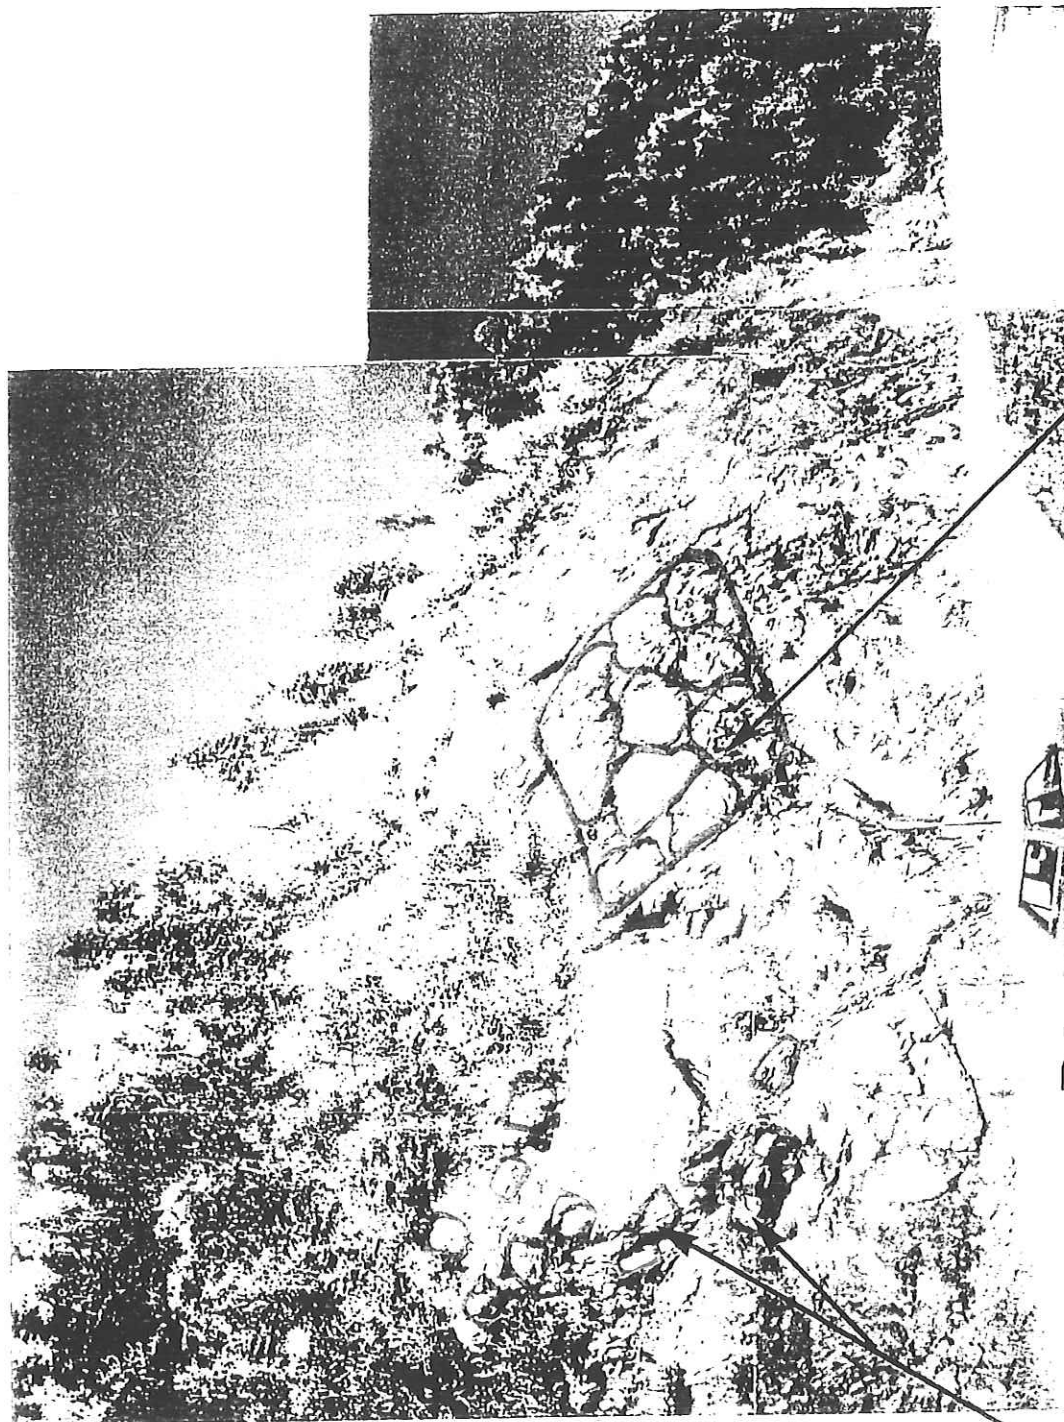
FIGURE: B19

Minor loose rock total volume about 6 m<sup>3</sup> in pieces up to 0.8 m<sup>3</sup> from about 4 m above road, and some large blocks of similar total volume about 10 m above road near base of tree line. Require selected manual or machine scaling. Might be difficult to remove with scaling bar; better with hoe-ram if reach available, or with wedging.

From 4 m to 10 m above road, about 50 m<sup>3</sup> of loose rock with open joints within a zone about 4 m long, 6 m high and 1.8 m thick. Sound and scale by hoe-ram working from side. Manual scaling probably difficult and slow.

trim with hoe-ram

light manual or hoe-ram scaling

underpin block with shotcrete

light scaling  
and shotcrete

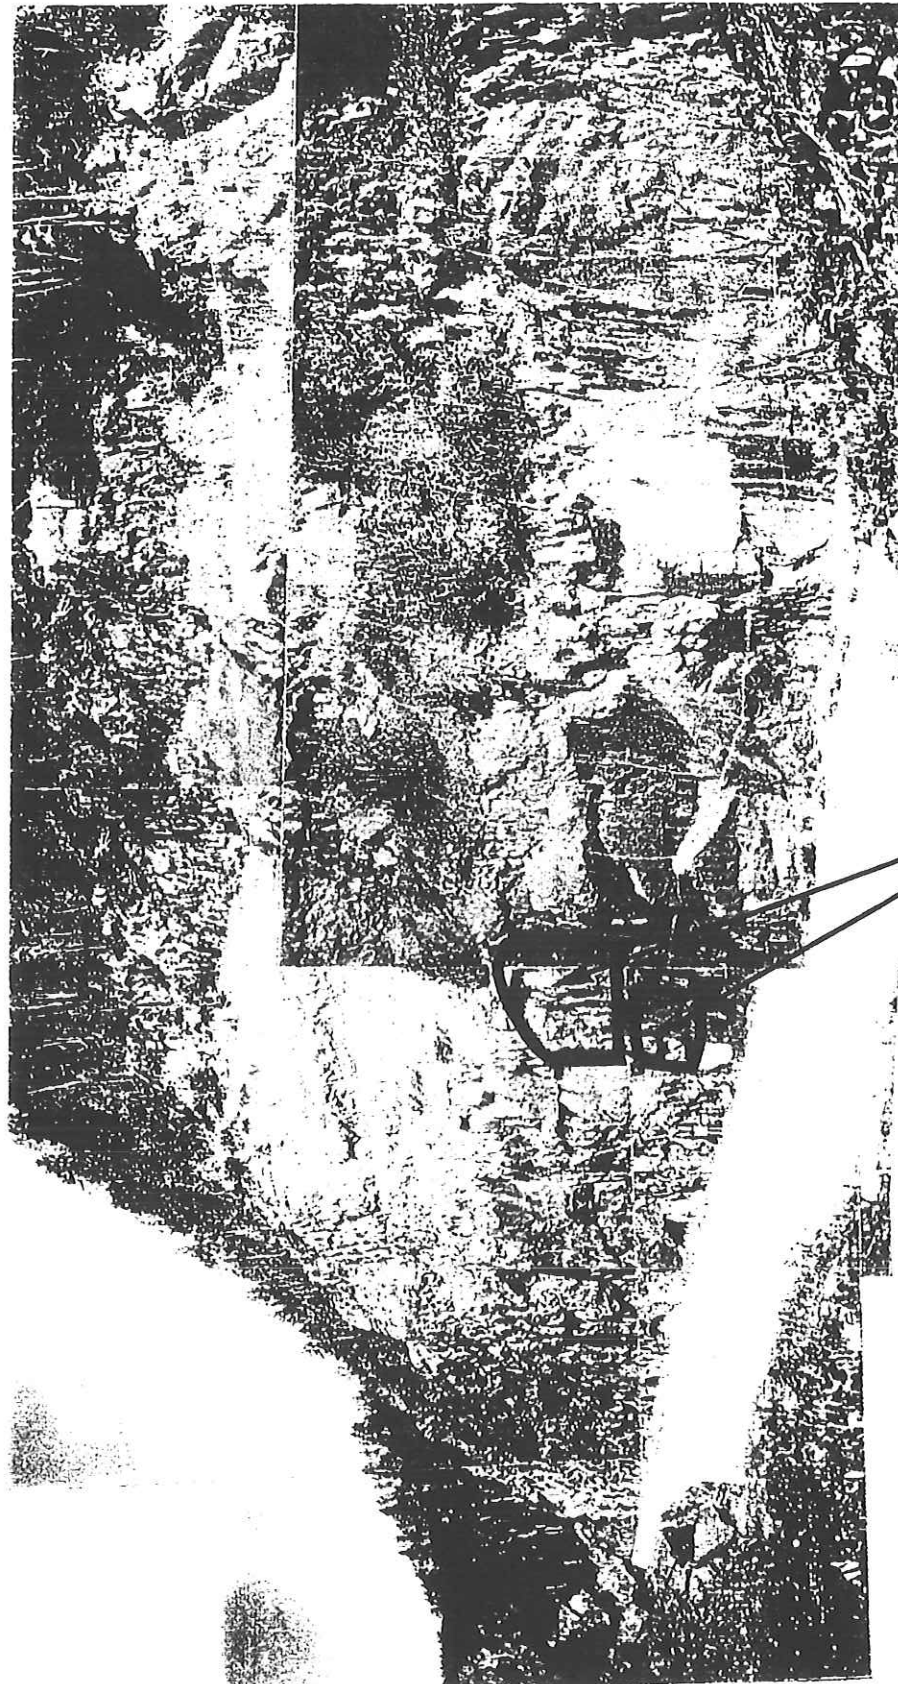
FIGURE: B22

Substantial unstable mass at base of tree line about 12 to 15 m above road just to left of mesh, precariously resting on steeply dipping joint face. Volume about 100 m<sup>3</sup> (8 m long, 5 m high and 2.5 m thick). Would cover road with debris if it came down. Might remove by trim blasting but difficult access for drilling. Would require crew working for about 1 week with plugger drills and wedges and/or explosives.

Immediately above RC is a vertical slab of potentially loose rock extending from 1 m above road to about 8 m above road. Volume about 40 m<sup>3</sup> (3 to 4 m long, 7 m high and 1.5 m thick). Can be scaled by hoe-ram but only after removing upper loose rock.

About 8 to 10 m above roadway at top of shelf along a line of green bushes, and above this at base of tree line near the slope crest, about five to ten medium to large blocks, up to 1.5 m<sup>3</sup>, might be trapped by mesh if they fall.

About 1 m<sup>3</sup> of very loose rock blocks about 3 m above road, very precarious and easily scaled by hand. These blocks may support a 10 m<sup>3</sup> block above, so scale either from the top down, or from side using hoe-ram. If overhang remains in place, repair undercut with remotely applied shotcrete.

light scaling and shotcrete

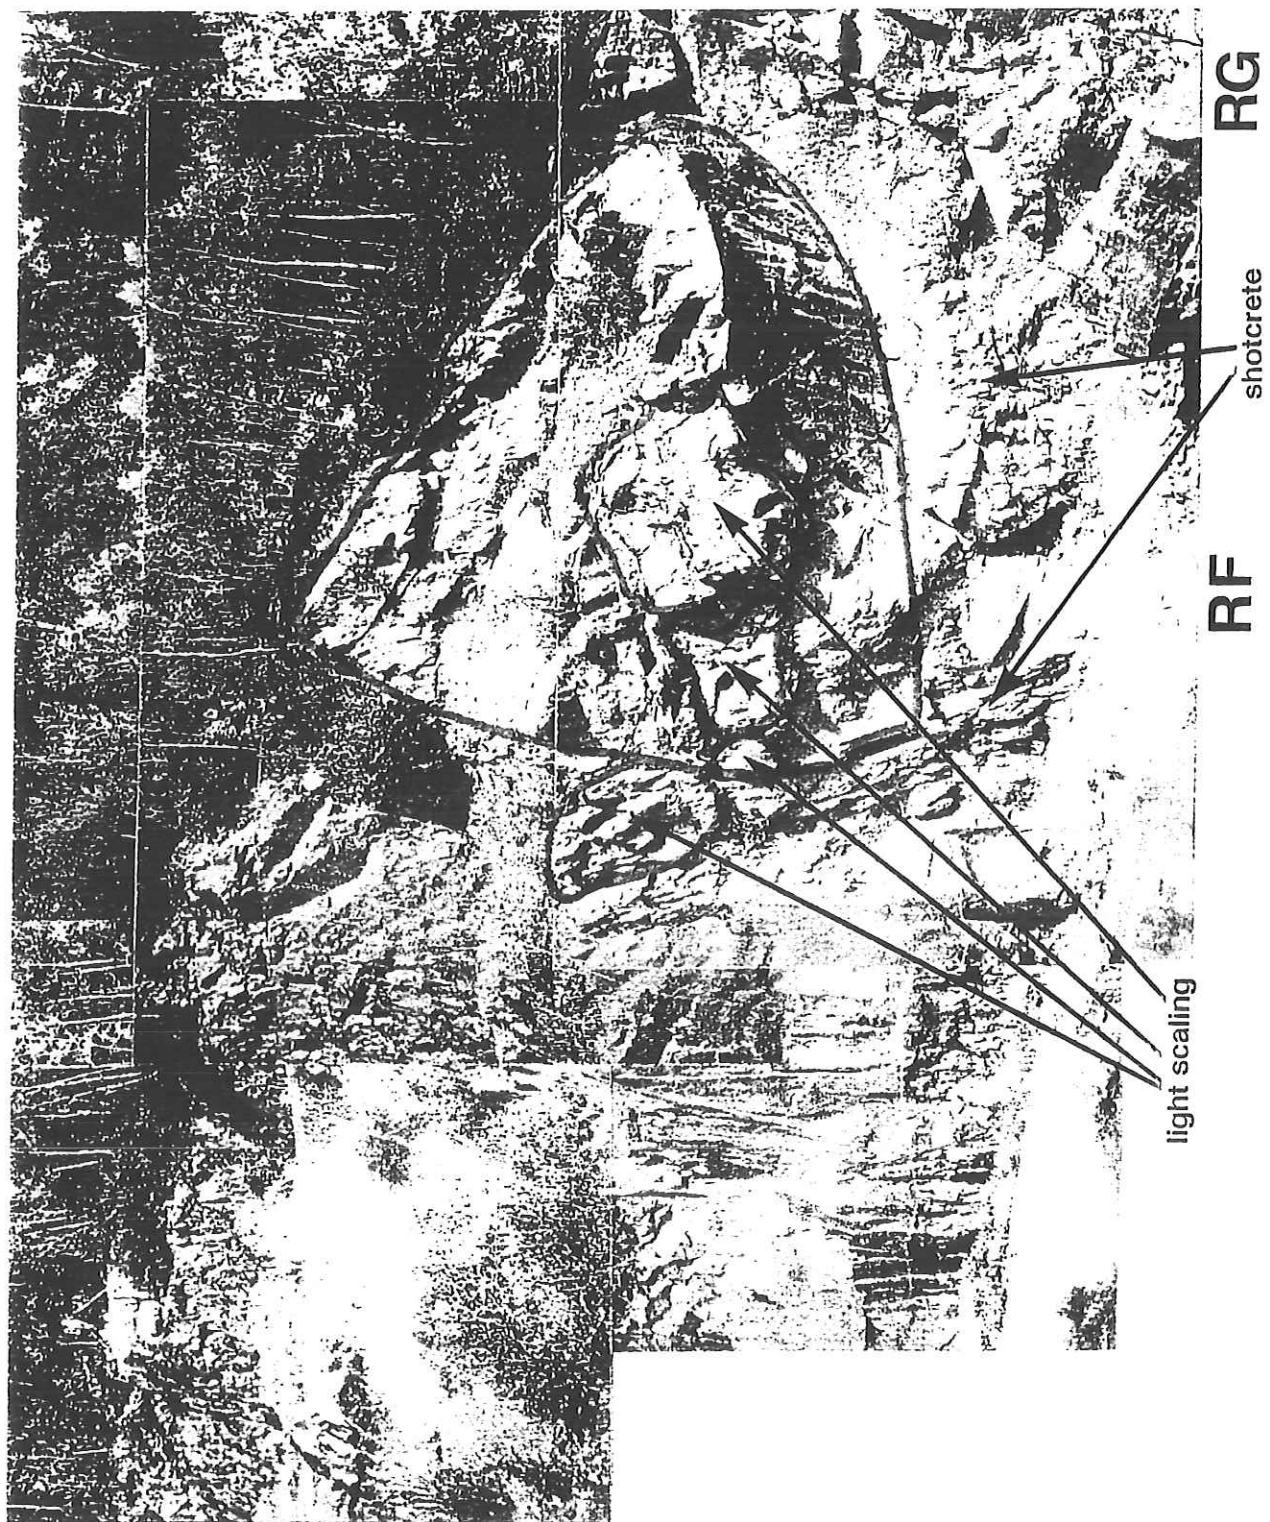
Slabby rock about 6 to 8 m above road, about 10 m either side of RF, may be keyed in but extensively cracked. Sound and scale by hoe-ram. About 12 m<sup>3</sup> of loose rock to be removed including slabby block from top of shear about 10 m above road.

Between Locations RF & RG a large triangular wedge of material has computed safety factor of 0.91 to 1.71 depending on assumptions. The left-hand side appears resting securely on a plane striking nearly perpendicular to the highway. The large mass is unlikely to slide, but because of microfissuring, will deteriorate over several years. Cable anchoring unsafe because of risk of disintegration during drilling. Scale only smaller loose blocks. Consider shotcrete stabilization for prolonged durability here and elsewhere.
