AN INVESTIGATION INTO THE PERFORMANCE
OF GRAVEL SHEETING AT THE
BIG PIC RIVER APPROACHES
DISTRICT #19. HWY. #17 TCH

DEPARTMENT OF HIGHWAYS, ONTARIO
MATERIALS AND RESEARCH
FORT WILLIAM REGION

DECEMBER, 1961.

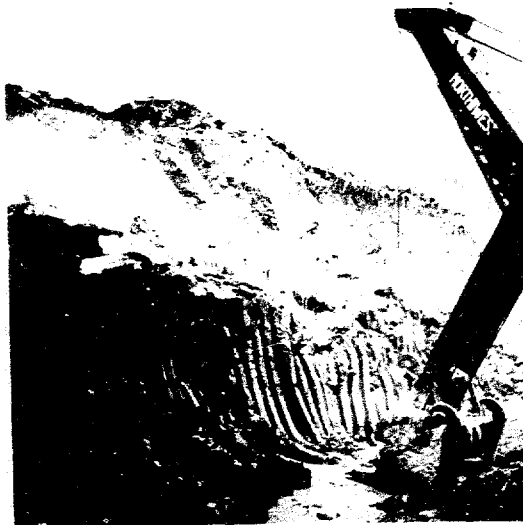
FIG. 2

N.W. slope during excavation
procedures. Note the soft
consistency of the clay material.

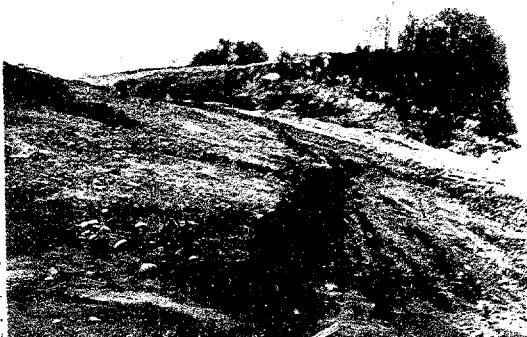
FIG. 3

View of the west approach cut
after excavation procedures
were completed.

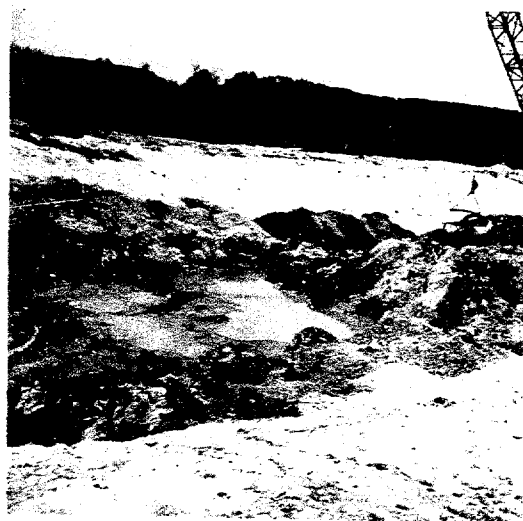
FIG. 5

A dragline subexcavating the roadbed through the west approach cut. Note the excessive water conditions in this cut.

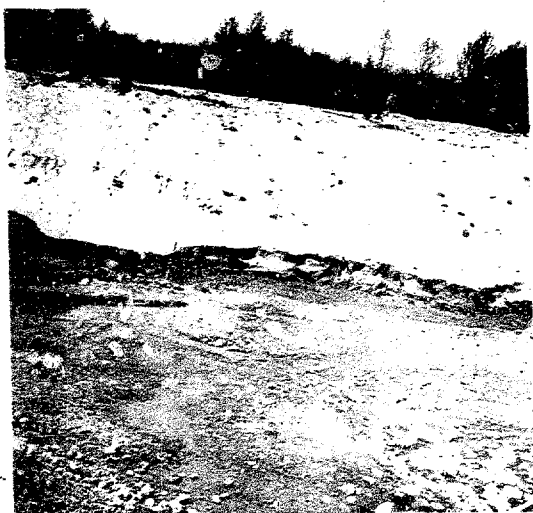
FIG. 6

Erosion in the ditchline of the west approach cut.

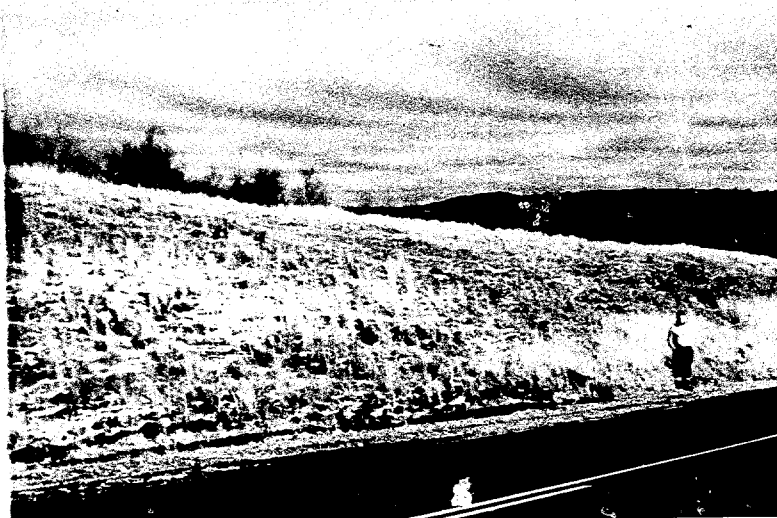
FIG. 8

View of the N.W. slope just west of the Big Pic River structure.

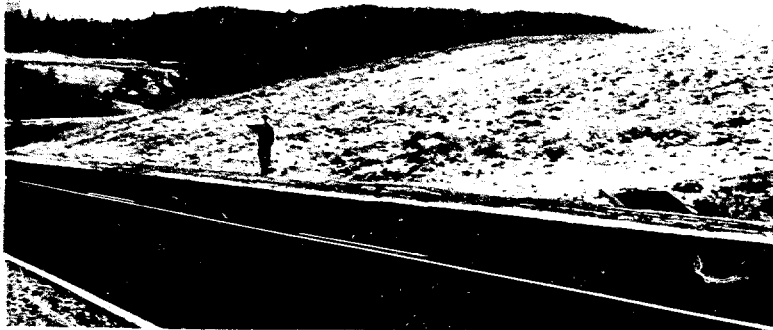
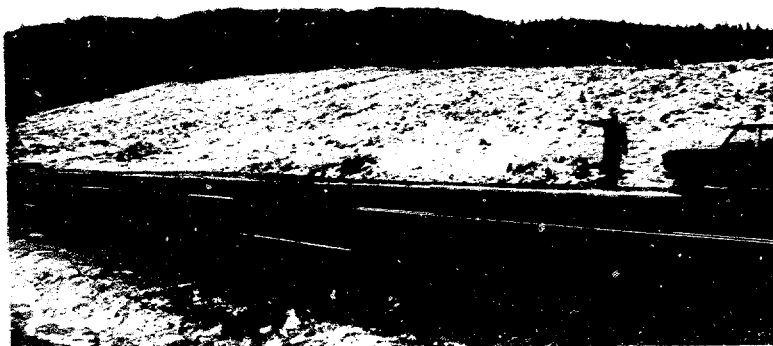
FIG. 10

View of the S.W. slope just west of the
Big Pic River structure.

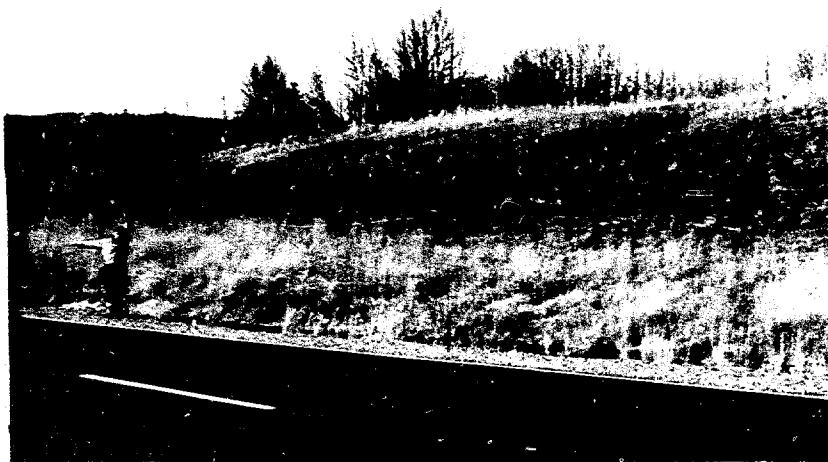
FIG. 11

Similar to Fig. 10, but further west along
the cut. This slope is also in excellent
condition.

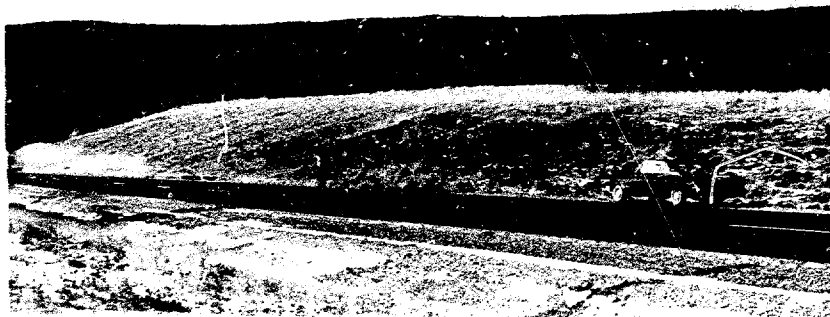
FIG. 12

Partial view of the N.E. slope. Both slopes in the east approach cut are in very good condition.

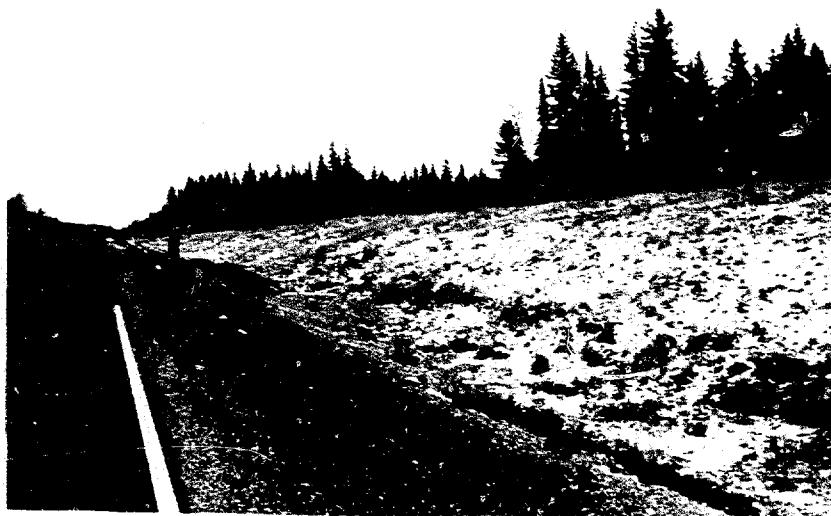
FIG. 13

Similar to Fig 12, but viewed from the opposite side of the cut.

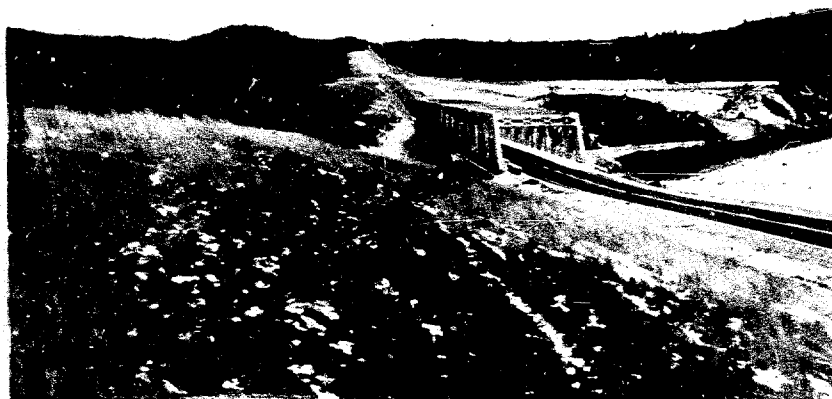
FIG. 14

S.E. slope looking east. (Refer to Fig 16)

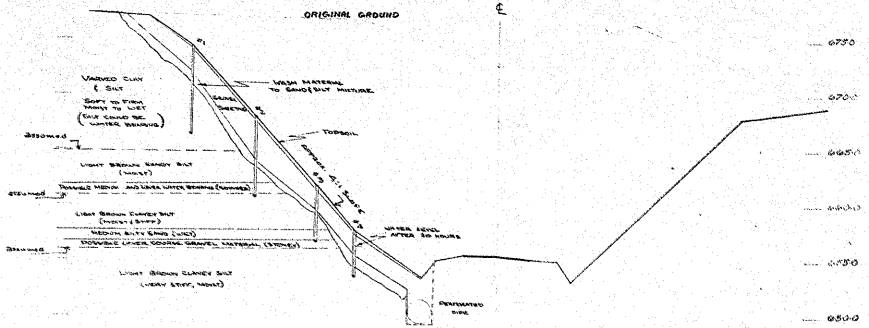
SECTION BB
SCALE 1 IN = 5 FT. VERTICAL
1 IN = 50 FT. HORIZONTAL

The sand and gravel layers appear to be water bearing, and this would account for the 1-foot layer of wash material (sand and silt) over this slope (Refer to section B-B on the attached sketch).
