FINAL REPORT

FOUNDATION INVESTIGATION AND DESIGN REPORT **Trapp Creek Culvert (Site 46-329C), Hwy 101, Chapleau, Sault Ste. Marie Area**

exp Services Inc.
August 10, 2015

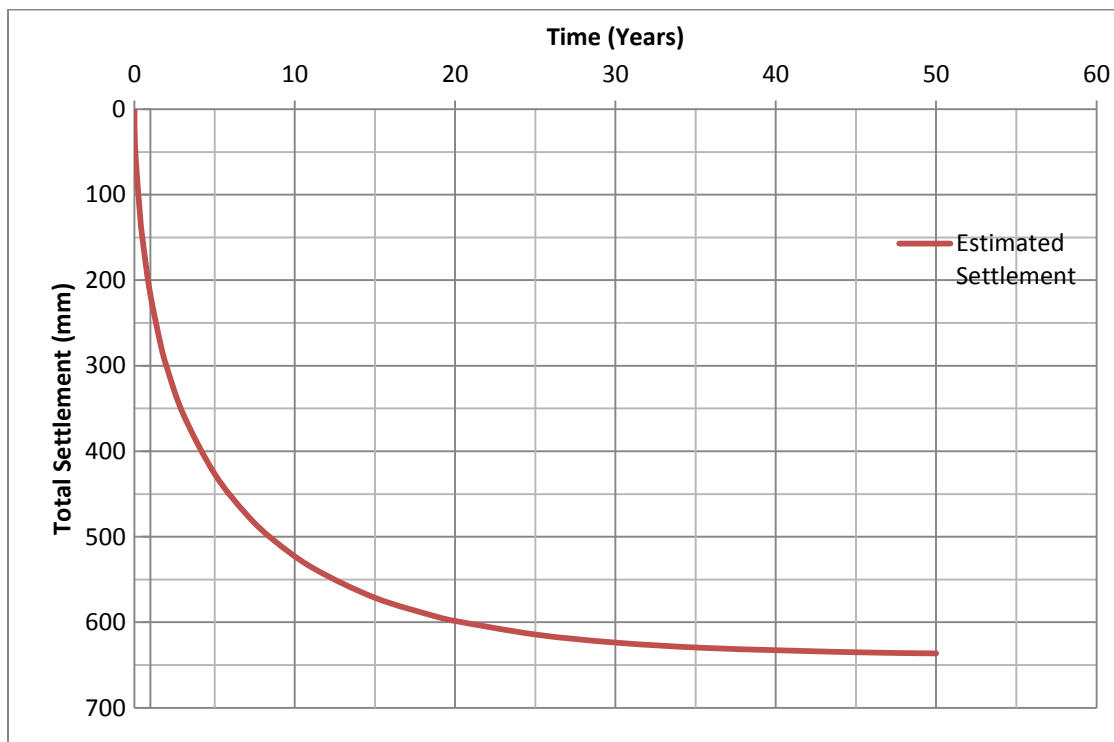
According to the results of settlement analyses, it is estimated that an approximately 570 mm consolidation settlement occurred within the period of last 15 years, which is approximately 90% of estimated total settlement of approximately 640 mm which could be expected in a 35 years period under the existing loading condition. Therefore, it is estimated that the remaining settlement of the existing embankment at the location of BH-4 could be around 70 mm. Similarly, at the locations of BH-2 and BH-3 it is predicted the remaining settlement could be between 100 mm and 150 mm.

Figure 1. Result of the settlement analysis –estimated settlement of the peat layer under current condition at location of BH-4

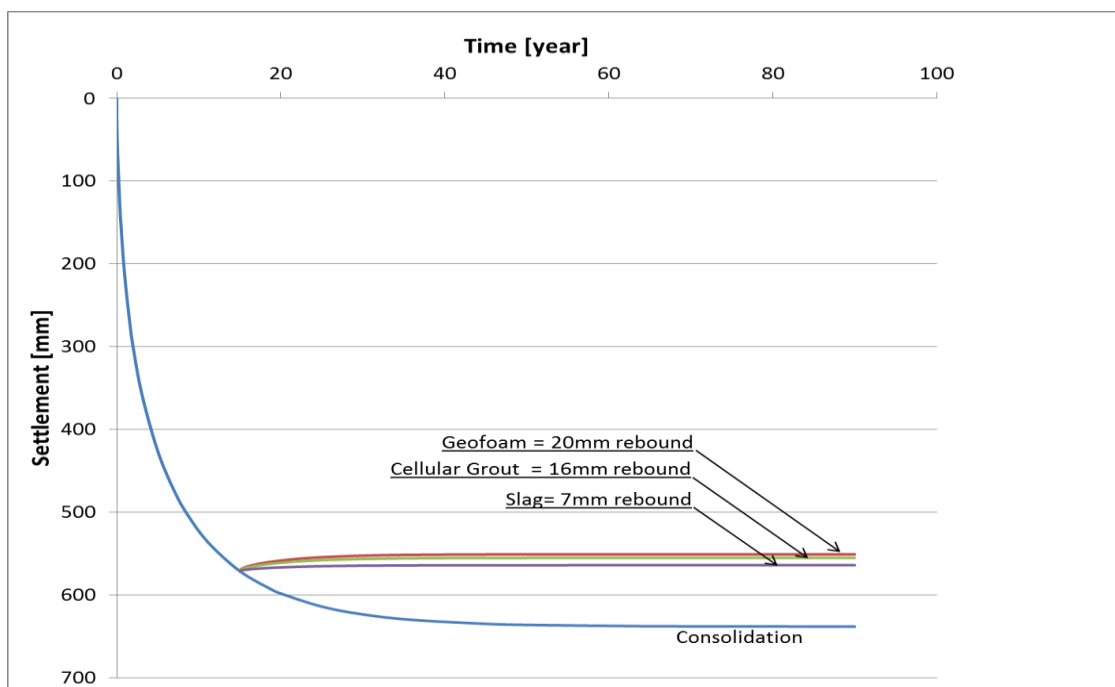
Figure 2. Result of the settlement analysis –estimated settlement of the peat layer after replacing 1.0 m of the existing embankment fill with lightweight fill at location of BH-4

As can be seen the calculated rebound due to reduction in the embankment load could be around 20 mm, 16 mm or 7 mm if the geofoam, cellular concrete or slag is used, respectively. Therefore,

The second option involves the reducing of the existing overburden pressure on the underlying peat by replacing approximately 1.0 m to 2.0 m of the existing earth embankment fill with lightweight fill between Sta. 10+080 and Sta. 10+210. Lightweight fills considered should be on MTO's Designated Sources for Material (DSM) list and conform to use and placement guidelines/directives. EPS-Expanded Polystyrene (Geofoam) with unit weight of approximately 1.0 kN/m^3 , cellular concrete with unit weight of approximately 5 kN/m^3 or slag with unit weight of approximately 13 kN/m^3 could be used as fill material.

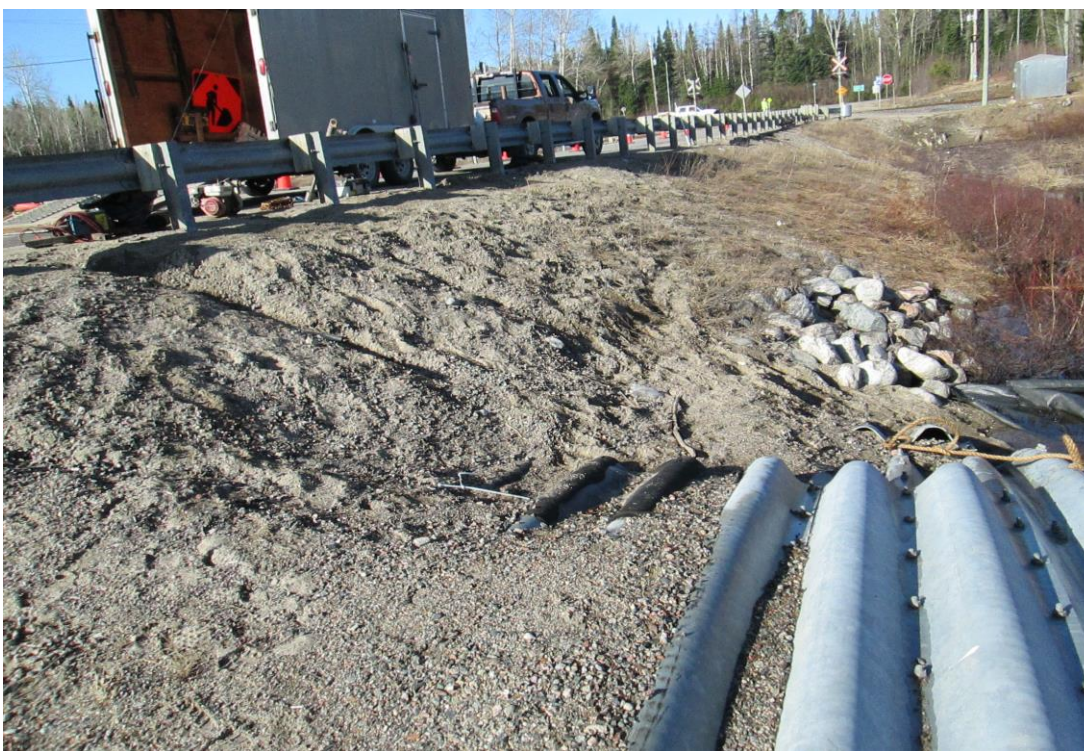
Photo 10. Washed away embankment slope on outlet side facing west

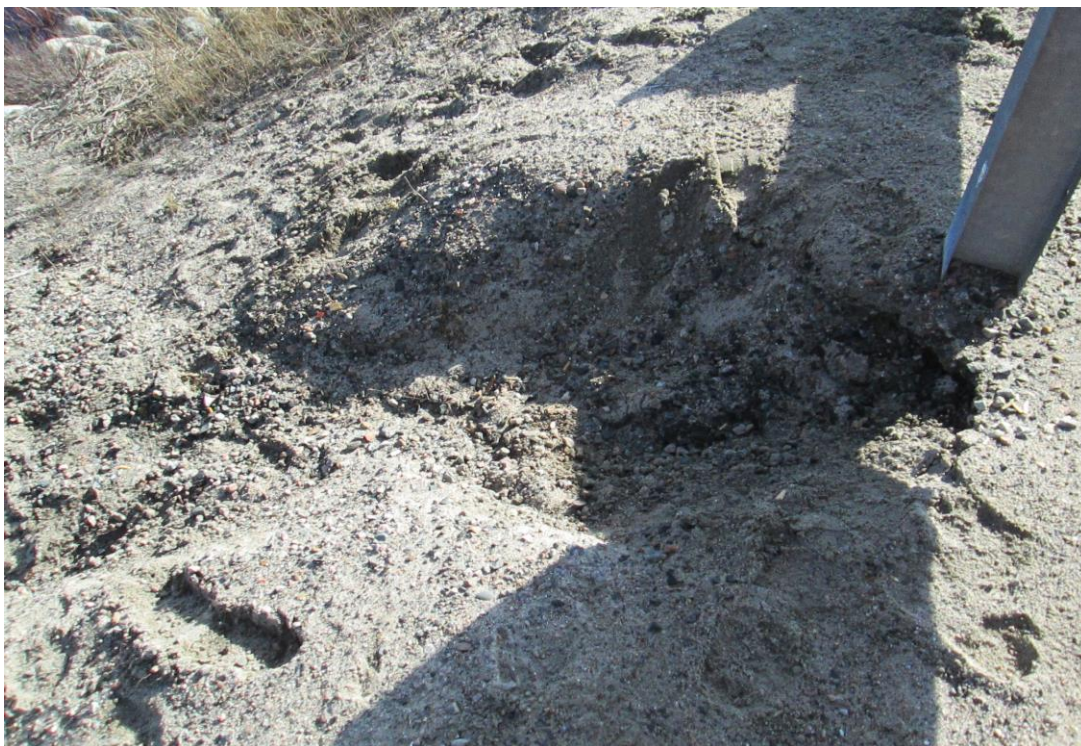
It is reported by MTO that the water channel turns to the west at the outlet end of the culvert and goes back into the toe of existing slope undermining of the corduroy at the toe of slope. This erosion was not possible to be observed at the time of this geotechnical investigation, since the high water level precluded access to the toe.

Photo 11. Washed away portion of embankment slope on outlet side

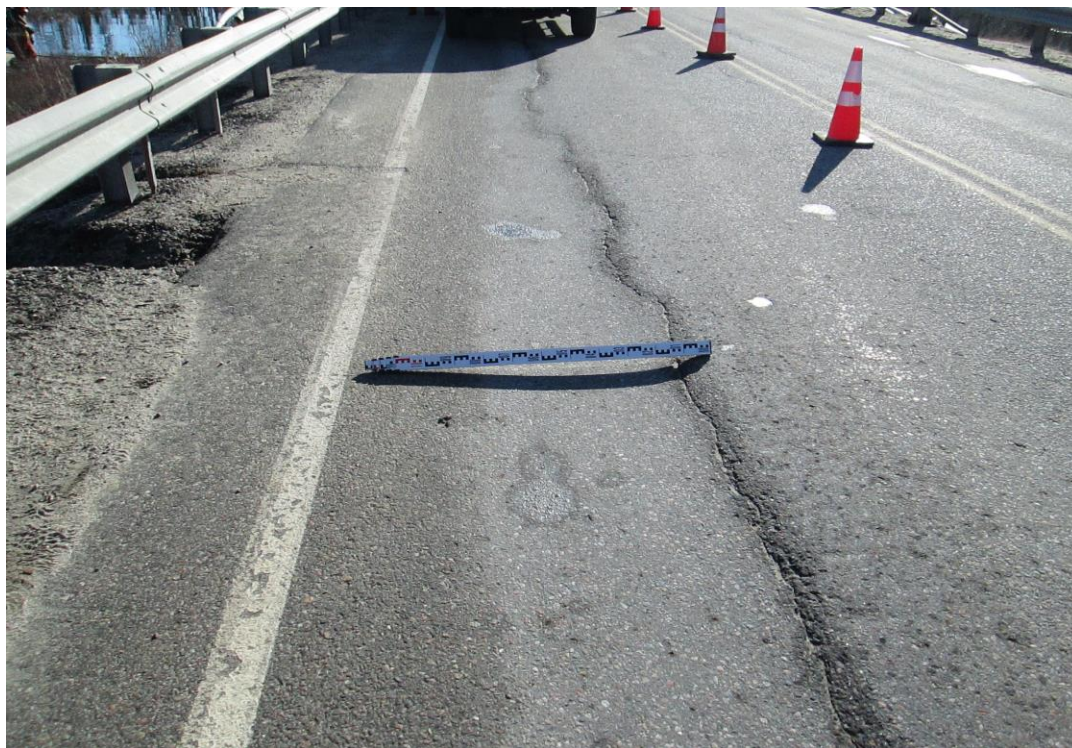
Significant cracks in the WBL were observed with 40 to 60 mm deep depressions, approximately 1.7 m from edge of pavement along approximate STA 10+100 to 10+ 200. (Photographs 12, Appendix A). The cracks were approximately 5 to 10 mm wide. A longitudinal meandering crack on the east side of culvert alignment on WBL spanning approximately from STA 10+150 to 10 + 160 and on both sides (east/west) side of the culvert alignment on EBL was also observed (Photographs 13 and 14, Appendix A). However any bulging at the toe was difficult to observe due to high water level and vegetation.

Photo 12. WBL roadway portion depressed on north-west half of embankment

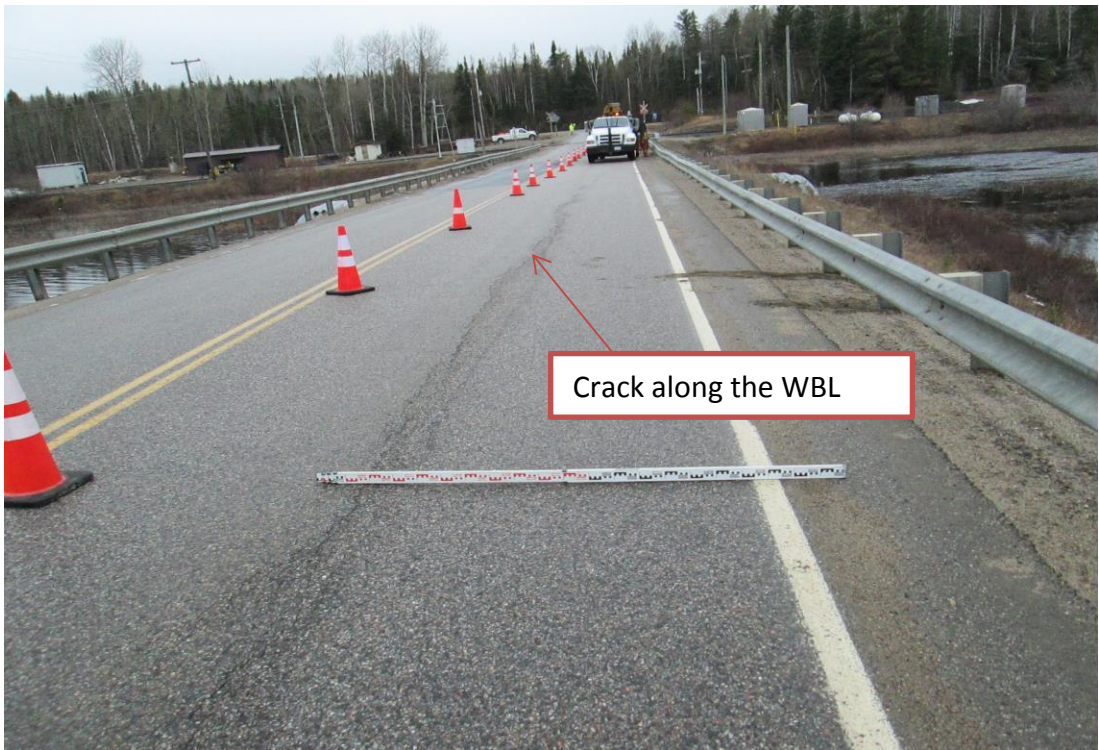
Photo 13. Typical crack on roadway along the WBL facing west

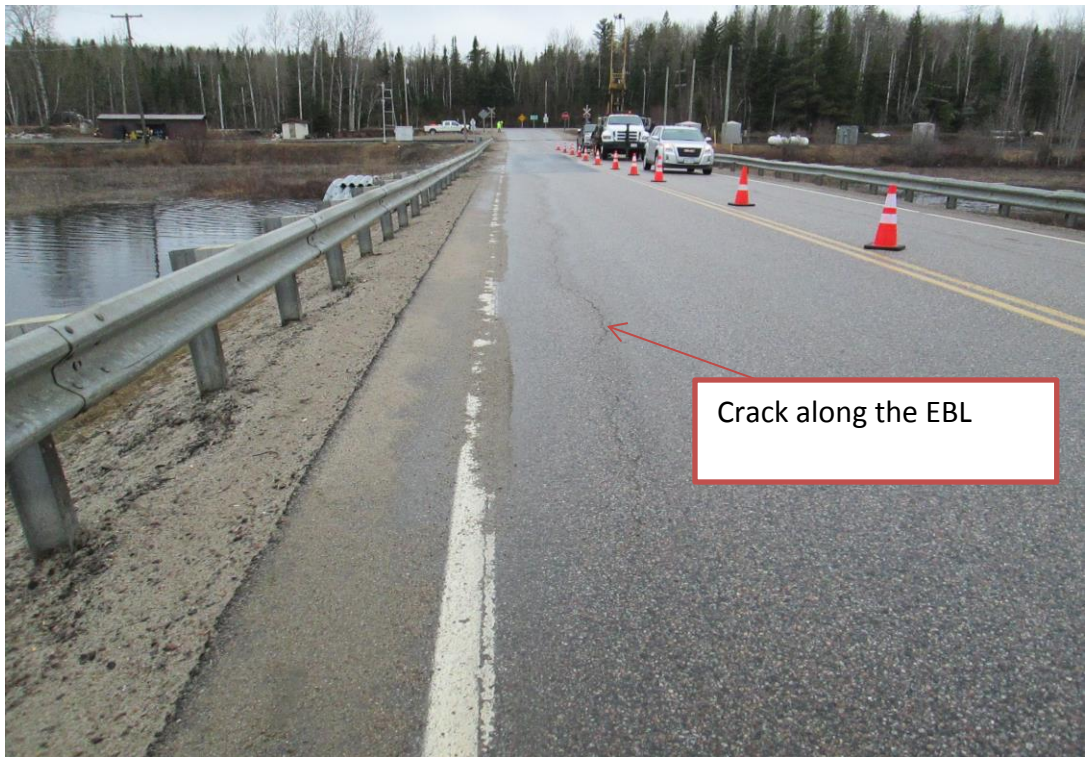
Photo 14. Typical crack on roadway along the EBL facing west

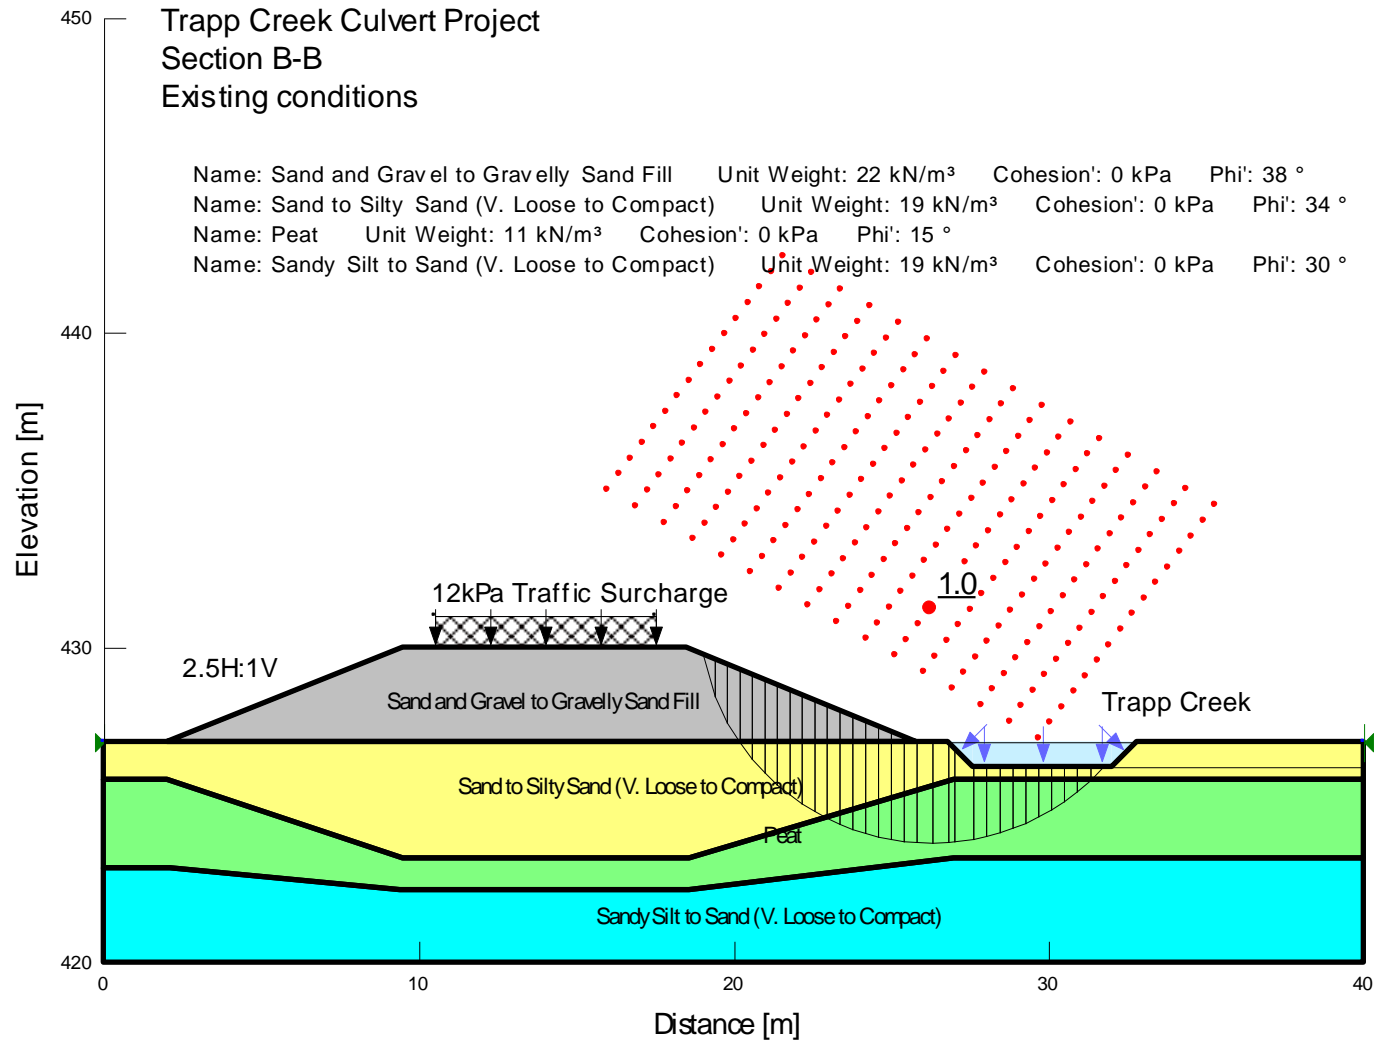
Figures in Appendix E show the results of global stability analyses at two locations: (i) at Section B-B shown on Drawing 2 in Appendix B and (ii) at Section D-D shown on Drawing 3 in Appendix B. As can be seen the minimum factor of safety (FOS) at both locations is around 1.0 (using conservative parameters), suggesting that the existing embankment slope is at the verge of instability. The cracks noticed in the pavement also can support this finding, noting also signs of erosion at the toe of the north embankment which are reported. Unfortunately, the area was flooded at the time of the investigation, so any detailed inspection of this erosion or bulging at the toe of the embankment was not possible. The meandering of the creek toward the west after its exit at the outlet also might contribute to the instability of the embankment at that location. In

Figure E1. Results of slope stability analyses, existing embankment at Section B-B

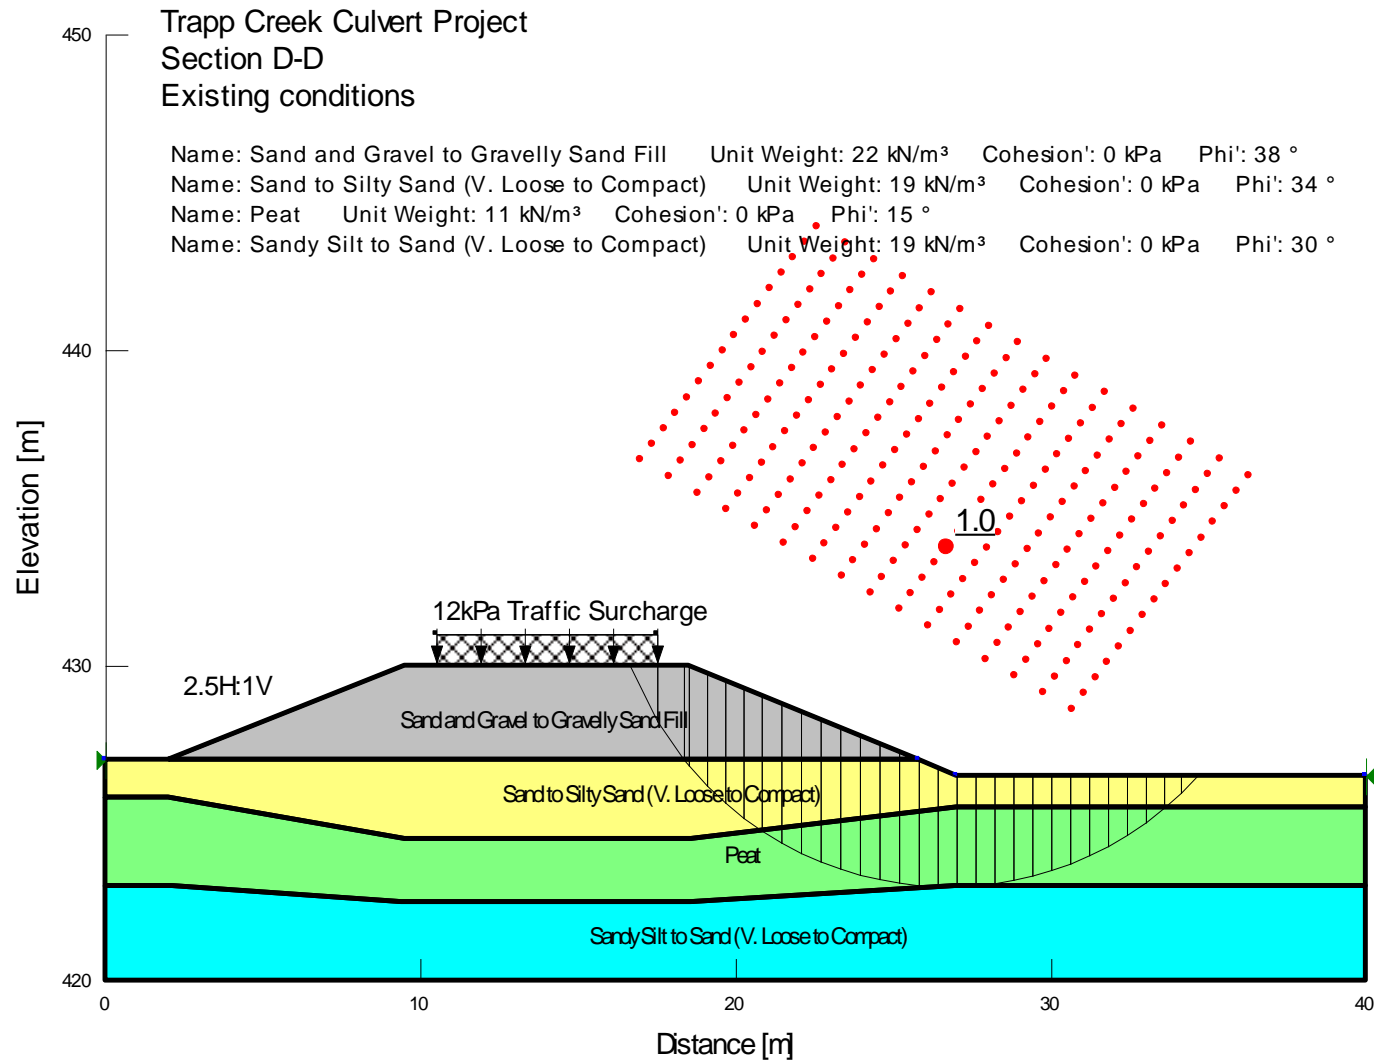
Figure E2. Results of slope stability analyses, existing embankment at Section D-D

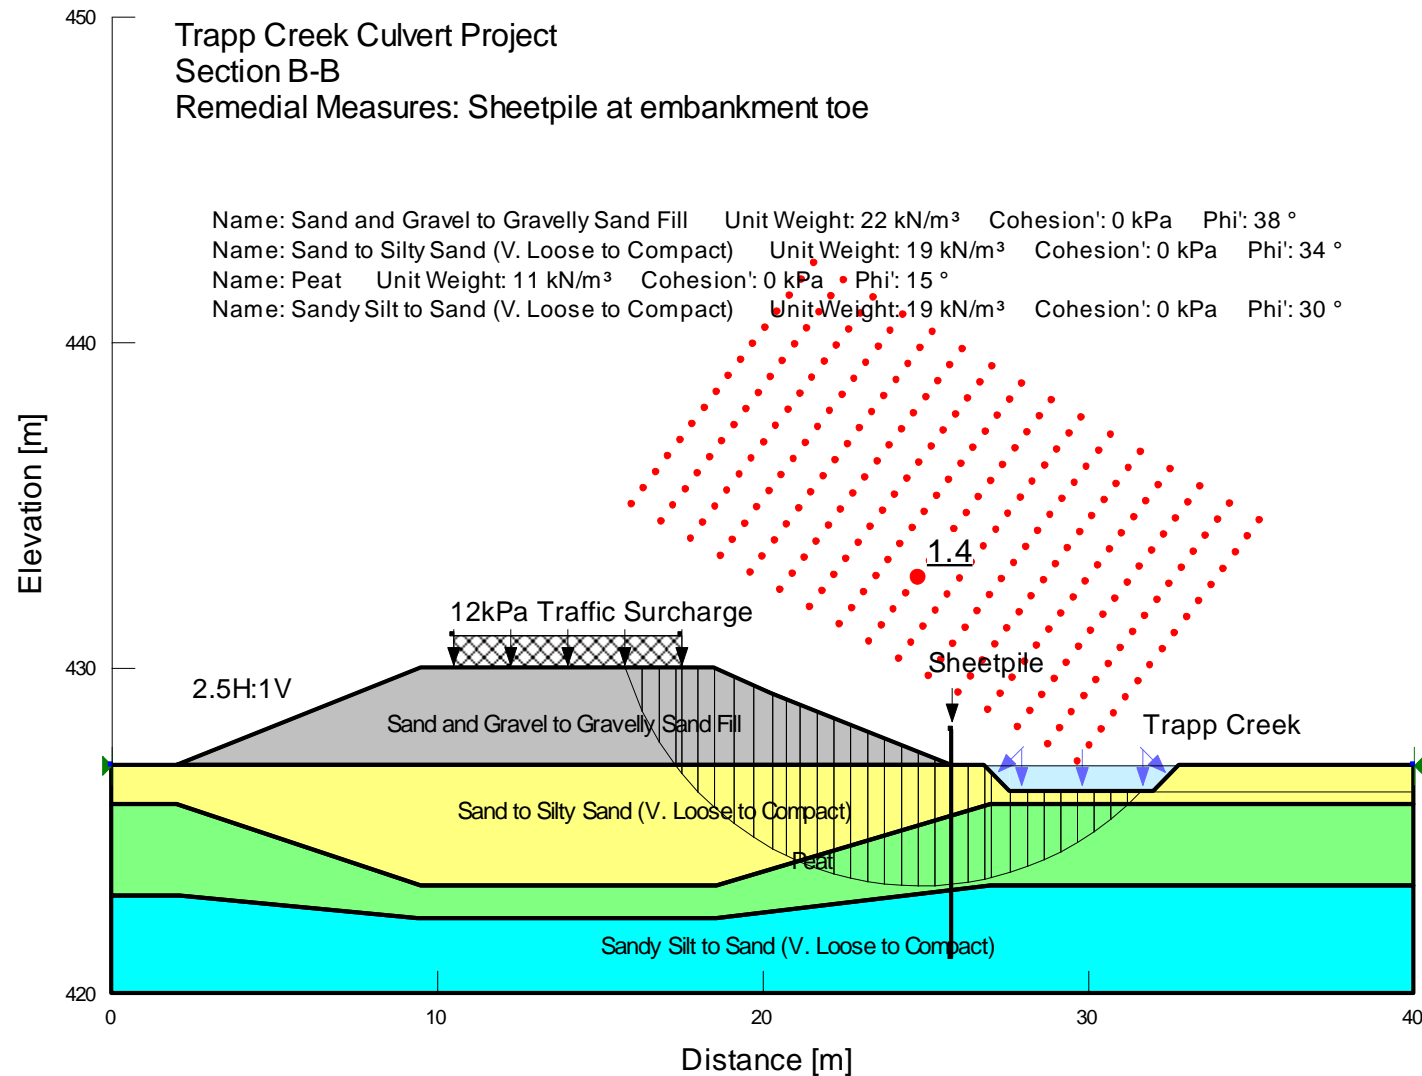
Figure E3. Results of slope stability analyses at Section B-B; Remedial measure – sheetpiles at embankment toe

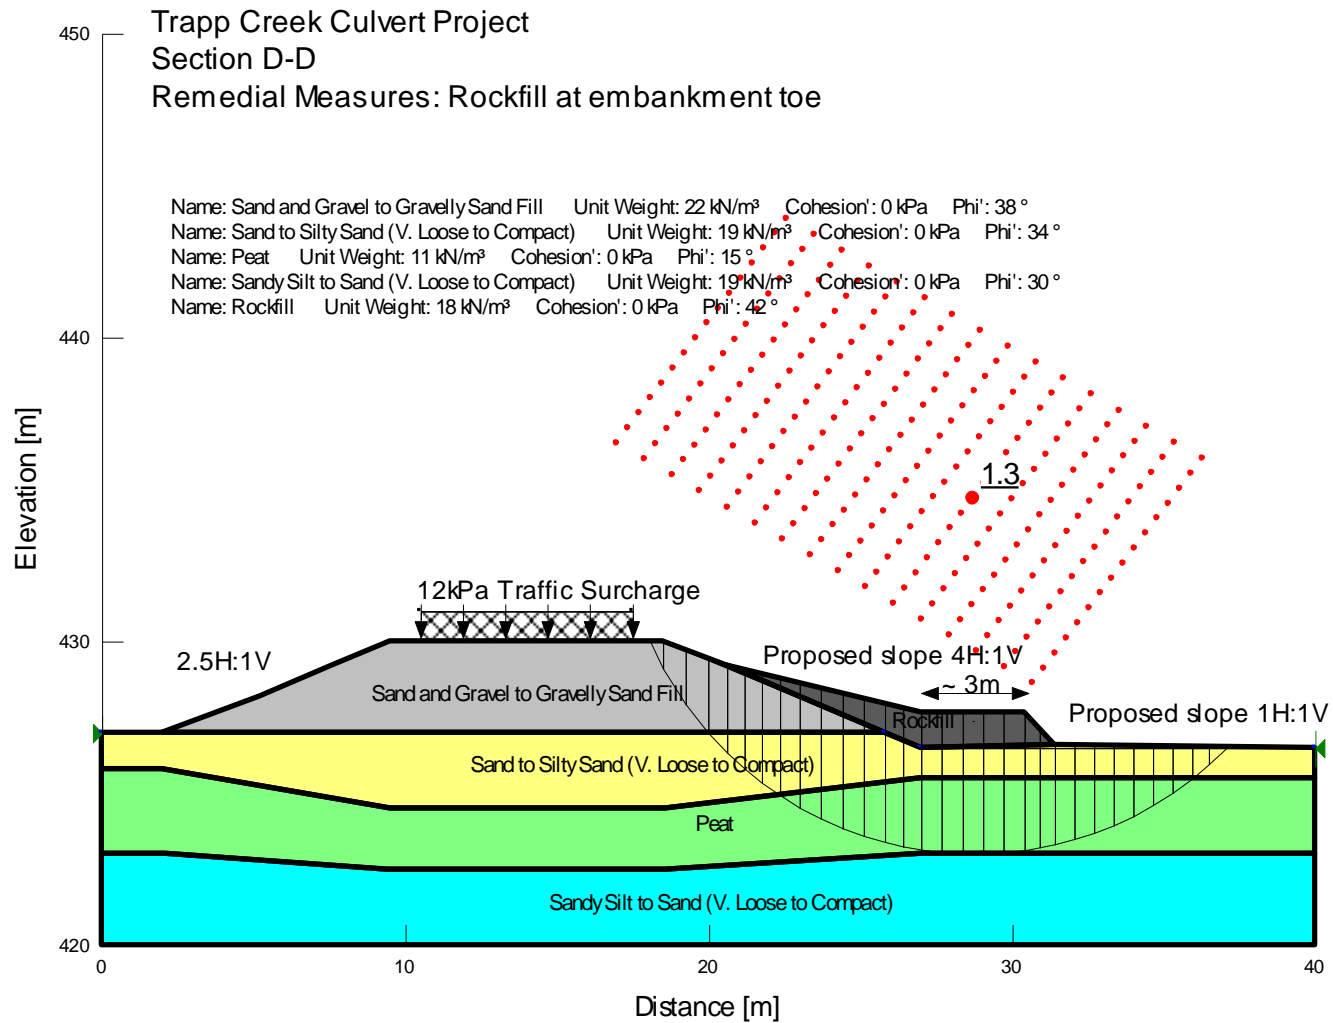
Figure E4. Results of slope stability analyses at Section D-D; Remedial measure – rockfill at embankment toe

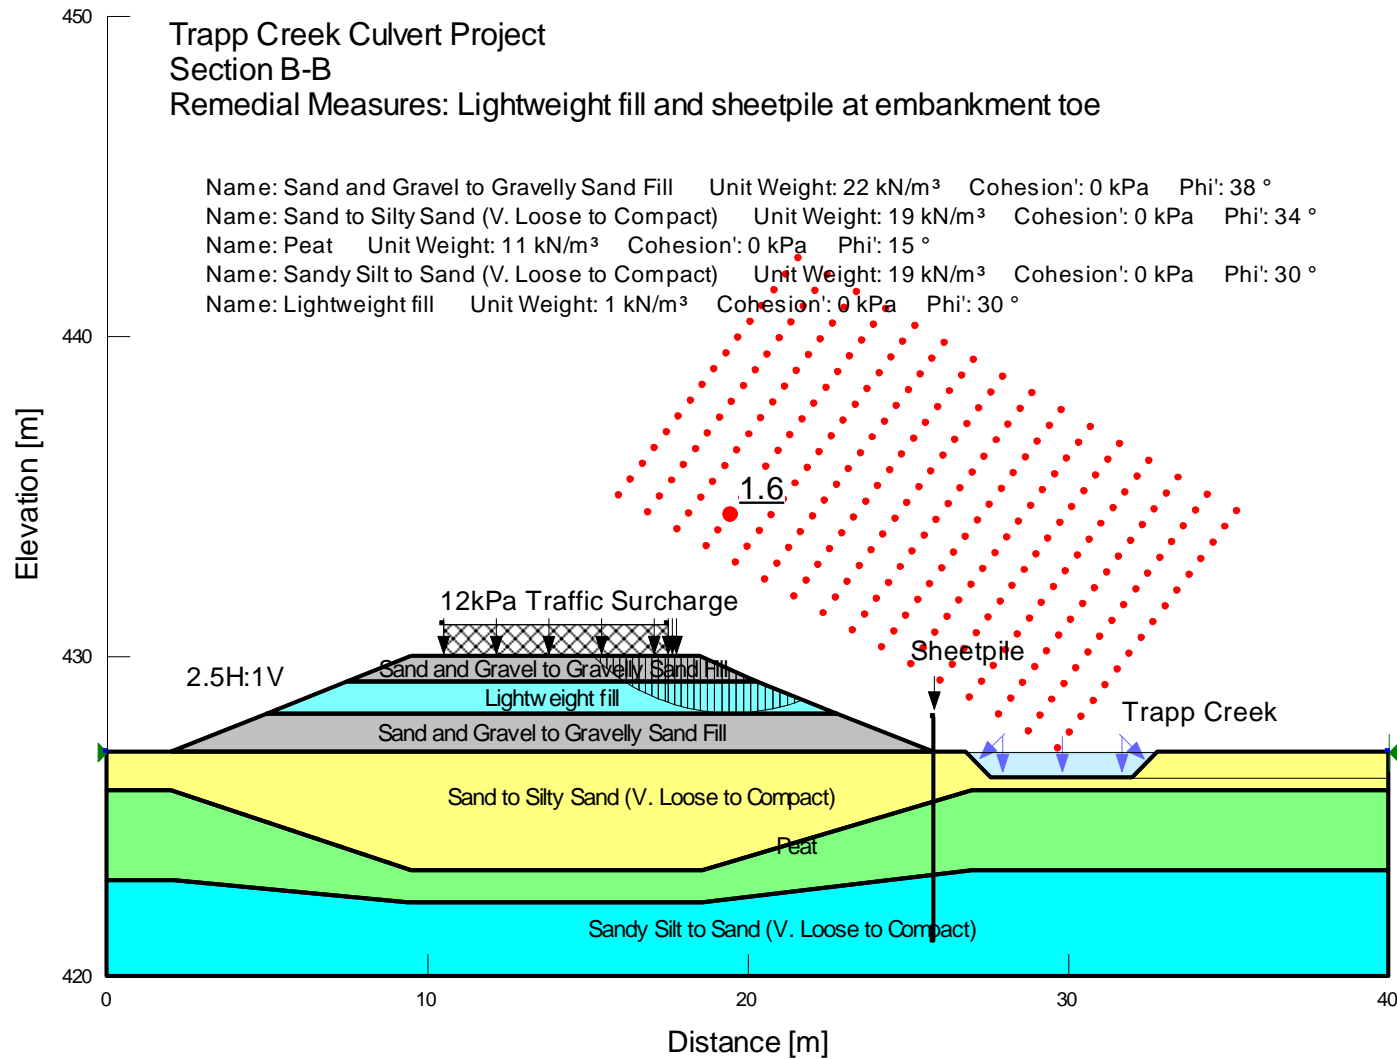
Figure E5. Results of slope stability analyses at Section B-B; Remedial measures – lightweight fill and sheetpiles at embankment toe

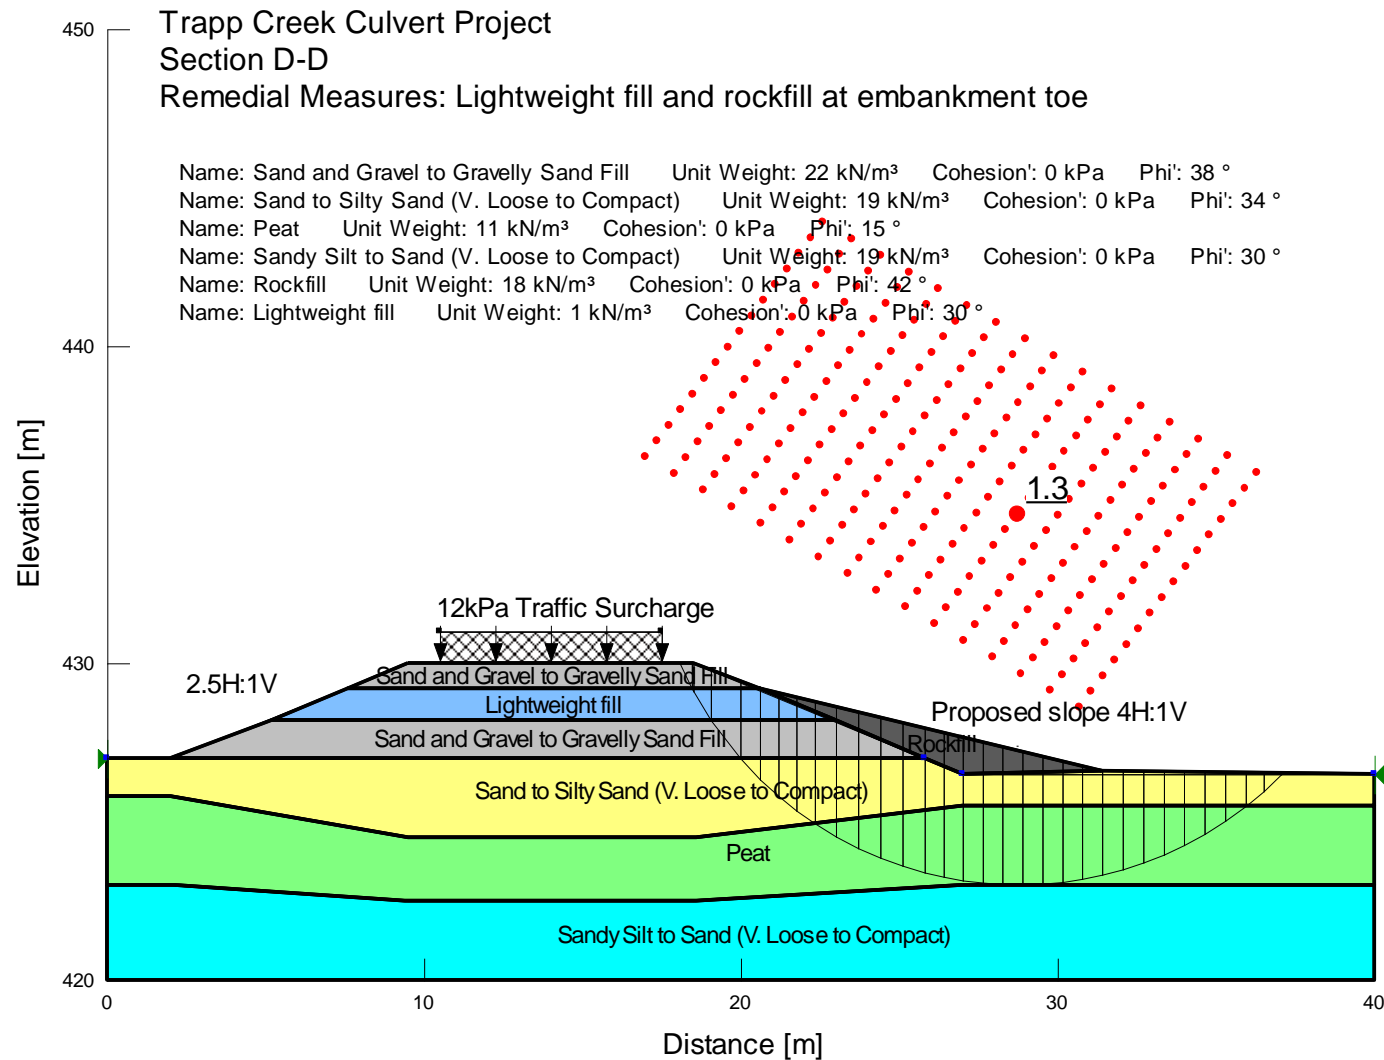
Figure E3. Results of slope stability analyses at Section D-D; Remedial measures – lightweight fill and rockfill at embankment toe

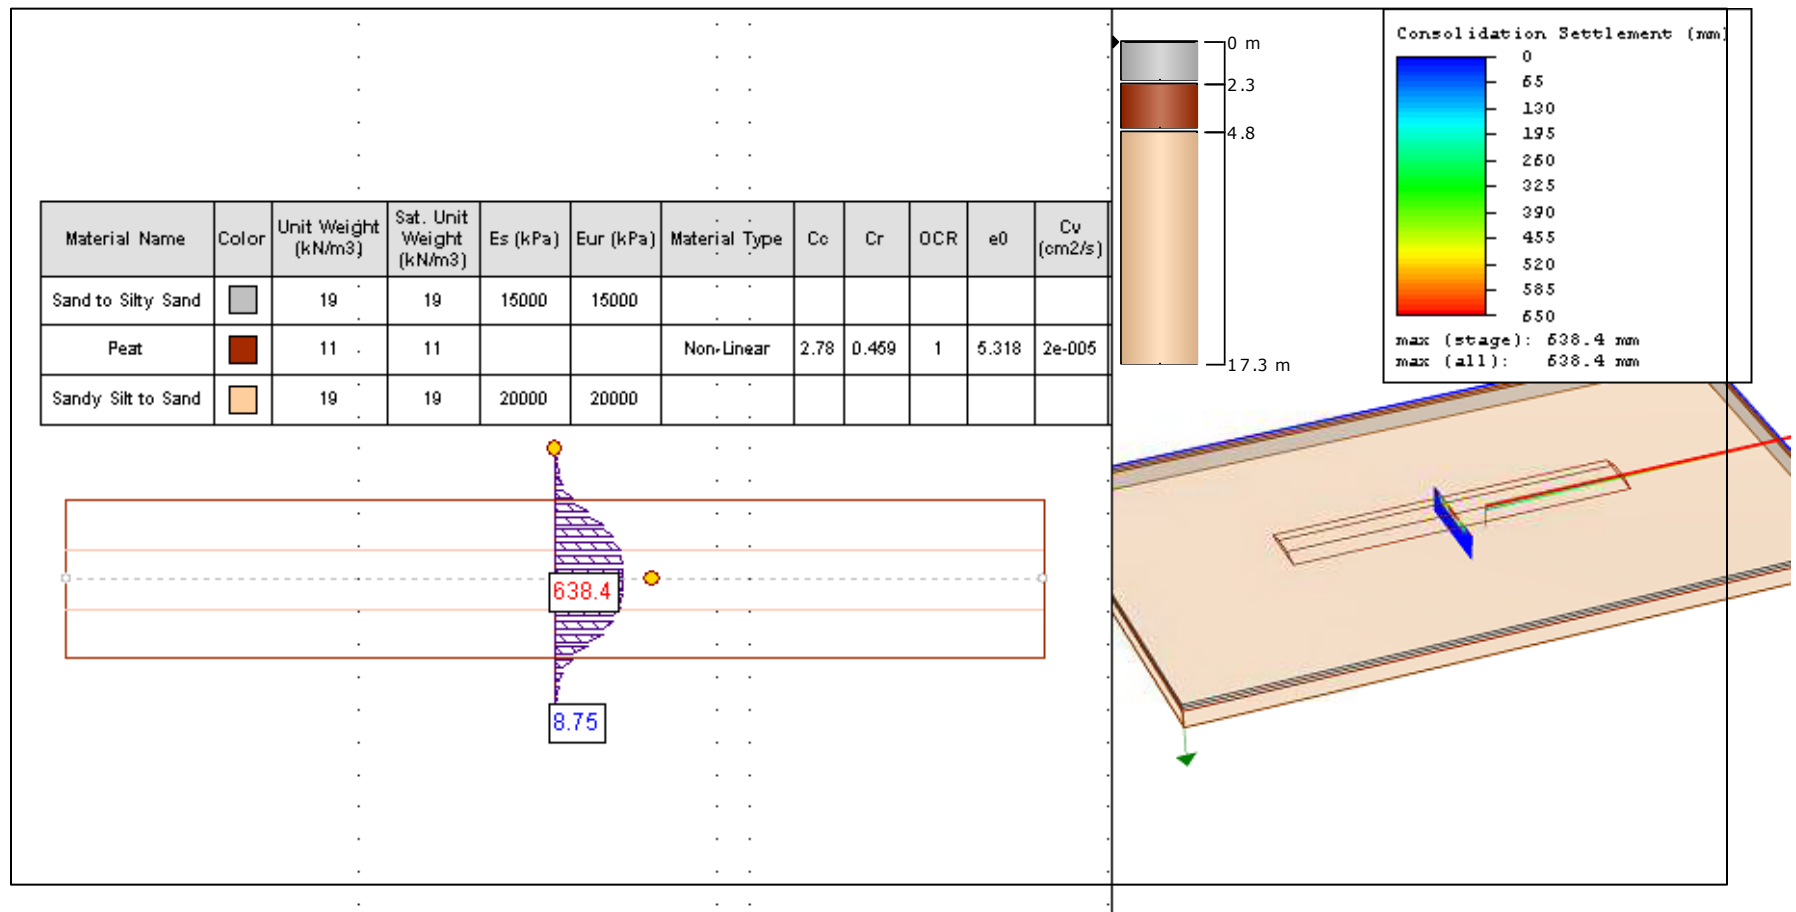
Figure F1. Settlement analysis at BH-4 location
