## **Appendix A – Site Photographs**

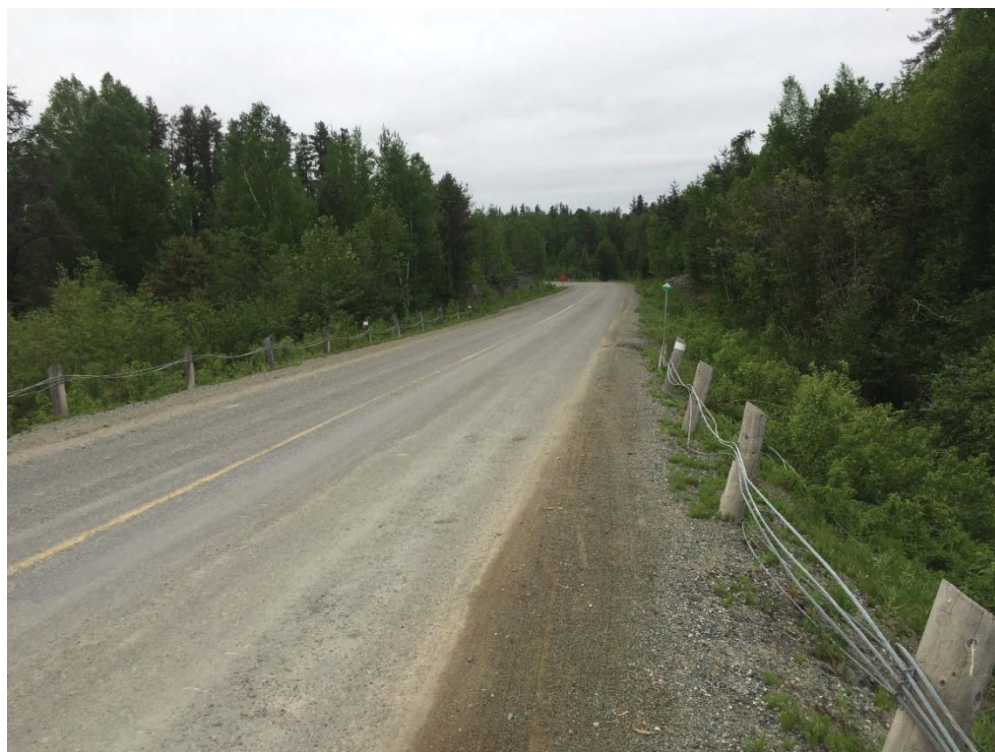
Photo 1. Hwy 672, looking north

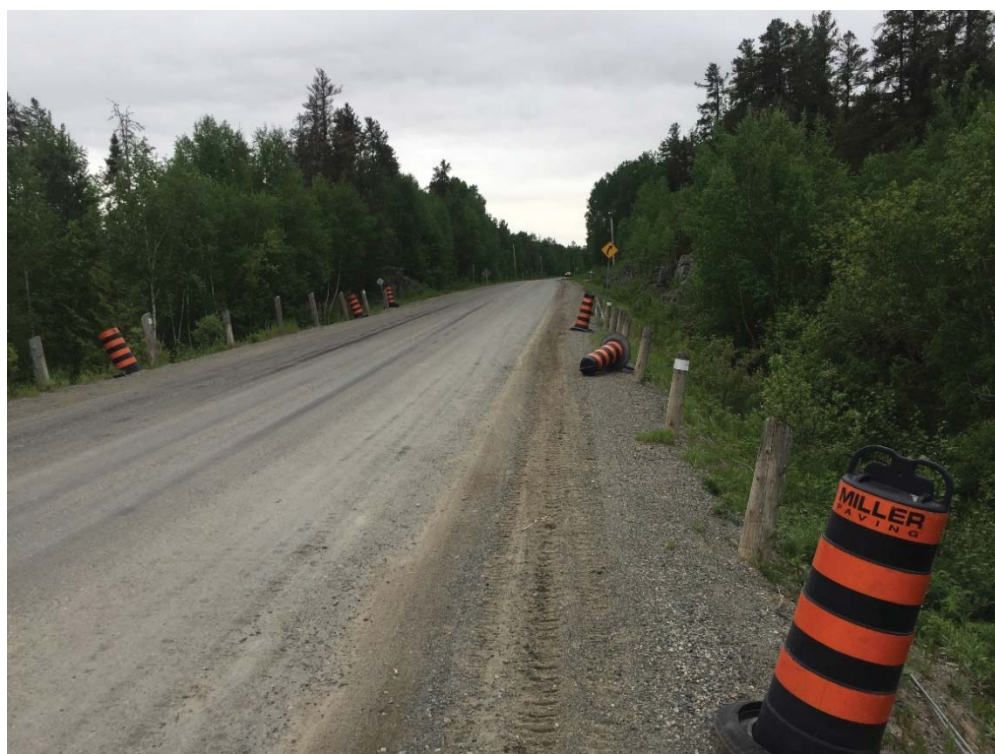
Photo 2. Hwy 672, looking south

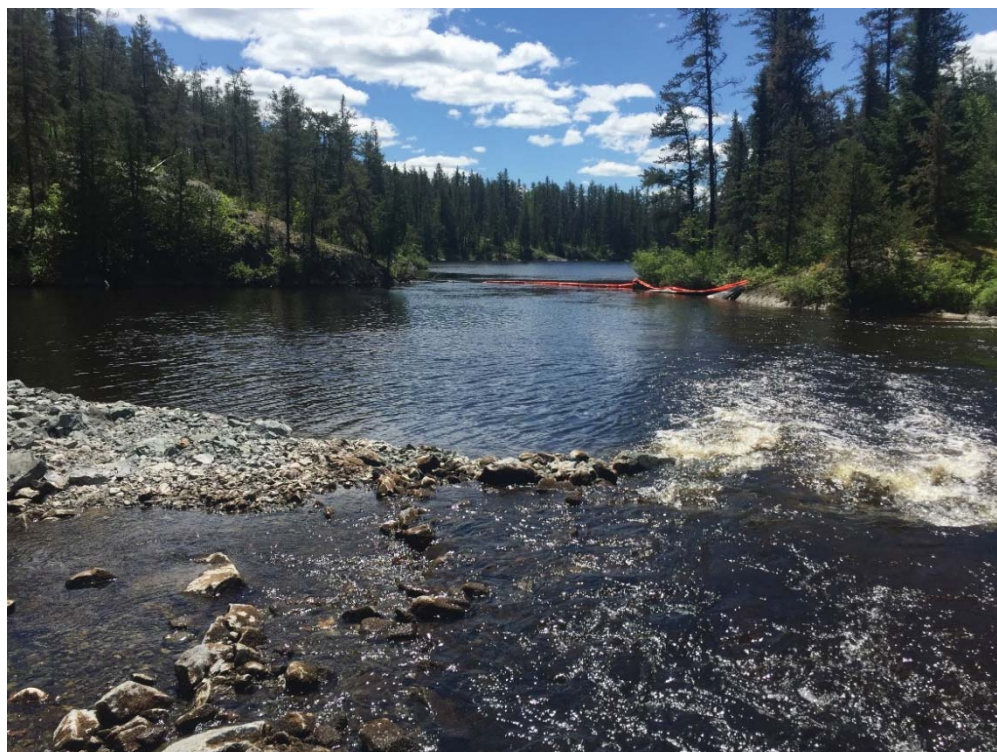
Photo 3. Looking east from the outlet of the culvert

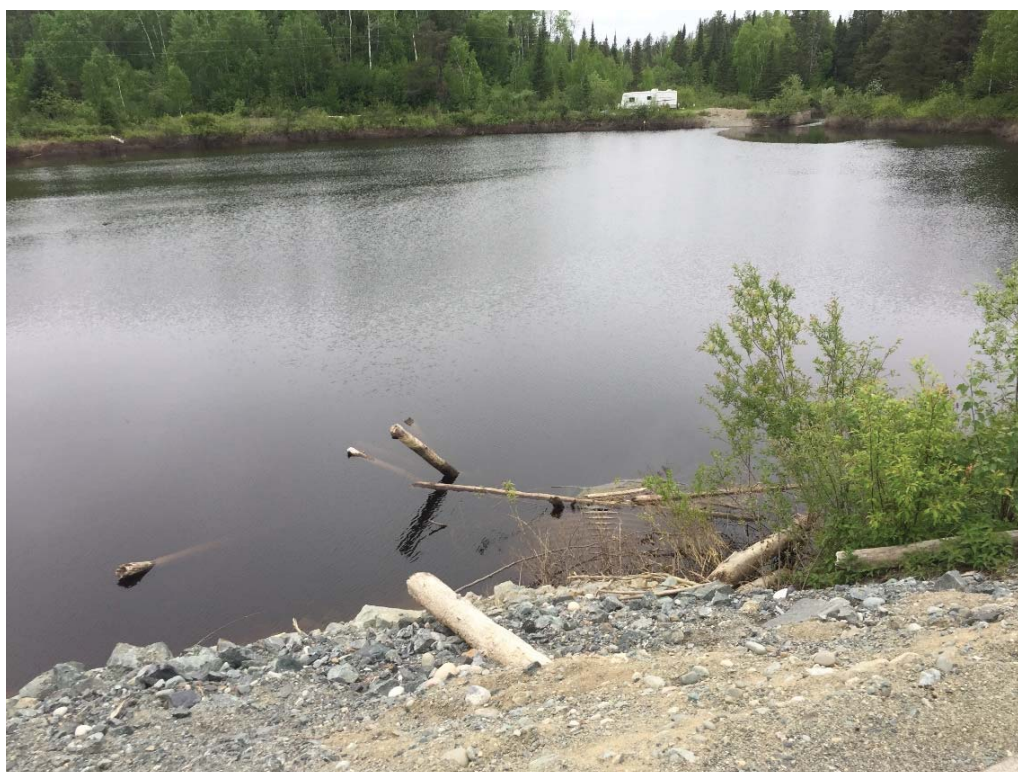
Photo 4. Looking west from the inlet of the culvert

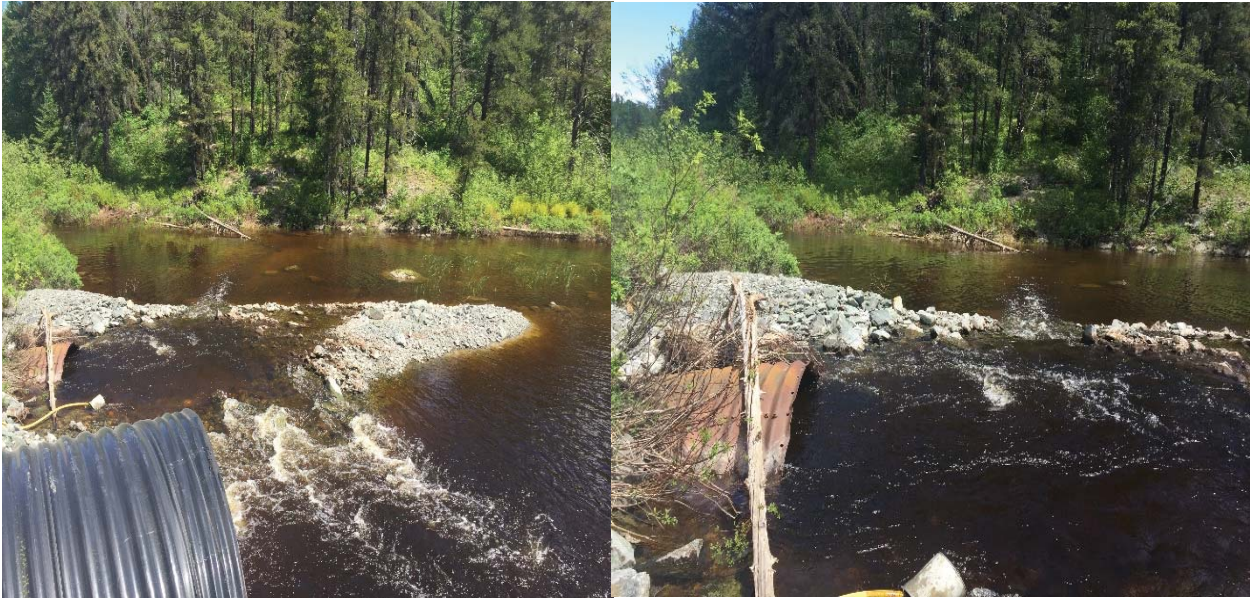
Photo 5. East (outlet) side of the embankment looking north

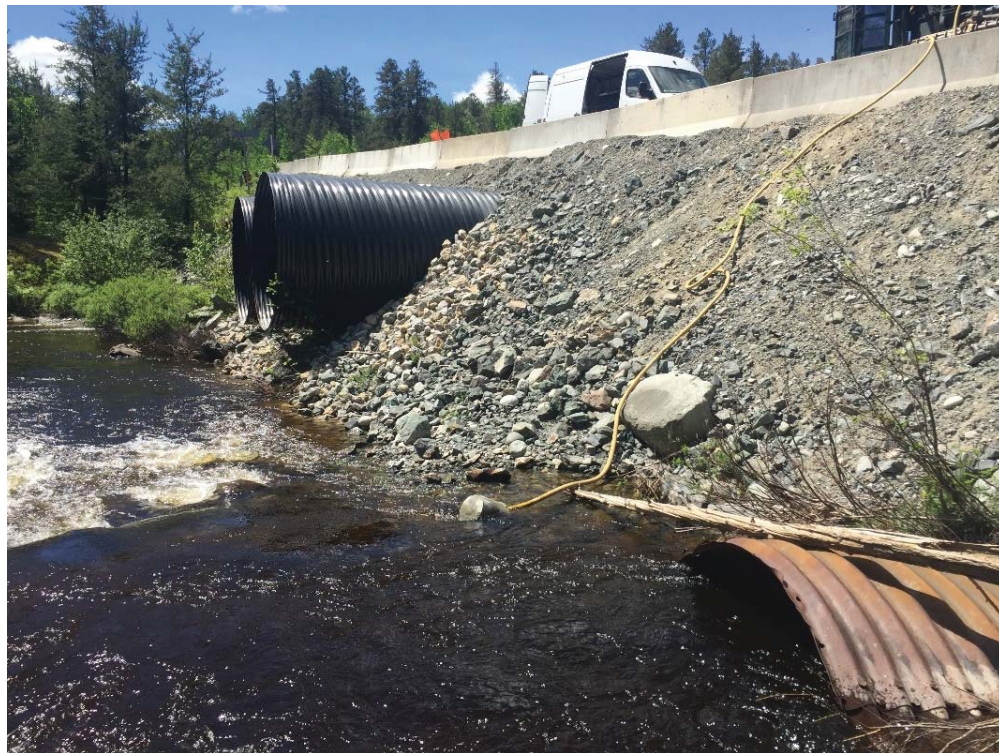
Photo 6. East (outlet) side of the embankment looking south

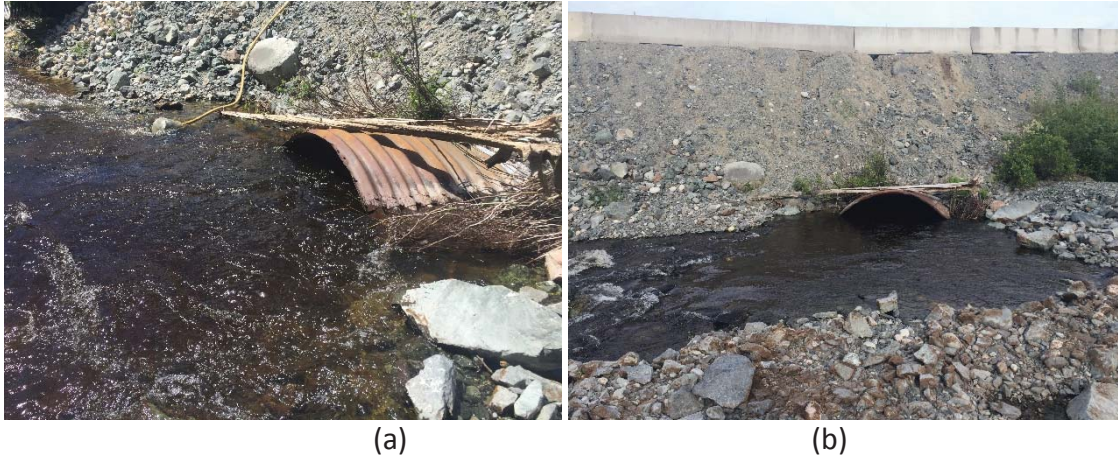
Photo 7. Water levels at outlet of existing culvert, (a) in June 2017 and (b) July 2017

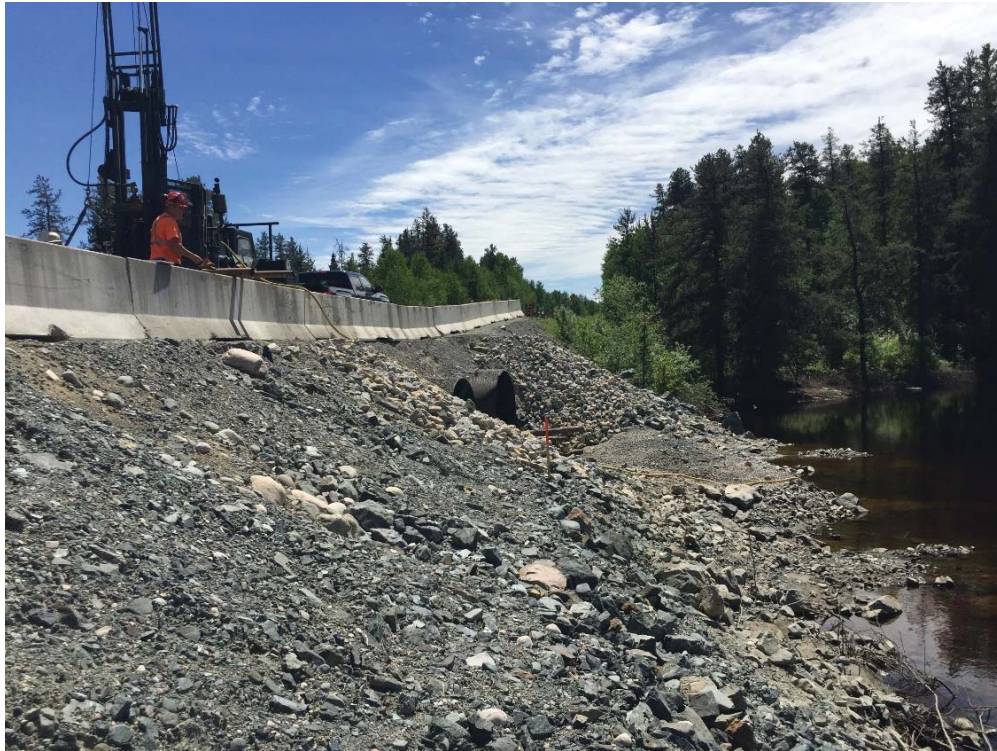
Photo 9. West (inlet) side of the embankment looking south

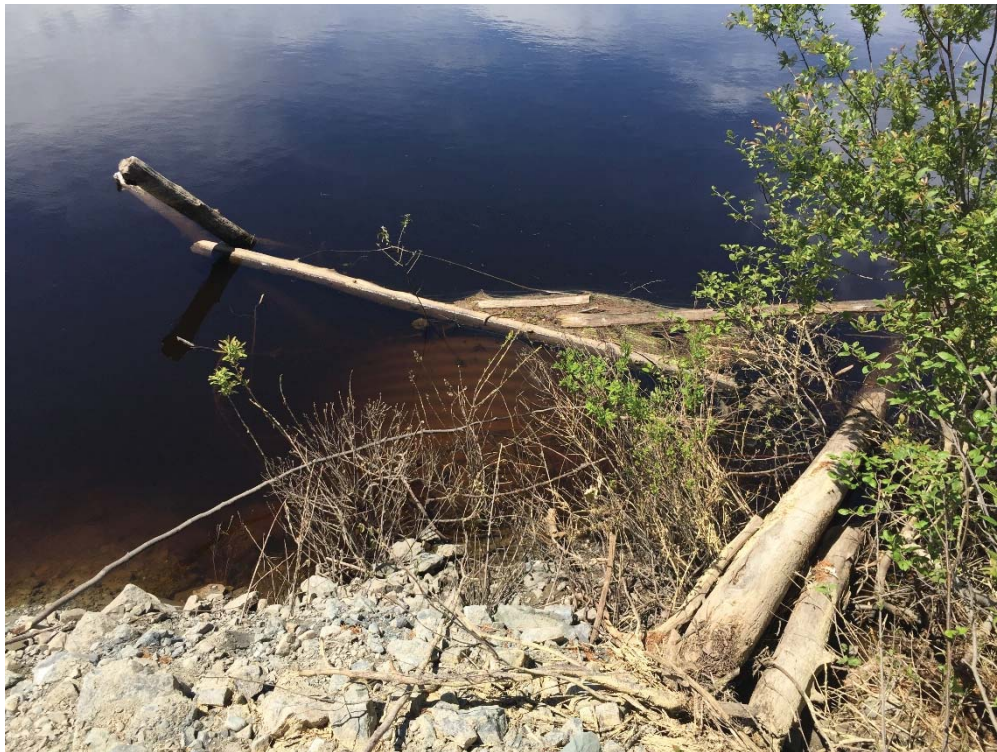
Photo 10. Submerged inlet of existing culvert during Phase I investigation on June 2017

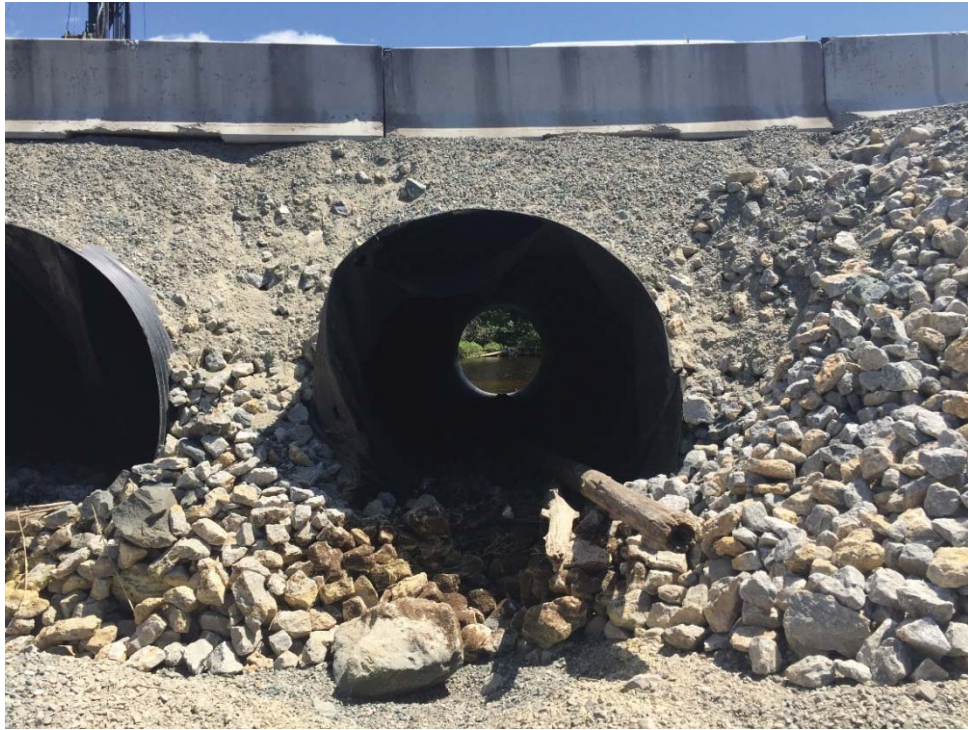
Photo 11. Temporary twin culvert, inlet side looking east

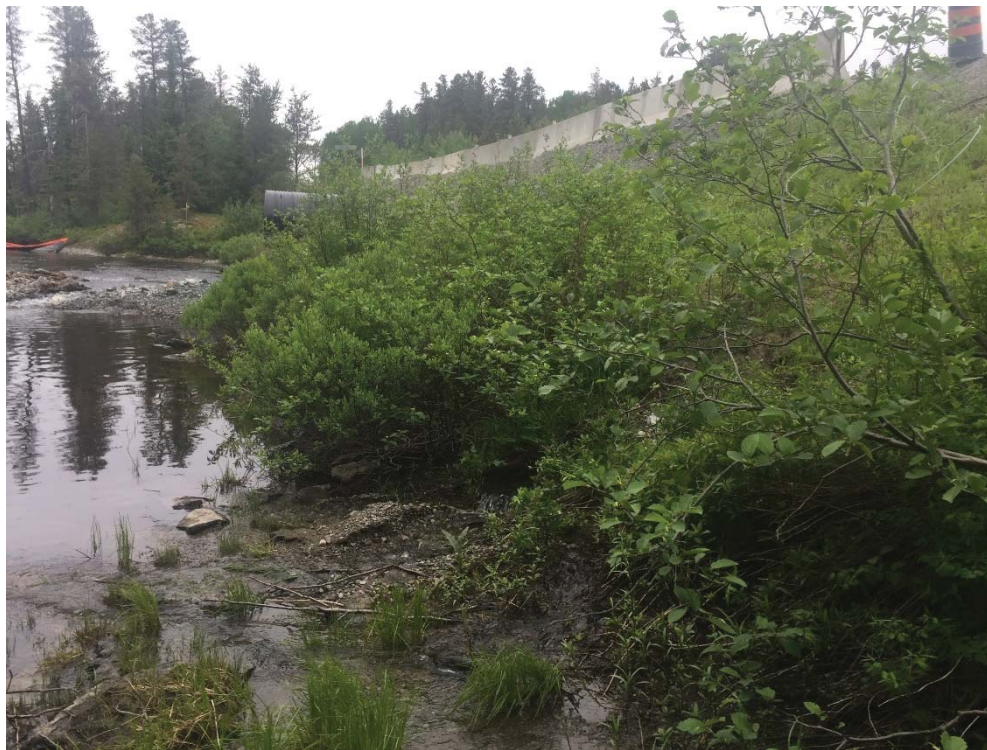
Photo 12. Water seepage through east(outlet) side of embankment north of existing culvert

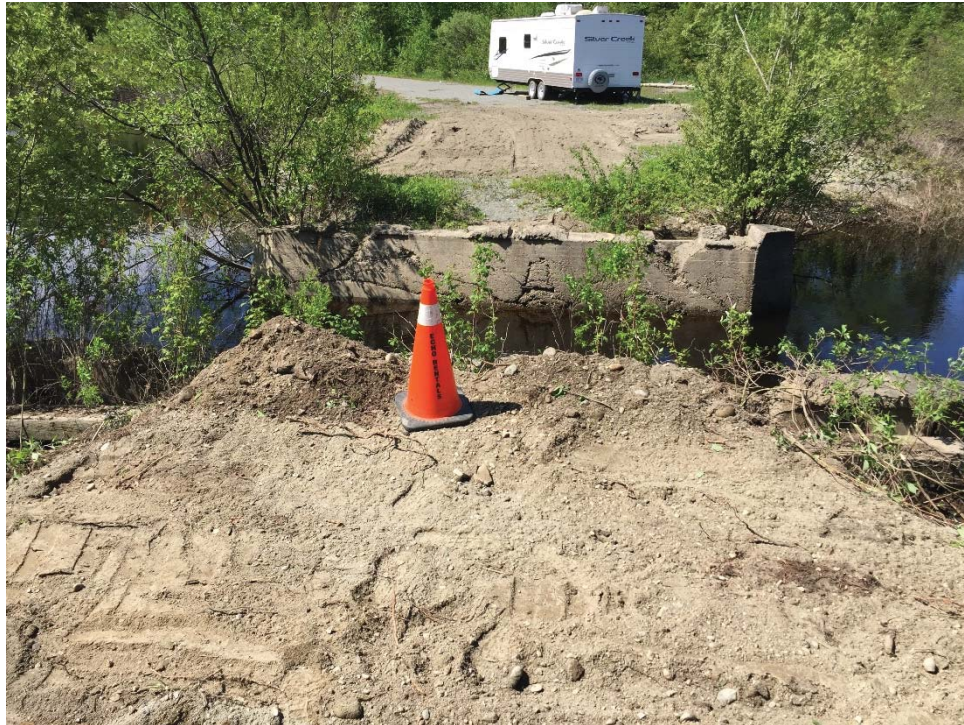
Photo 13. Temporary modular bridge location looking south, note existing abutment

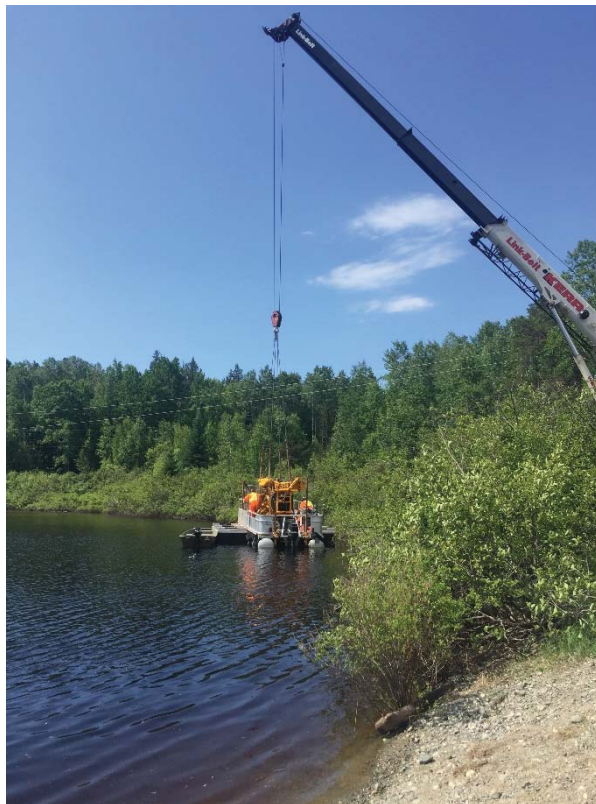
Photo 14. Crain lifting of barge and rig and placing them in water

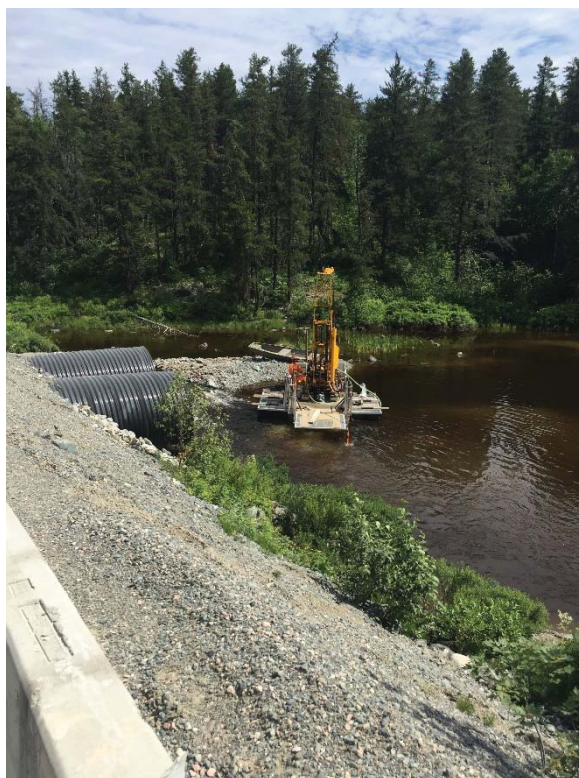
Photo 15. Borehole BH-1 drilling using a barge

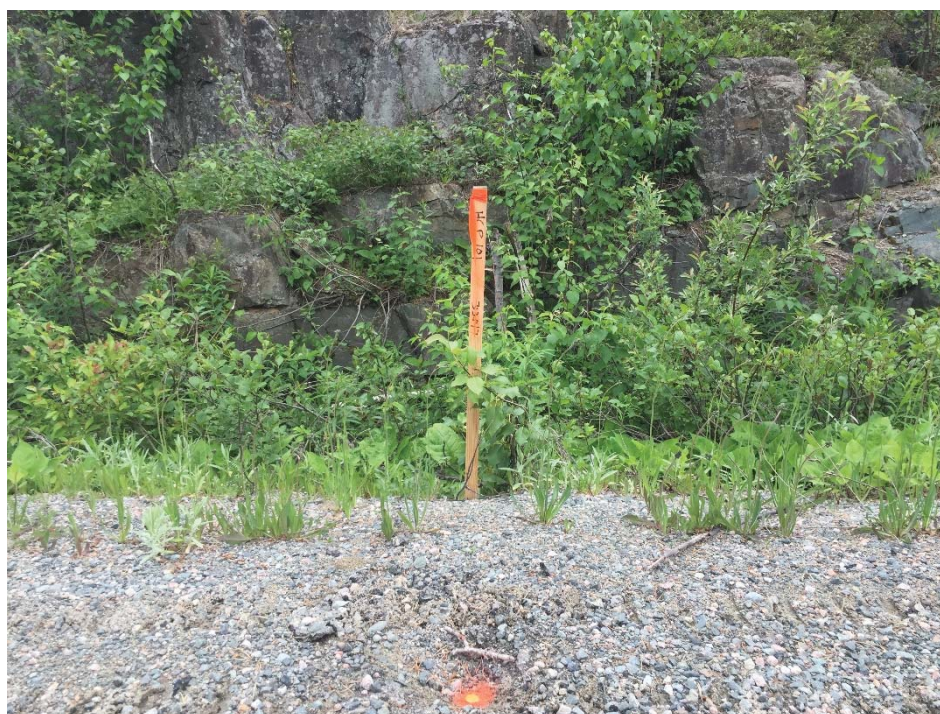
Photo 16. Benchmark HCP (101)
