THURBER ENGINEERING LTD.

FINAL MEMORANDUM

TECHNICAL MEMORANDUM STEEP COBBLE SLOPE, GULLY EROSION MITIGATION HIGHWAY 129, 37.4 KM NORTH OF HIGHWAY 554 AGREEMENT NO. 5020-E-0012, WORK ITEM #17 GWP 5161-18-00

GEOCRES NO: 41J-144

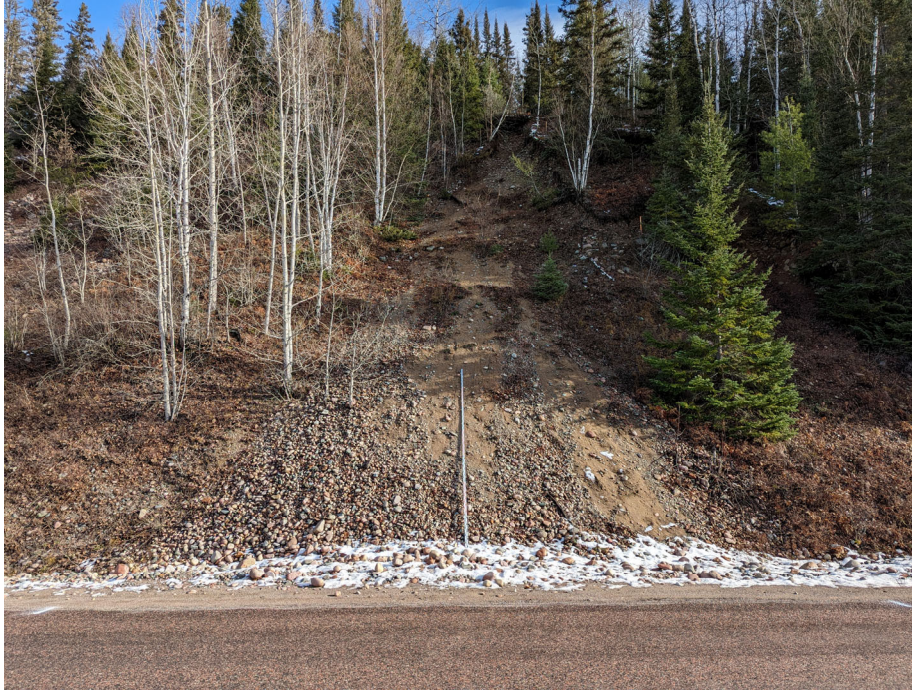
A gully was identified from approximately Station 19+176 to 19+188; for the purposes of this memo this gully will be referred to as the South Gully. The average slope from the crest to the toe at the South Gully was measured to be approximately 1.34H:1V and the depth of the gully was estimated to be 1.5 m. The vertical height of the gully was measured to be approximately 21.4 m. There is very limited vegetation within the gully, the surficial material consisted of sand with round cobbles and was estimated to be very loose in consistency. A significant number of cobbles were present at the toe of slope at the time of the site visit. Along the south side of the gully, the possible formation of an increased slope crest was observed creating a detached vegetated area that is less stable and at risk of sliding down the slope. The potential failure of this formation would result in the limit of the gully expanding along the south side of the gully to approximately Station 19+170.

Photo 1. South Gully Sta. 19+176 to 19+188 (looking east) [taken Nov. 2023]

Based on an evaluation of the erosion mitigation design alternatives and the geometry of the existing gullies, the recommended erosion mitigation option, from a foundation engineering perspective, is to install rock protection within the gully locations with a geotextile separation layer. It is noted that since no drainage improvements will be carried out the rock protection will need to provide erosion control as well as serve as an armored drainage channel.

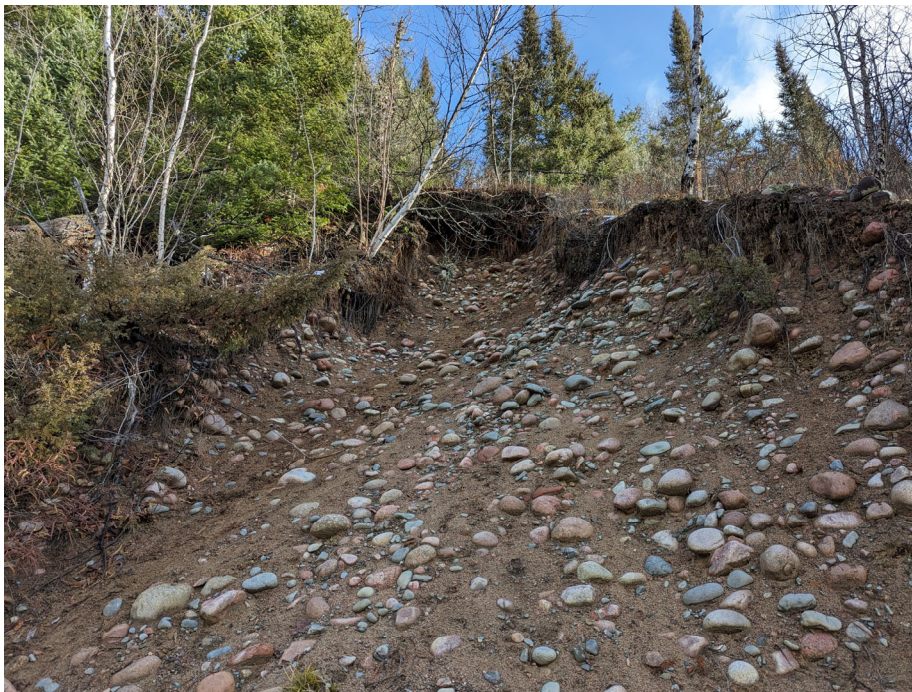
Photo 2. South Gully crest (looking east) [taken Nov. 2023]

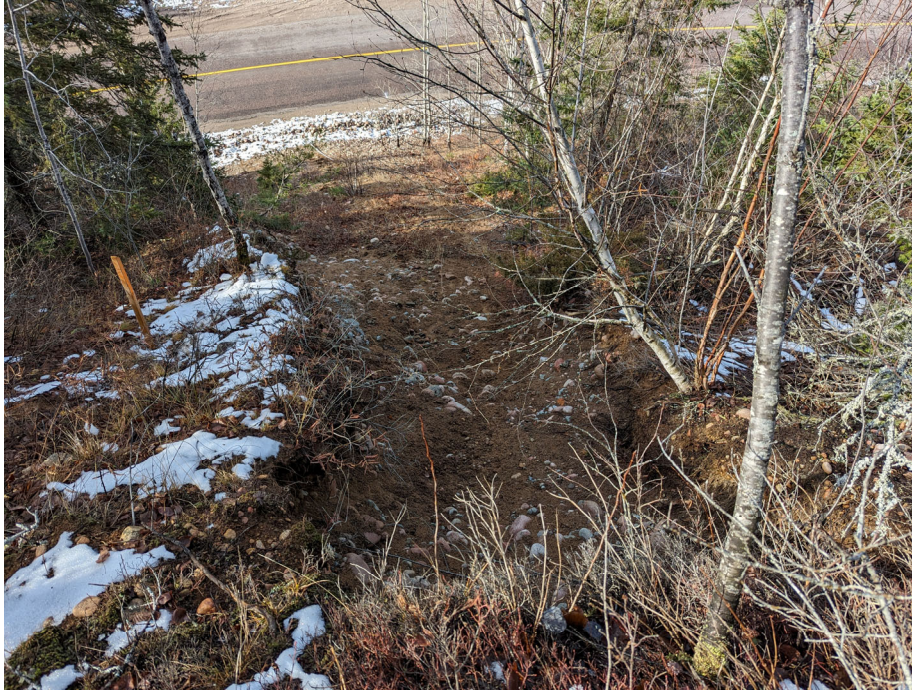
Photo 3. South Gully viewed from crest (looking west) *[taken Nov. 2023]*

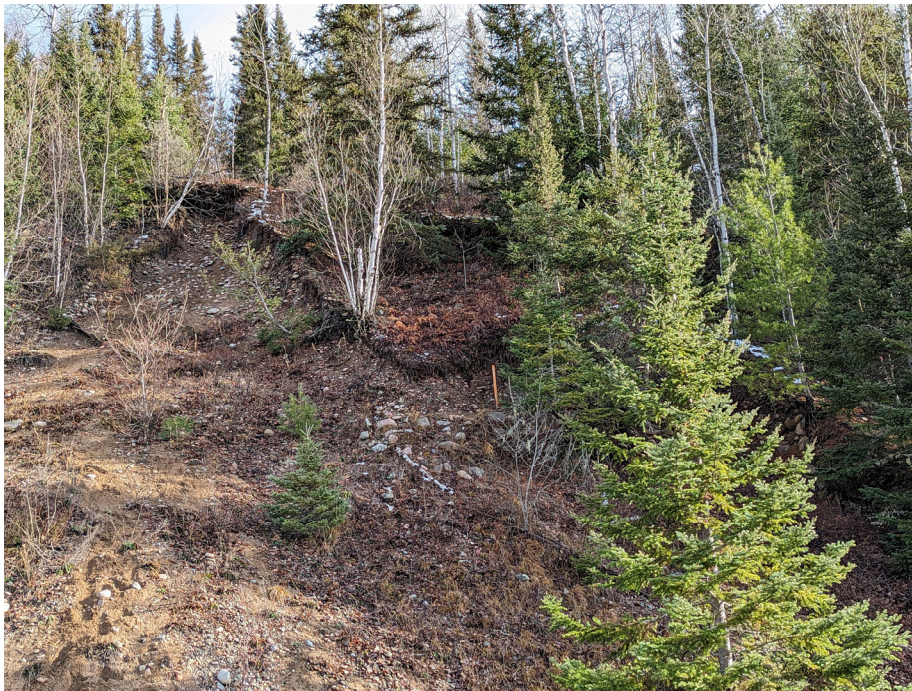
Photo 4. South Gully expansion to south (looking east) *[taken Nov. 2023]*

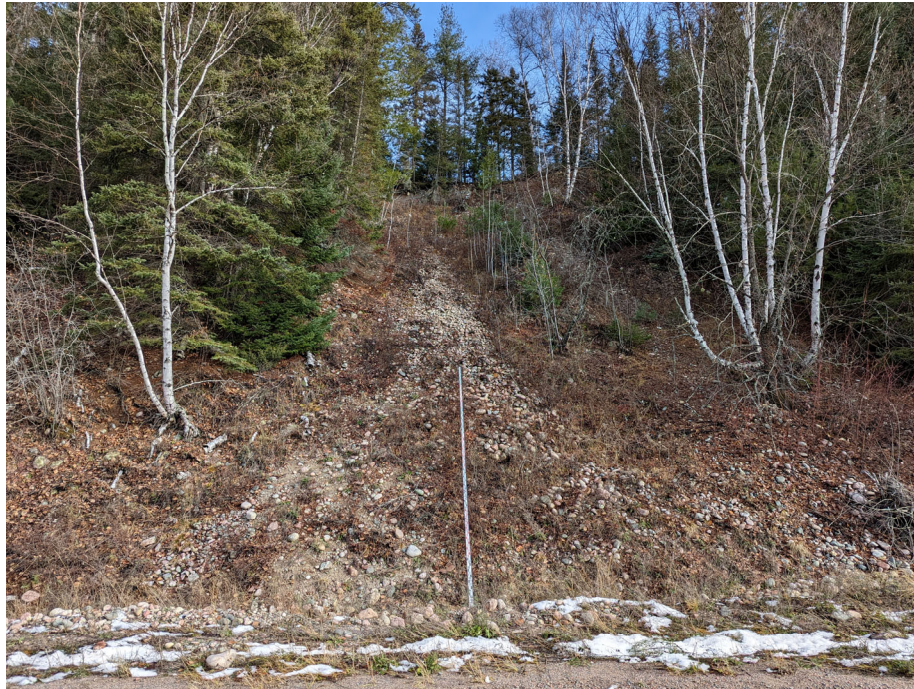
The second gully was identified from approximately Station 19+370 to 19+384; for the purposes of this memo this gully will be referred to as the North Gully. The average slope from the crest to

the toe at this location was measured to be approximately 1.39H:1V and the depth of the gully was estimated to be 1.5 m. The vertical height of the gully was measured to be approximately 21.8 m. Some vegetation was observed within this gully which is a possible indication that the North Gully is less active than the South Gully. The surficial material consisted of sand with silt containing frequent round cobbles and was estimated to be very loose in consistency. Cobbles were present at the toe of slope within the ditch at the time of the site visit.

Photo 5. North Gully Sta. 19+370 to 19+384 (looking east) *[taken Nov. 2023]*

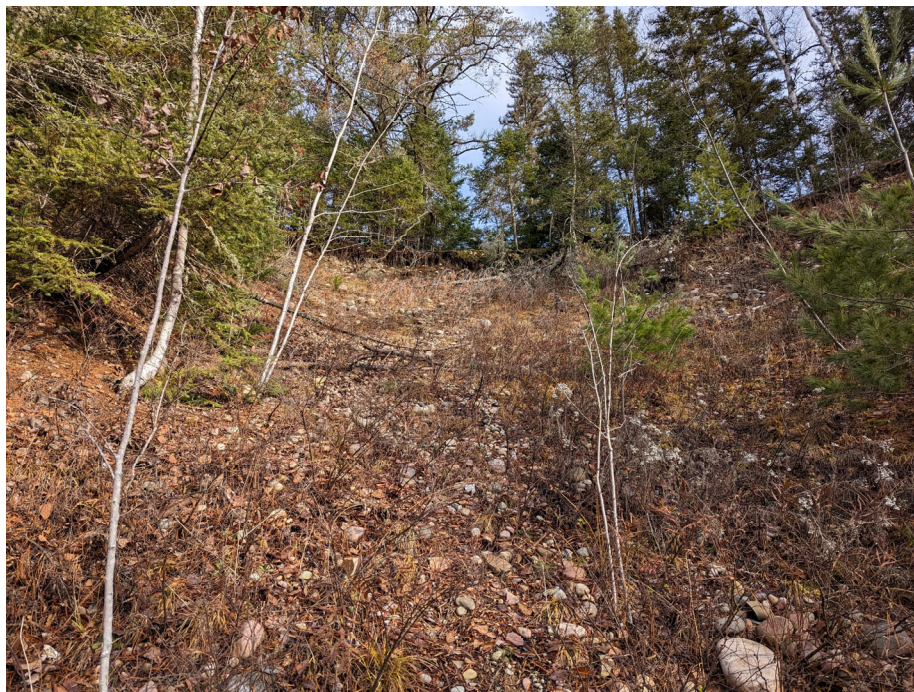
Photo 6. North Gully crest (looking east) *[taken Nov. 2023]*

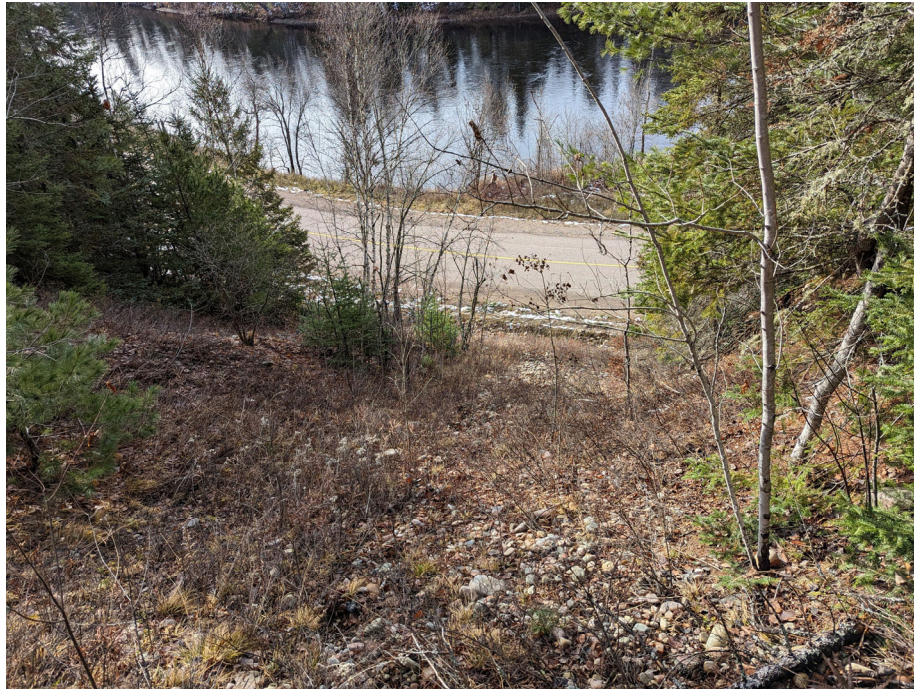
Photo 7. North Gully viewed from crest (looking west) *[taken Nov. 2023]*

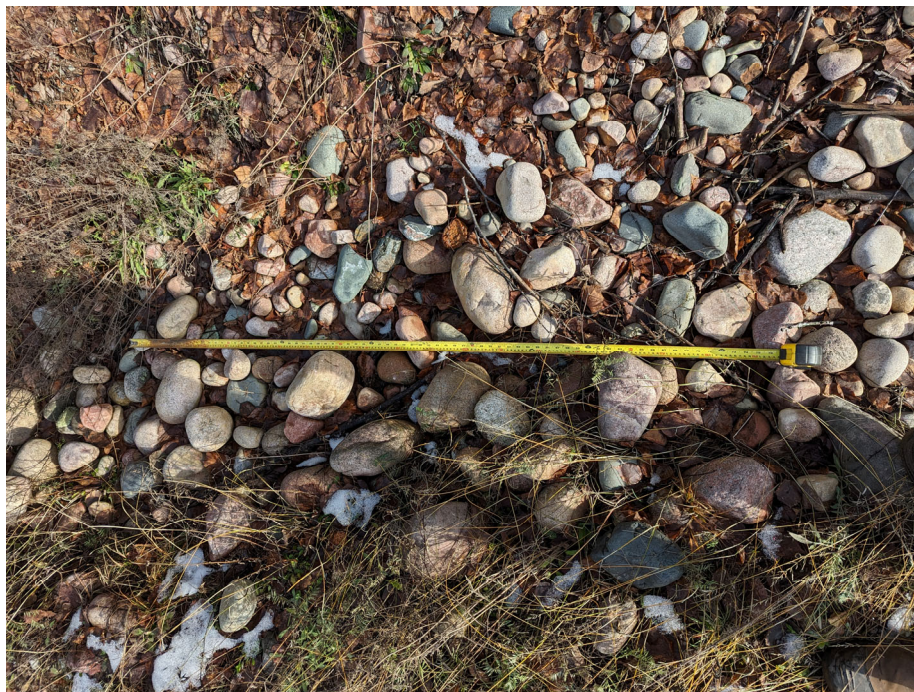
- The presence of cobbles within the cut slope soils is an inherent highway hazard with cobbles rolling down the slope and into the near driving lane. The cobbles are released from the slope as the surrounding soil matrix is eroded away by flowing water.

Photo 8. Cobbles up to 200 mm observed at toe of North Gully *[taken Nov. 2023]*

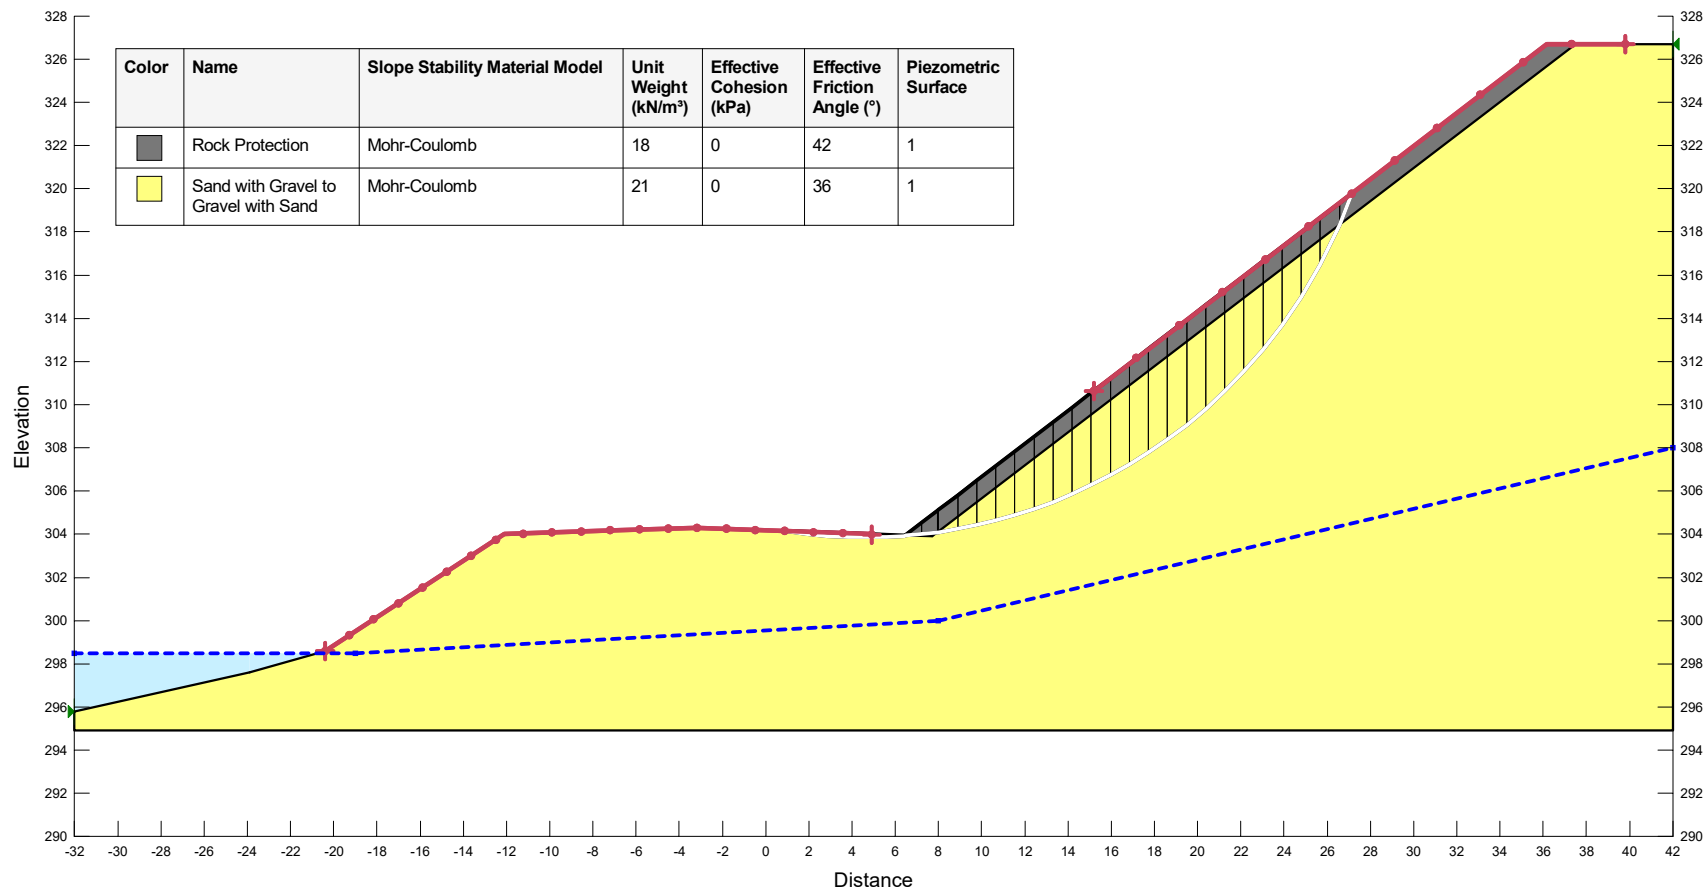
Figure 2

We have completed a slope stability assessment; a copy of the output is appended to this memo. The existing slopes are marginally stable with a factor of safety of 1.18. A second analysis has also been completed and is also appended which shows that the rock protection will have a negligible impact on overall slope stability. Thus, the slope will not achieve the typical MTO target factor of safety.
