GEOCRES No. 52A-122

STR. SITE No. 48W-77

LOCATION Whitefish River at
Nolalu

Subject: Re: Foundation Investigation for Whitefish River at Nolalu
W.O. 79-12006 Site 48W-77
District 19, Thunder Bay

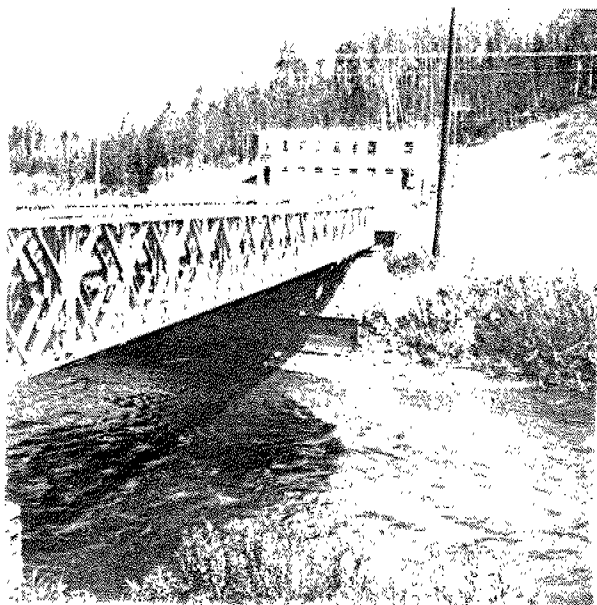
Looking
48W -77 North, along
new bailey bridge

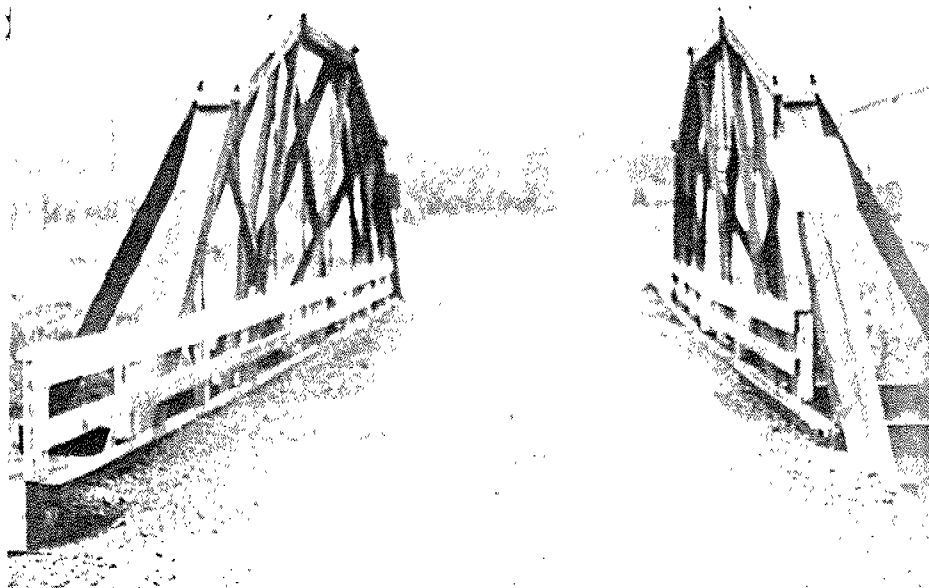
Previous structure
which failed Spring/77

As part of Northwestern Region's municipal bridge program for unorganized townships it was proposed to replace the existing Whitefish River structure. However, due to excessive ice loads, the structure failed during the spring and was replaced with a bailey bridge founded on rock filled timber cribs. This memorandum will present the results of a limited foundation investigation carried out at the site on June 28, 1979 for a possible replacement structure. No final report will be issued until a new structure replacement scheme is formalized.

Depending upon the final profile grade of the structure, foundations can be supported on spread footings founded on bedrock for an allowable bearing pressure of 10 t.s.f. Alternatively, footings can be built up from bedrock to the required elevation using mass concrete.

Adequate precautions should be taken to protect the river banks and approach embankment from river scour action. This may be achieved by suitably placed rip-rap.
