LOCATION ATIKOKAN RIVER

BRIDGE REPAIRS

Atikokan River Bridge; Hwy. #622;  
Site 45-112; District #19-Thunder Bay.

SUBJECT: D 3292  
Atikokan River Bridge, Hwy. 622  
Site 45E-112, District 19 (Thunder Bay)

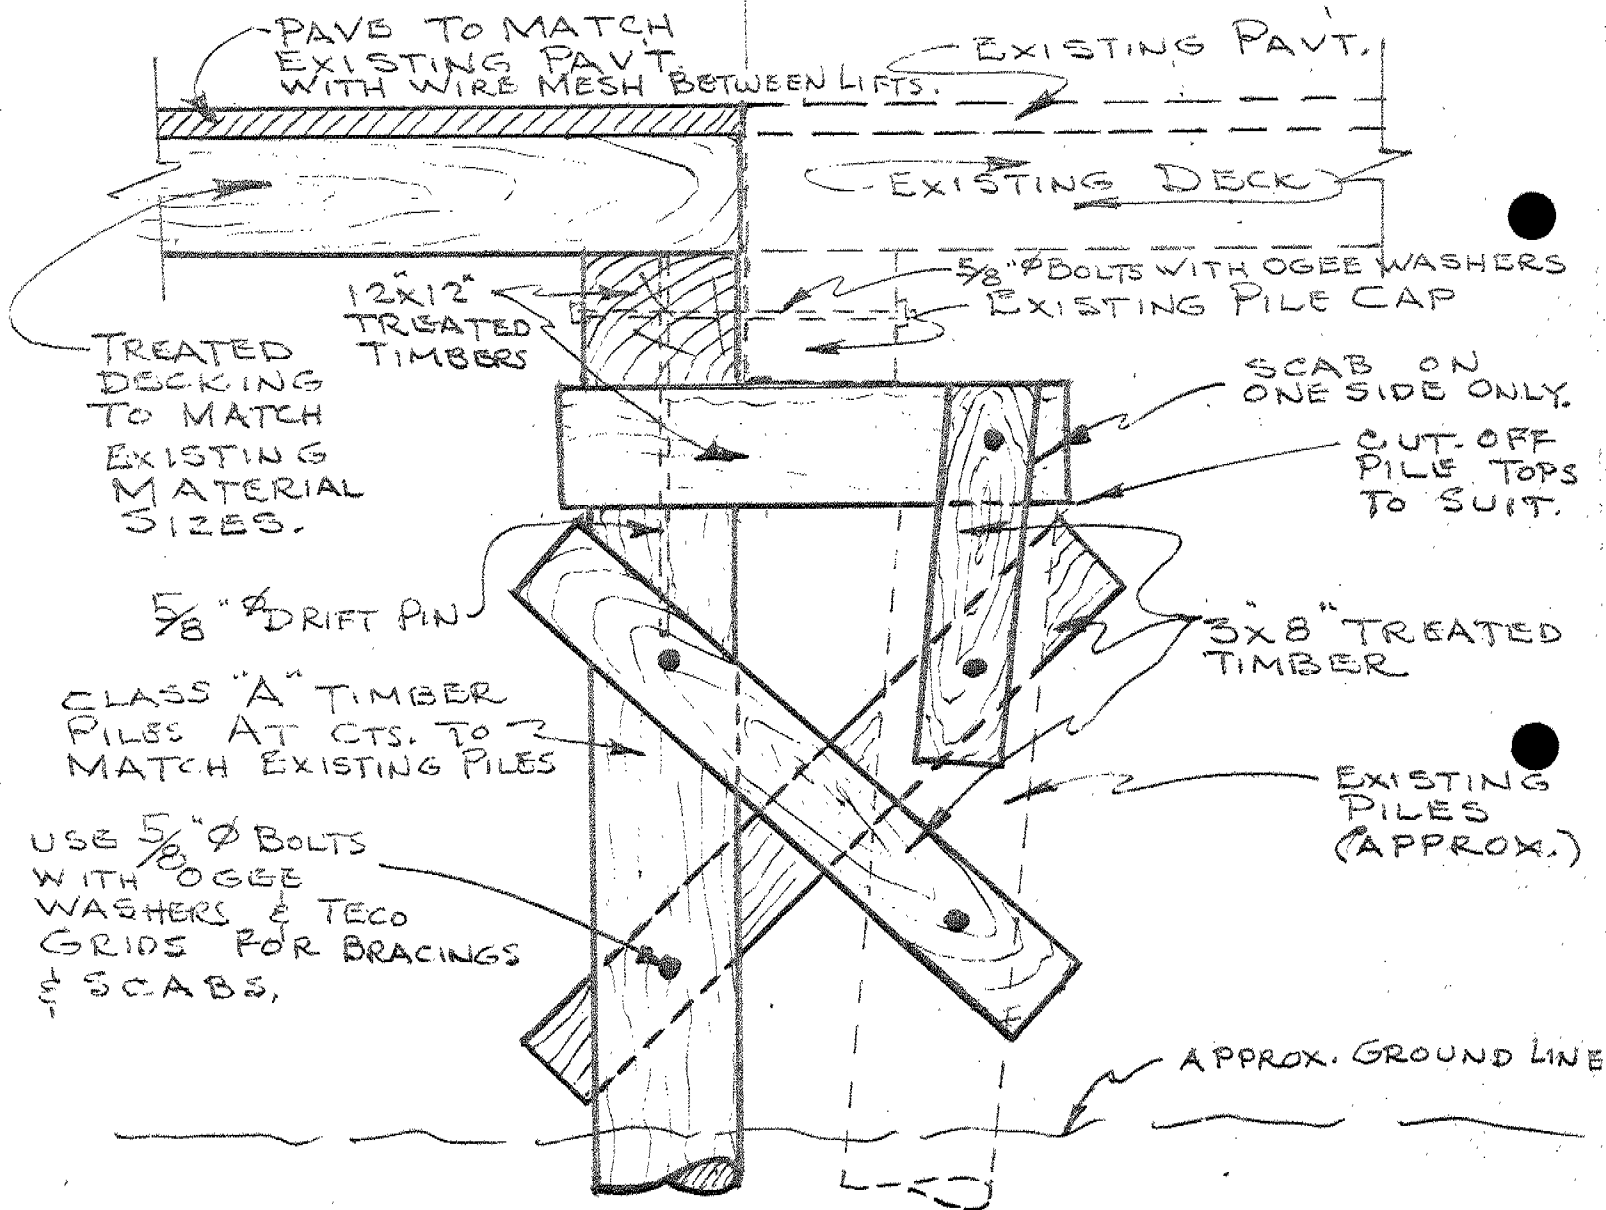
TYPICAL LONGIT. SECT'N.  
OF  
PROPOSED NORTH SPAN  
ATIKOKAN R. BR.  
HWY. 622 SITE: 45E112

NOTES: - REMOVE EXISTING  
N. ABUT. RET'G.  
WALL.

ROCK FILLED  
TIMBER CRIB  
(WASH GRANULAR  
MATERIAL INTO  
VOIDS AS ROCK  
FILL IS PLACED)

2:1  
ROCK FILL

ADDITIONAL PROPOSED SPAN

EXISTING N. SPAN

In order to increase the length of the extra span proposed in your memo of January 4<sup>th</sup>, it is suggested that the extra span consist of 2" x 12" laminations with a timber plank deck and asphalt surface. The span could then be lengthened to 18'.

The deck size would not then match with the existing but this could be accommodated by adding to the size of the existing bearing beam. The slope in front of the rock-filled timber crib would then be flatter.

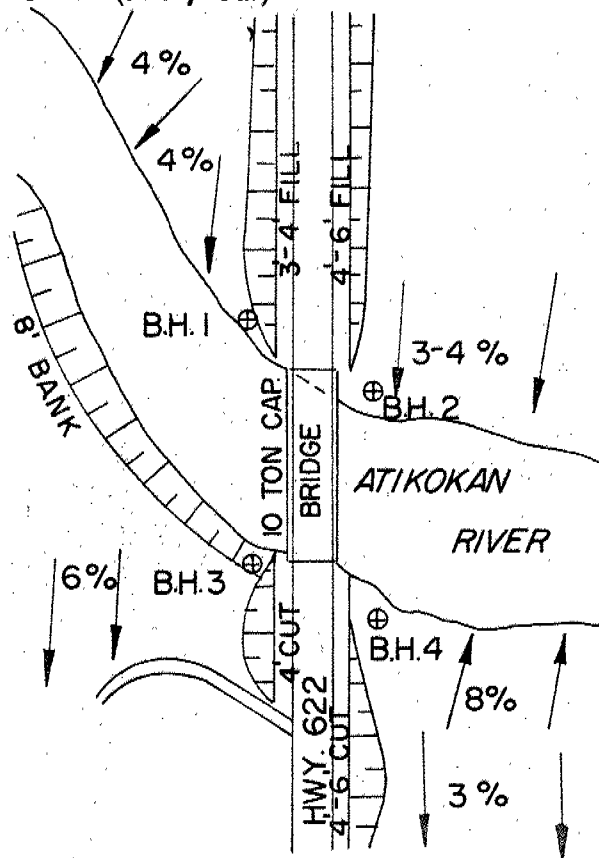
ATIKOKAN - Hwy. 622 - 1000' ± N. Hwy. 11B - December 4, 1972

Borehole No. 1 - 35' from  $\phi$  of Rd (D-6') - North-West Corner of Bridge

0" - 2" Tps  
 2" - 14" Br Si (Frozen)  
 14" - 24" Tps  
 24" - 46" Gr Br Cl Si (Sat)  
 46" - 120" Gr Br VF Si Sa (Sat, Loose @ 46"-84", V Soft @ 84"-108", Loose @ 108"-120")

Borehole No. 2 - 30' from  $\phi$  of Rd (D-8') - North-East Corner of Bridge

0" - 6" Tps  
 6" - 56" Gr Br Cl Si (Sat)  
 56" - 144" Gr Br VF Si Sa (Sat, Loose @ 56"-144")

Borehole No. 3 - 30' from  $\phi$  of Rd (D±0') - South-West Corner of Bridge

0" - 2" Tps  
 2" - 10" Gr Br Cl Si (Frozen)  
 10" - 14" Dk Br Org (Frozen)  
 14" - 48" Gr Br Cl Si (Wet)  
 48" - 154" Rd Br H Cl (Wet, Sat @ 96"-154", Firm @ 48"-120", Soft @ 120"-150", Firm @ 150"-154")

Borehole No. 4 - 35' from  $\phi$  of Rd (D-1') - South-East Corner of Bridge

0" - 1" Tps  
 1" - 26" Gr Br Cl Si (Frozen)  
 26" - 30" Dk Br Org (Wdy)  
 30" - 60" Br Lt Cl (Wet, Firm)  
 60" - 132" Rd Br H Cl (Wet, Firm, Soft & Sat @ 96"-132")  
 132" - 138" Gr Si (Firm, Sat)

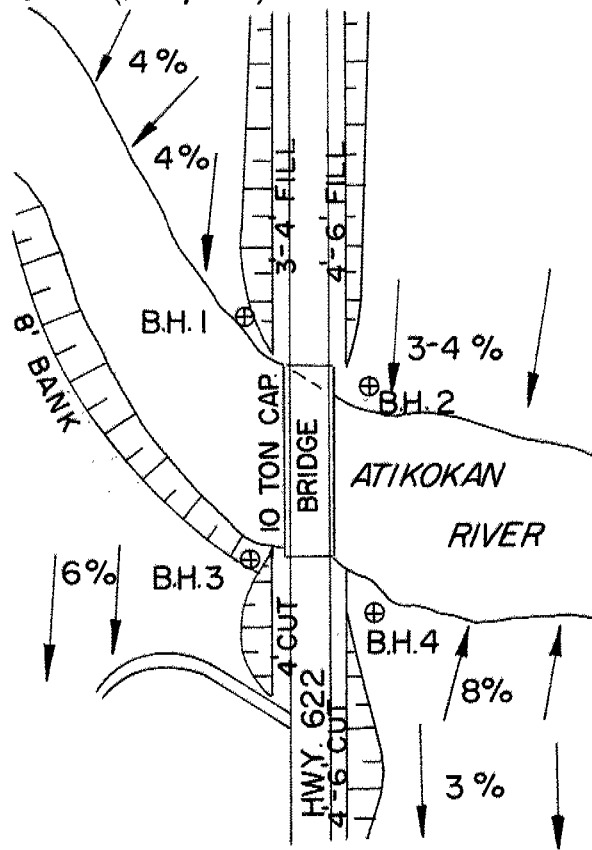
ATIKOKAN - Hwy. 622 - 1000' ± N. Hwy. 11B - December 4, 1972

Borehole No. 1 - 35' from  $\phi$  of Rd (D-6') - North-West Corner of Bridge

0" - 2" Tps  
 2" - 14" Br Si (Frozen)  
 14" - 24" Tps  
 24" - 46" Gr Br Cl Si (Sat)  
 46" - 120" Gr Br VF Si Sa (Sat, Loose @ 46"-84", V Soft @ 84"-108", Loose @ 108"-120")

Borehole No. 2 - 30' from  $\phi$  of Rd (D-8') - North-East Corner of Bridge

0" - 6" Tps  
 6" - 56" Gr Br Cl Si (Sat)  
 56" - 144" Gr Br VF Si Sa (Sat, Loose @ 56"-144")

Borehole No. 3 - 30' from  $\phi$  of Rd (D±0') - South-West Corner of Bridge

0" - 2" Tps  
 2" - 10" Gr Br Cl Si (Frozen)  
 10" - 14" Dk Br Org (Frozen)  
 14" - 48" Gr Br Cl Si (Wet)  
 48" - 154" Rd Br H Cl (Wet, Sat @ 96"-154", Firm @ 48"-120", Soft @ 120"-150", Firm @ 150"-154")

Borehole No. 4 - 35' from  $\phi$  of Rd (D-1') - South-East Corner of Bridge

0" - 1" Tps  
 1" - 26" Gr Br Cl Si (Frozen)  
 26" - 30" Dk Br Org (Wdy)  
 30" - 60" Br Lt Cl (Wet, Firm)  
 60" - 132" Rd Br H Cl (Wet, Firm, Soft & Sat @ 96"-132")  
 132" - 138" Gr Si (Firm, Sat)
