FOUNDATION INVESTIGATION REPORT

Distress of Embankment
Constructed Over An Organic Terrain
From 8.4 Miles to 11.0 Miles West of Raith
W.P. 910-75-01
Hwy. 17 (T.C.H.) District 19, Thunder Bay

FOUNDATION INVESTIGATION REPORT
for
Distress of Embankment
Constructed Over An Organic Terrain
From 8.5 Miles to 11.0 Miles West of Raith
W.P. 910-75-01
Hwy. 17 (T.C.H.) District 19, Thunder Bay

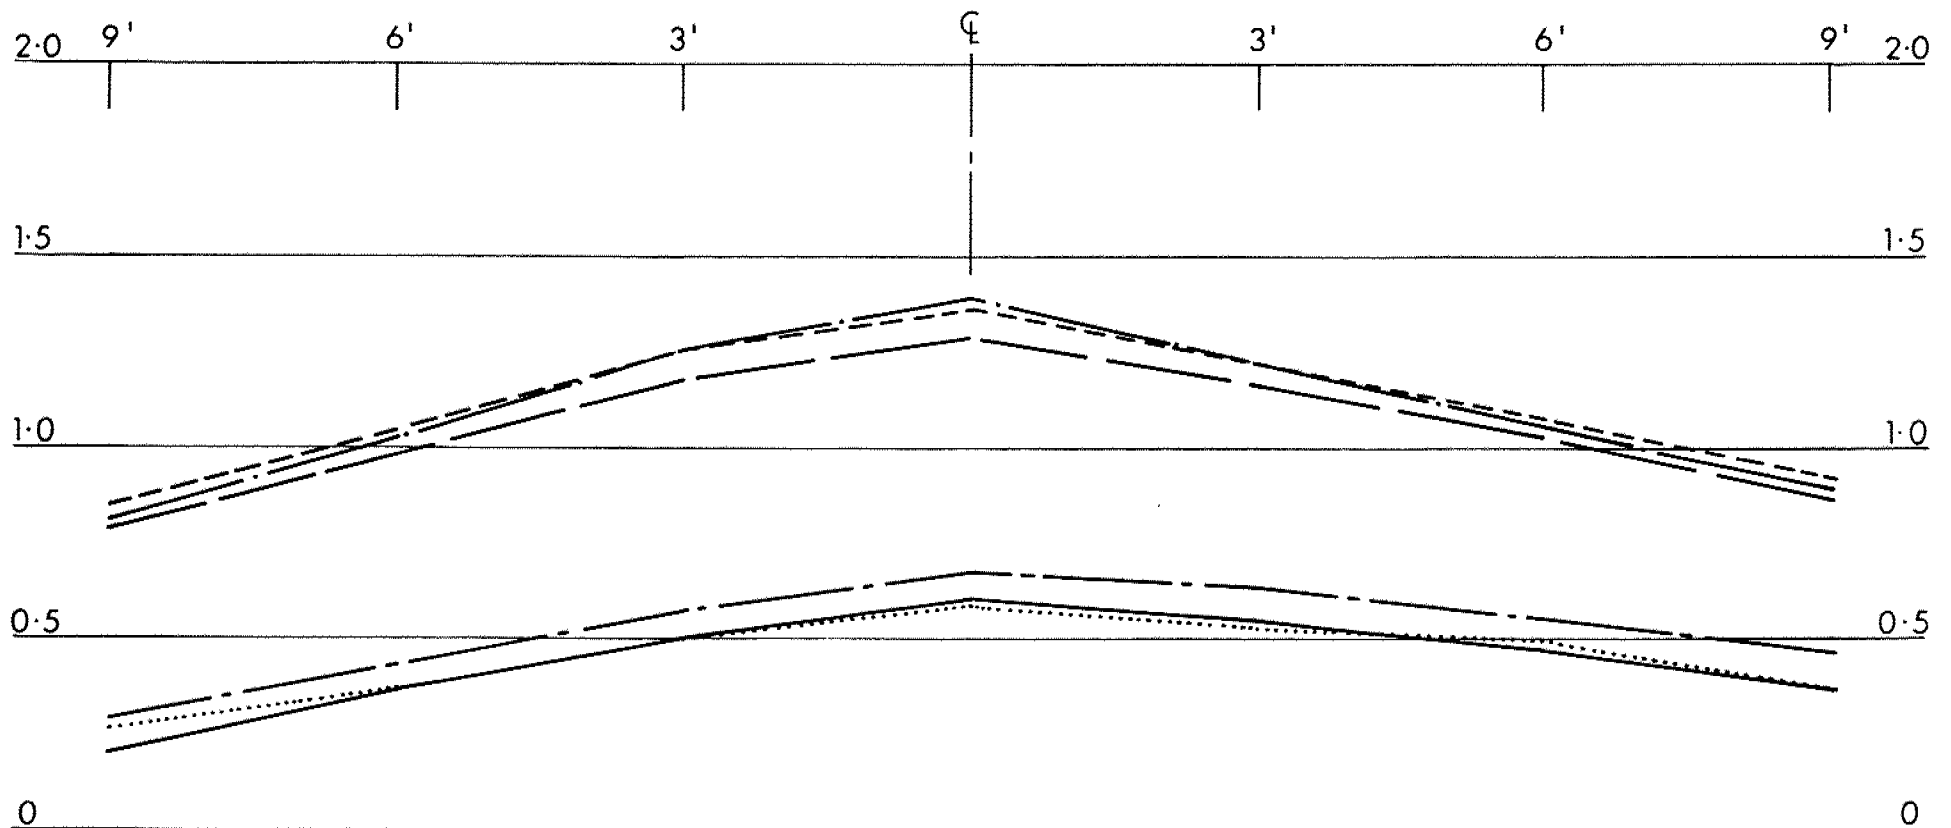
FIG. 10

An examination of the heave data clearly shows that the entire embankment heaves up, with greater heave being recorded at the centre than at the edges. Unfortunately, the data is very scanty, regarding the progression of heave with time. Frost heaving was slightly higher in 1963-64, although 1964-65 was a more severe winter. "Ontario experience shows that repeated freeze-thaw cycles at the beginning of the cold season will produce large heaves." Weather records show that 1963-64 had more such cycles in the initial part of winter.

PAVEMENT HEAVE WITH TIME
(TYPICAL SECTION)

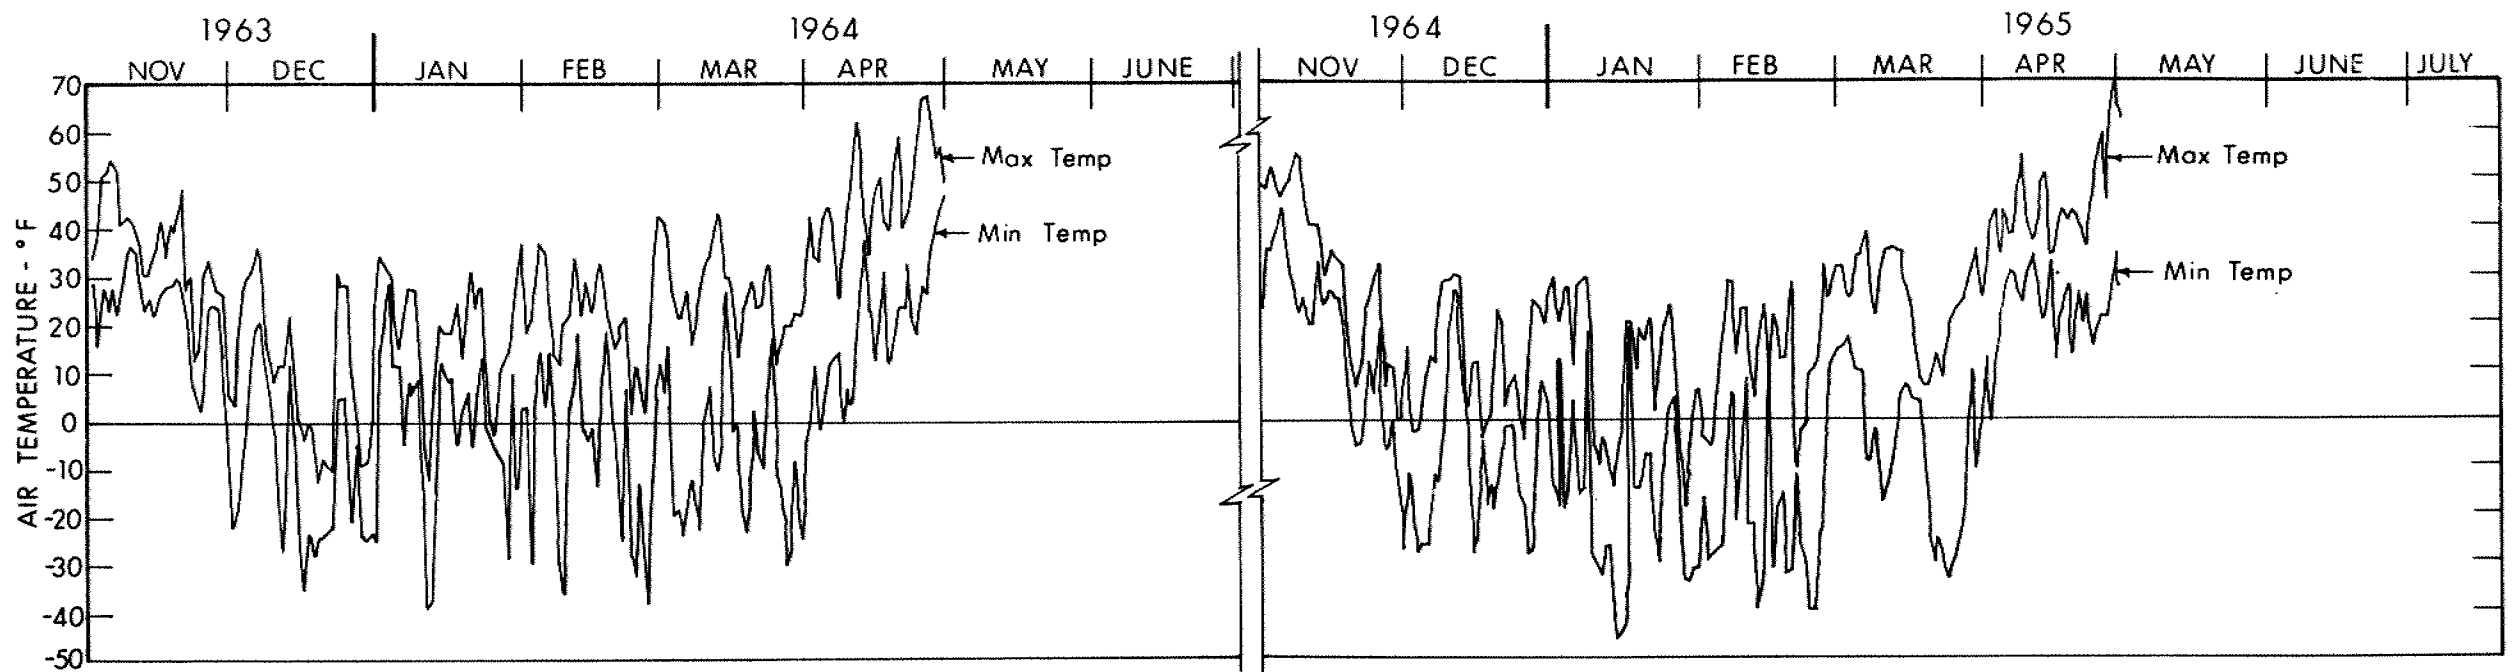
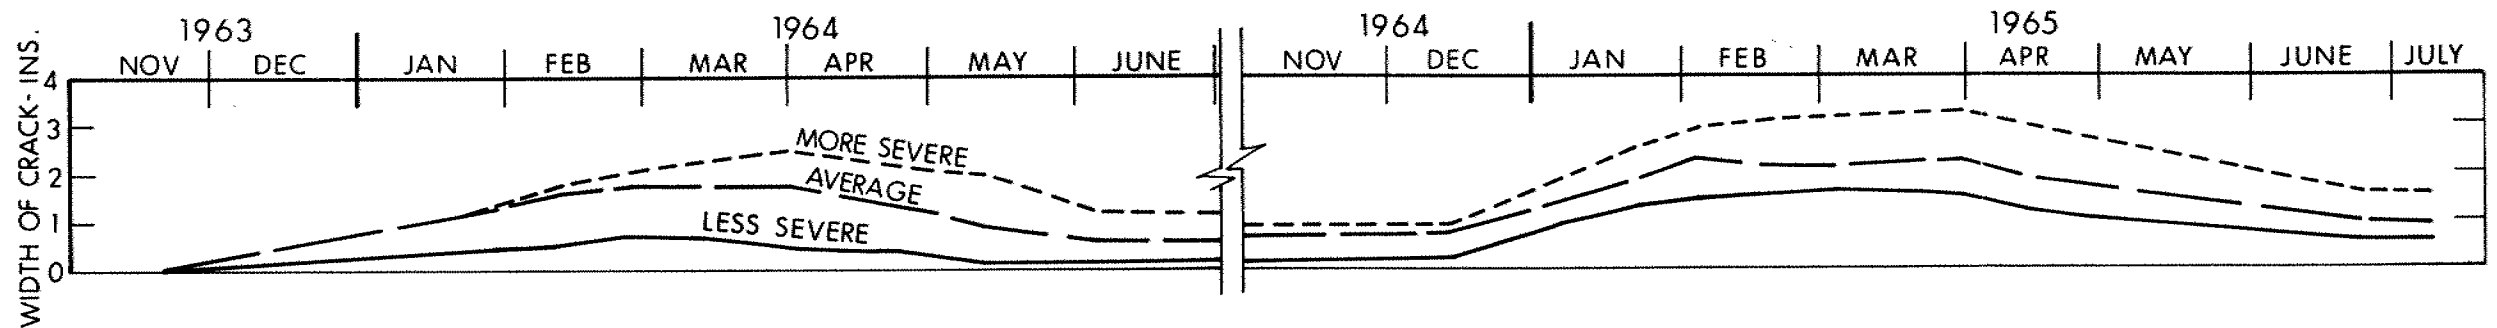
The width of cracks was monitored more frequently. These measurements show that the rate of opening of cracks was more rapid in the early part of winter. This is particularly true for 1964-65 when almost all opening was reached by February 5, 1965. The overall width of the worst crack was in the order of 10 in. but the data shows that during one winter its opening increased by about 3 in. In the monitored section the average increase in the opening of the cracks was about 2 in. (Fig. 11).

WIDTH OF CRACK vs TIME

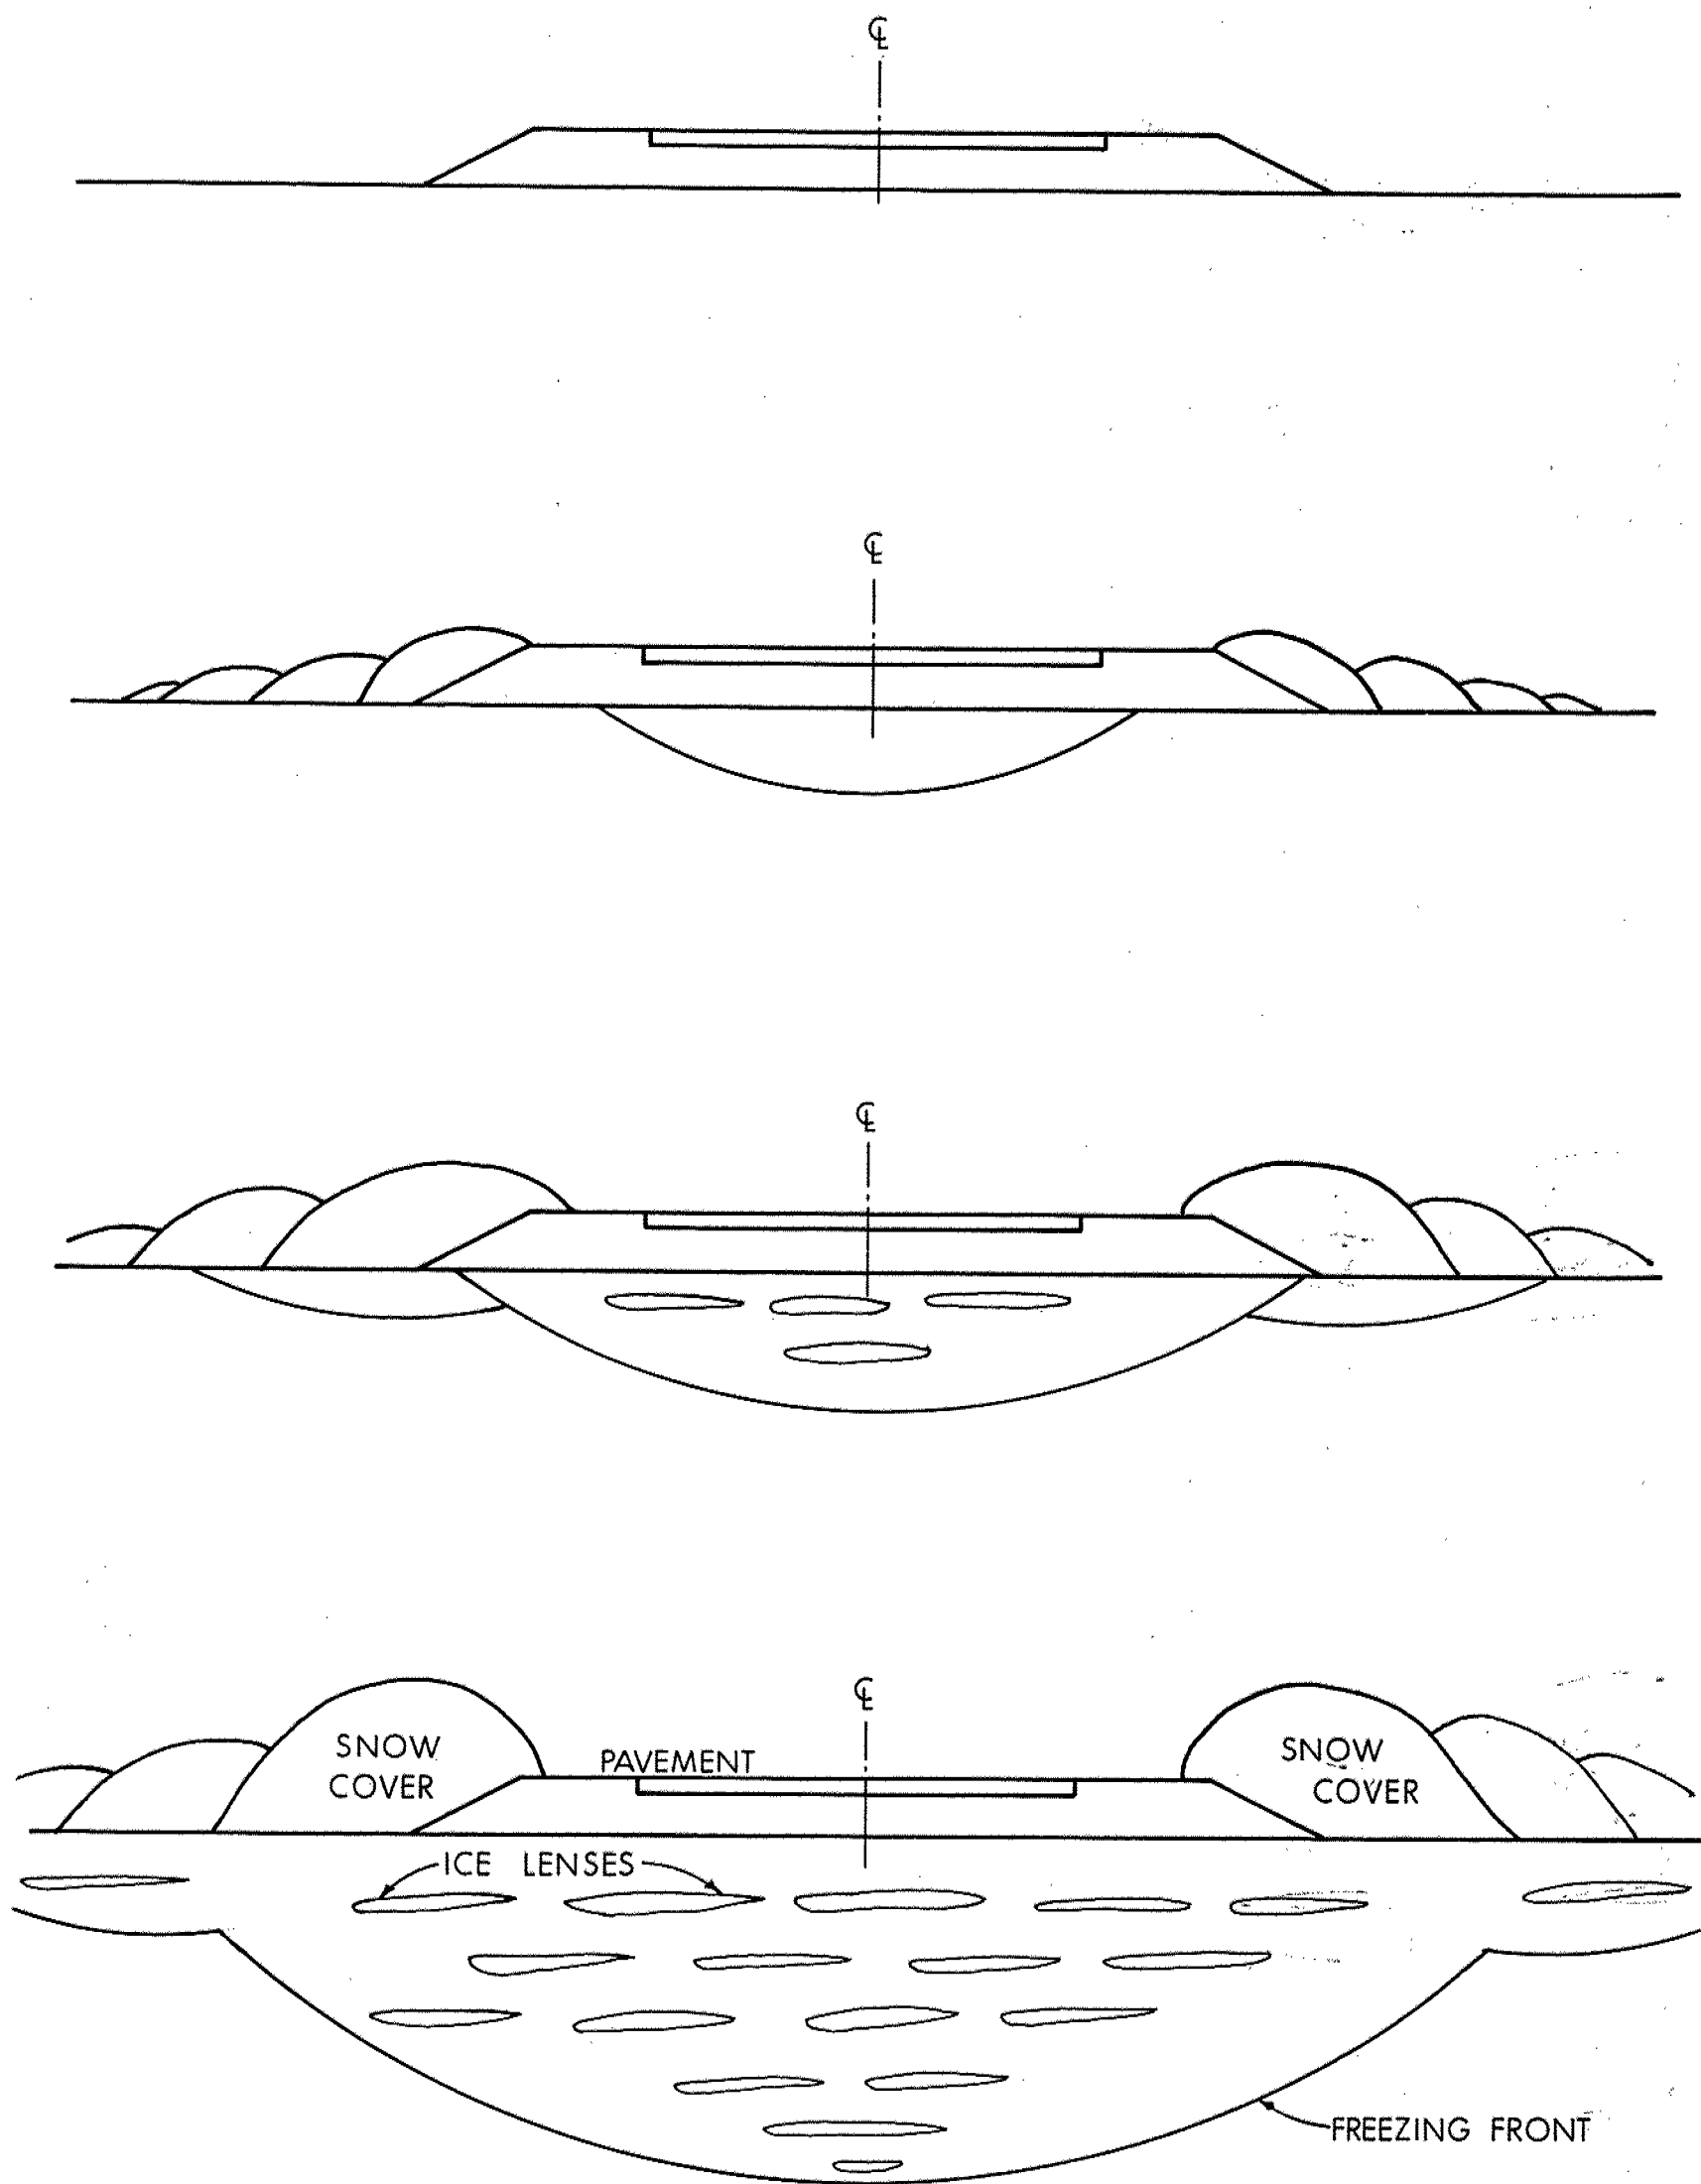
A frost heave that is greater at the centre of the road than on the sides, may cause bending and tensile stresses in the road structure and result in cracking. If the roadway structure consists of coarse grained material, it does not retain any water in the pores and therefore, lacks adequate tensile strength in

MECHANISM OF DIFFERENTIAL FROST HEAVE

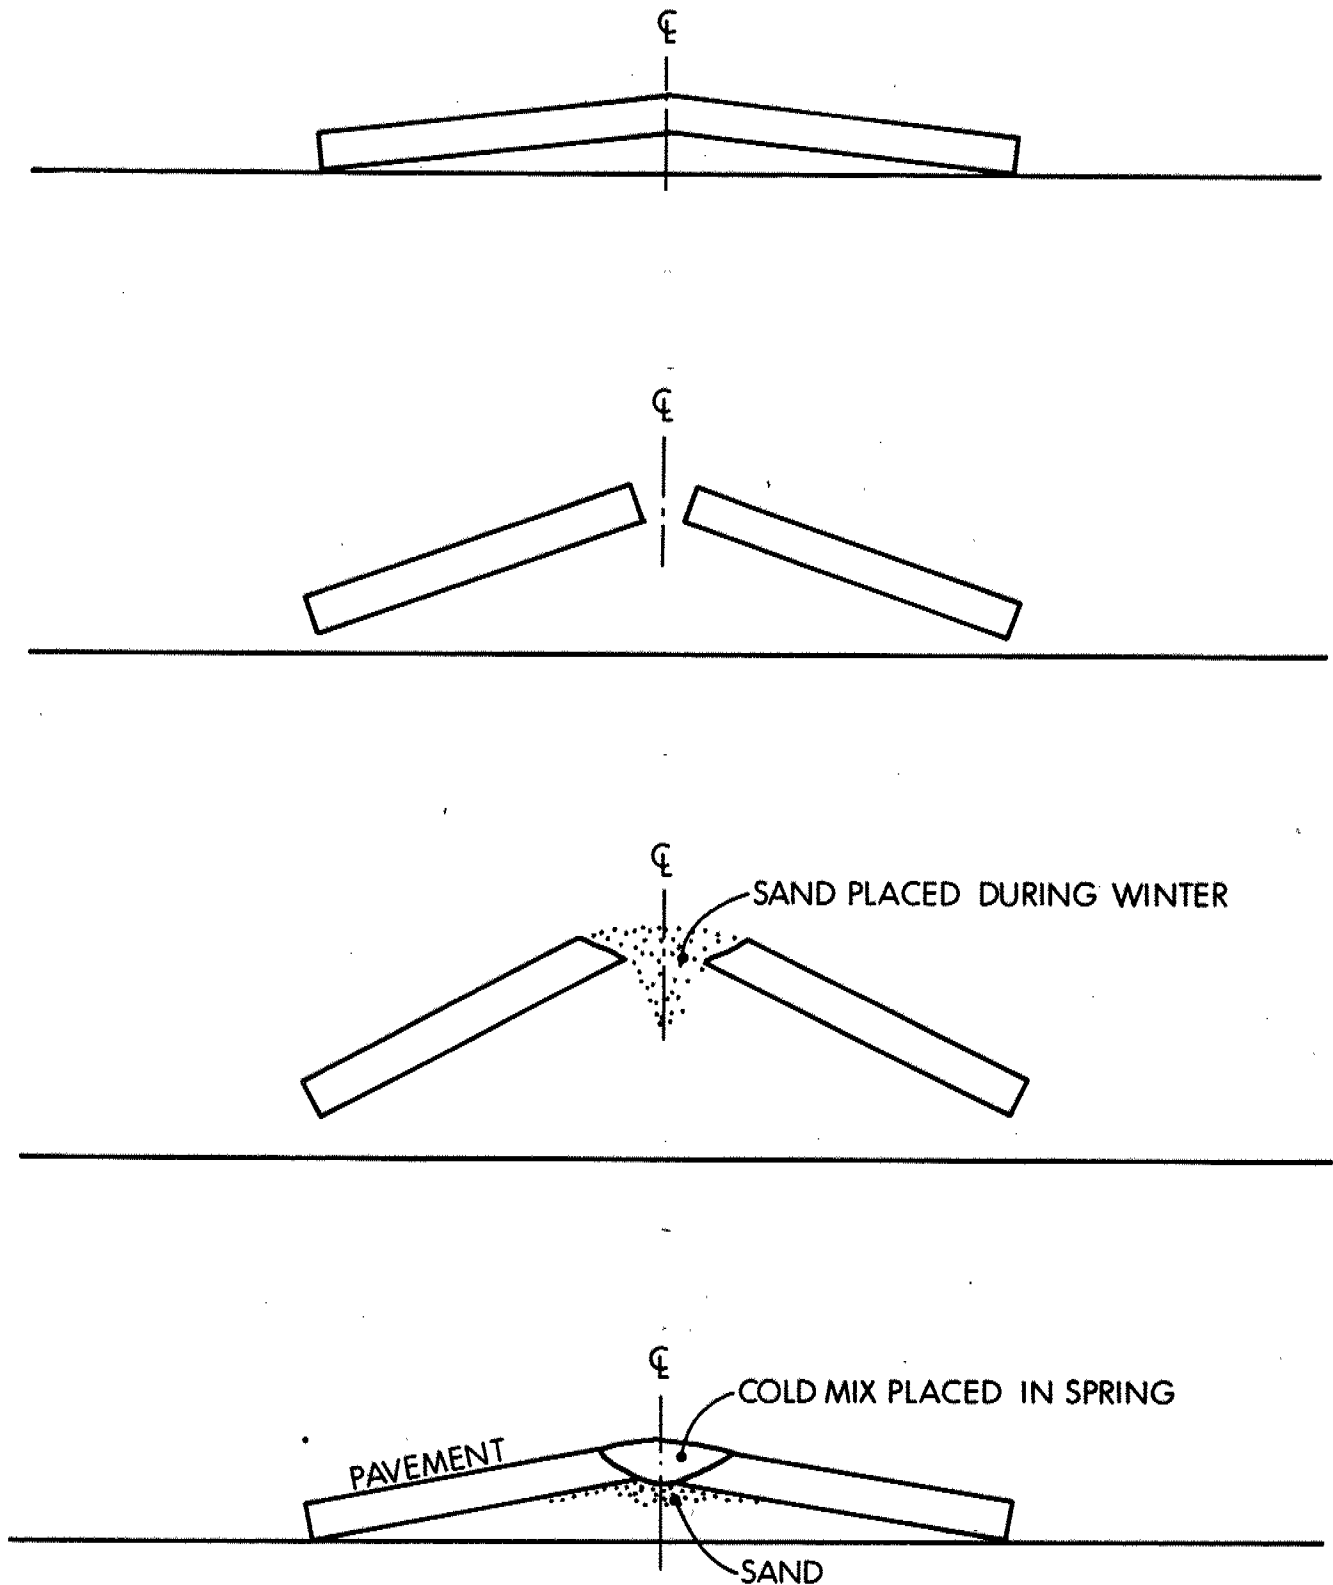
During the winter, cold mix or patch filler which was placed in the preceding spring becomes loose due to the shrinkage of pavement and frost heave that is greater at the centre than at the edges.

This is then gradually removed by the traffic or snow plough. Edges of cracks are chipped by the traffic or snow plough,

contributing to the widening of the cracks. Sand used for filling the cracks in the winter prevents the cracks to return to their initial position in the spring. The present width of cracks is the sum of the cumulative effect of the above process over a period of many years and does not reflect the damage done during a single winter. (Fig. 13)

PROCESS OF WIDENING OF LONGITUDINAL CRACK

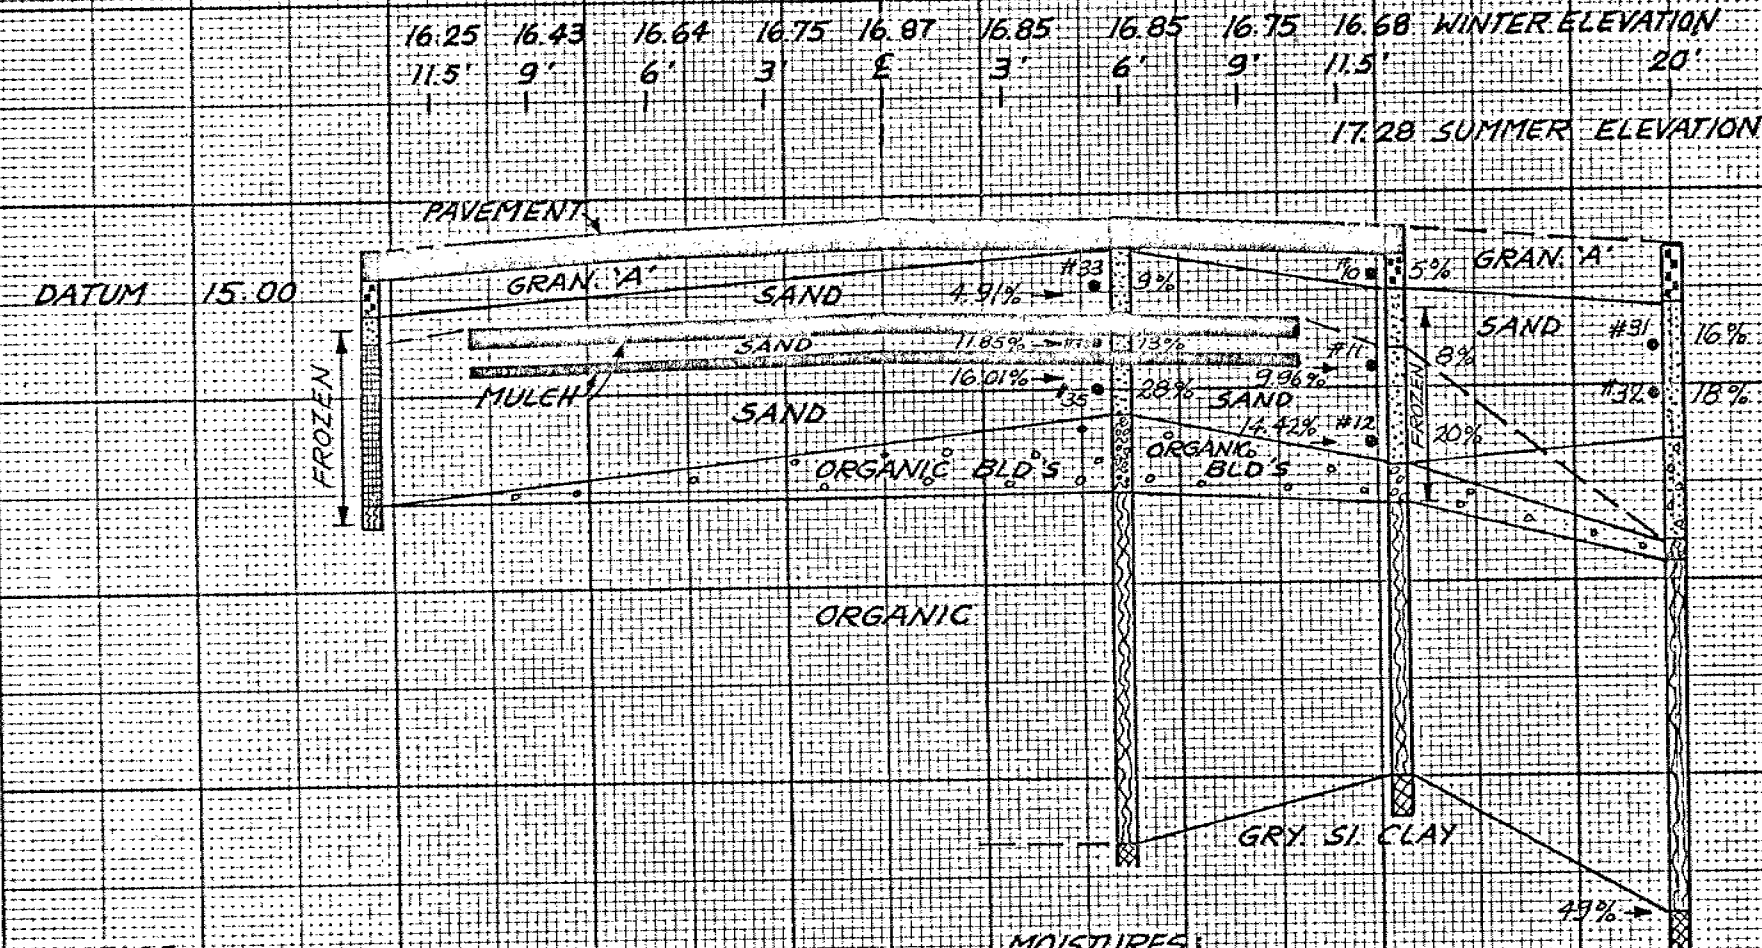
NO LONGITUDINAL CRACKING
SAMPLE SECTION
STA 1364+78

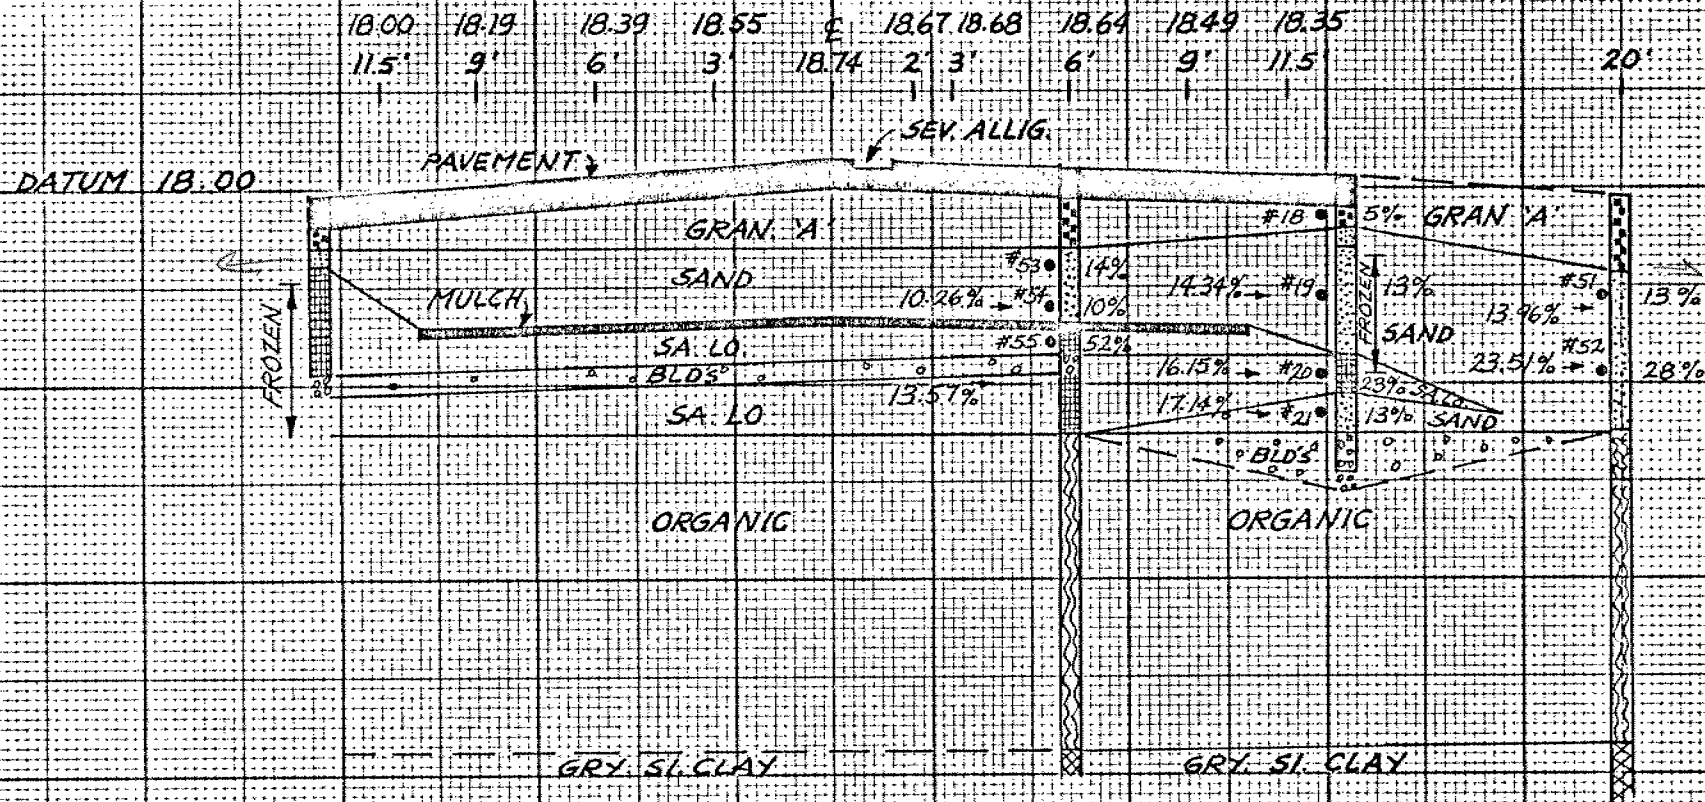
STA. 1389+00

SEVERE LONGITUDINAL CRACKING SAMPLE SECTION (3)
