foundation investigation and design report

Road Distortion Problems
5.8 km East of Kashabowie River

FOUNDATION INVESTIGATION REPORT
For
Road Distortion Problems
Highway 11
5.8 km East of Kashabowie River
District #19, Thunder Bay
Cont. 79-38

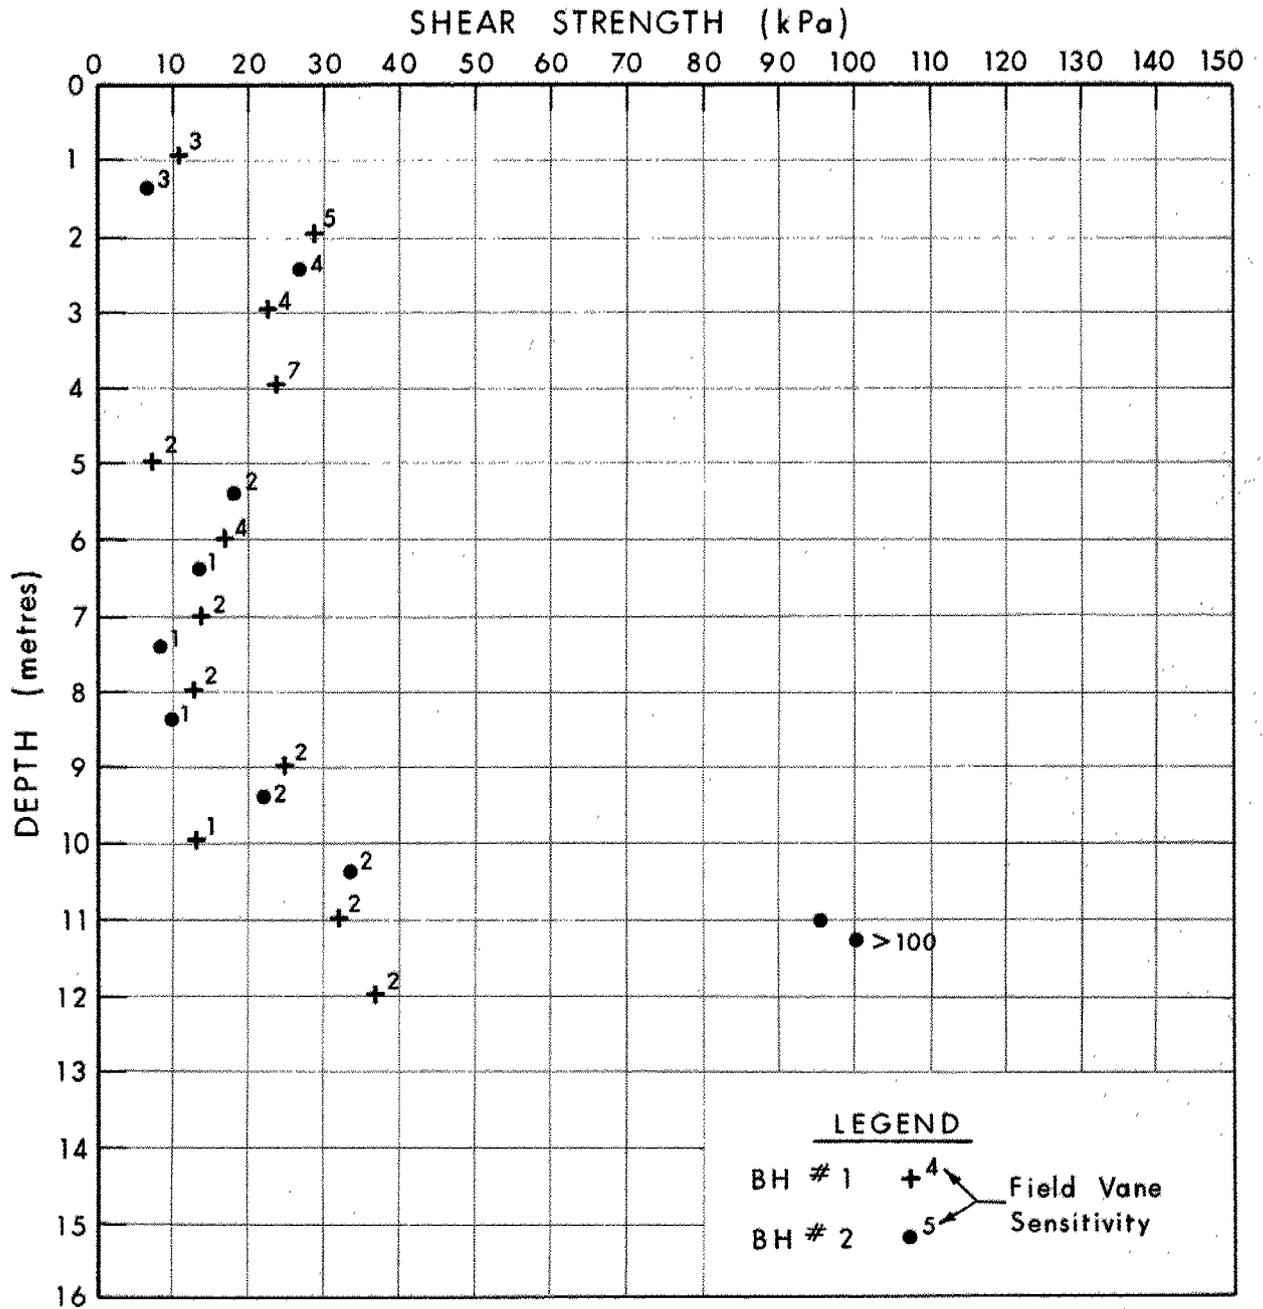
FIG No 1

The subsoils in this area consist of 2.5 to 7 m of muskeg underlain by clay investigated to a maximum depth of 11.5 m. Field vane tests completed north and south of the embankment indicate the material to generally vary from very soft to firm, becoming very stiff at the bottom of one vane hole. The consistency was assessed using field vane shear strength values ranging from 7 to 35 kPa generally, with one reading greater than 100 kPa obtained at the bottom of borehole 2. The shear strength values are shown graphically on Fig. 1.

UNDRAINED SHEAR STRENGTH VS DEPTH
