Remedial Works For
"Highway 622 Dams"

FOUNDATION INVESTIGATION REPORT

W. O. 85-6-3003

District #19, Thunder Bay (Atikokan)

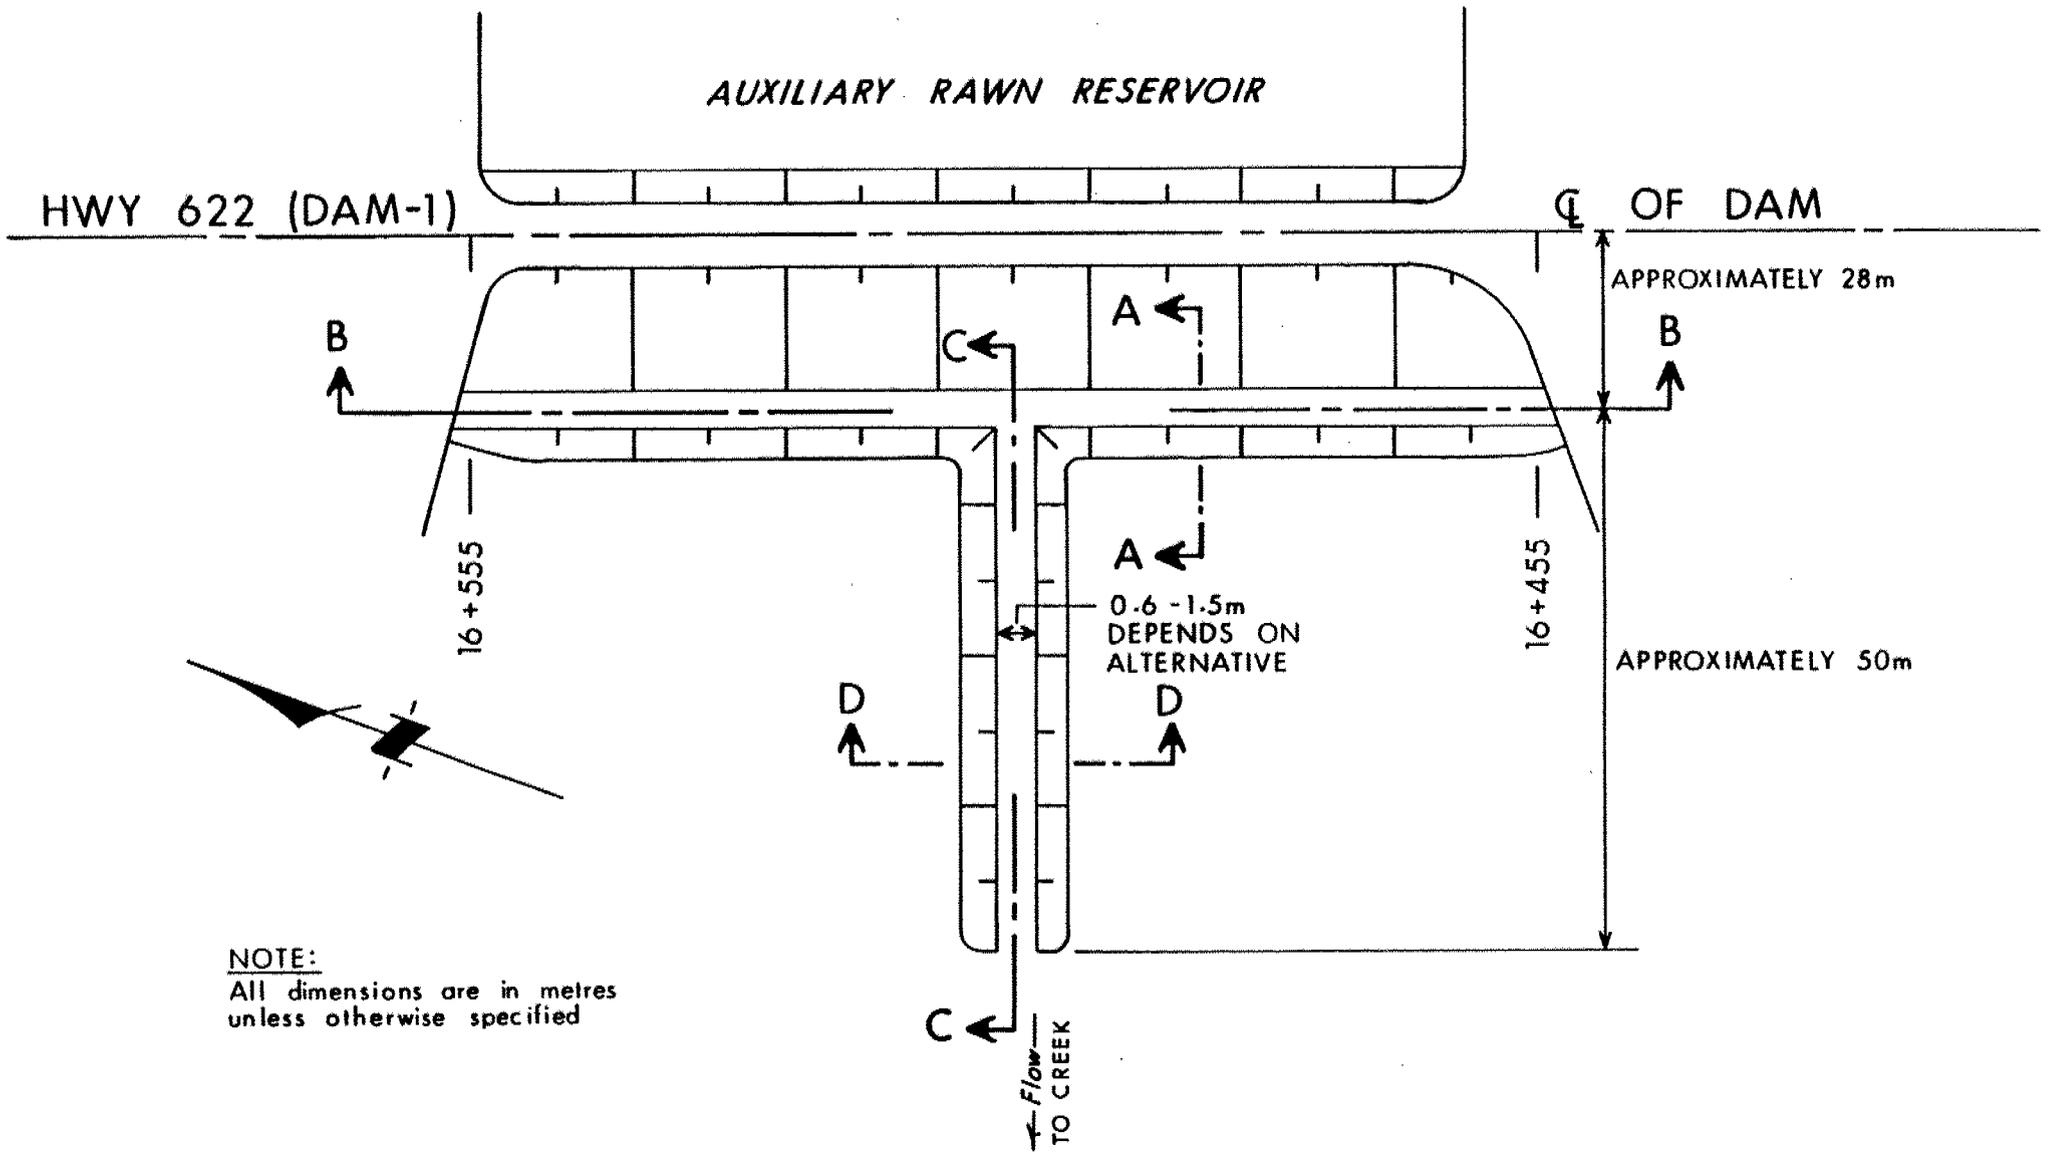
Fig 11

The seepage was observed at the toe of Dam No. 1 nearer the south abutment. The quantity of seepage was measured to be about 13 imperial gallons per minute. However, taking into account some amount of seepage by passing, the actual quantity of seepage is probably estimated to be about 30 imperial gallons per minute. The seepage from the toe of the dam forms a small stream as previously mentioned. It should be noted that if some remedial measures are not taken, seepage at the Dam No. 1 could lead to piping and would cause washout and failure of the dam.

It is therefore recommended that for the Alternative #1 (natural filter system), select filter material be placed against the downstream toe of the dam and within the drainage trench between select drain material and foundation soil. The details of this filter system are presented on the schematic drawings (Plans and Sections, see Figures 11 to 15).

A minimum 0.3 m (1 ft.) of select filter material should be placed beneath the select drain. It should be noted that since the depth of frost penetration is estimated to be about 2.4 m at the Atikokan area, frost protection material be placed over the filter system in order to prevent the drainage system from freezing. A minimum 15 cm of suitable earth cover should be placed over the frost protection for future vegetation. The construction details are shown on Figures 11 to 15.

It is therefore recommended that for the Alternative #2, a smaller size trench (0.6 m in width) be excavated, then filter fabric (Class I, non-woven) be placed against the trench, and select drain material be placed within the filter fabric. The details of this filter system are presented on the schematic drawings (Figures 11 to 15).

As shown on the above drawings, a perforated drain pipe should be surrounded with select drain material and be wrapped with a 350 μ m opening size of filter fabric to prevent the finer material from migration. A minimum 0.3 m (1 ft.) of select filter material should be placed beneath the select drain. Frost protection material should be also placed over the filter system. A minimum 15 cm of suitable earth cover should be placed over the frost protection for future vegetation. The construction details are shown on Figures 11 to 15.

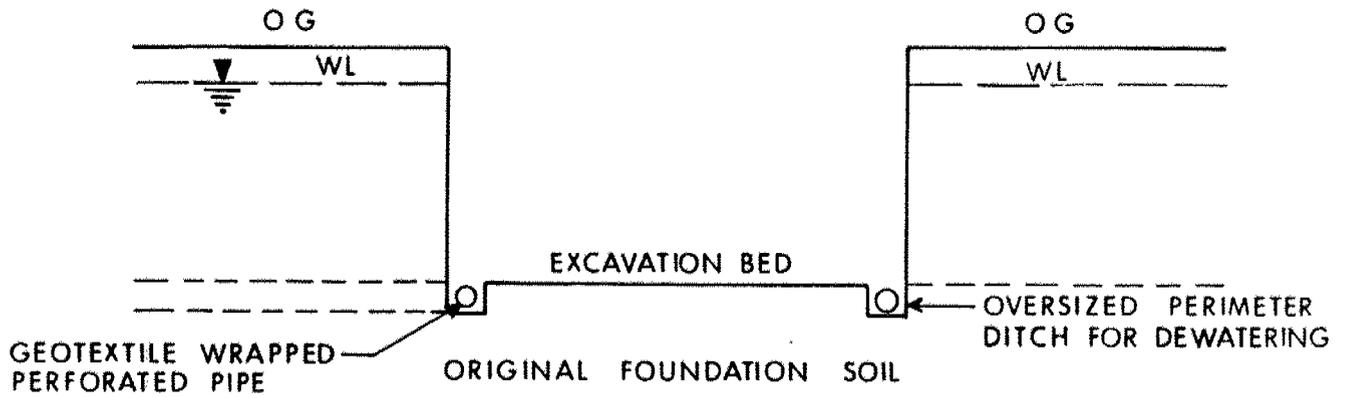
FIG No 16

The filter system should be placed "In The Dry". However, since the fill and foundation materials are a granular deposit and the water table is at or immediately below the existing ground surface, it will be necessary to prevent the base of the excavation from boiling due to an unbalanced excess hydrostatic head.

As mentioned above, a trench will be excavated through a granular deposit. If a steel sheet piling method is not used, the excavation wall could not stand for a long period of time. It is therefore recommended that a stage excavation and filling method be adopted for the installation of a filter system. It is our opinion that 5-6 m of excavation and backfill at a time would be appropriate. It should be noted that if filter fabric is used for the filter system, it

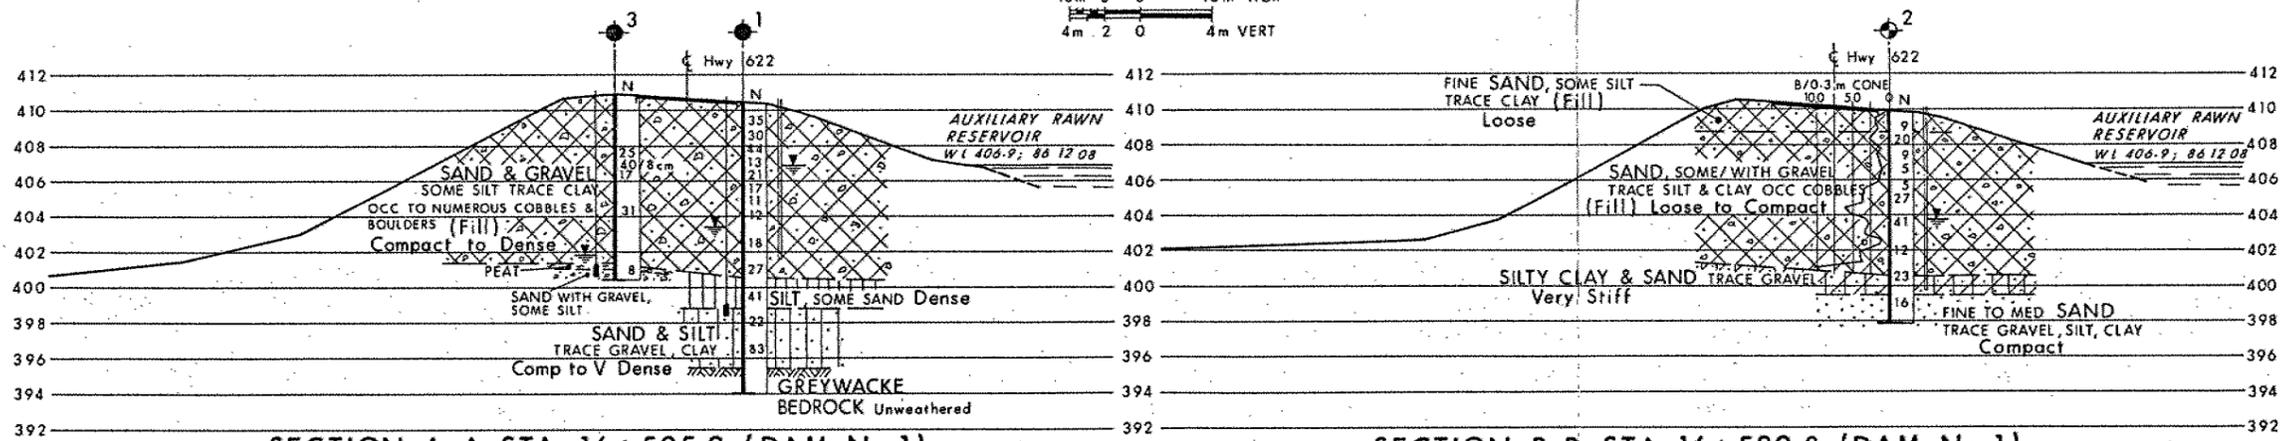
SECTION A-A STA 16+505.2 (DAM No 1)

It should be also noted that based on the observed water level in Borehole #1, the water levels recorded in the piezometer installed within the dam foundation demonstrated the existence of a downward hydraulic gradient within the foundation soil. This lower water level appears to indicate that no artesian pressure exists within the foundation soil of the dams. Furthermore, if a downward hydraulic gradient truly existed, the groundwater would have moved downward and outward towards the toe of Dam No. 1 not only through the dam, but also through the foundation.

materials as shown on the stratigraphical section (Borehole No.1). These downward hydraulic gradients suggest that the sand and silt foundation soils are acting as an effective underdrain for the dam section.
