**FOUNDATION INVESTIGATION AND REMEDIATION DESIGN
FOR FAILED EMBANKMENT
HIGHWAY 17 FROM STATION 12+100 TO 12+400
TOWNSHIP OF BOYS
WEST OF KENORA
Geocres No.: 52E-50
AGREEMENT NO.: 6005-A-000167**

**July 17, 2007
GS-TB-007607**

**Prepared For:
Ministry of Transportation
615 S. James Street
Thunder Bay, Ontario P7E 6P6**

Foundation Investigation and Remediation Proposal for Failed Road Embankment

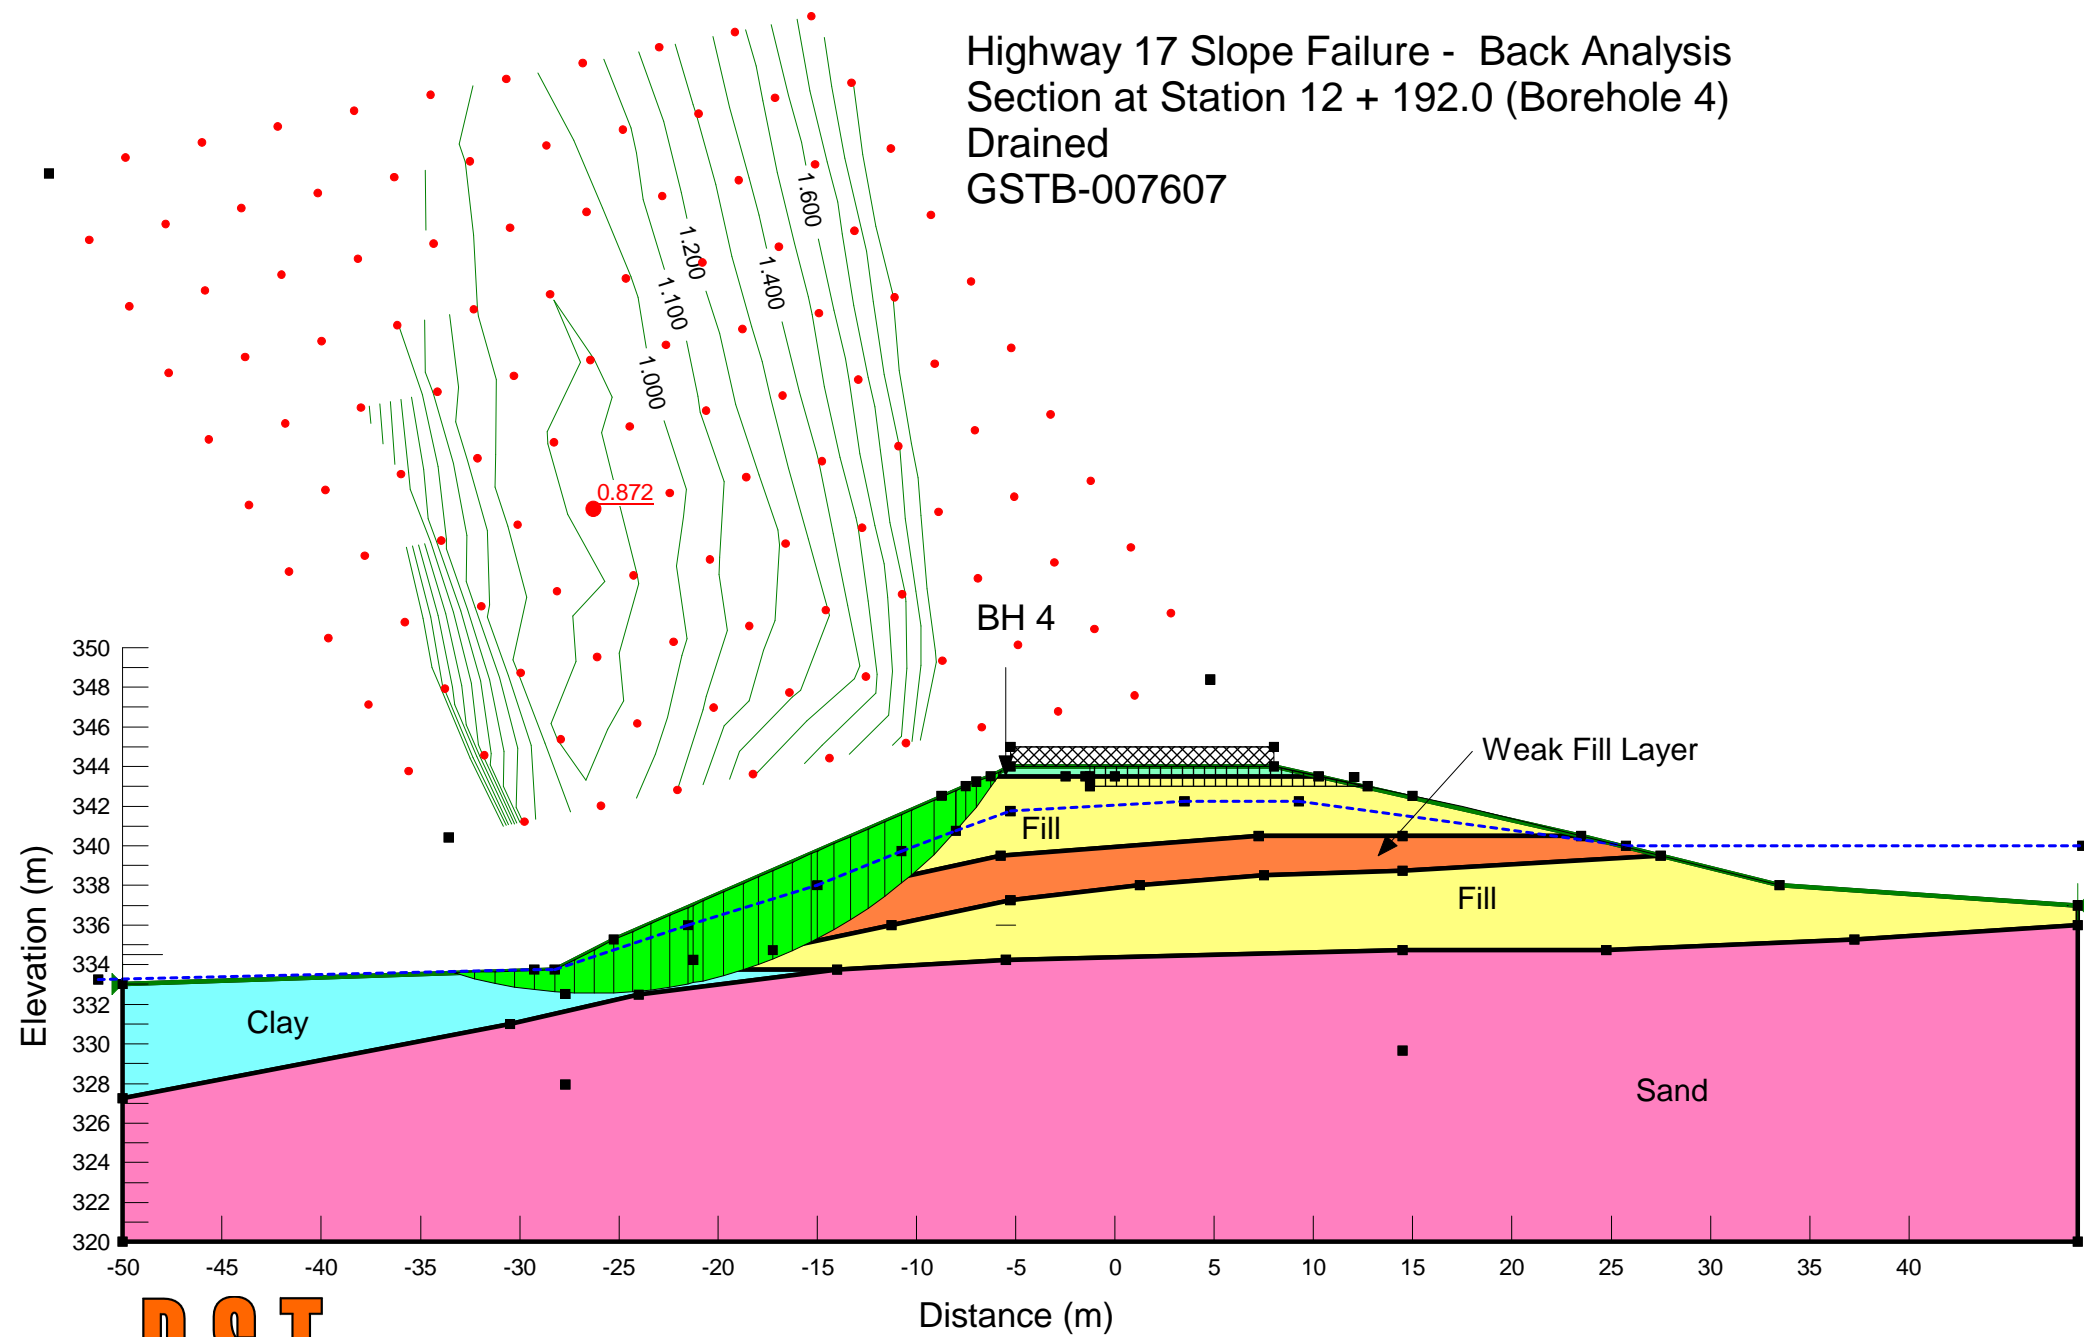
Highway 17 Slope Failure - Back Analysis
Section at Station 12 + 192.0 (Borehole 4)
Drained
GSTB-007607

The analyses found, however, that the embankment would fail if the groundwater level rises 6 m above the present level within the embankment. Both drained and undrained conditions were applied to the clay for this case. The geometry of the failure slip is mainly in the fill material and very

Reference Section	Groundwater Condition	FOS		Remarks
		Undrained In Clay	All Drained Parameters	
BH4	With measured level	1.36	1.23	
BH4	With high GW within the embankment	0.99	0.87	See Enclosures 19 and 20
BH5	With measured level	1.34	1.48	
BH5	With high GW within the embankment	1.07	0.97	See Enclosures 21 and 22

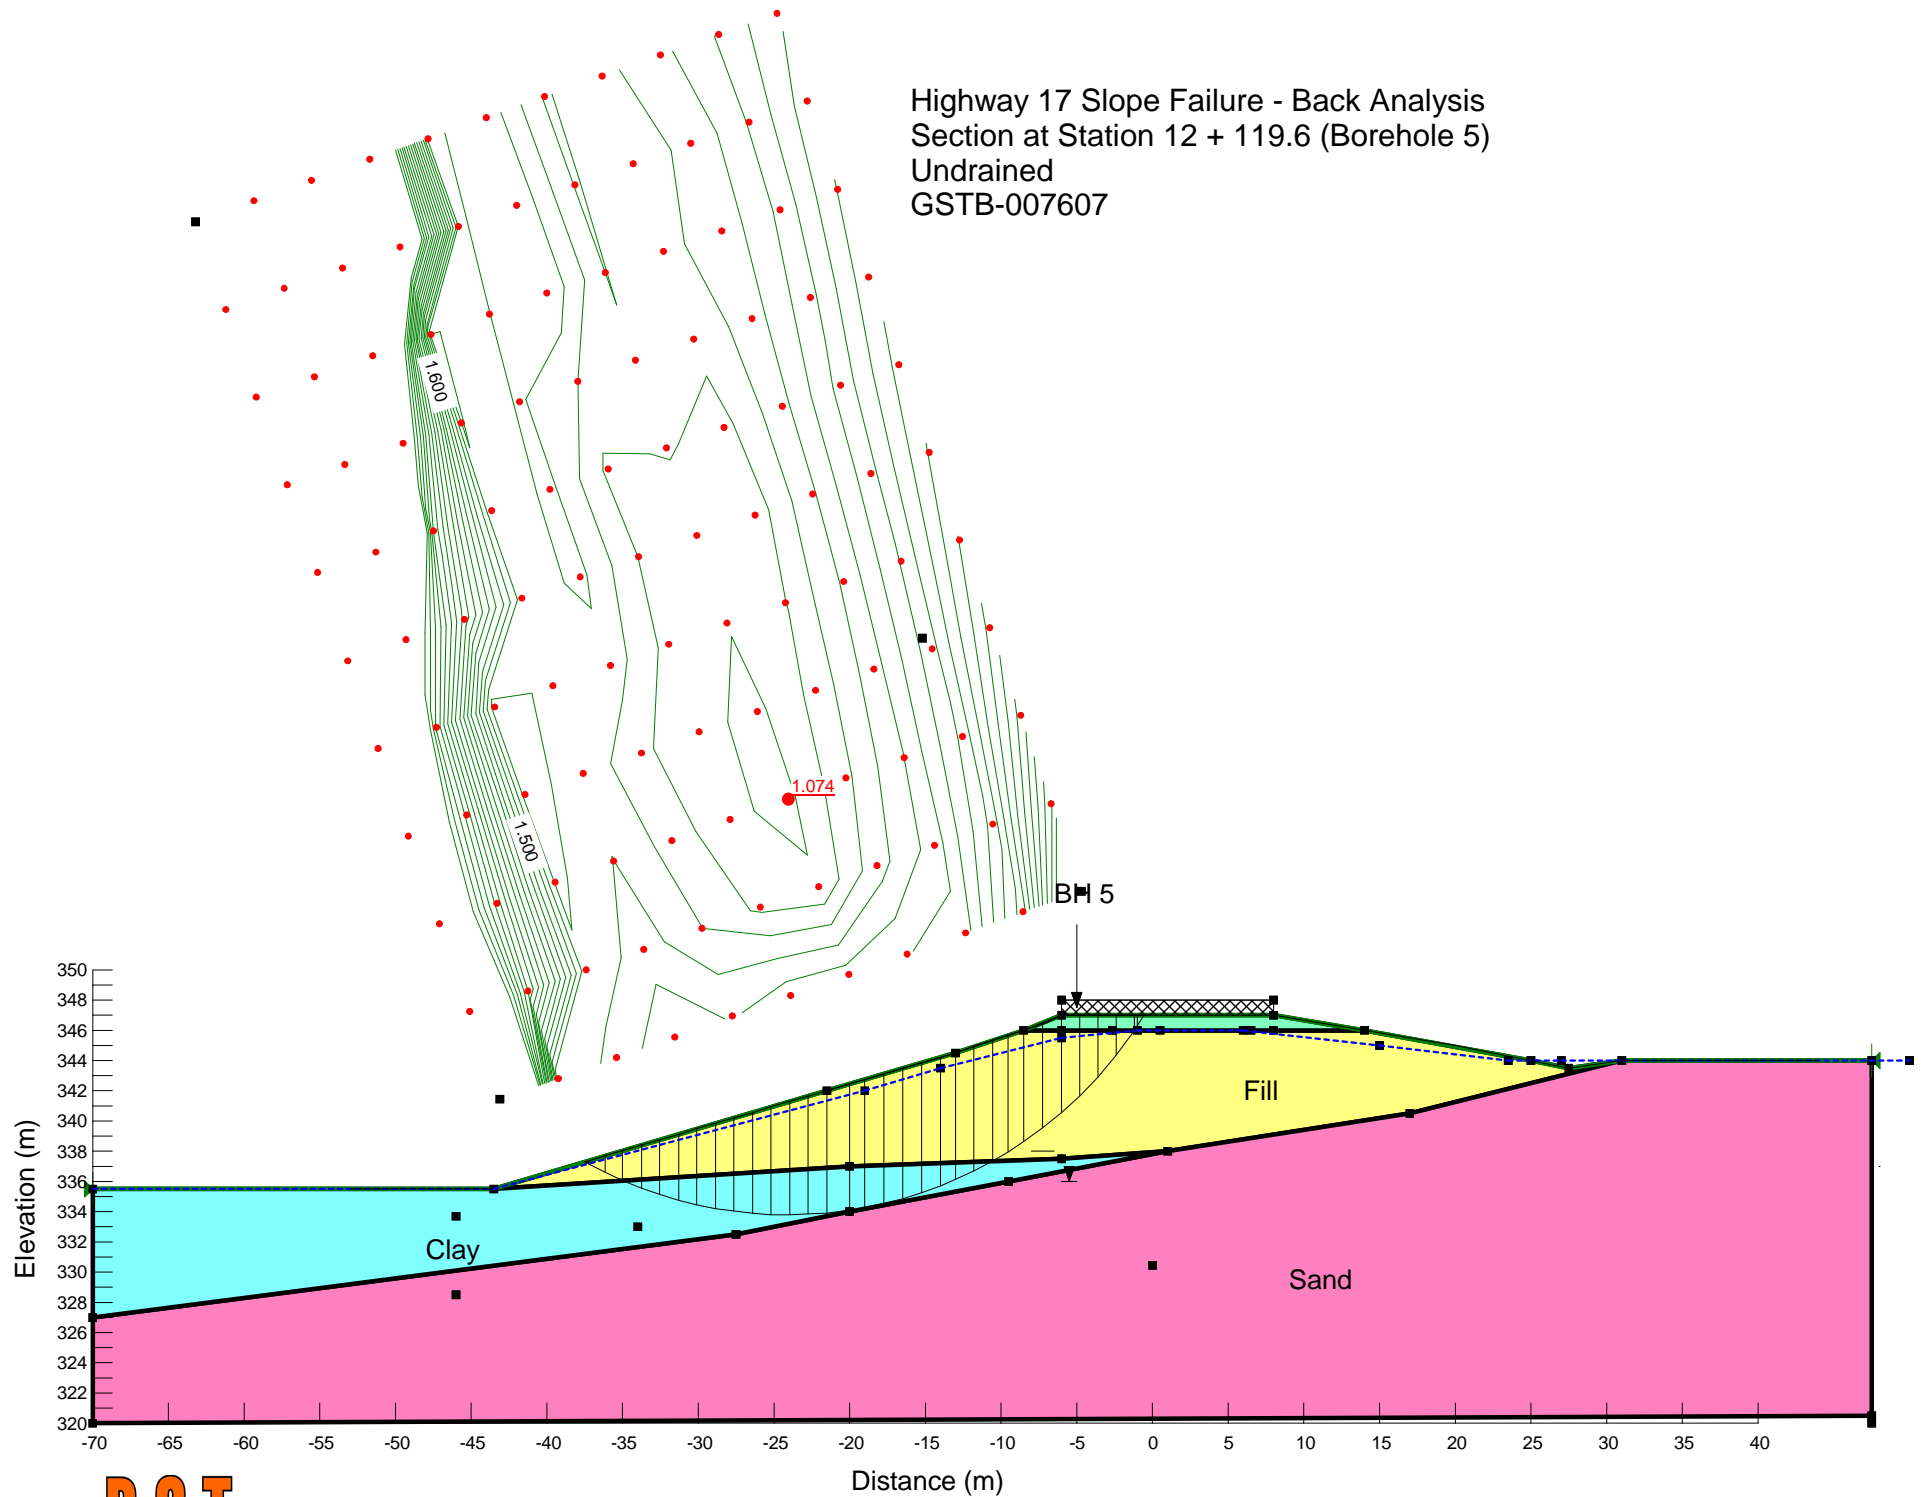
Highway 17 Slope Failure - Back Analysis
Section at Station 12 + 119.6 (Borehole 5)
Undrained
GSTB-007607

Analyses were also repeated for the smaller failure area at the BH 5 location using geotechnical parameters from the back analysis at BH 4.

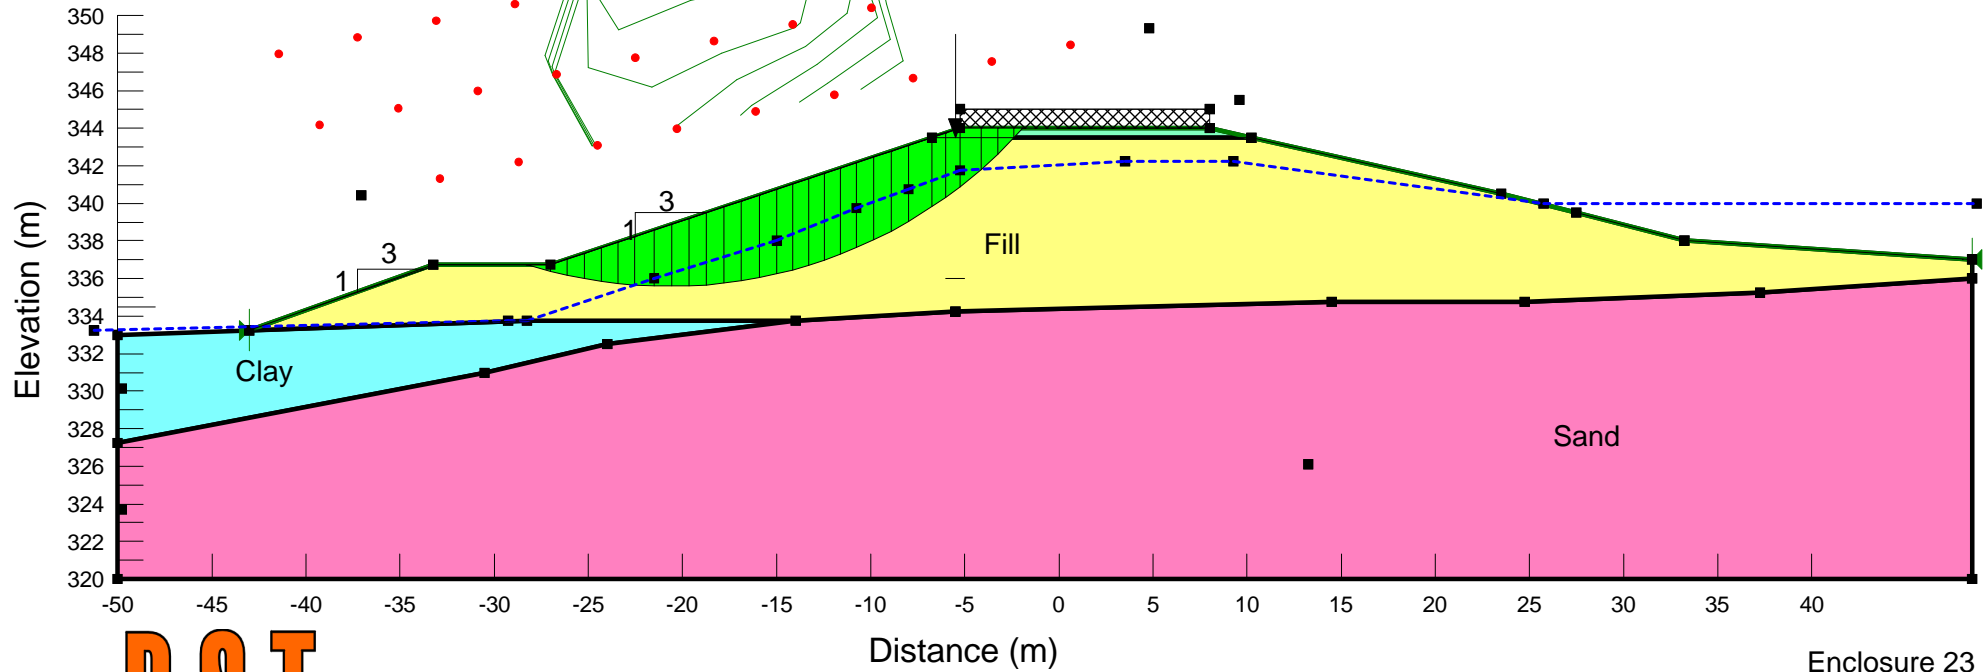
Highway 17 Slope Failure - Stabilization Option - 3.0:1.0
Section at Station 12 + 190.0 (Borehole 4)
Drained
GSTB-007607

Analyses were carried out assuming a 3h to 1v re-constructed slope with no counter berm and a lowered water table within the embankment. This configuration was found to be adequate (FOS > 1.5) when the water table at the centerline is at the level of the south toe. To achieve this level, the water table would need to be lowered. There is, however, insufficient subsurface information for the detailed design of drainage measures to achieve this.

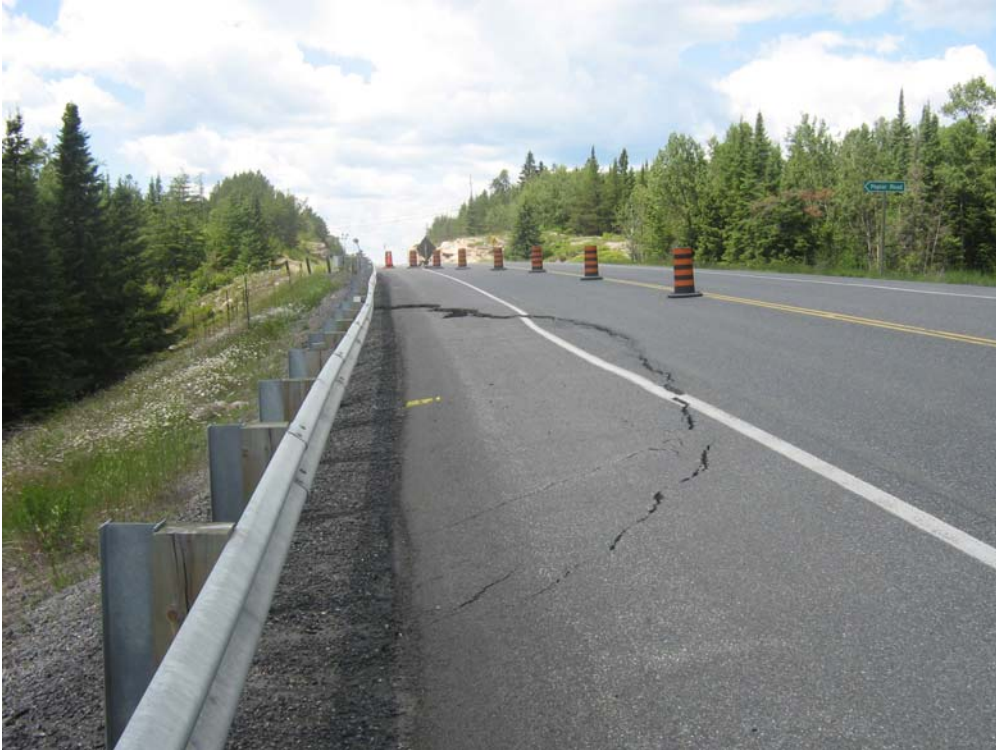
Figure 1. Tension crack along small slip

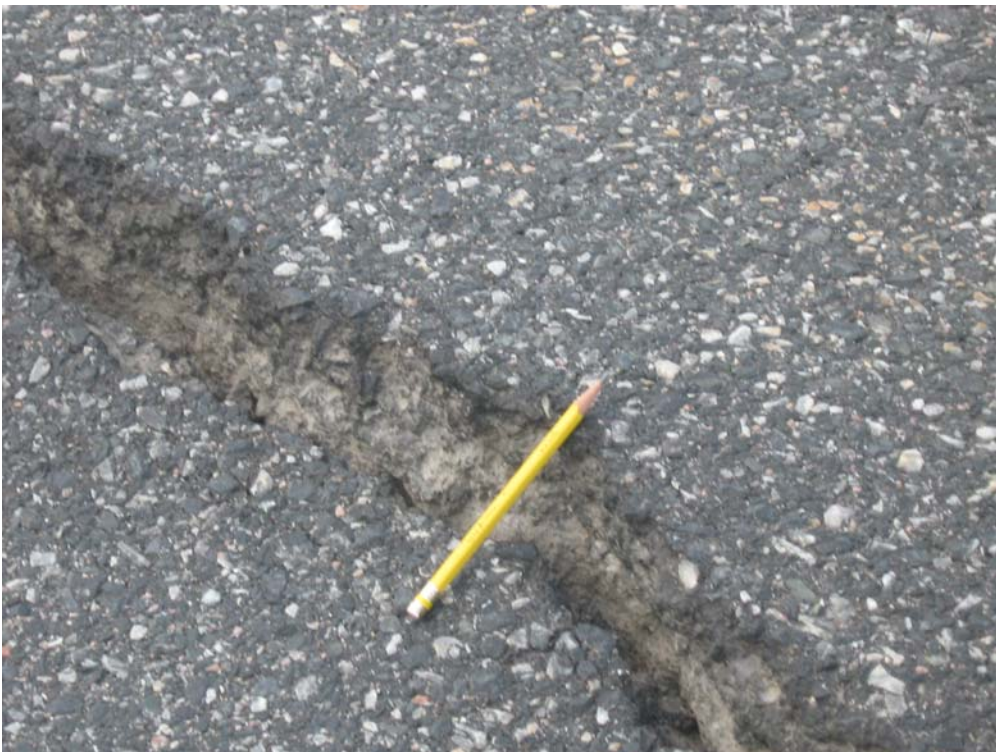
Figure 2. Relative width and depth of tension crack
