ENGINEERING MATERIALS OFFICE
FOUNDATION DESIGN SECTION

WO 94-11015 DIST 19
HWY Local Road STR SITE -

River Bank Failure - Polly Lake Local Road

Re: WO 94-11015, River Bank Failure - Polly Lake Local Road
From south side of Polly Lake Road approximately 1.0 Km west of Highway
11 and 14.3 Km north of junction Hwy 11/Hwy 17, Nipigon

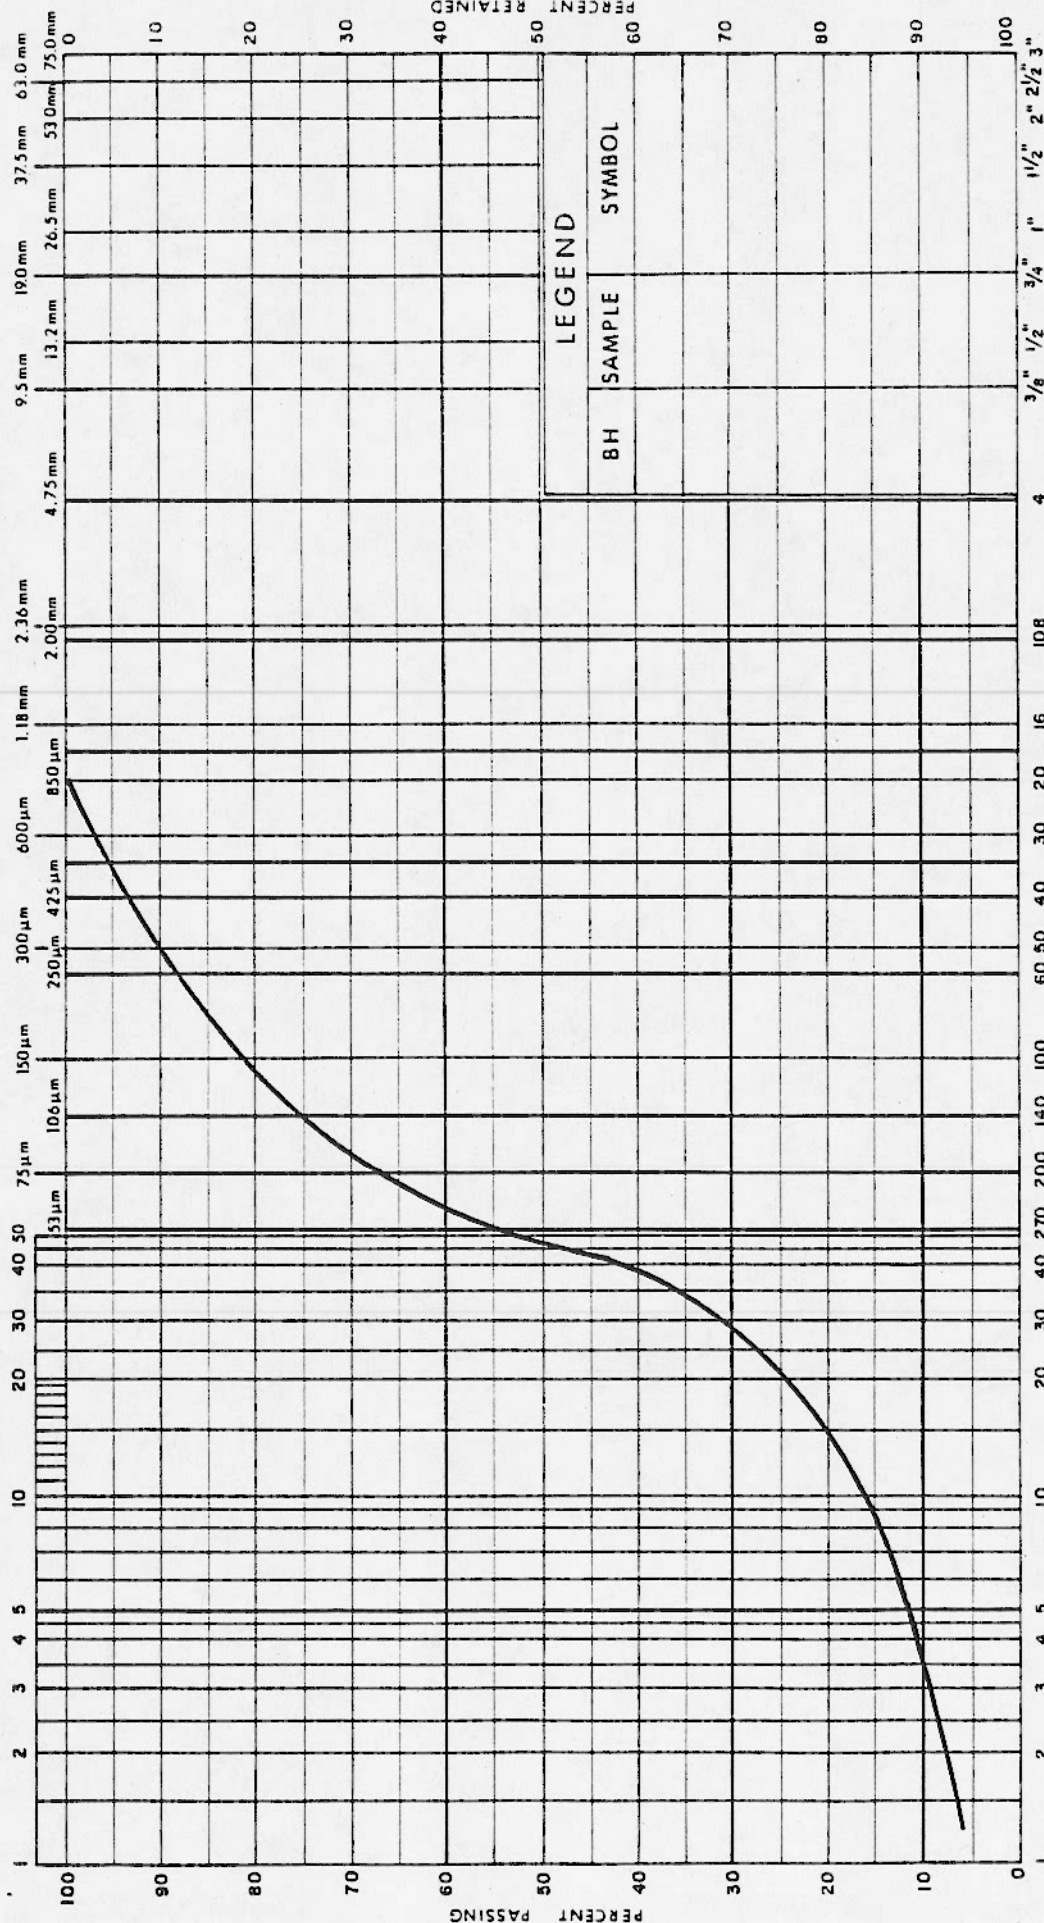
FIG No 1

The subsurface conditions are believed to be generally uniform. Based on the subsoil stratigraphy found within the area, the river bank is believed to consist of a Silty Sand. Test borings conducted at the toe of the embankment by the Regional Geotechnical Office confirmed that a Sandy Silt material extended down to 6.0 m. Gradation tests indicate a high percentage of fine Sands and Silts (See Figure 1). Underlying the above material is believed to be a granular deposit consisting of Sand with interbedded Silt layers, with the full extent of this deposit not proven.

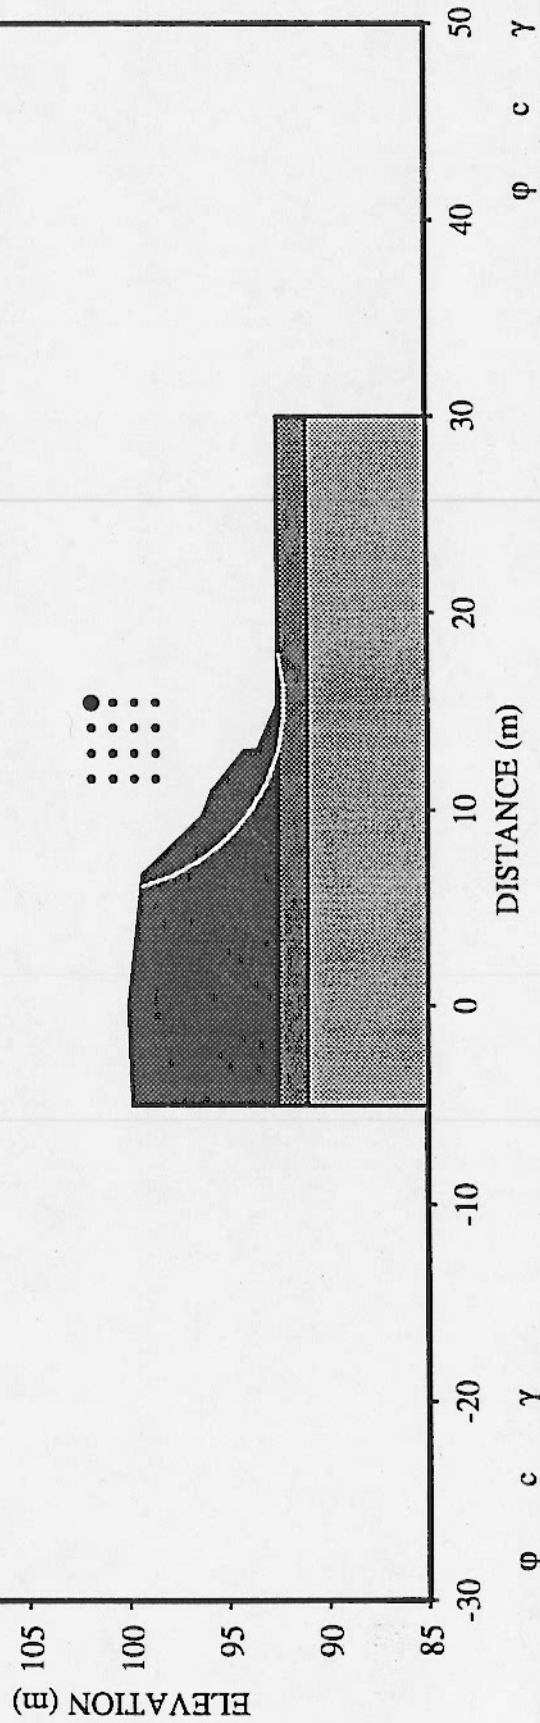
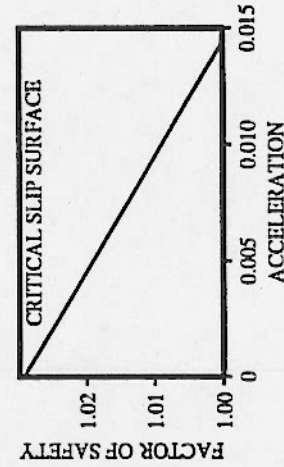
Fig 2

Based on observations the instability at this site appears to be due to surficial erosion of a similar nature to the failure upstream. Instabilities are caused primarily due to undercutting of the river bank by the erosive power of the creek, further aggravated by rapid drawdown of the creek water level. As the slides occur primarily within the existing Silty Sand embankment there was no evidence of deep seated failures. It should be noted that this type of failure is of a recurring nature occurring during the spring thaw period or the period of heavy precipitation.

The stability analysis carried out on the existing slopes indicates that the slope area is unstable with a Factor of Safety less than unity. Refer to Figure 2 for an illustration of the embankment model and a summary of assumptions considered in the stability analysis.

Minimum factor of safety 1.03 at $X_c = 15.5$ $Y_c = 101.8$ tangent at 92.2

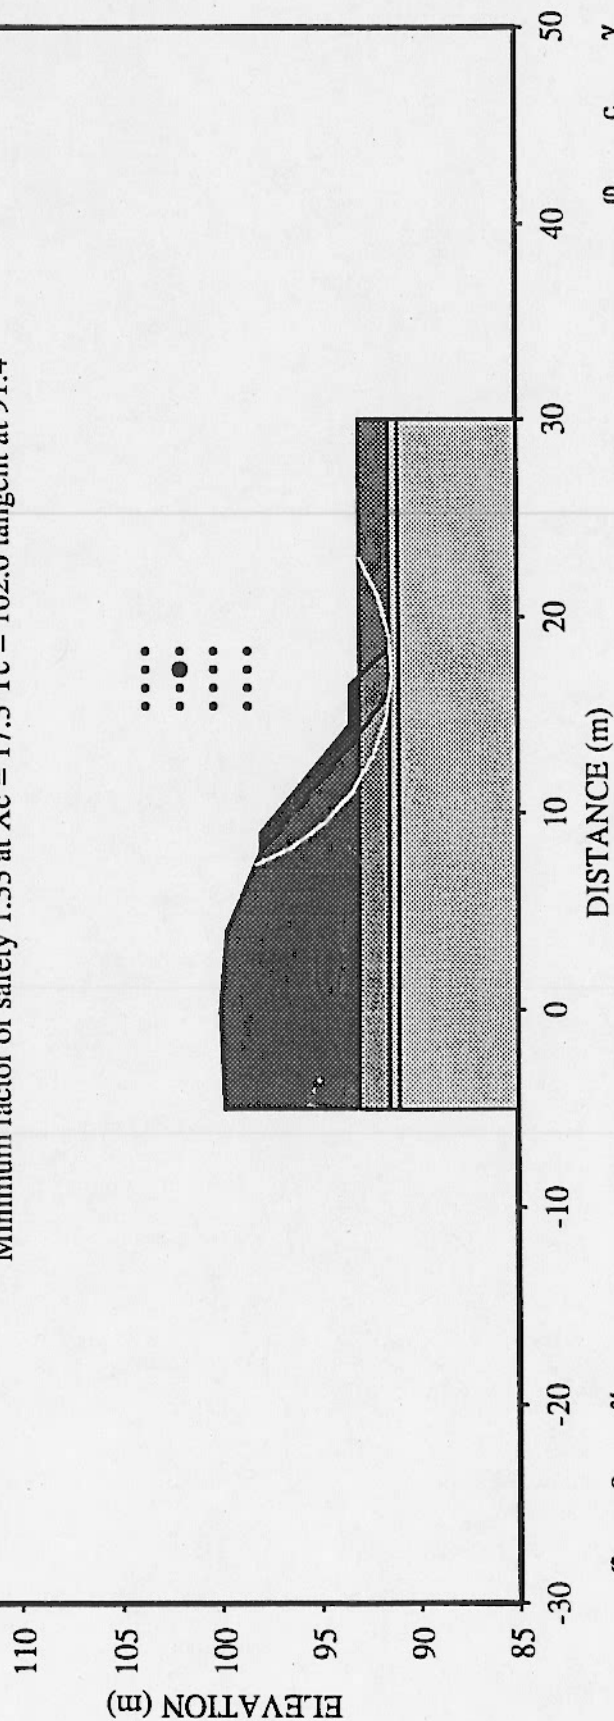
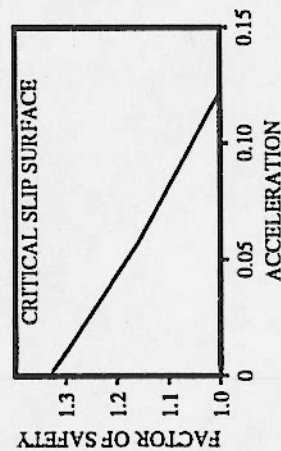
Fig. 3

As illustrated in Figure 3, the stability analysis of generalized embankment conditions indicates that this type of failure can be controlled by rock protection. It is recommended that the following remedial measures can be carried out as soon as possible in order to stabilize the embankment slope in the distressed area:

Minimum factor of safety 1.33 at $X_c = 17.3$ $Y_c = 102.0$ tangent at 91.4
