Updated Foundation Investigation Report

Highway 599 Trout Creek Culvert Replacement

Agreement No. 6019-E-0004

June 23, 2022

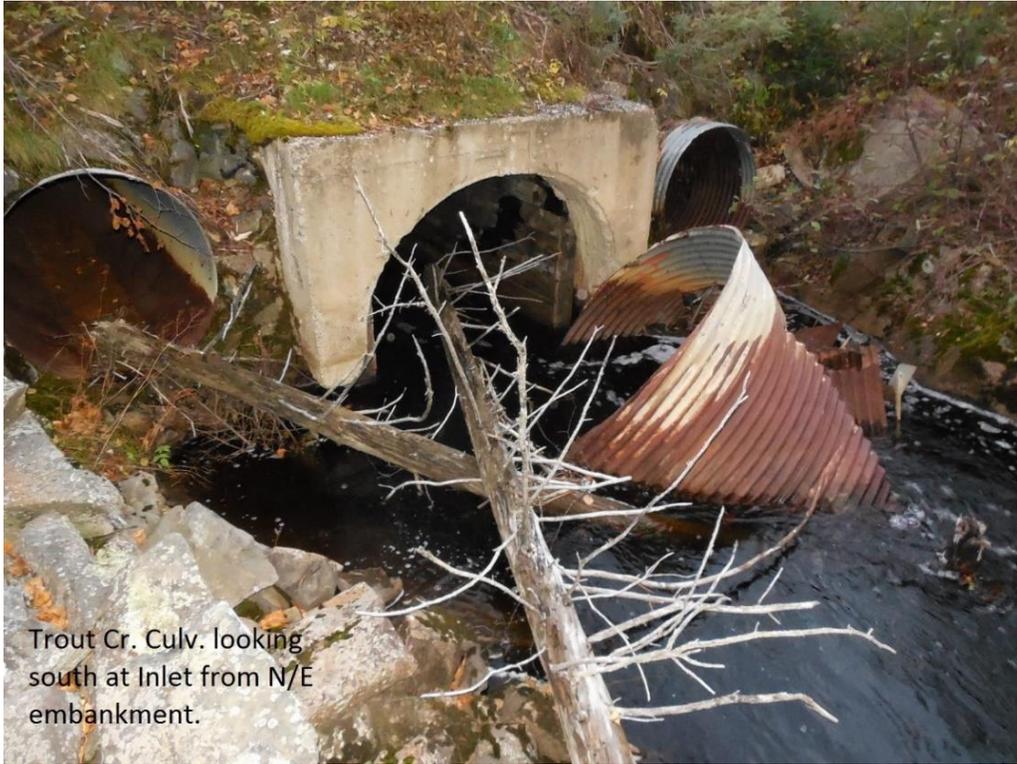
Photograph 1. Inlet side of the culvert, October 2020

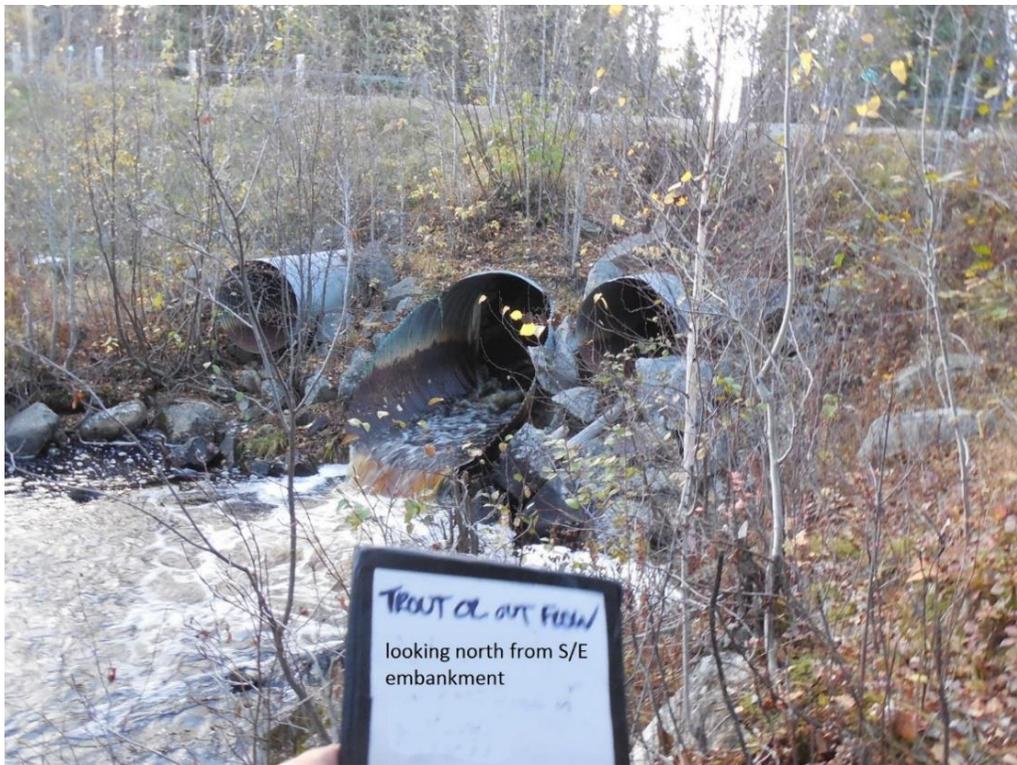
Photograph 2. Outlet side of the culvert, October 2020

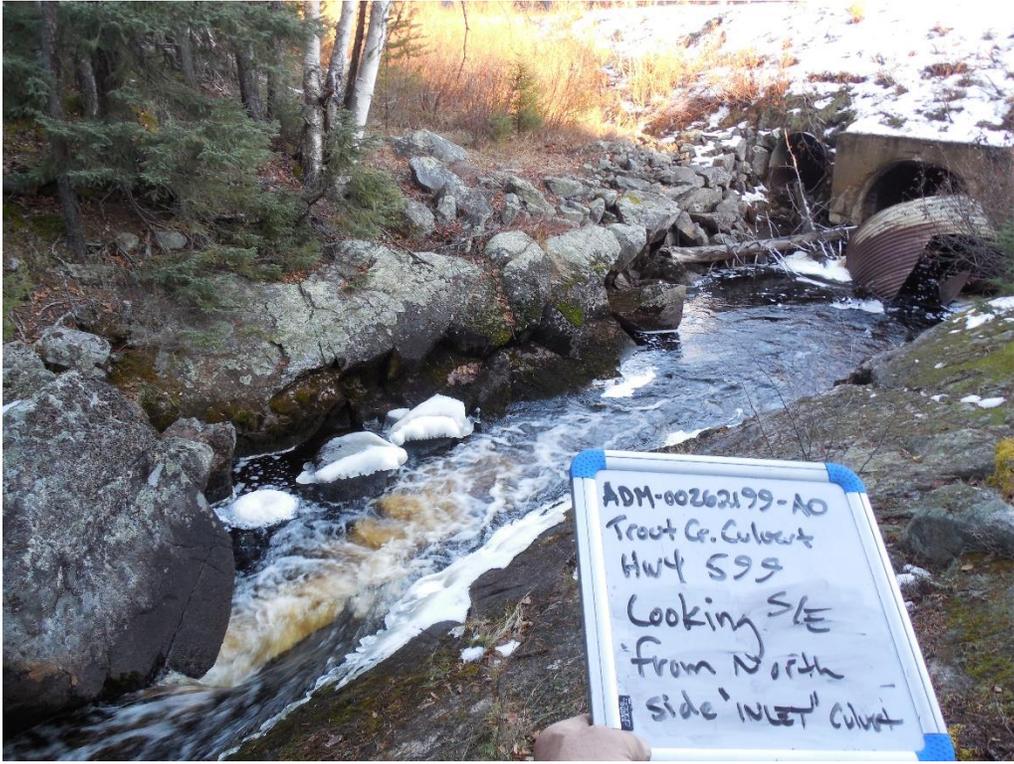
Photograph 3. Inlet side of the culvert (facing south), November 2020

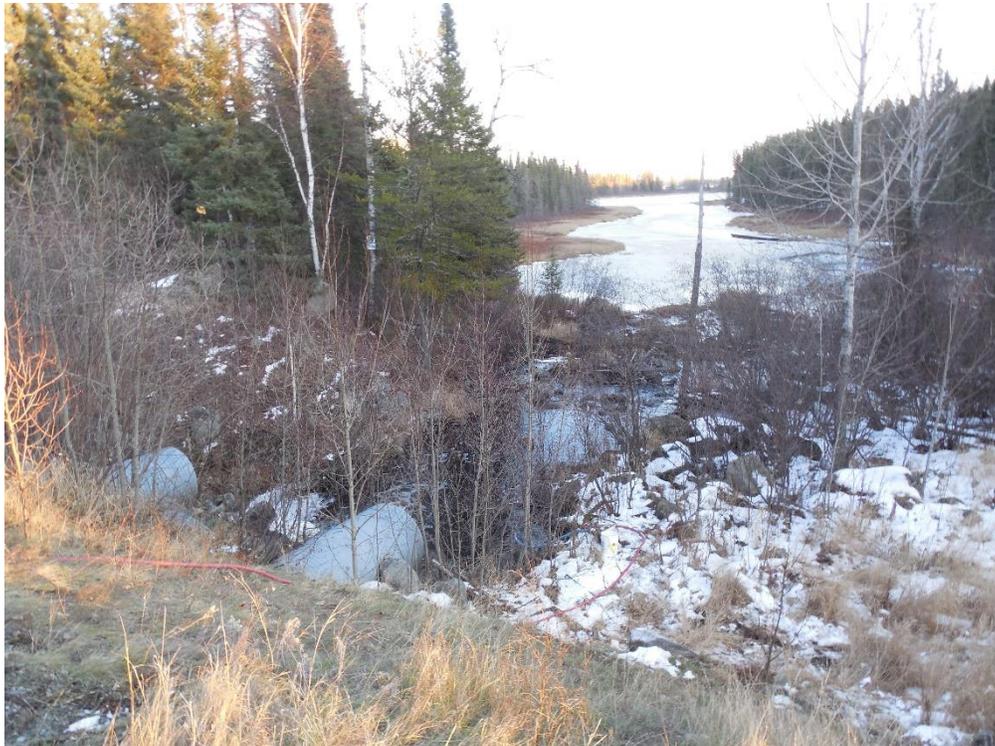
Photograph 4. Outlet side of the culvert (facing south), November 2020

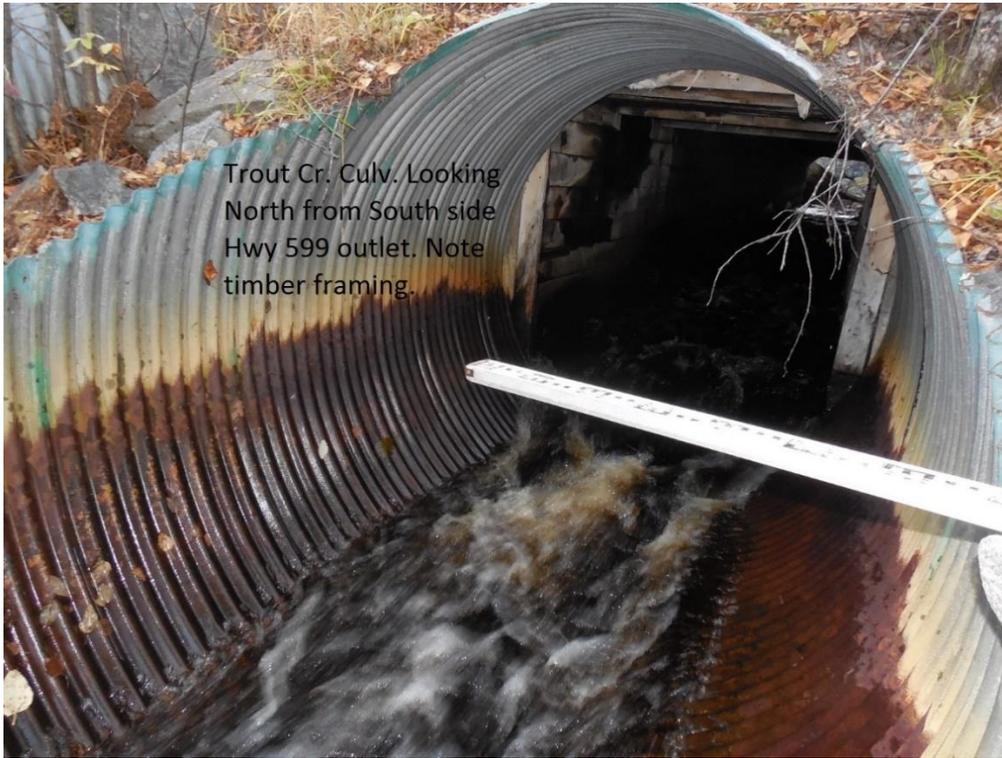
Photograph 5. Inside of the centreline culvert at outlet, October 2020

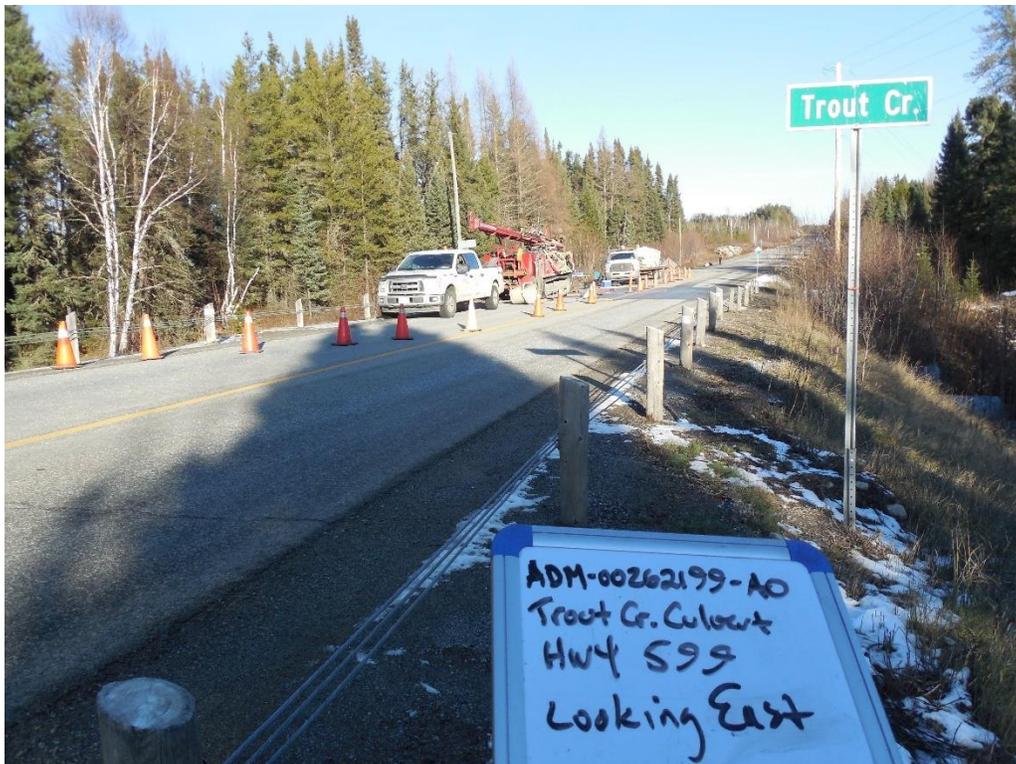
Photograph 6. Drilling borehole BH20-1 on the Highway 599 embankment (facing east), November 2020

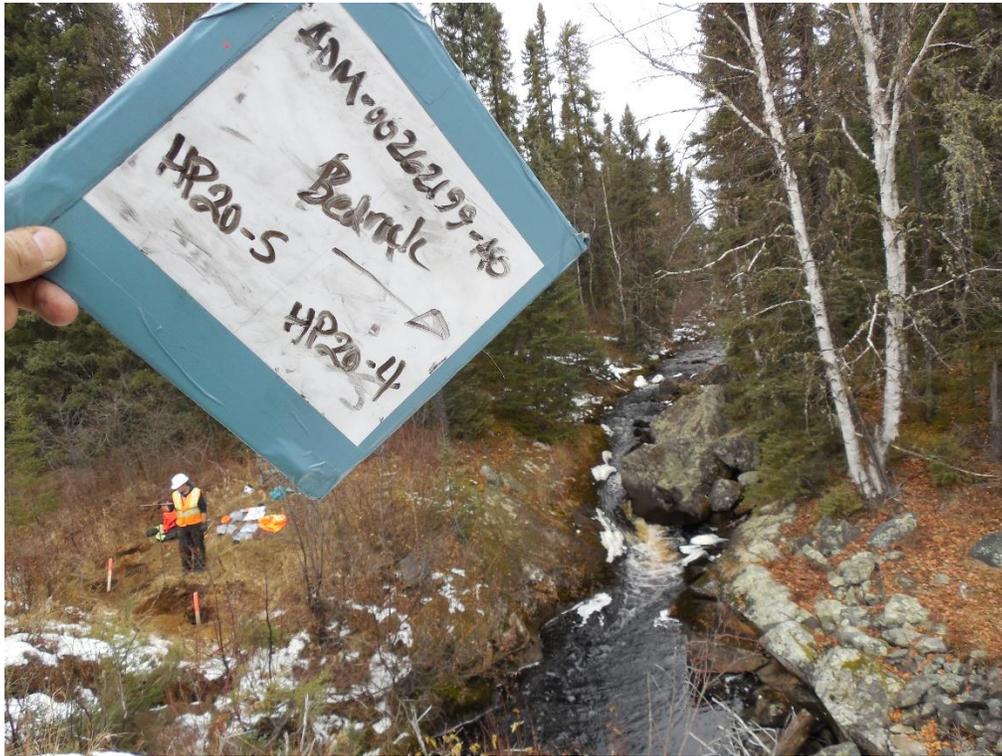
Photograph 7. Drilling hand probe hole HP20-4, HP20-5, at the inlet side, November 2020

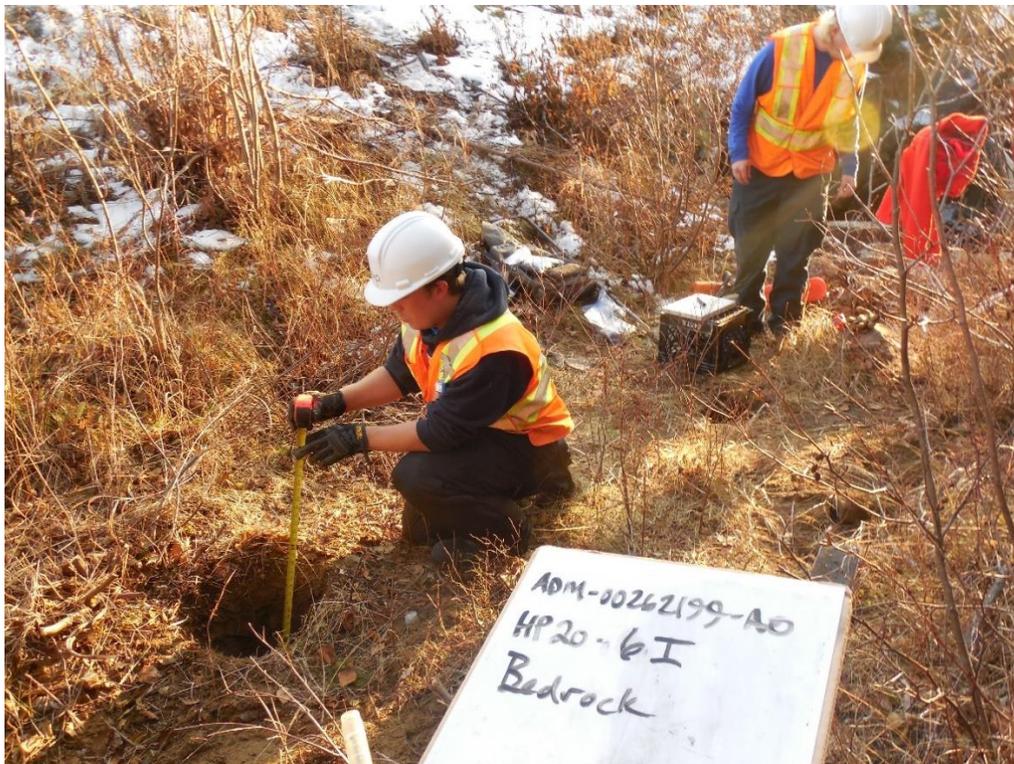
Photograph 8. Drilling hand probe hole HP20-6I, at the inlet side, November 2020

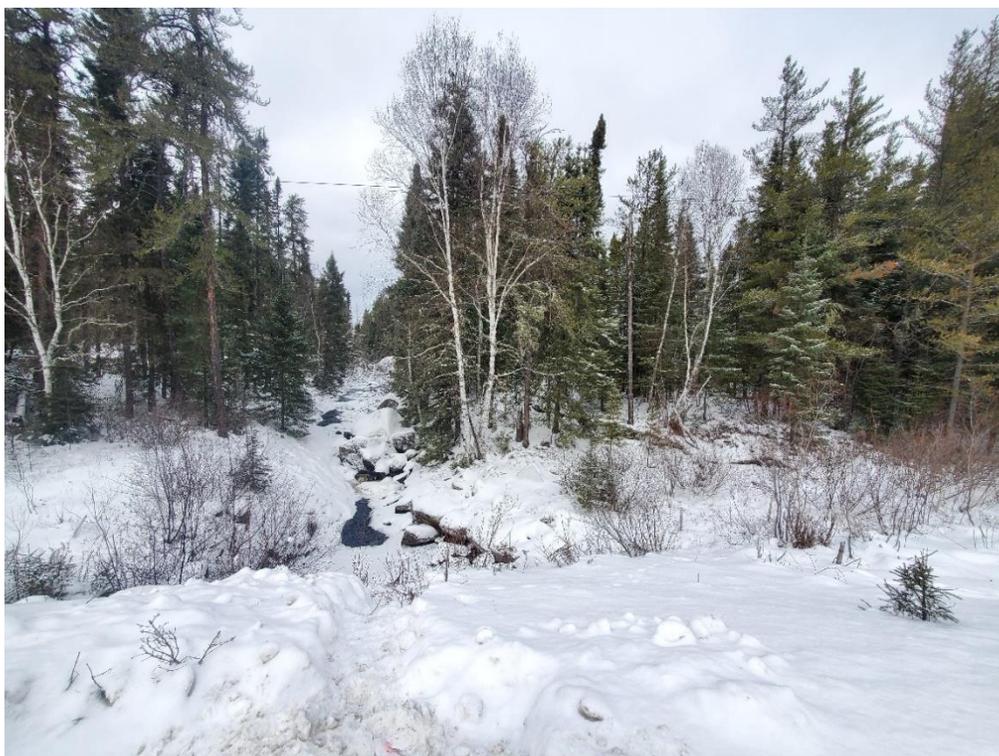
Photograph 9. Inlet side of culvert (facing north), November 2021

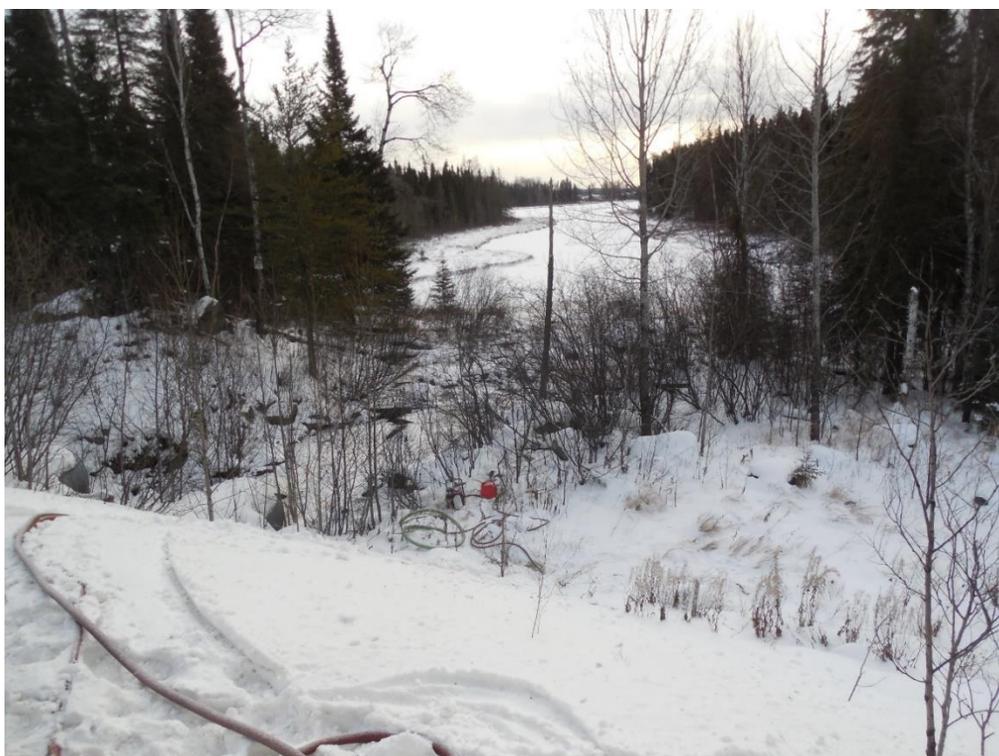
Photograph 10. Outlet side of culvert (facing south), November 2021

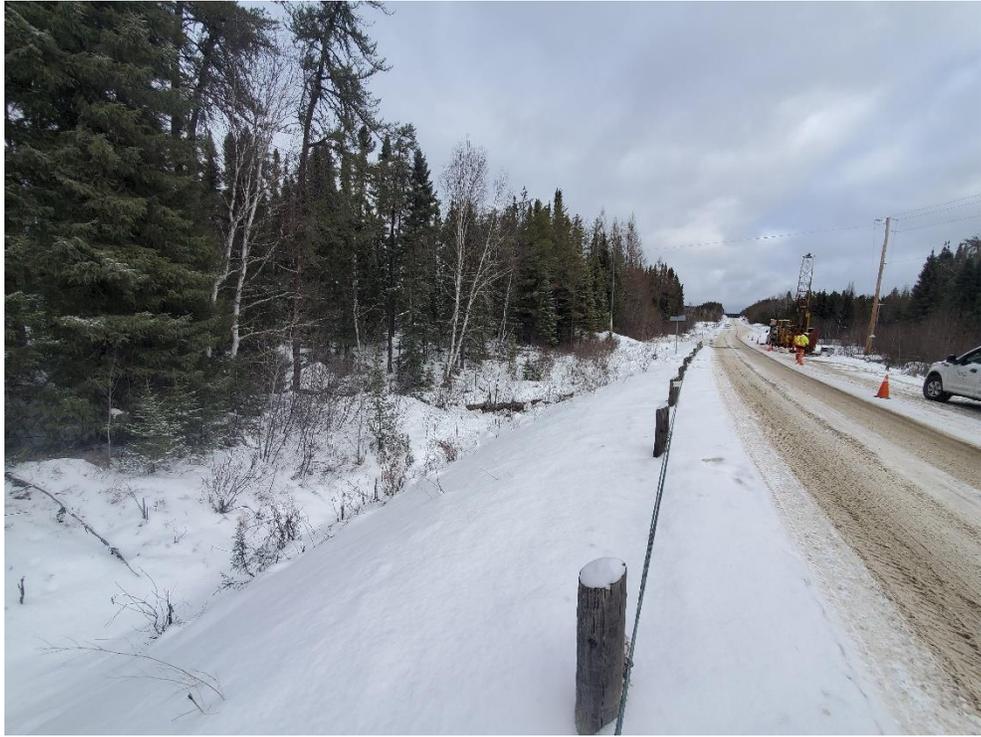
Photograph 11. View of north embankment (facing east), November 2021

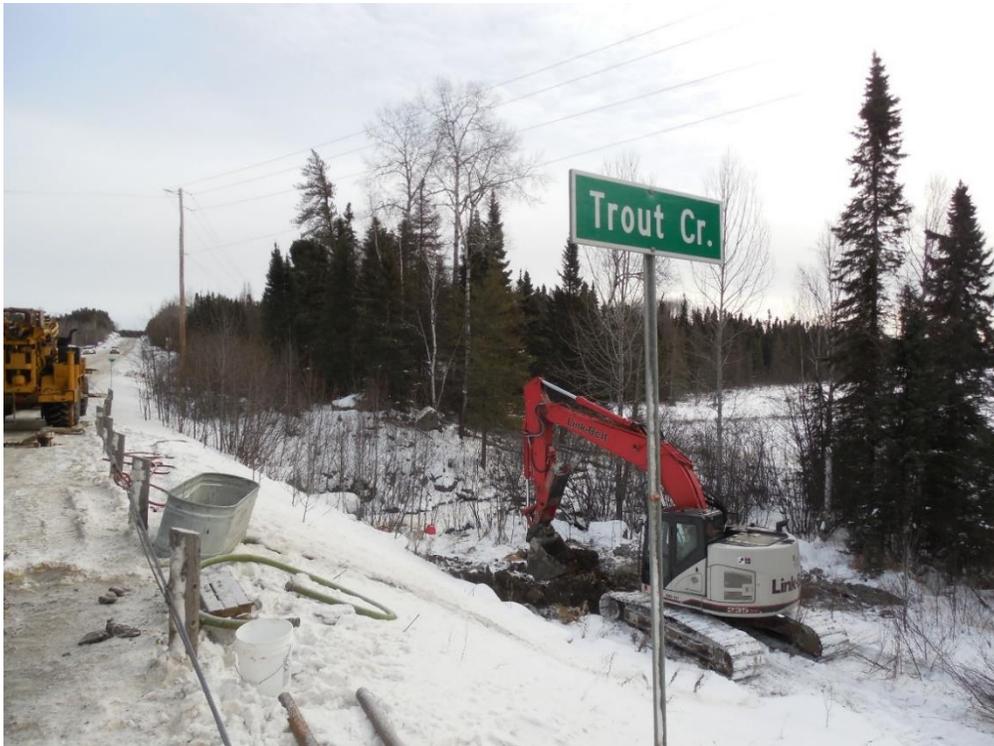
Photograph 12. View of south embankment (facing east), November 2021. Test pit TP21-1 advanced on the south side of Highway 599 and west of culverts.

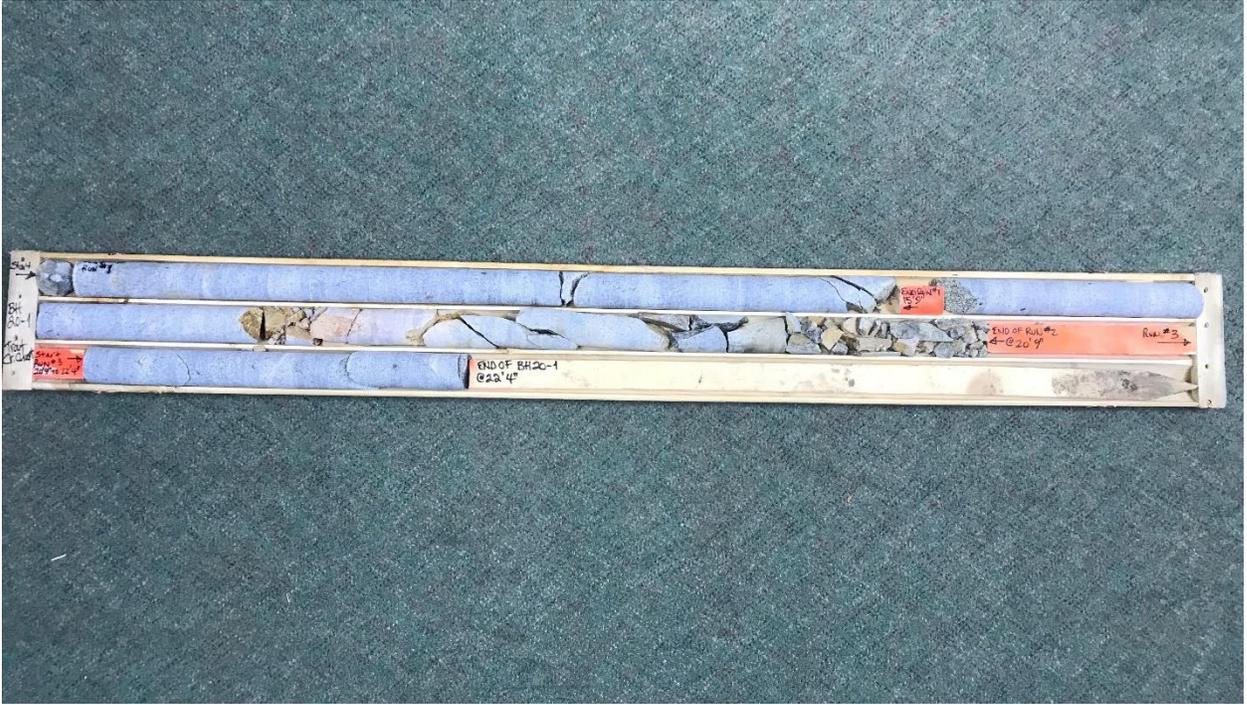
Based on the bedrock NQ and HQ cores (~ core diameter 47 mm and 64 mm, respectively) recovered, the bedrock at the site consisted of meta-volcanic rock. In general, the rock samples are described as pink/white to grey/black and/or green in colour, fine to coarse grained, severely fractured to very sound. The Rock Quality Designation (RQD) measured on the core samples typically ranged from approximately 30% to 93%, indicating a rock mass of poor to excellent quality, mostly fair quality. The total core recovery (TCR) ranged from 99% to 100%. The top 0.5 m of the bedrock is estimated to be weathered.

Photograph E1. Bedrock Core Samples, Borehole **BH20-1**, November 2020

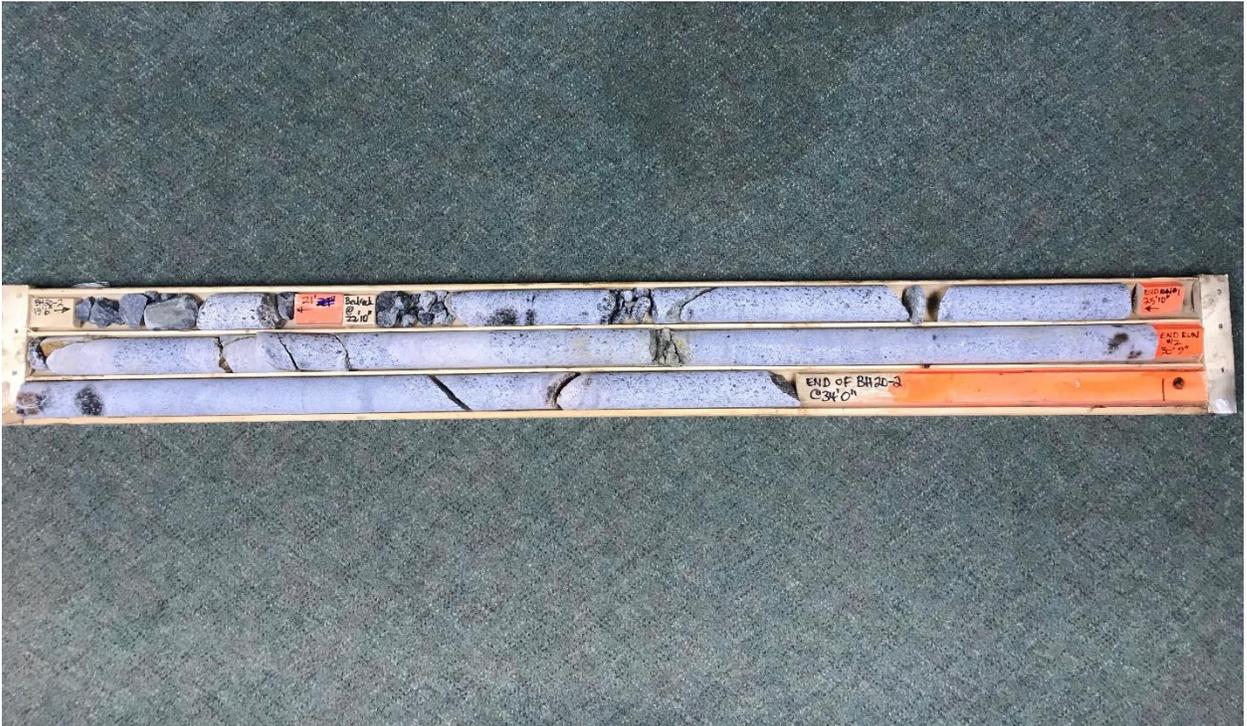
Photograph E2. Bedrock Core Samples, Borehole **BH20-2**, November 2020

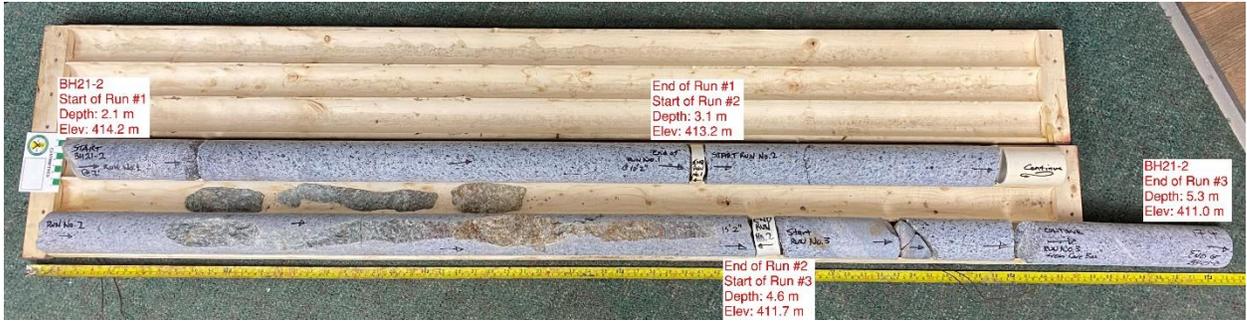
Photograph E3. Bedrock Core Samples, Borehole **BH21-2**, November 2021

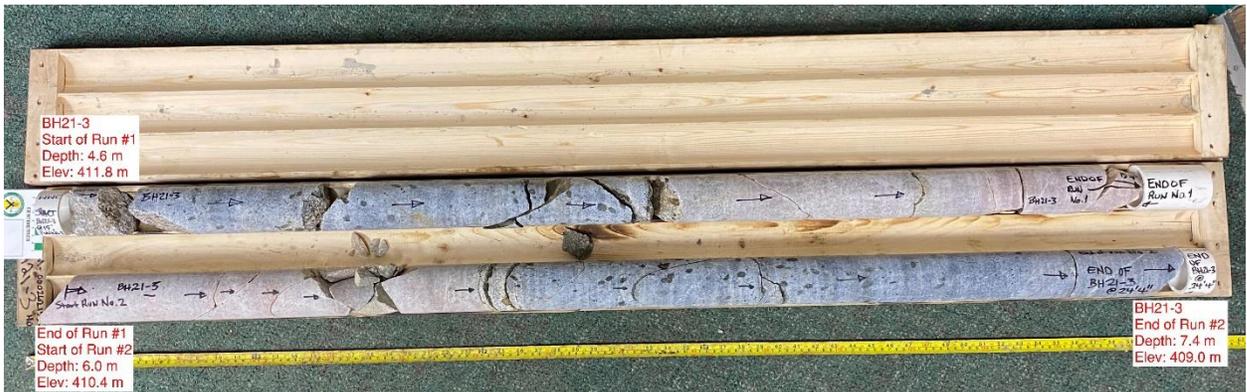
Photograph E4. Bedrock Core Samples, Borehole **BH21-3**, November 2021

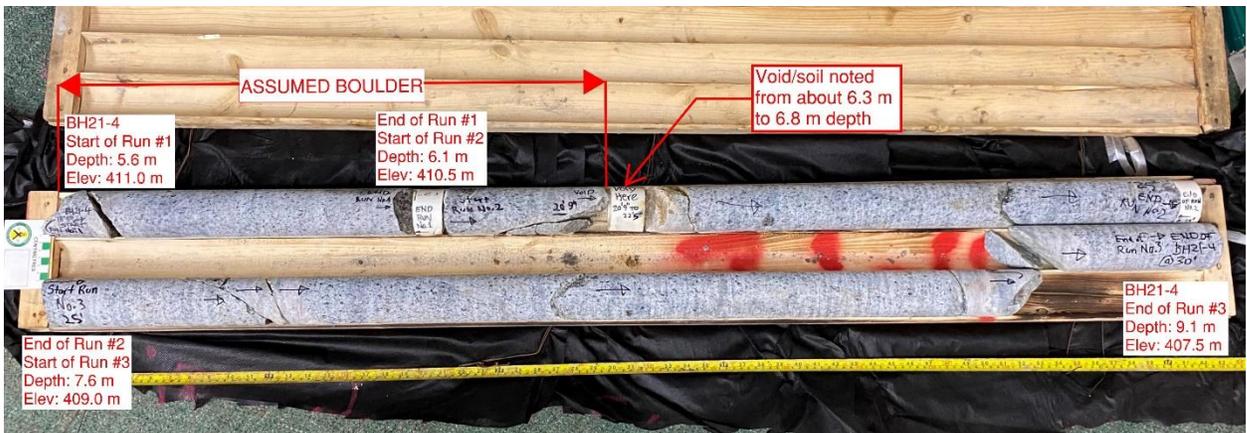
The composition of this layer was silt, sand, and gravel with occasional to some cobbles and boulders and trace clay. The material was grey in color and wet. The SPT “N” values within this layer ranged from 33 blows per 0.3 m to 50 blows per 0.125 m penetration, suggesting that this layer was dense to very dense in relative density. It is noted that rock coring techniques were initiated at BH21-4 at about 5.6 m and that a boulder was observed from 5.6 m to 6.3 m below ground surface. Below the boulder, a rock void within the silt till was observed to about 6.8 m below ground surface.

Photograph E5. Assumed Boulder (5.6 m to 6.8 m depth) and Bedrock Core Samples (6.8 m to 9.1 m), Borehole **BH21-4**, November 2021
