## Foundation Investigation and Design Report

*Embankment Instability on Highway 658, Township of Redditt*

Agreement No. 6021-E-0019

December 20, 2022

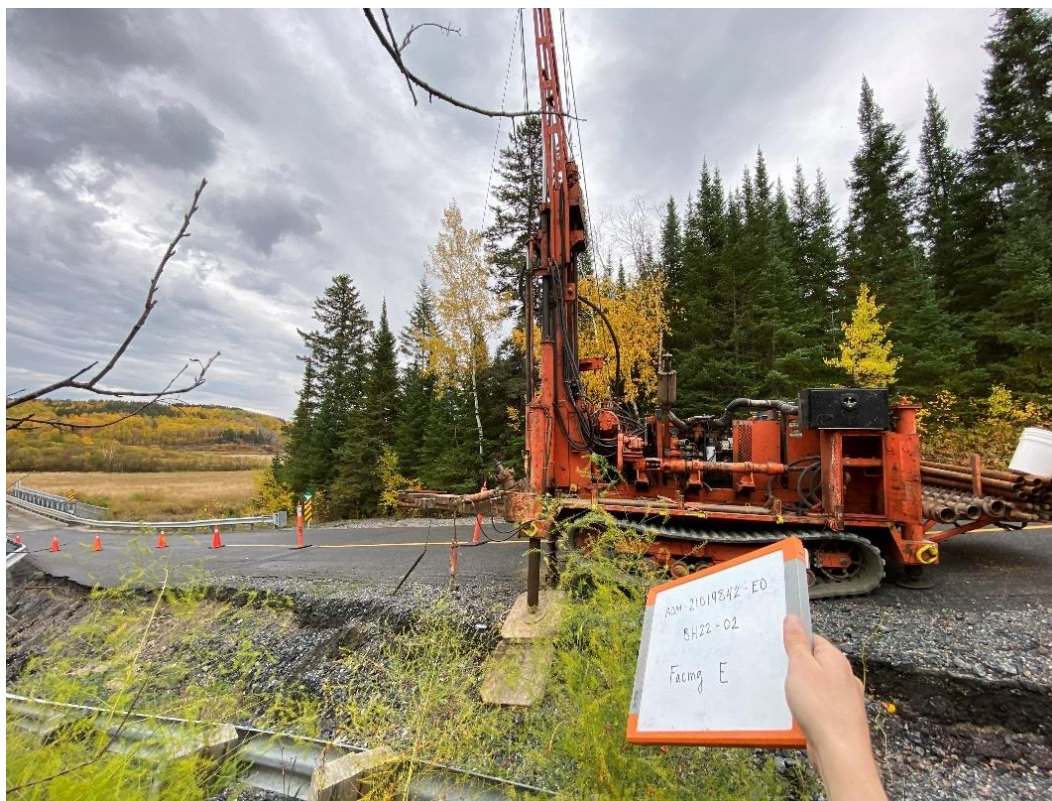
followed by a very soft, medium plastic clay layer. The surficial soils near the toe of the slope instability were visually observed to consist of a wet to saturated organic layer over a silt/clay mix. Mature vegetation growth was observed on both sides of the roadway and in the vicinity of the slope instability. Various trees and shrubs were observed to exhibit a downslope lean, consistent with the down slope movement of the slope instability (Photograph 3 in Appendix A). It was also observed that the west side of the roadway embankment was inundated with water at the top of the roadway embankment from surficial drainage along the roadway (e.g., heavy spring precipitation, snow melt, etc.), coupled with flood water rise along the Black River floodplain area at the slope toe. The east gravel shoulder of the roadway across from the slope instability exhibited ditch erosion from surficial drainage flow downward from south to north towards the Black River floodplain (Photograph 4 in Appendix A). At the north portion of the site adjacent to the location of the bridge, the area was observed to be soft swampy marshlands with various vegetative growth during the investigation in October 2022 (Photograph 6 in Appendix A).

Photograph 6. General conditions of north portion of site, facing northeast, October 2022

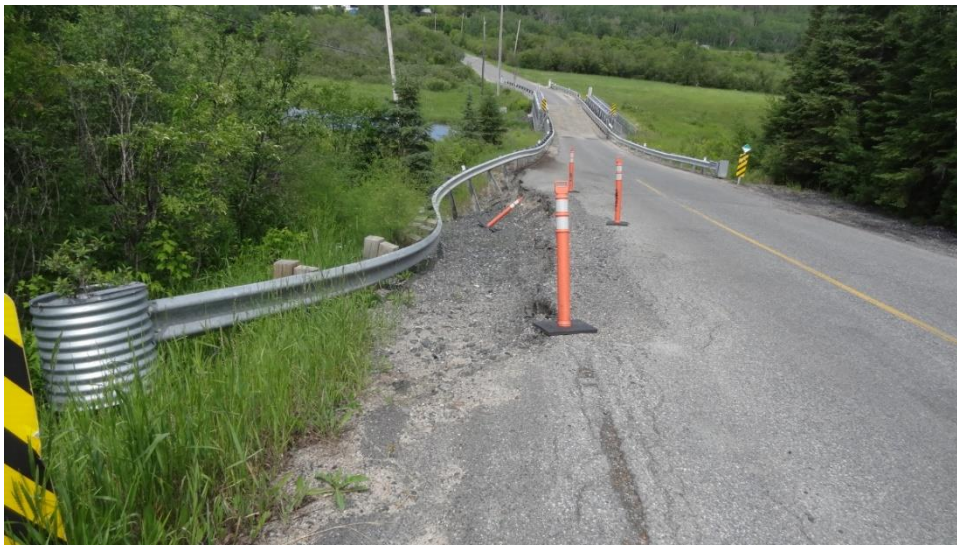
*Photo 1 (Looking North): July 7, 2022 – Highway 658 Slope Instability*

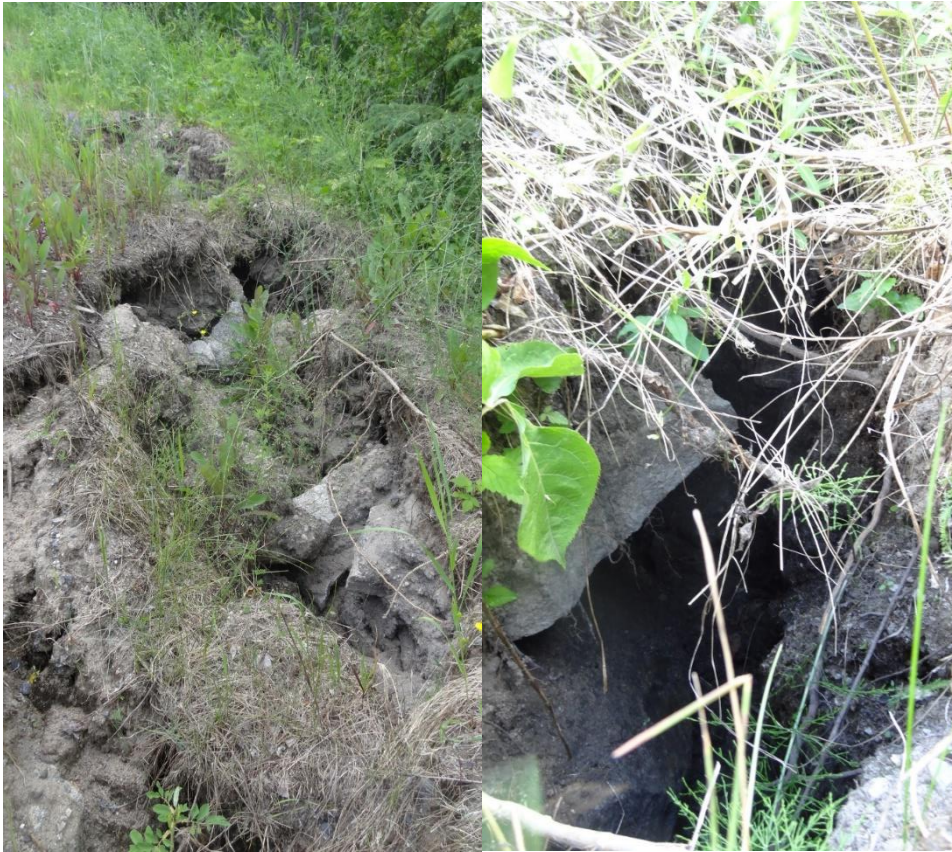
*Photo 4 and Photo 5: July 7, 2022 – Tension Cracks Directly West of Highway 658 within Slope Instability*

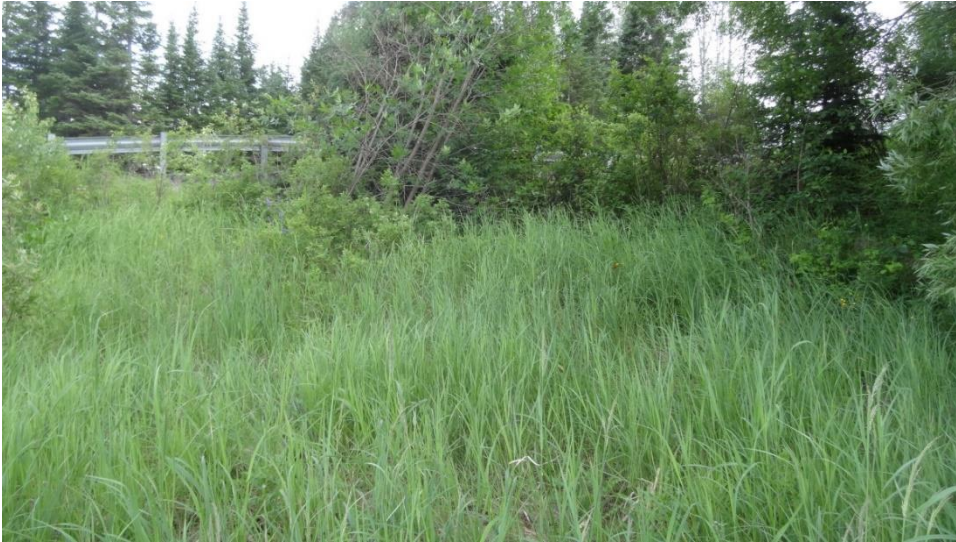
*Photo 7 (Looking Southeast): July 7, 2022 – Leaning Trees 2022 Slope Instability*

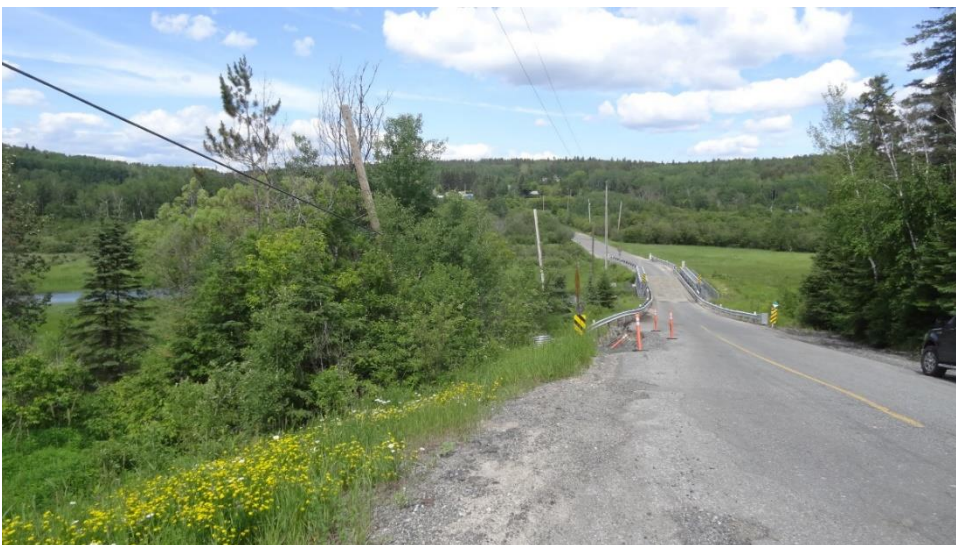
*Photo 8 (Looking North): July 7, 2022 – Leaning Power Poles 2022 Slope Instability*

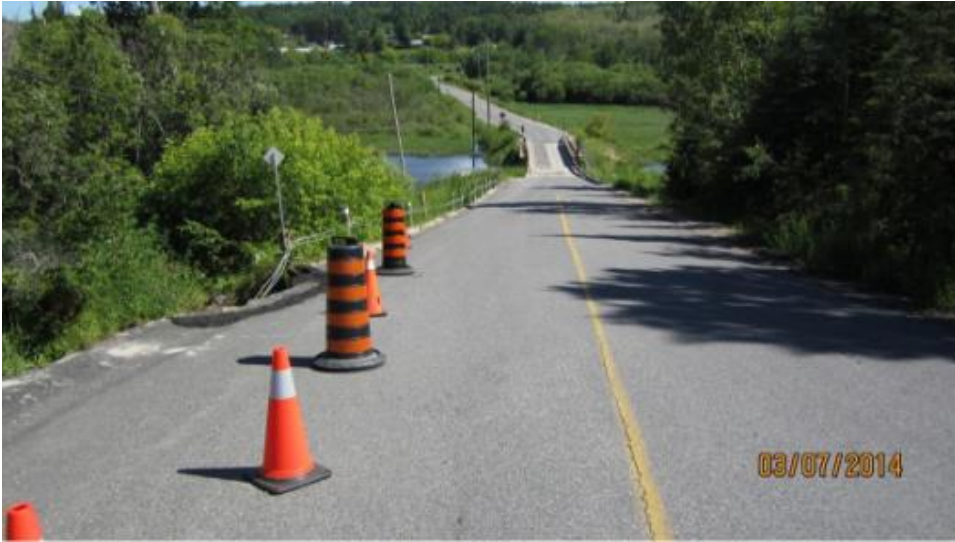
*Photo 9 (Looking North): July 3, 2014 – Leaning Power Poles 2014 Slope Instability*

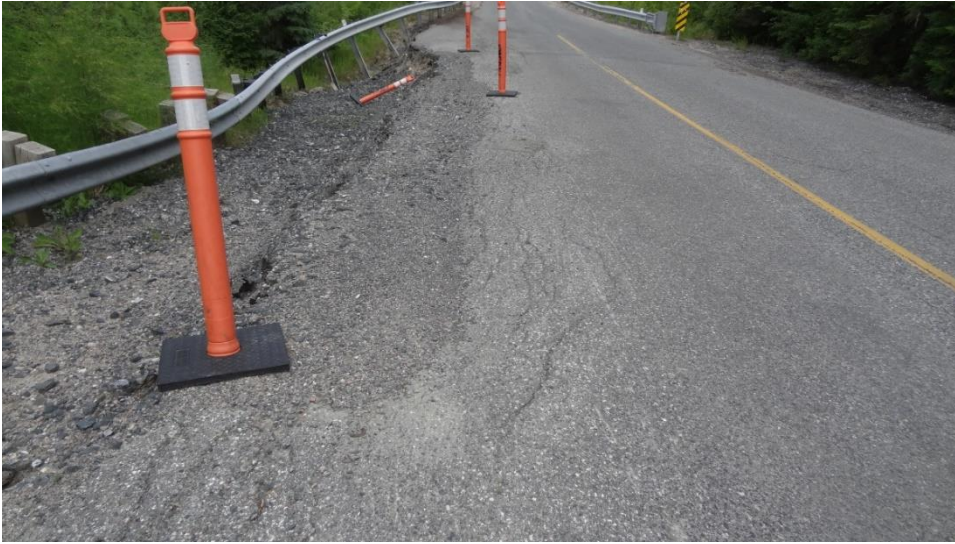
*Photo 10 (Looking North): July 7, 2022 – Highway 658 West Shoulder Gravel-Treated Roadway Repair*

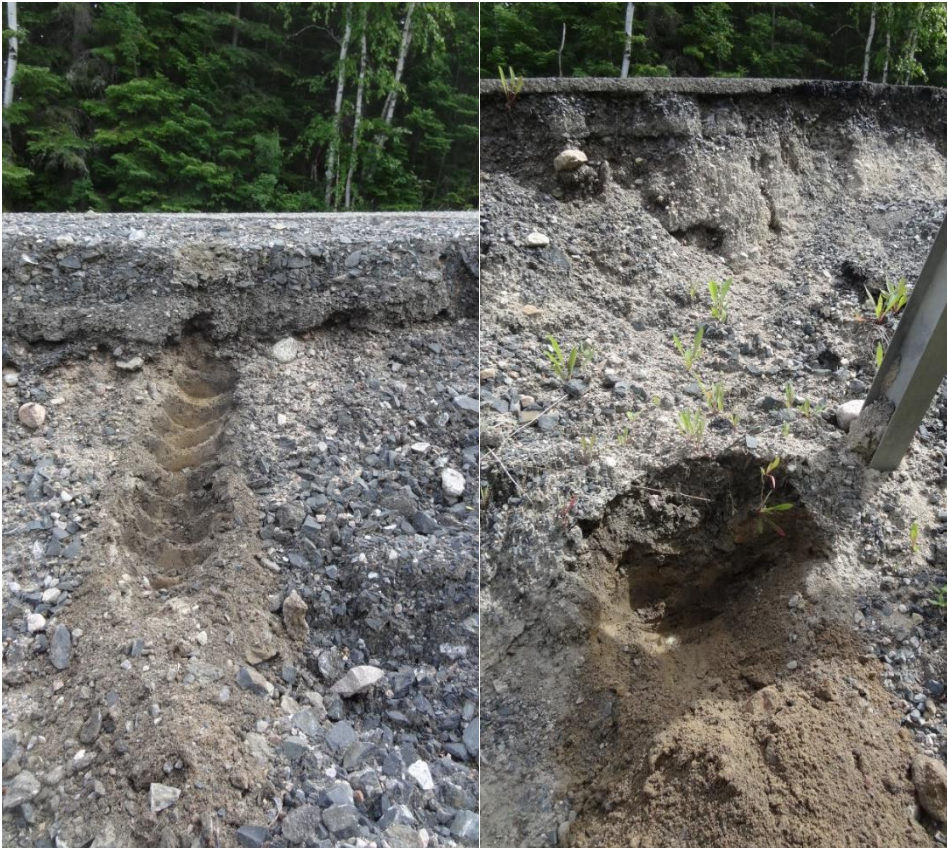
*Photo 12 and Photo 13: July 7, 2022 – Soils Adjacent to the Exposed Head Scarp Adjacent to Highway 658*

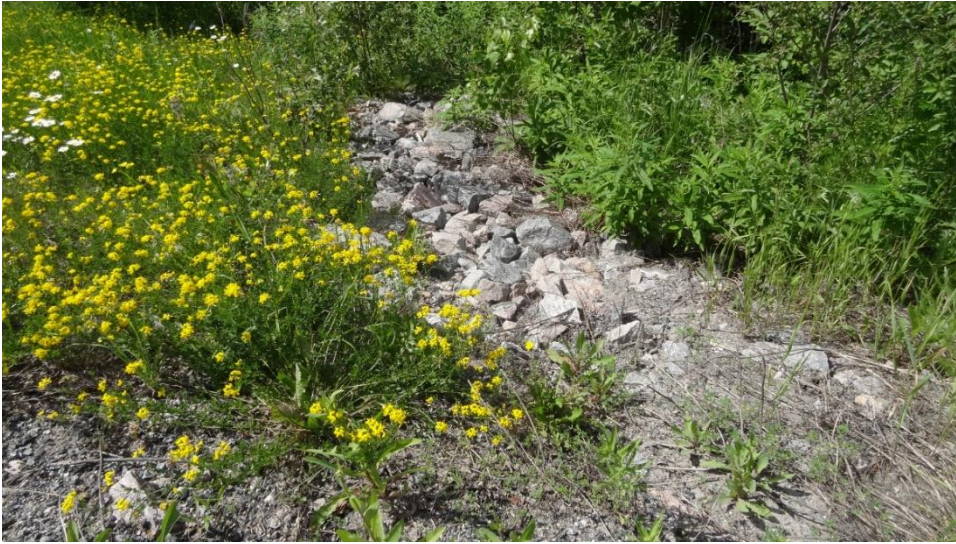
*Photo 16 (Looking West Down Slope): July 7, 2022 – 2014 Instability Area with Rock Fill Slope Armoring*
