**FINAL
FOUNDATION INVESTIGATION REPORT
HIGHWAY 17 NON-STRUCTURAL CULVERT AT STATION 11+560
STABILITY ASSESSMENT OF TEMPORARY STAGING FILLS AND CUTS
INWOOD TOWNSHIP, ONTARIO
AGREEMENT NO.: 6022-E-0038, ASSIGNMENT NO.: 5**

GEOCRES NO.: 52G01-001

Client Name: Ministry of Transportation

Date: April 12, 2024

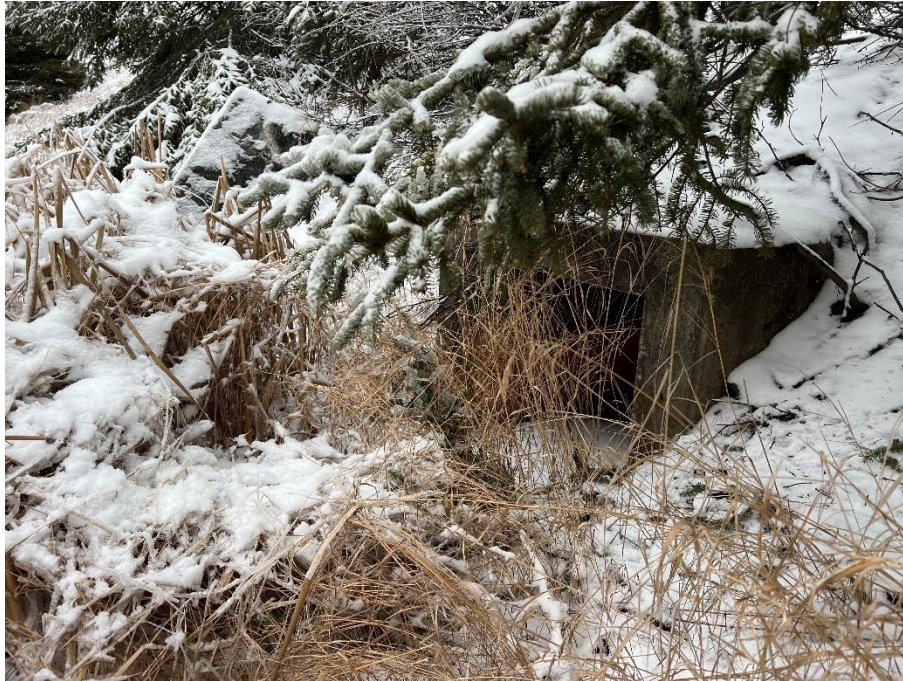
Photo 1: Culvert inlet *(taken on January 2, 2024)*

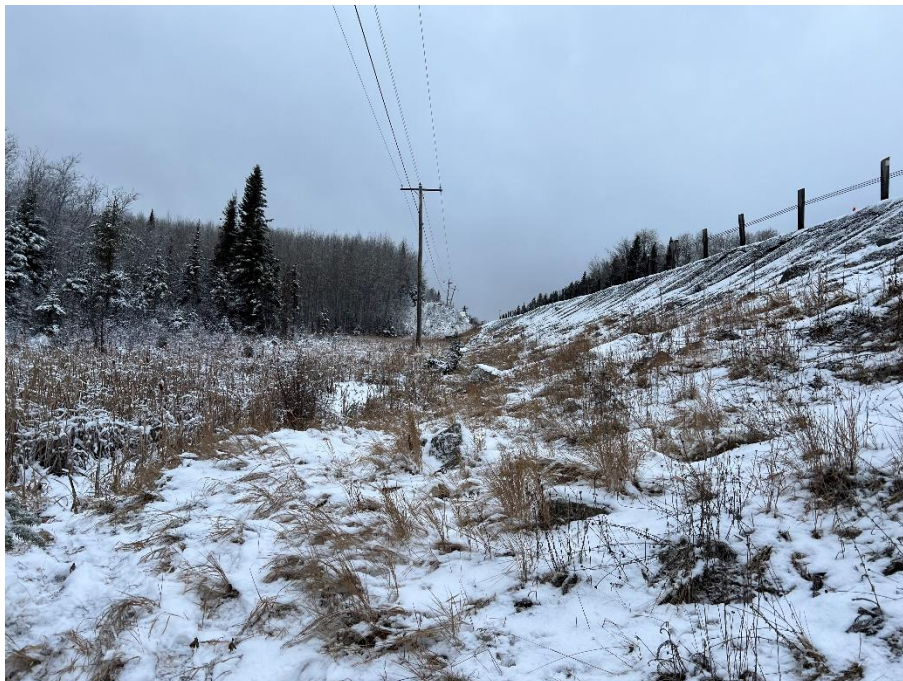
Photo 2: Culvert outlet *(taken on January 2, 2024)*

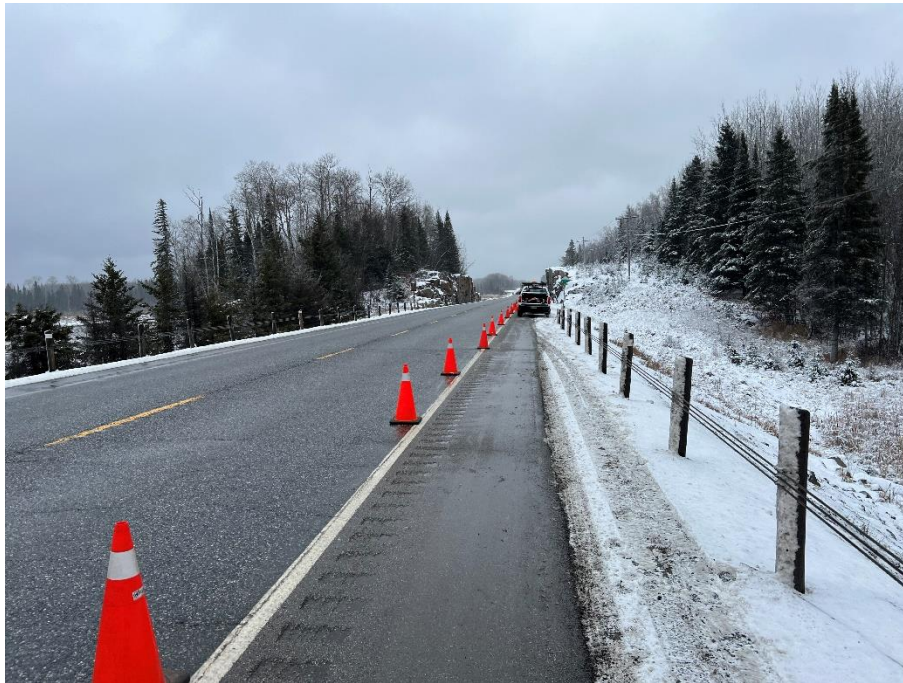
Photo 3: Highway 17 east of the culvert alignment *(taken on January 2, 2024)*

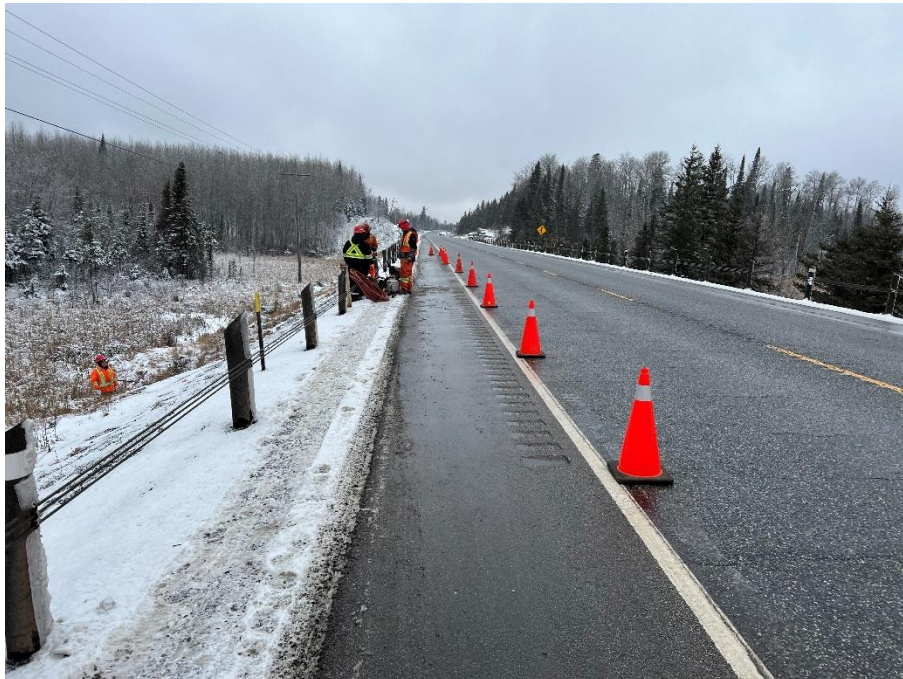
Photo 4: Highway 17 west of the culvert alignment *(taken on January 2, 2024)*

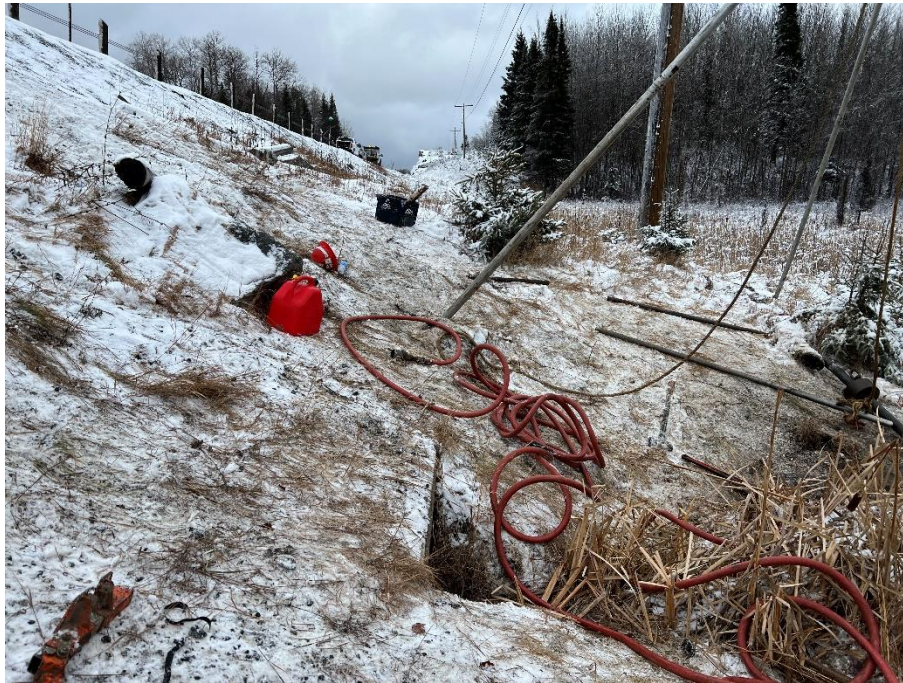
Photo 5: Looking east at the eastbound embankment *(taken on January 2, 2024)*

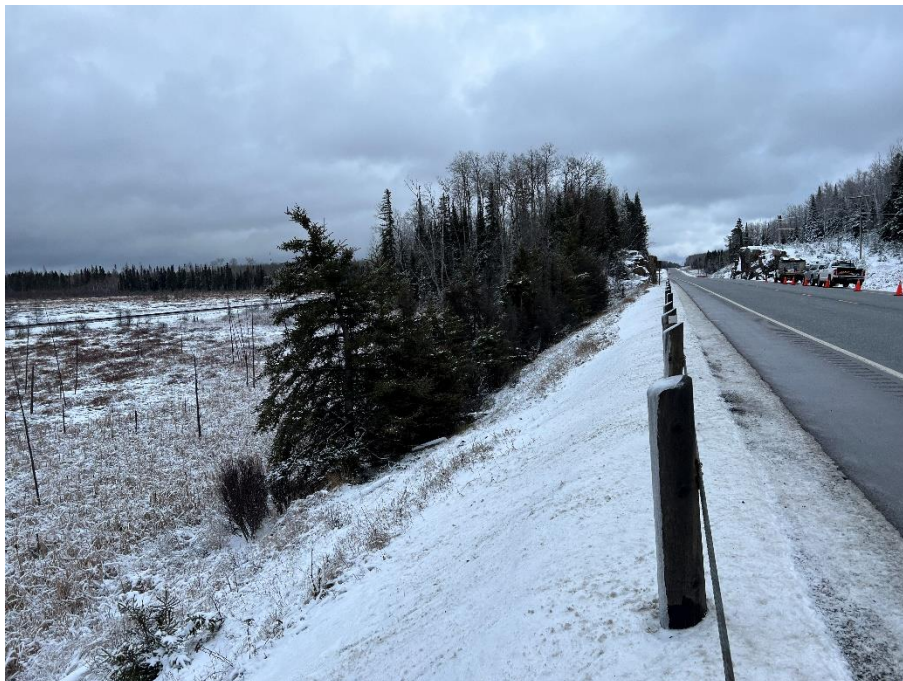
Photo 6: Looking east at the westbound embankment *(taken on January 2, 2024)*
