FOUNDATION EVALUATION REPORT

PROPOSED DREDGING OF HOLLAND MARSH NORTH CANAL BRIDGE 1, MTO STRUCTURE NOS. 37-32 1 AND 2

March 5, 2012

11-9-IEG1A

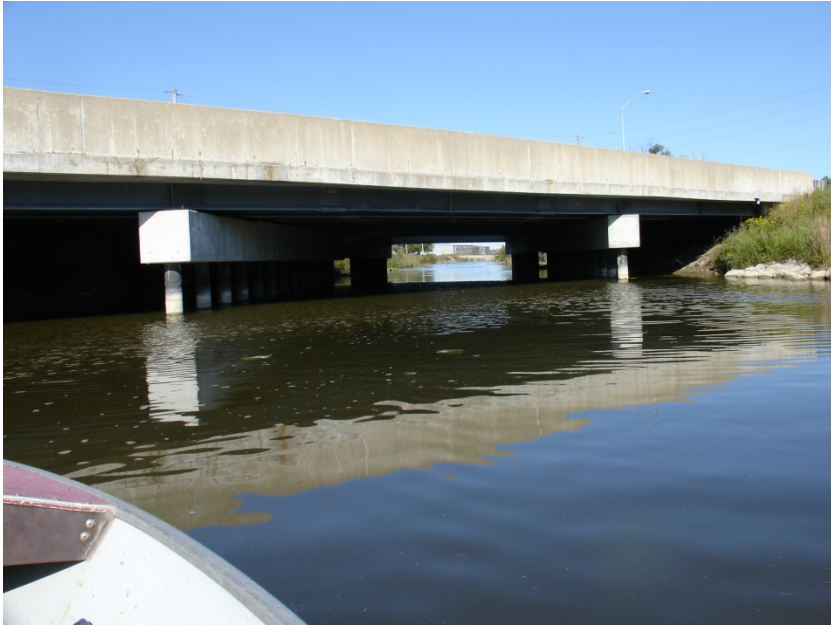
Bridge 1 - Overall view looking south

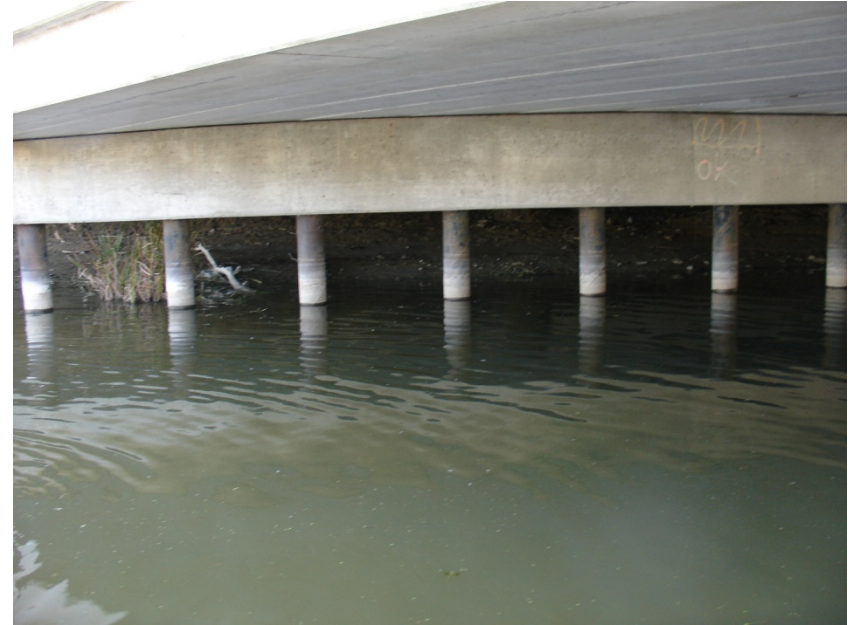
Bridge 1 - East piles south bridge

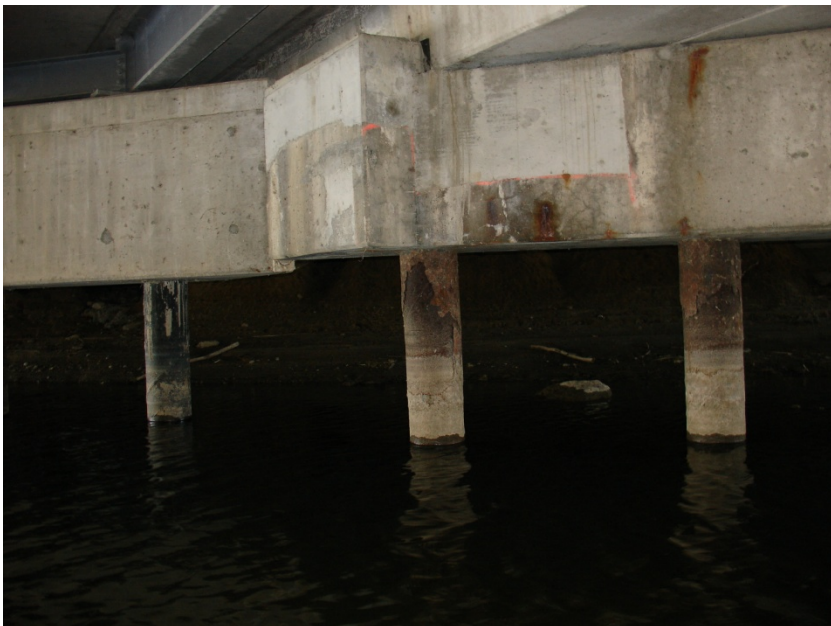
The pipe piles are considered to be in a fair to good condition at the time of our inspection, with some deterioration and loss of section caused by flaking.

Bridge 1 - Typical deterioration of east piles

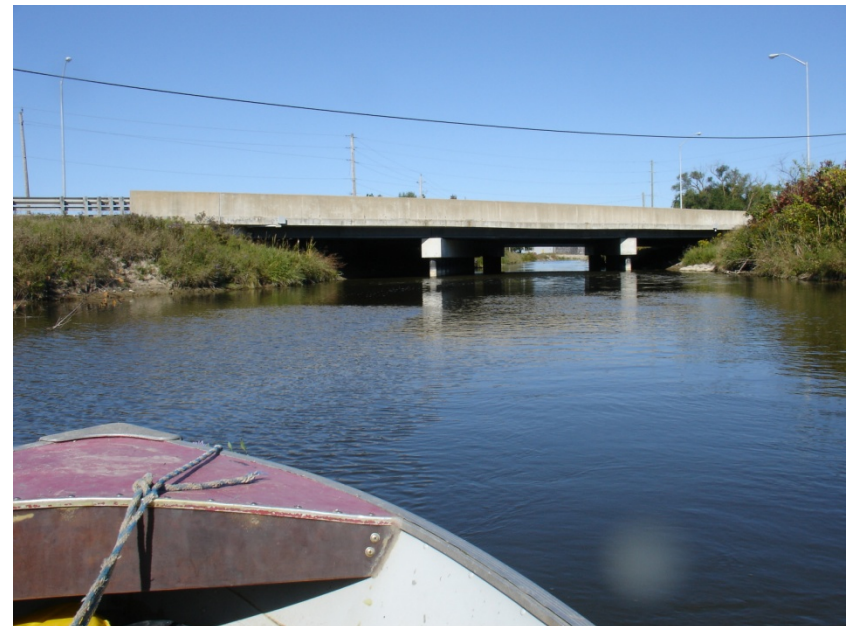
Bridge 1 - Overall view looking north

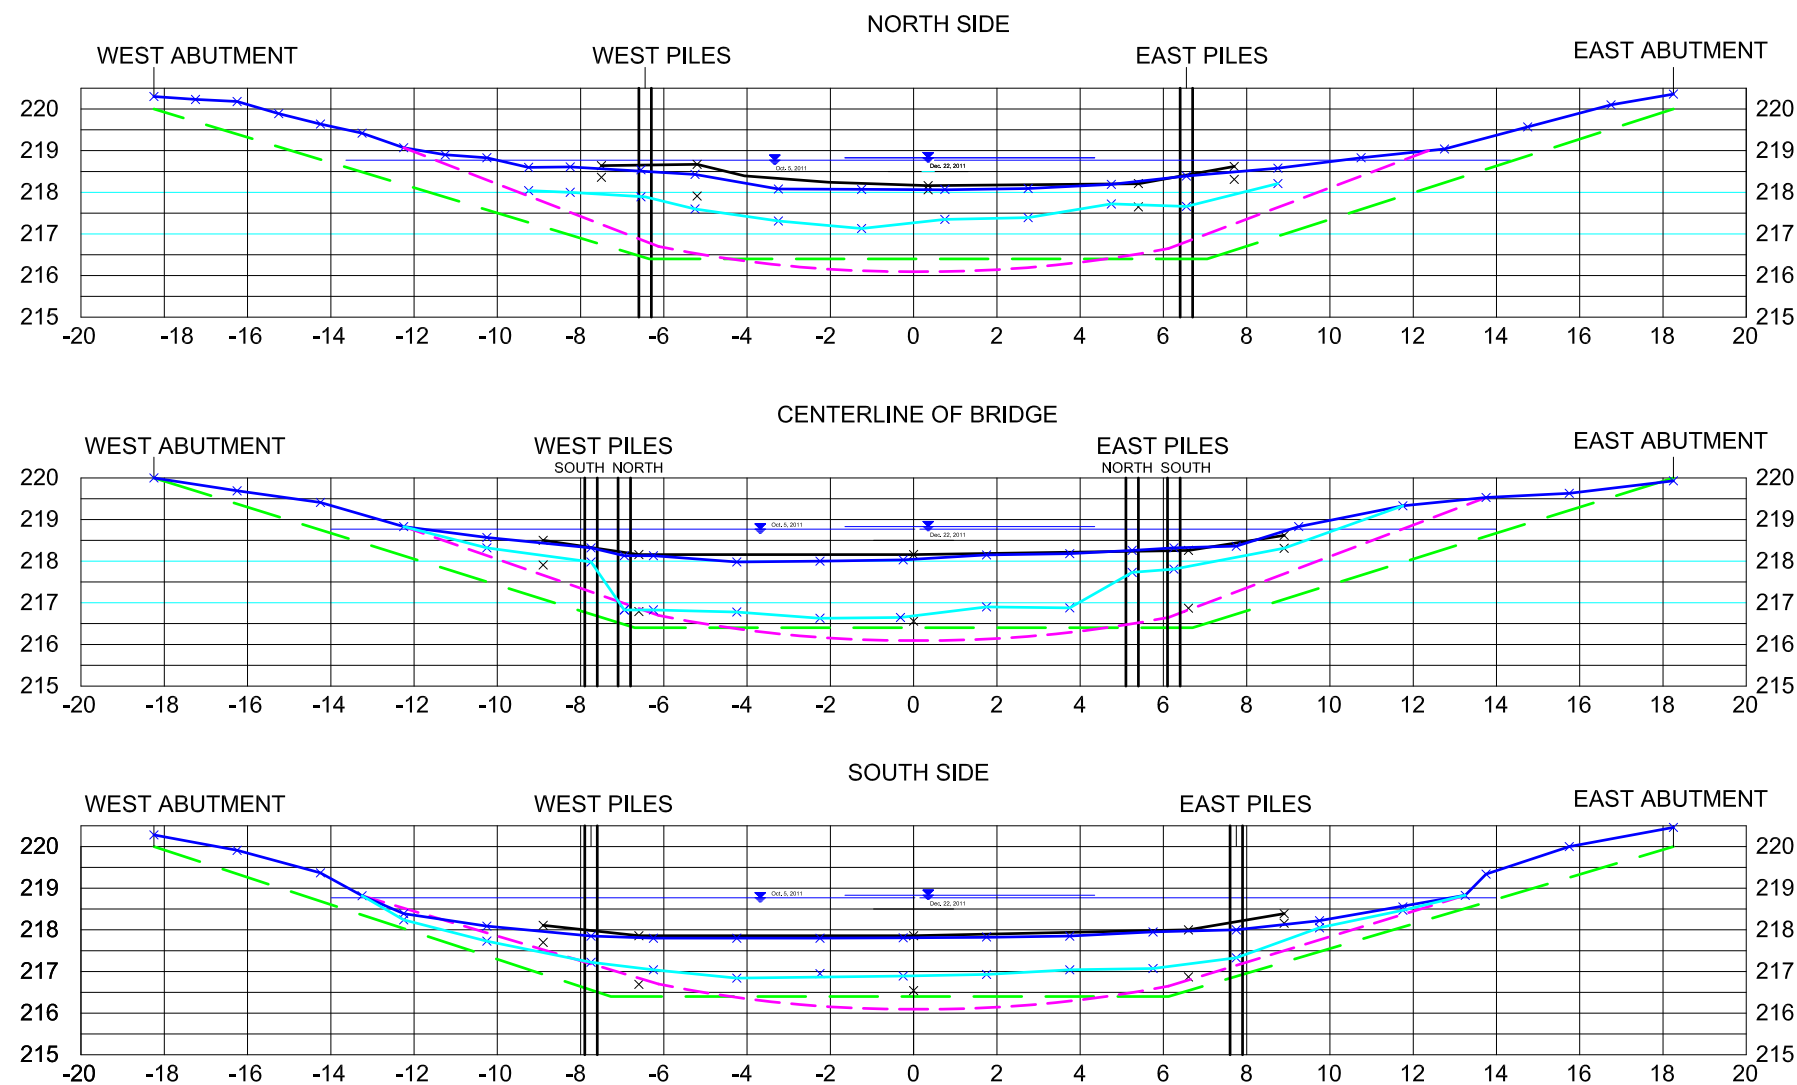
SOUNDING PROFILE

The existing and the proposed dredged cross-sections are presented on the sounding profiles, Drawing 3. The estimated extent of sediment based on sounding results are presented on Drawing 5. The design extent of dredging is presented in Drawing 6.

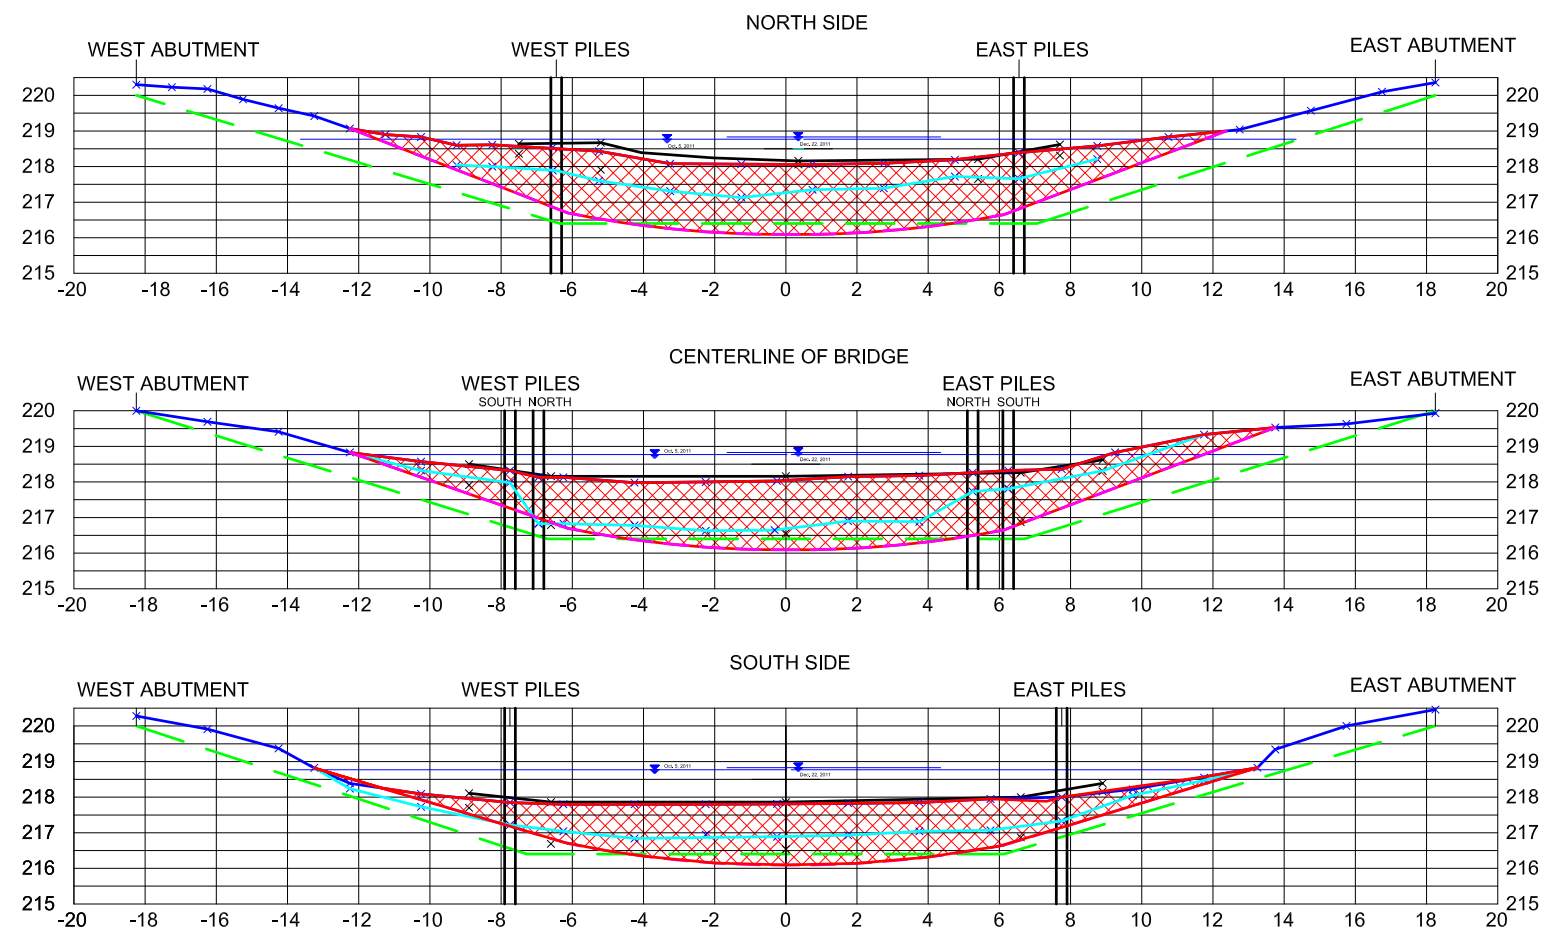
BRIDGE 1
PROPOSED SEDIMENT REMOVAL

Based on dredging to Elevation of 216.1 m, along the centerline of the canal, and between Elevations 216.8 and 216.9 m at the locations of the piles, there should be a minimum pile embedment depth of 17.4 m upon dredging. The potential risks for dredging from a geotechnical perspective will be little.

It is proposed that water-jetting and/or vacuum suction be carried out adjacent to the piles and between the piles and the abutments to provide a smooth dredged cross-section.

- 2) Water-jetting and/or vacuum suction should be allowed adjacent to the pipe piles to provide a smooth transition on the dredged cross section, provided that there is assurance that the water jetting work will not cause potential damage to the pipe piles.
