**FINAL**  
**FOUNDATION INVESTIGATION AND DESIGN REPORT**  
**HIGHWAY 11 BULLEN CREEK CULVERTS, DISTRICT OF MUSKOKA**  
**AGREEMENT NO. 5017-E-0003**  
**Site Nos.: 42X-0034/C1 & 42X-0034/C2**

**G.W.P. 5138-13-00**

Geocres No.: 31E-390

February 2019  
Thurber File: 20244

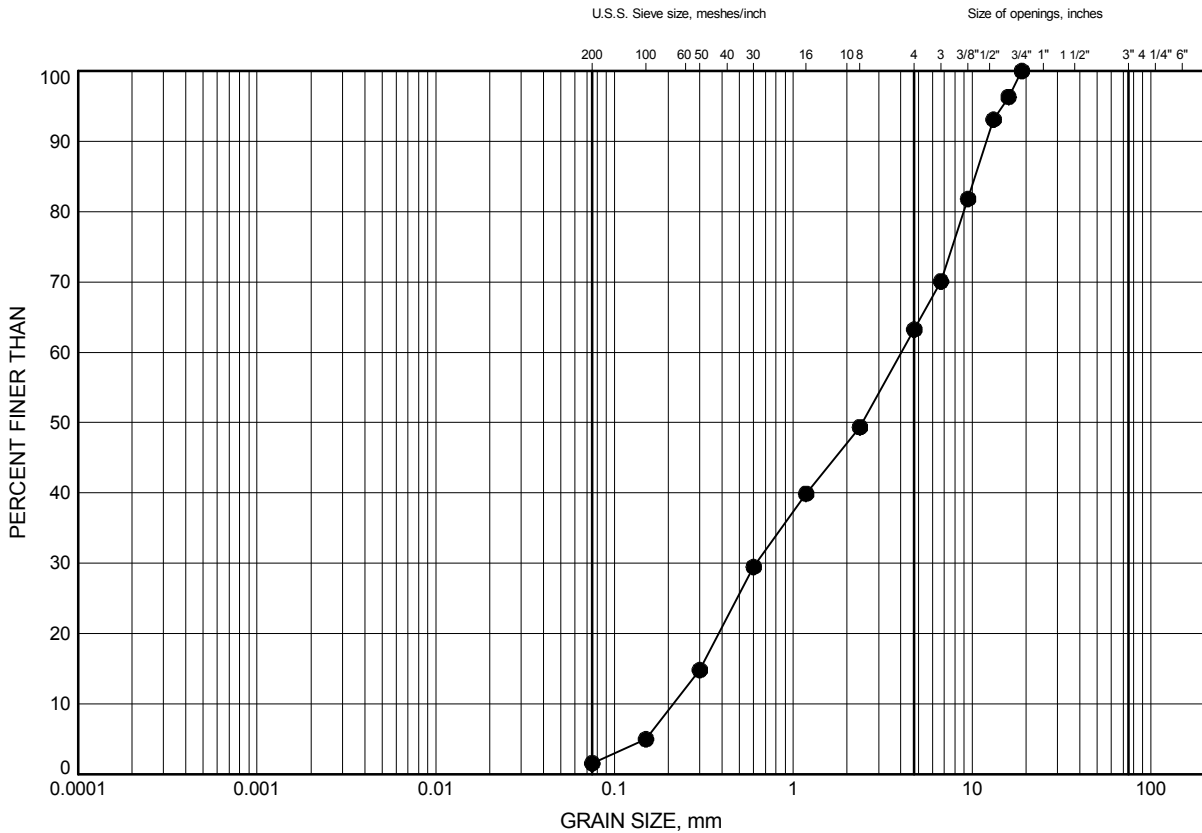
FIGURE C1

Recorded moisture contents ranged from 3 to 13%. The results of a grain size analysis conducted on a single sample of the pavement granular are summarized below and are illustrated on Figure C1 in Appendix C.

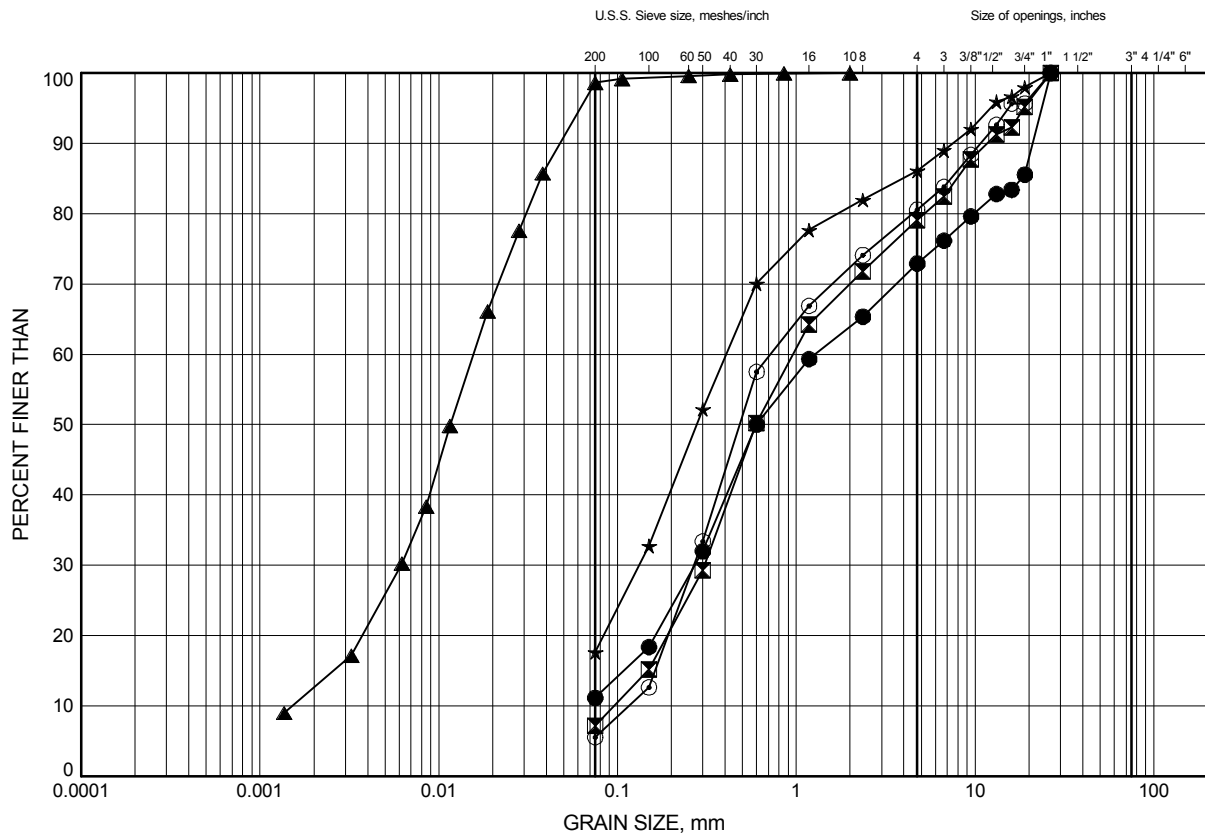
FIGURE C2

Recorded moisture contents ranged from 14 to 23%. An Atterberg Limits test indicated that the material is non-plastic. The results of grain size analysis conducted on a single sample of the silt embankment fill are summarized below and are illustrated on Figure C2 in Appendix C.

Recorded moisture contents ranged from 4 to 16%. The results of grain size analyses conducted on four samples of the sand fill are summarized below and are illustrated on Figure C2 in Appendix C.

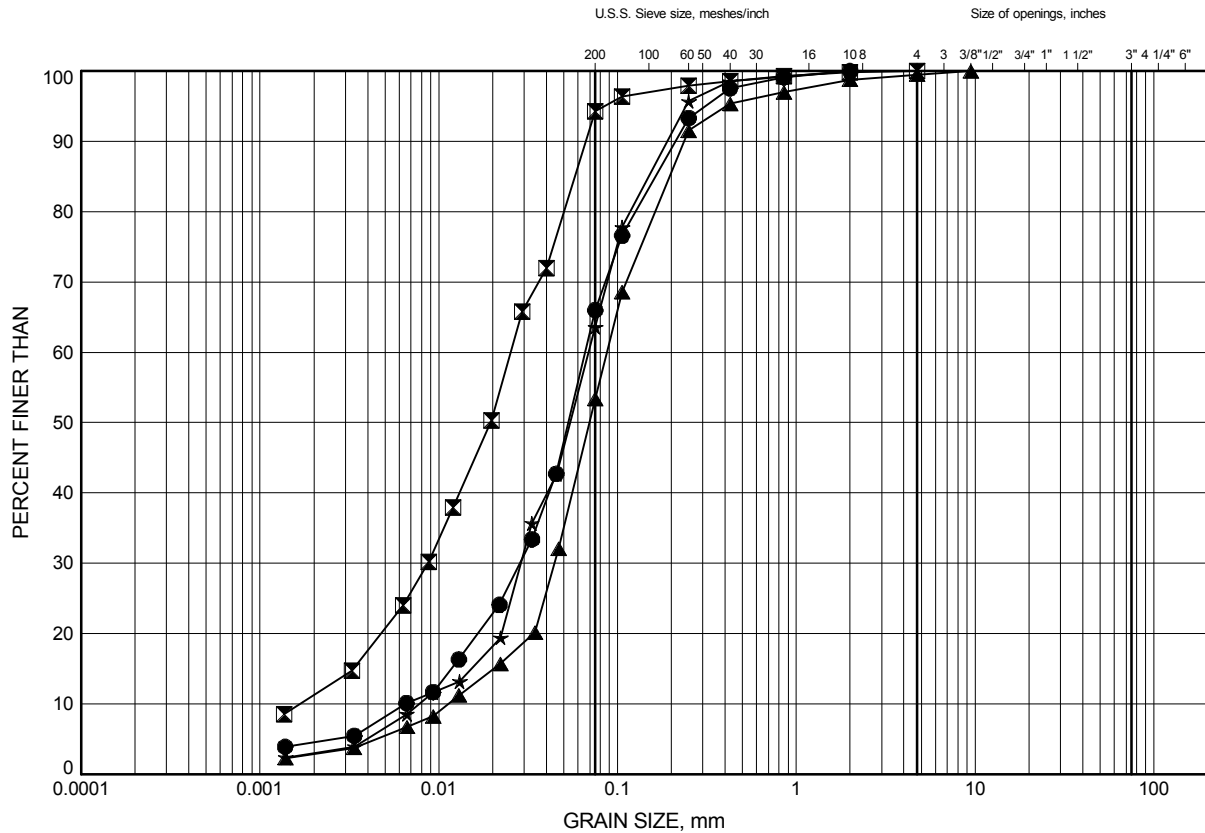
FIGURE C3

Recorded moisture contents ranged from 22 to 55%. Organic content testing was completed on one sample of the silt from Borehole 18-2 with a result of 7.5% organic content. The Atterberg Limit testing indicated the silt with organics was non-plastic. The results of grain size analyses conducted on four samples of the silt to sandy silt are summarized below and illustrated on Figure C3 in Appendix C.

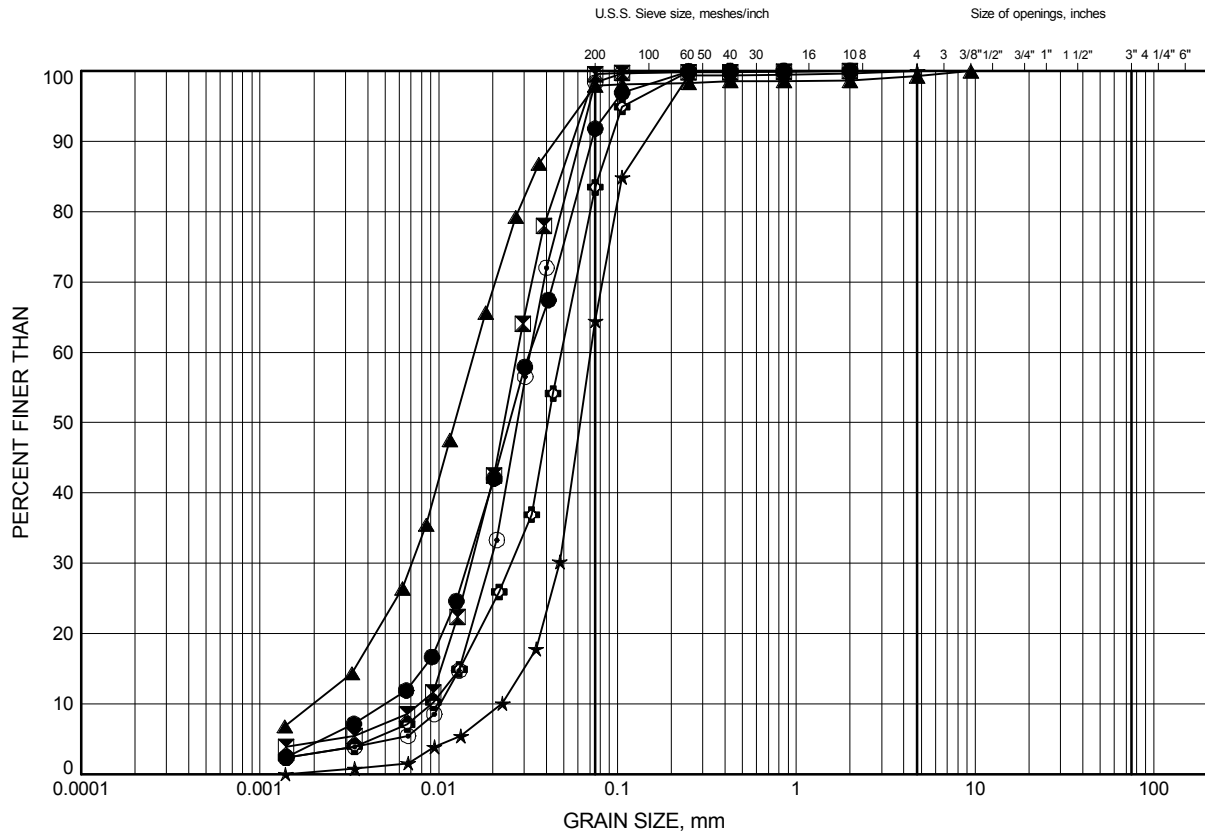
FIGURE C4

Recorded moisture contents ranged from 17 to 31%. Atterberg Limit testing on seven samples all indicated the material is non-plastic. The results of grain size analyses conducted on seven samples of the silt are summarized below and illustrated on Figures C4 and C5 in Appendix C.

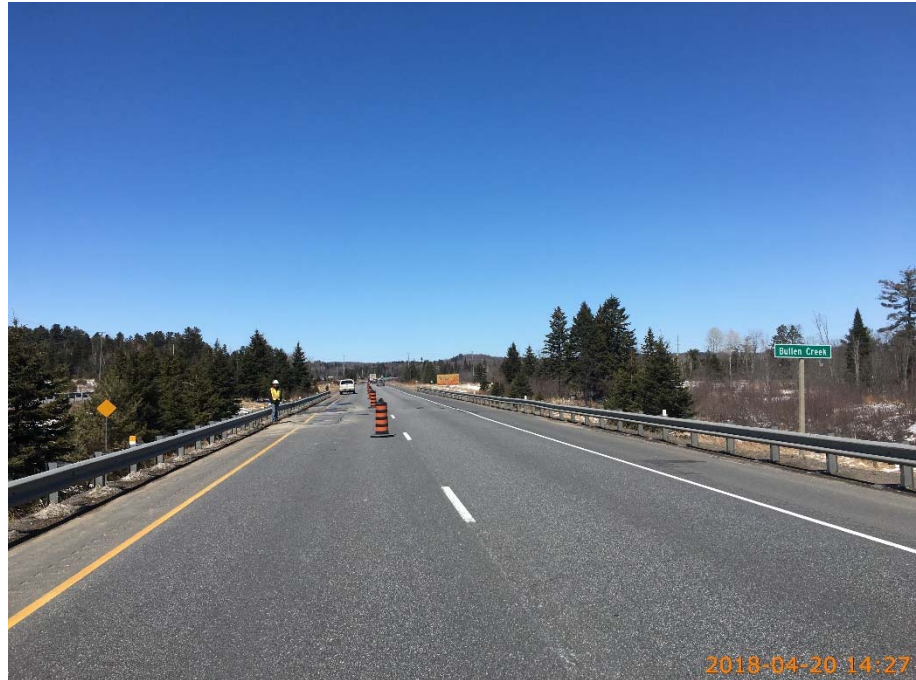
**Photo 1. Looking north along Highway 11 Northbound**

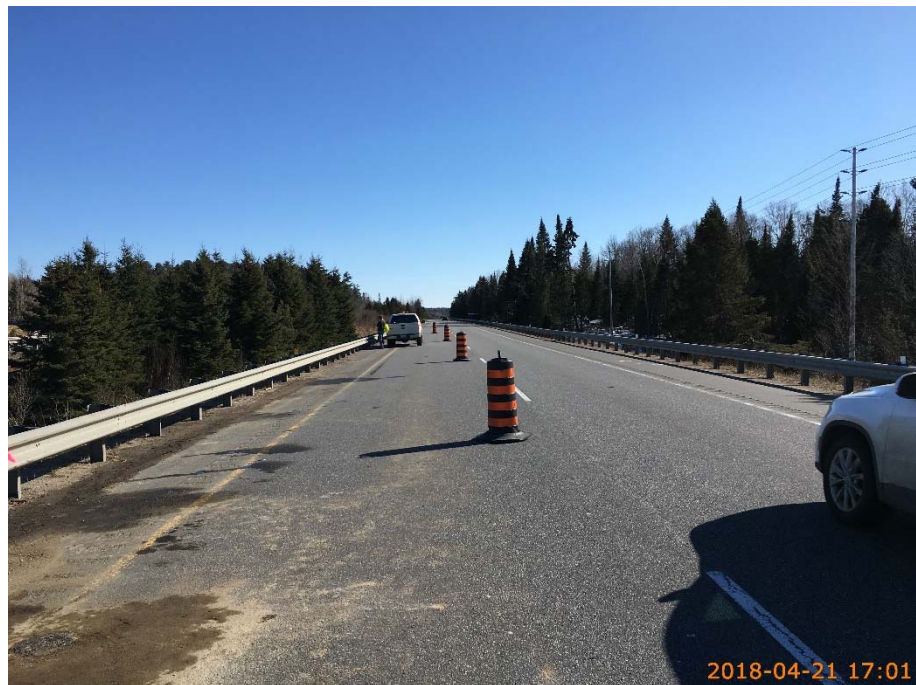
**Photo 2. Looking south along Highway 11 Southbound**

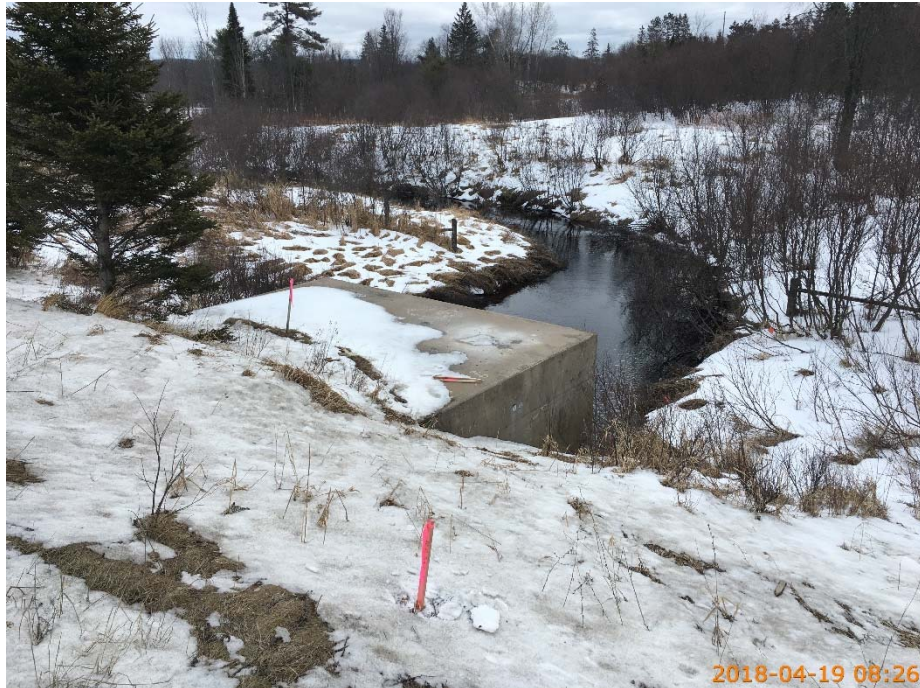
**Photo 3. Northbound outlet (42X-0034/C1) looking east**

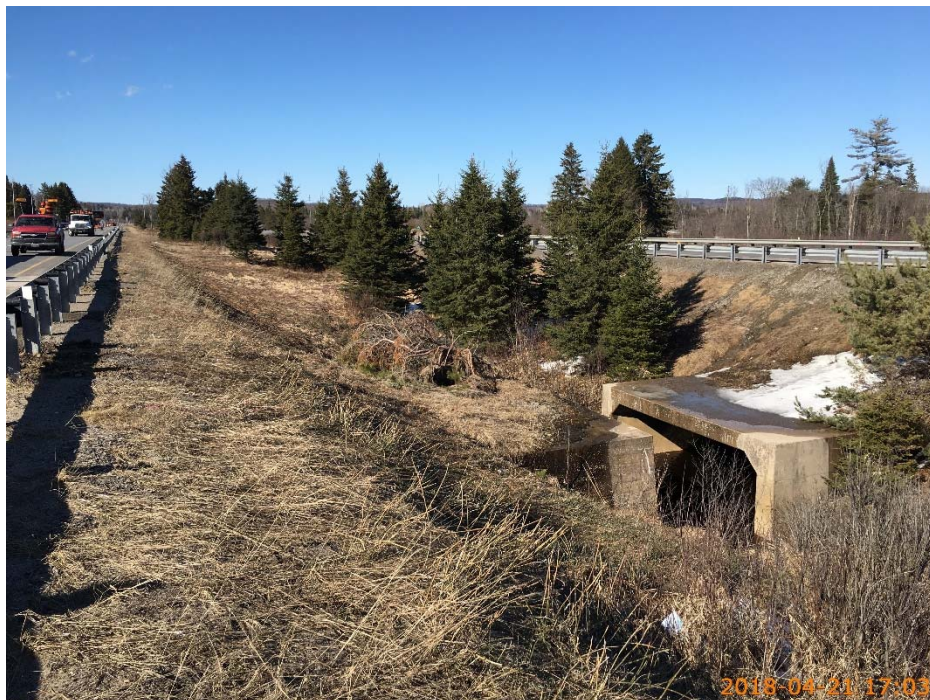
**Photo 4. Looking north at culvert ends in median**

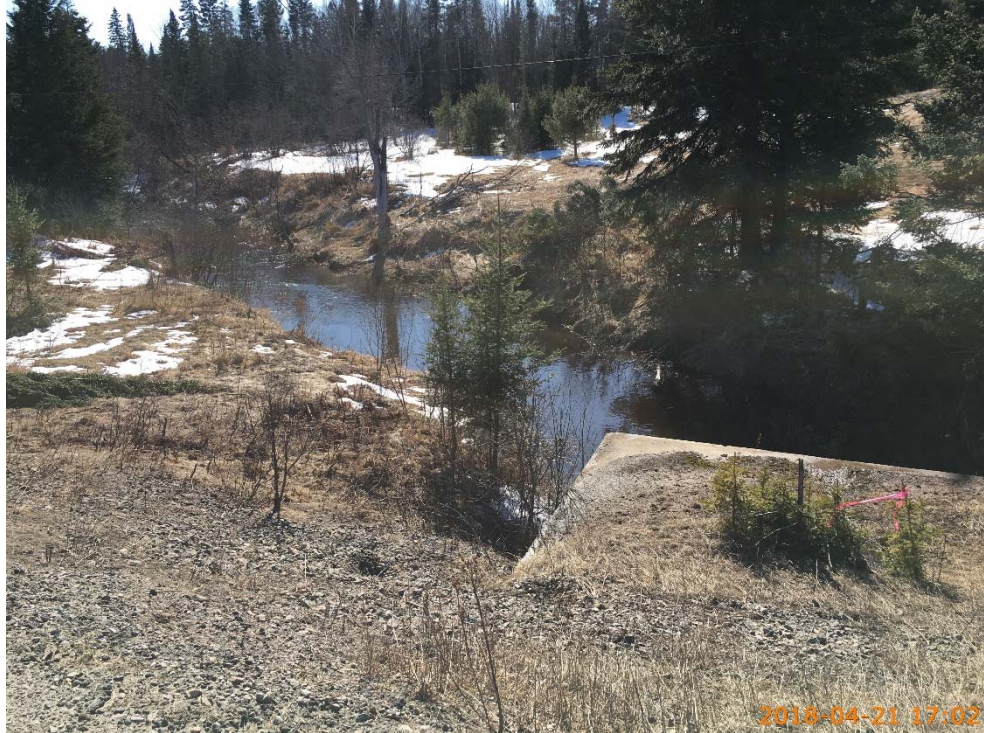
**Photo 5. Southbound inlet (42X-0034/C2) looking west**
