Foundation Investigation Report

Rehabilitation/Replacement of 25 Non-Structural Culverts at various locations of Highway 9, Highway 12, Highway, 400, Highway 401, Hwy 404 in Simcoe County, York Region, Durham Region, and City of Toronto - **Highway 12 CSPA Culvert Replacement (CV-0204-0012-0001)**

Final Report

May 17, 2023

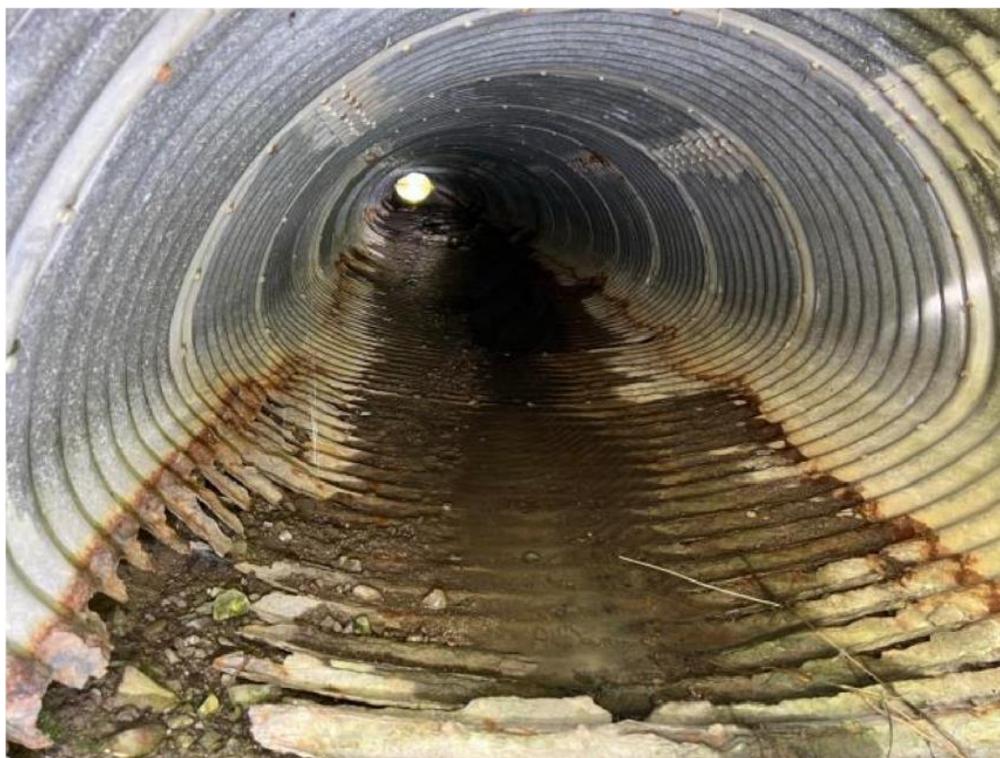
Photographs 1 and 2 (taken by MTO) and Photographs 3 to 9 (taken by EXP between July 2022 and October 2022) in Appendix A show the existing site, culvert, and road conditions. Photographs 1 and 2 show the condition of the inside of the culvert. It can be seen that the culvert barrels are corroded up to the springline; this also provides an indication of the high creek water levels expected through the culvert. It can be seen that the bottom of the culvert is almost completely deteriorated due to corrosion at the inlet side of the culvert. Photographs 3 and 4 shows the outside of the culvert inlet and outlet, respectively, and the side slopes of the embankment surrounding the culvert. Both ends of the culvert are surrounded by light vegetation immediately adjacent to the culvert opening. Photographs 5 and 6 show the existing condition of the NBL and SBL lane of Highway 12 at the culvert location, respectively. The existing pavement appears to be in good condition.

Photograph 1. Inside of existing CSPA culvert at inlet side (taken by MTO)

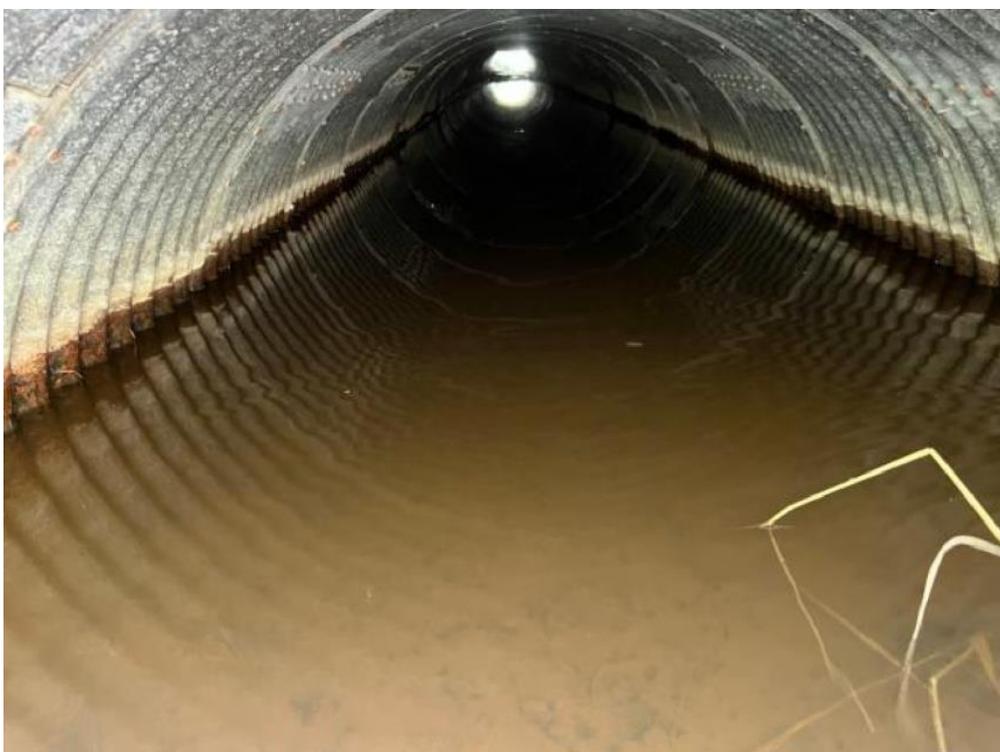
Photograph 2. Inside of existing CSPA culvert at outlet side (taken by MTO)

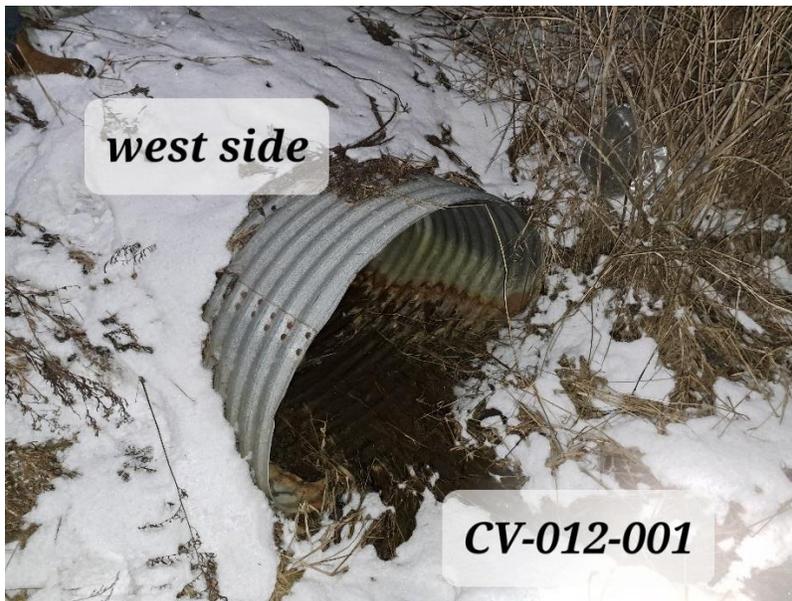
Photograph 3. Culvert inlet and embankment side slope area (facing east), January 2023 (taken by EXP)

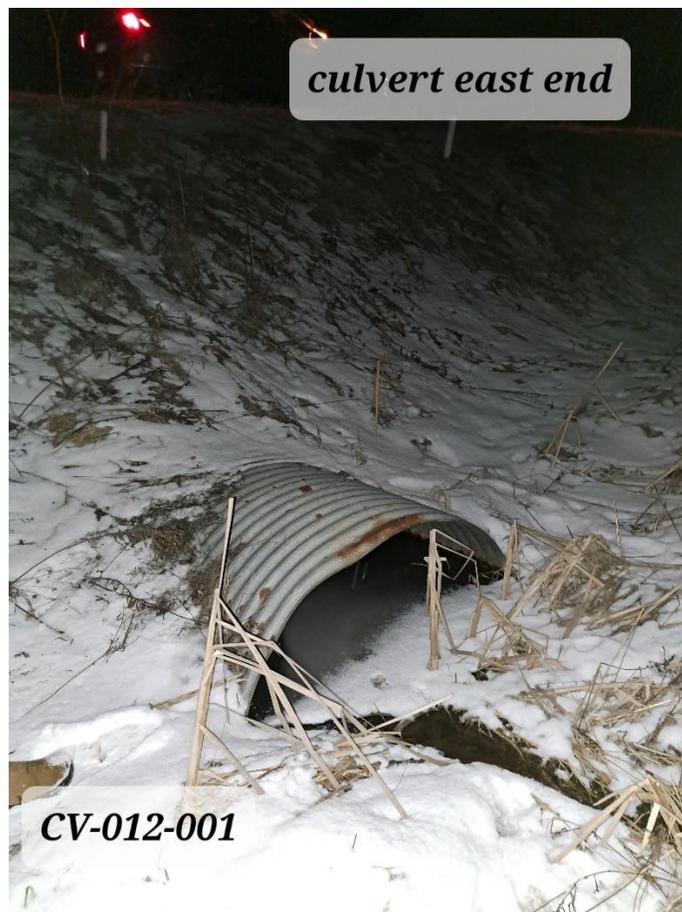
Photograph 4. Culvert outlet and embankment side slope area (facing west), January 2023 (taken by EXP)

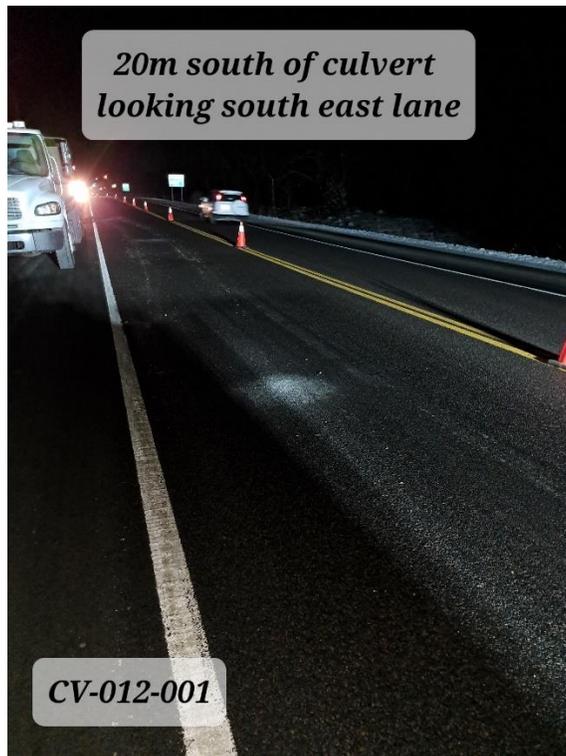
Photograph 5. Highway 12 roadway at culvert location, NB lane (facing south), January 2023 (taken by EXP)

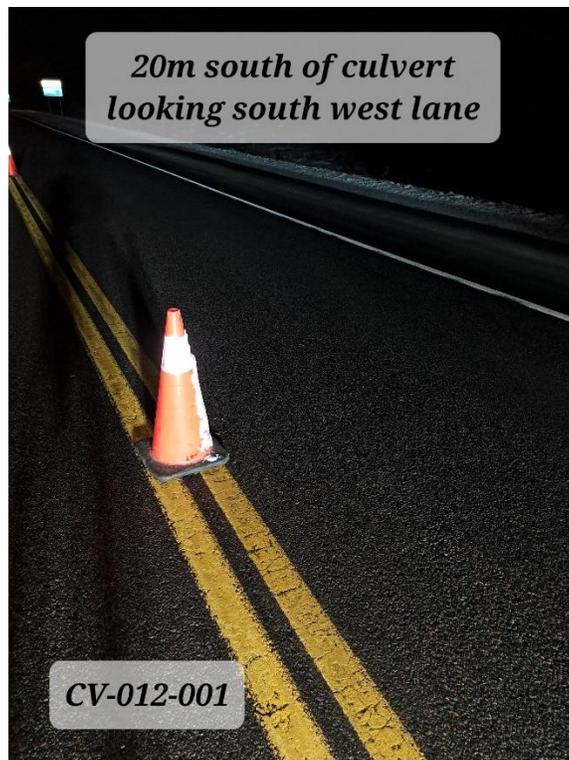
Photograph 6. Highway 12 roadway at culvert location, SB lane (facing south), January 2023 (taken by EXP)
