**Foundation Investigation and  
Design Report**  
Culvert Replacements  
Highway 7 - Norwood to Havelock  
Township of Dummer and Belmont  
W.P. 67-99-00

Project No. 122410158 (1047243)  
Geocres No. 31C-199

Prepared by:  
Stantec Consulting Ltd.  
200 – 2781 Lancaster Rd.  
Ottawa, ON K1B 1A7

August 2010

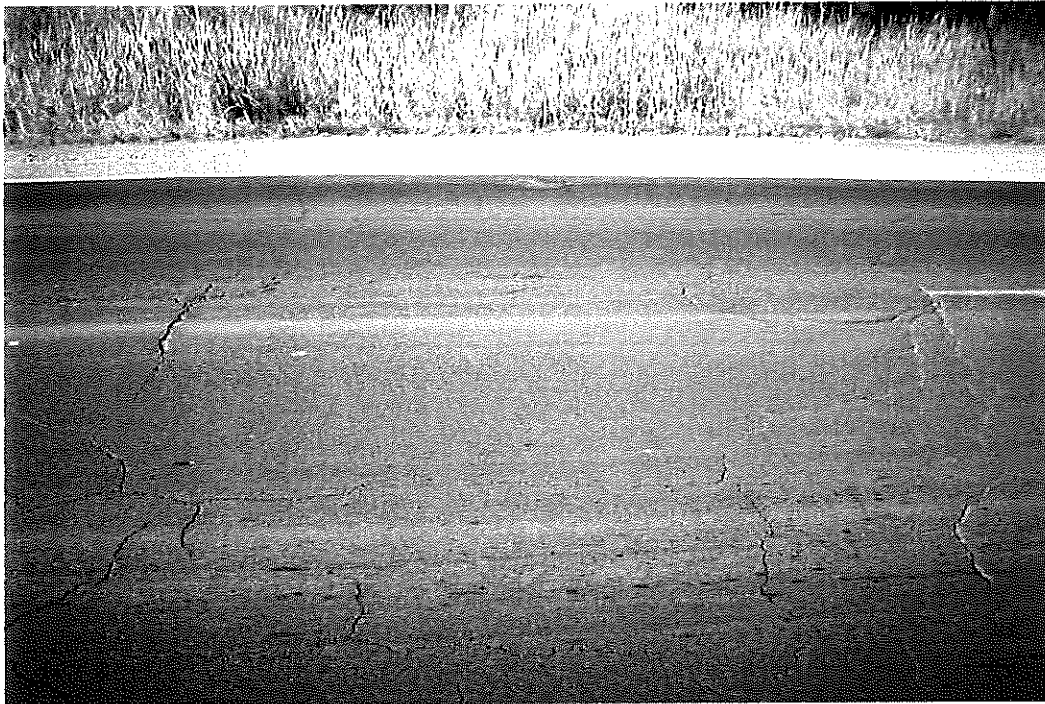
Photo 1 in Appendix B shows the general condition of the highway and the adjacent swamp. Photo 2 in Appendix B shows the general condition at the end of the existing culvert.

**Photo 1:** 27+139 – View of road and adjacent land in vicinity of culvert.

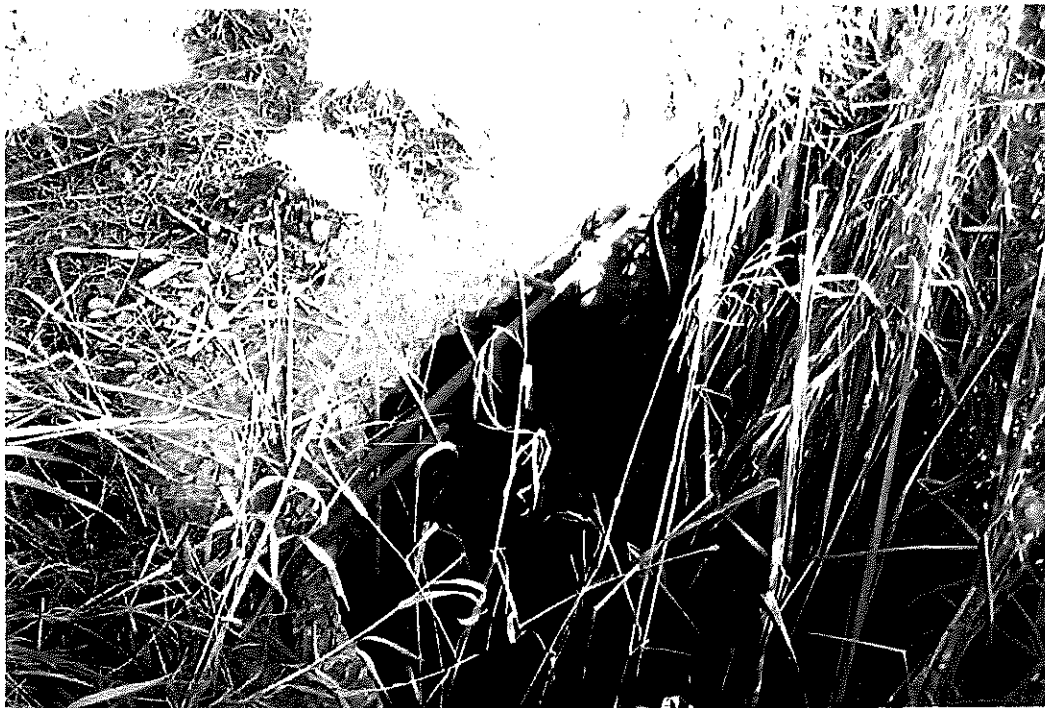
**Photo 2:** 27+139 – End of existing culvert.

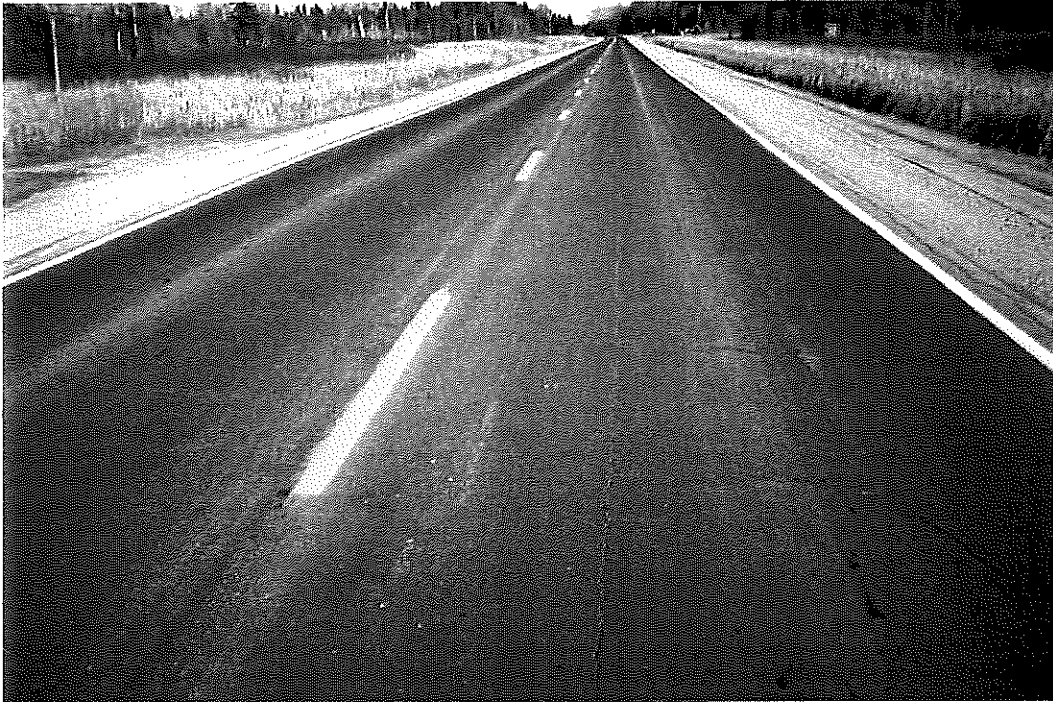
Photo 3 in Appendix C shows the general condition of the highway and the adjacent swamps. Photo 4 in Appendix C shows the general condition at the south end of the existing culvert.

**Photo 3: 10+937 – View of general conditions in vicinity of culvert.**

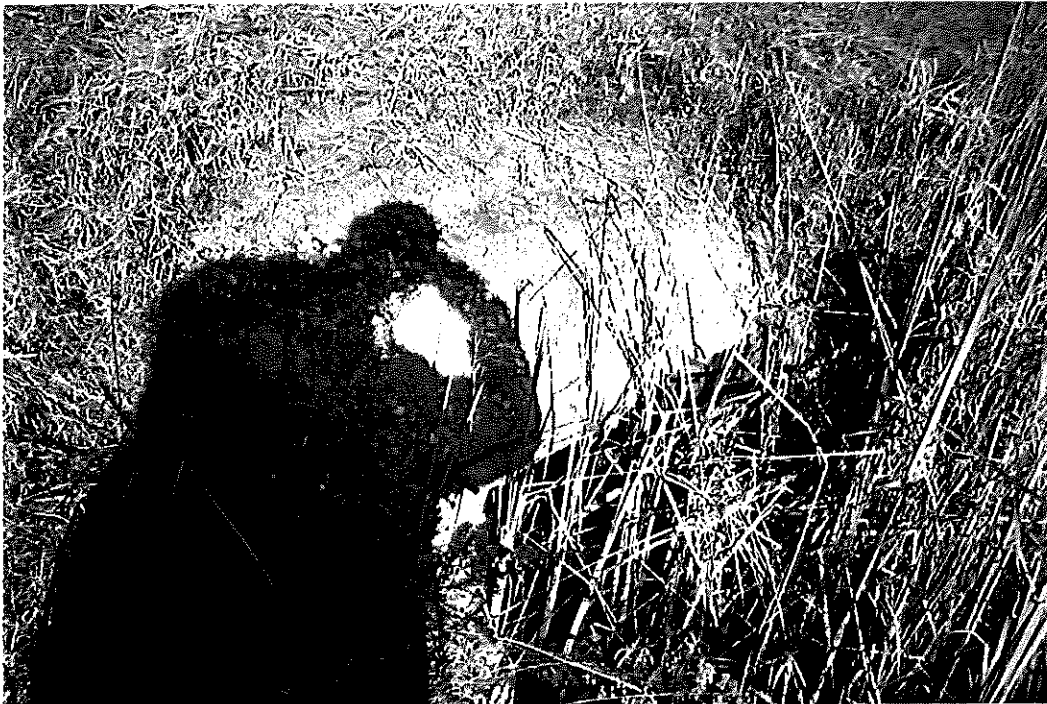
**Photo 4: 10+937 – End of existing culvert.**

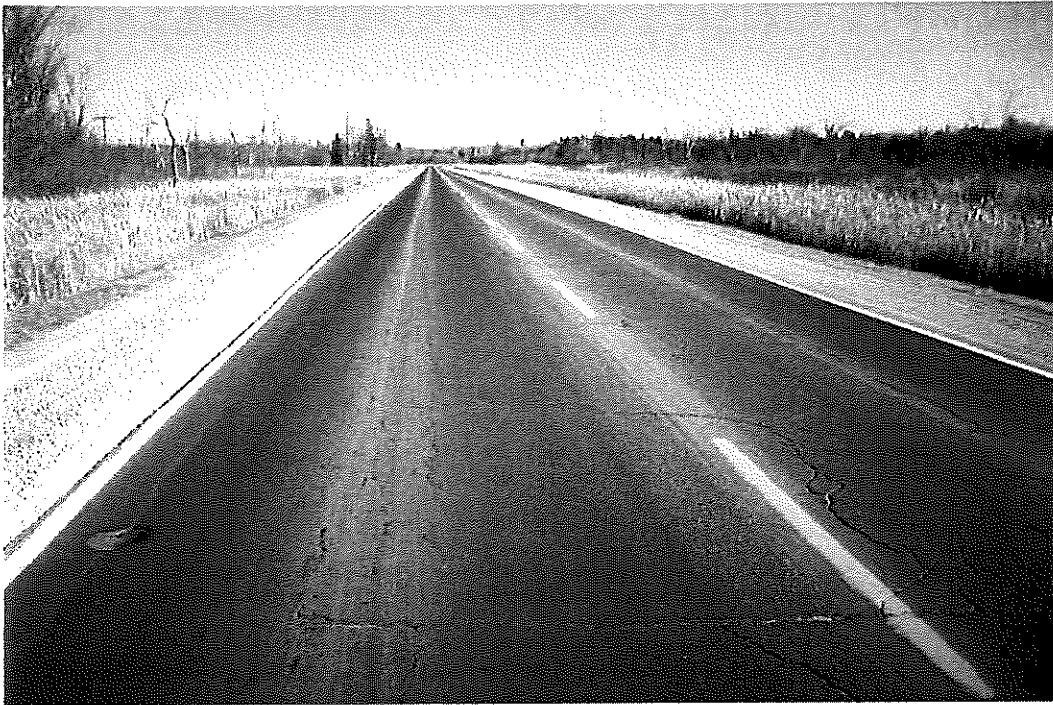
Photo 5 in Appendix D shows the general condition of the highway and the adjacent swamps. Photo 6 in Appendix D shows the general condition at the end of the existing culvert.

**Photo 5: 11+963 – View of general conditions in vicinity of culvert.**

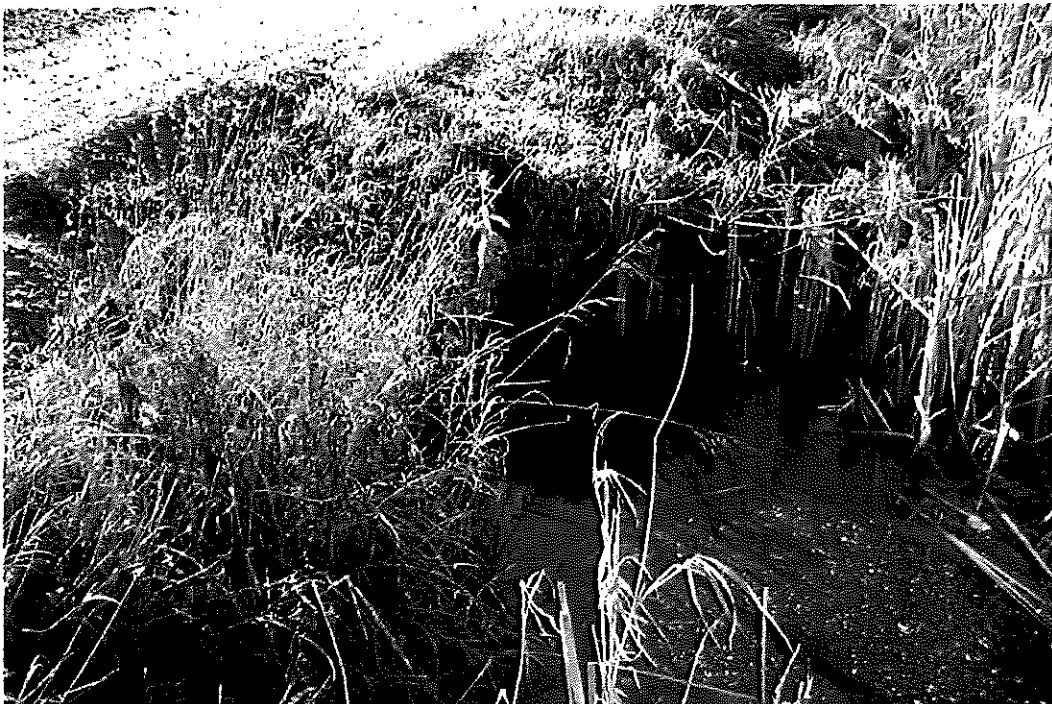
**Photo 6: 11+963 – End of existing culvert.**

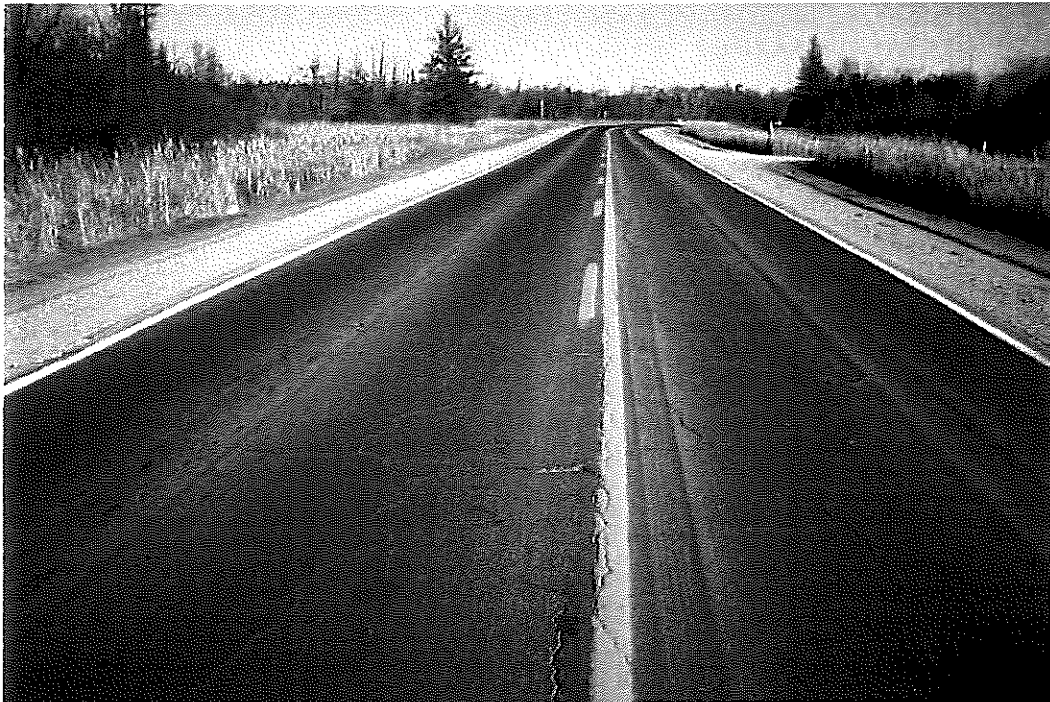
Photo 7 in Appendix E shows the general condition of the highway and the adjacent swamp. Photo 8 in Appendix E shows the general condition at the end of the existing culvert.

**Photo 7: 12+387 – View of general conditions in vicinity of culvert.**

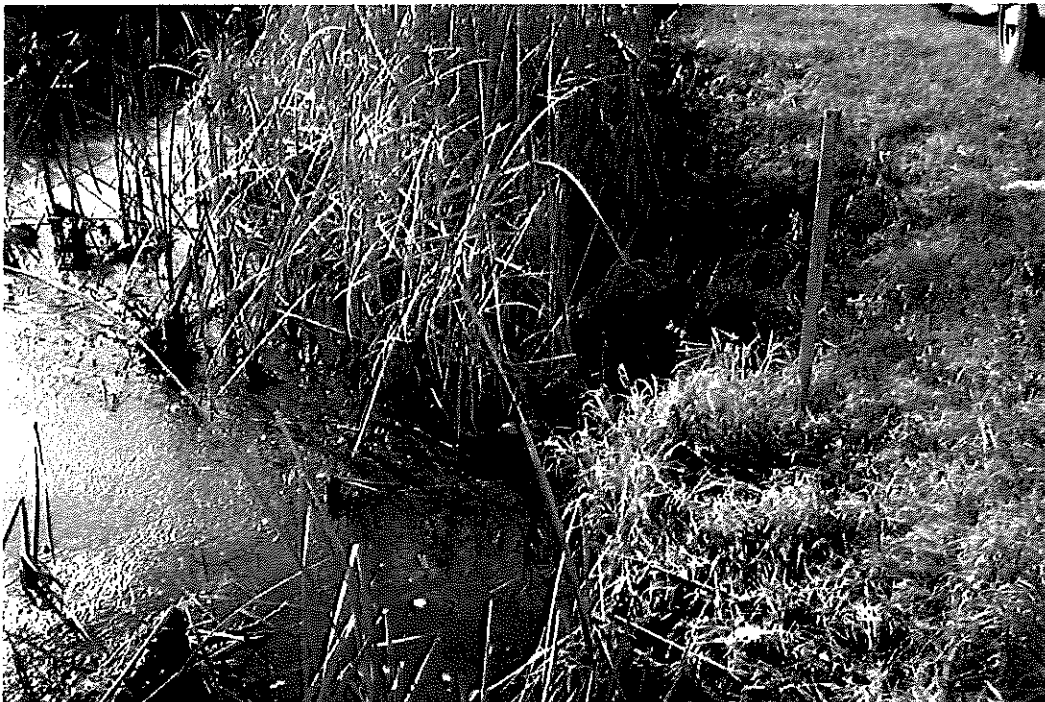
**Photo 8: 12+387 – Water at end of existing culvert.**
