## **Foundation Investigation and Design Report**

Chippewa Creek Culvert  
Rehabilitation  
Site No. 46-362, Highway 11,  
North Bay, ON

G.W.P. 5144-06-00

Prepared by:  
Stantec Consulting Ltd.  
400 – 1331 Clyde Avenue  
Ottawa, ON K2C 3G4

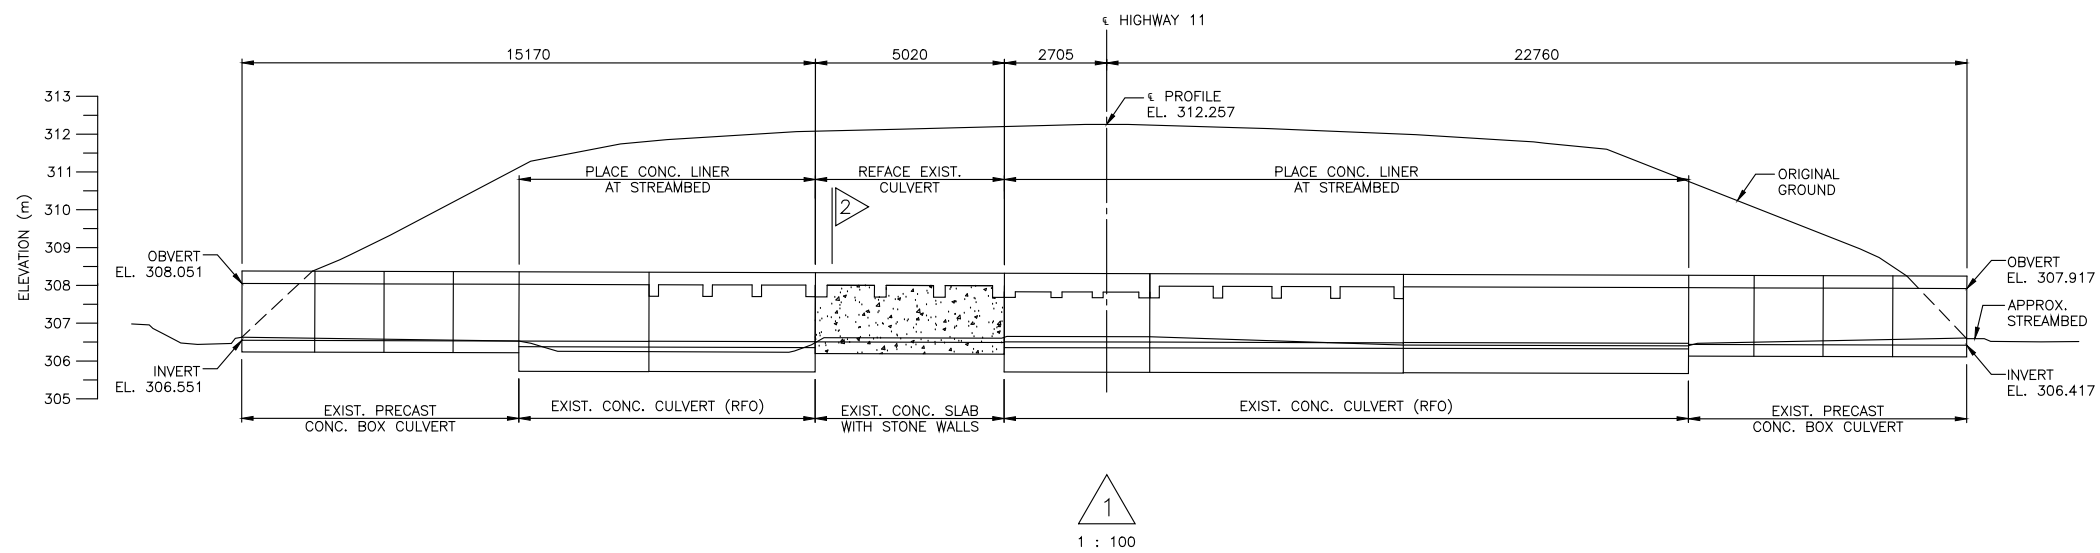
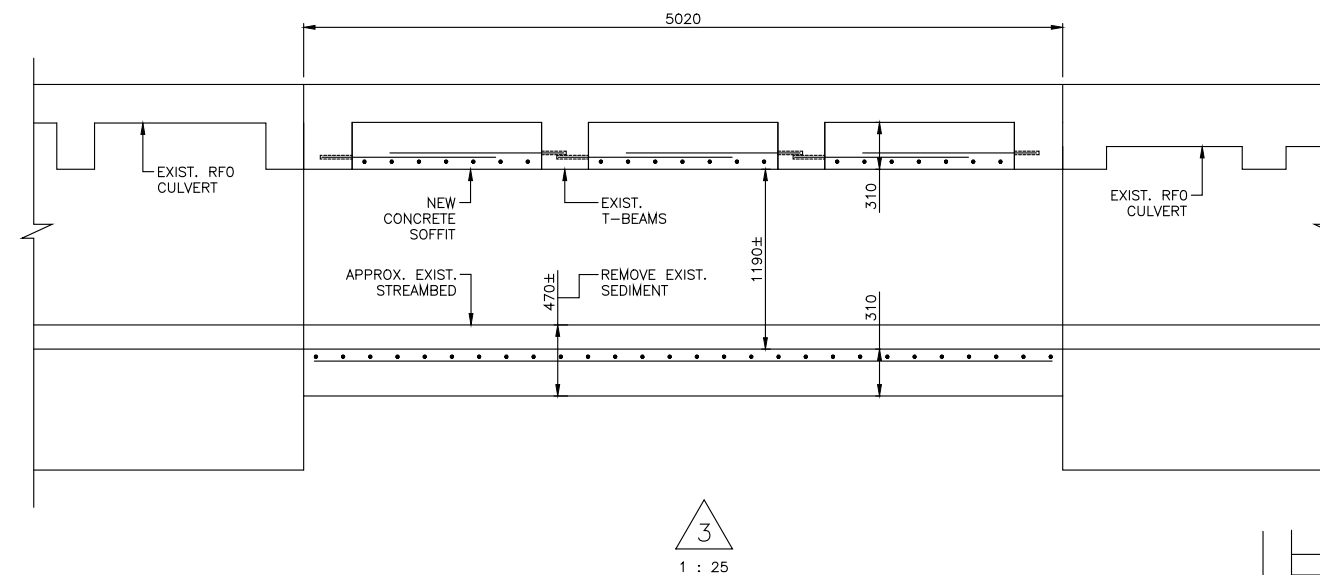
The middle portion of the existing culvert is shown on Section 2 on Drawing P1 provided in Appendix A. The concrete slab is depicted to rest on stone and mortar foundations which have been partially eroded by the creek flow. The stone and mortar foundations are approximately 0.75 m wide at the top and 1.3 m wide at the base. It is estimated that the footing embedment depth inside the culvert, below the streambed, is 1.8 m. The proposed rehabilitation includes the placement of a reinforced cast-in-place concrete box with a top of floor about 1.7 m above the underside of the existing stone and mortar foundation.

The proposed rehabilitation of the culvert involves relining the poor performing middle portion of the culvert, repairing deteriorated concrete for the remainder of the culvert, installing concrete lining at the streambed within the open bottom portions of the culvert, adding stone walls at the culvert inlet and providing rock protection at both ends of the culvert.

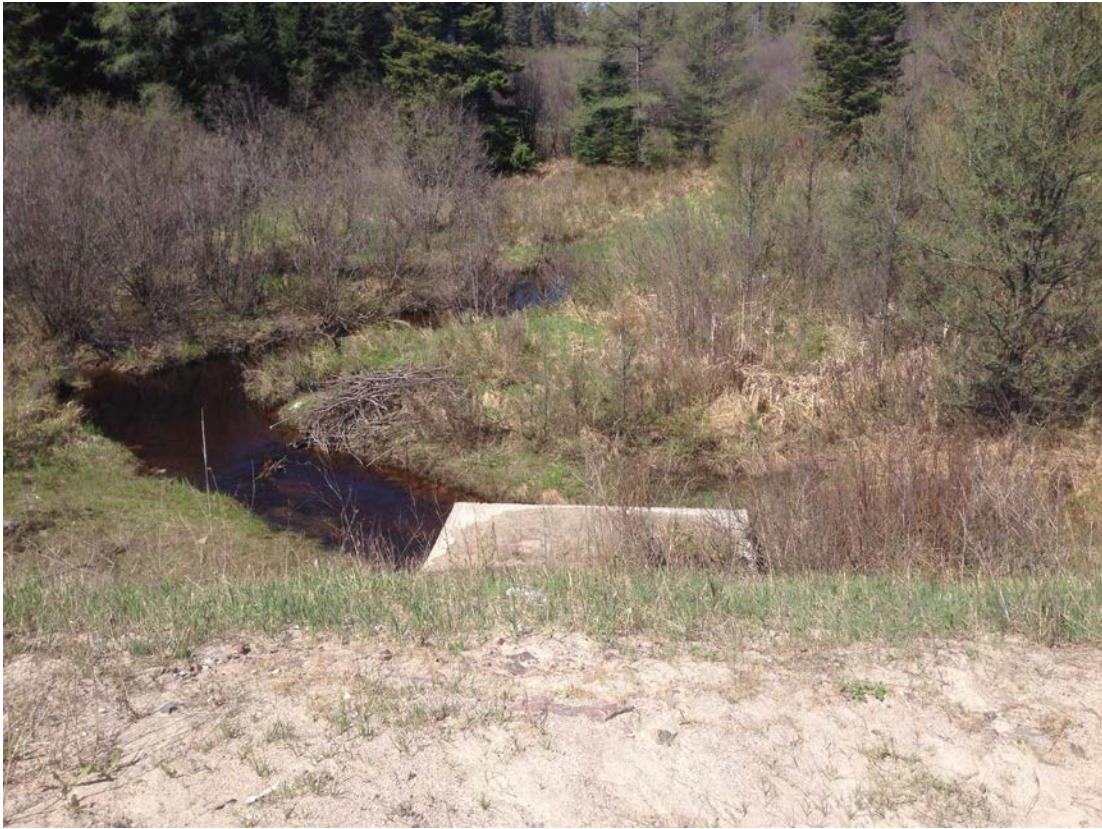
Photo No. 3: Culvert inlet, west side of Highway 11.

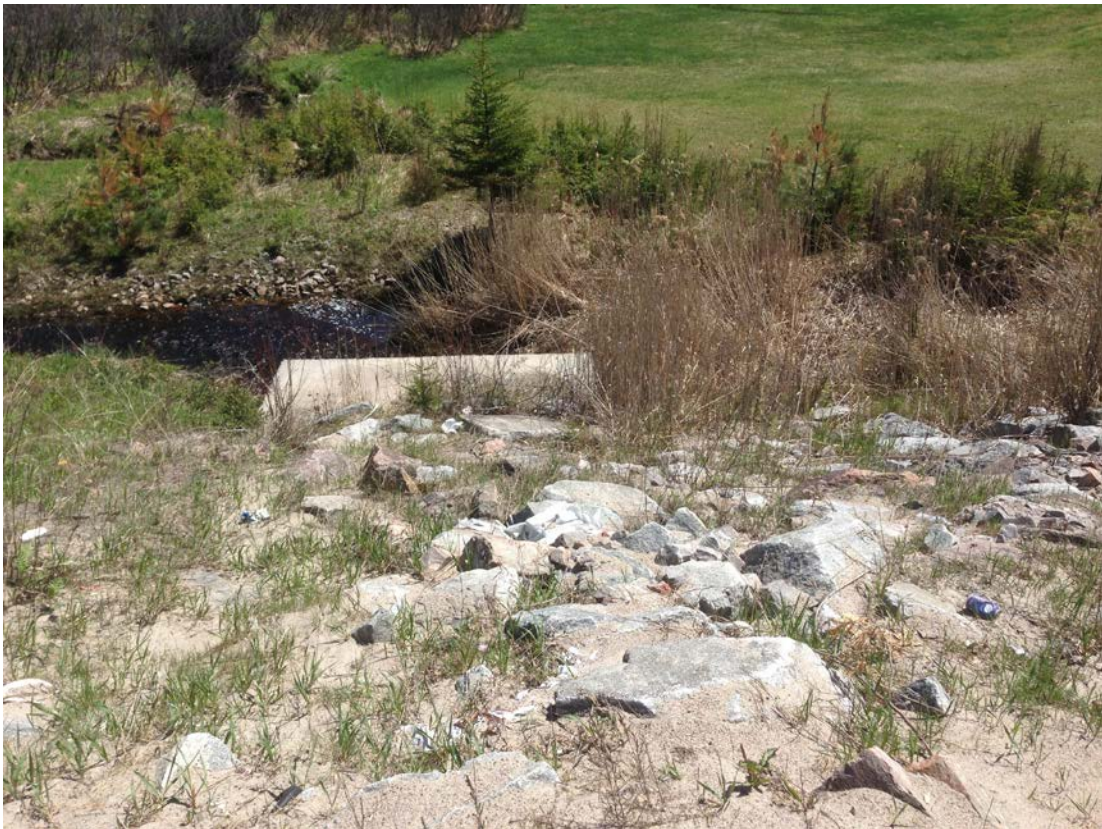
Photo No. 4: Culvert outlet, east side of Highway 11 showing rock fill on slope.

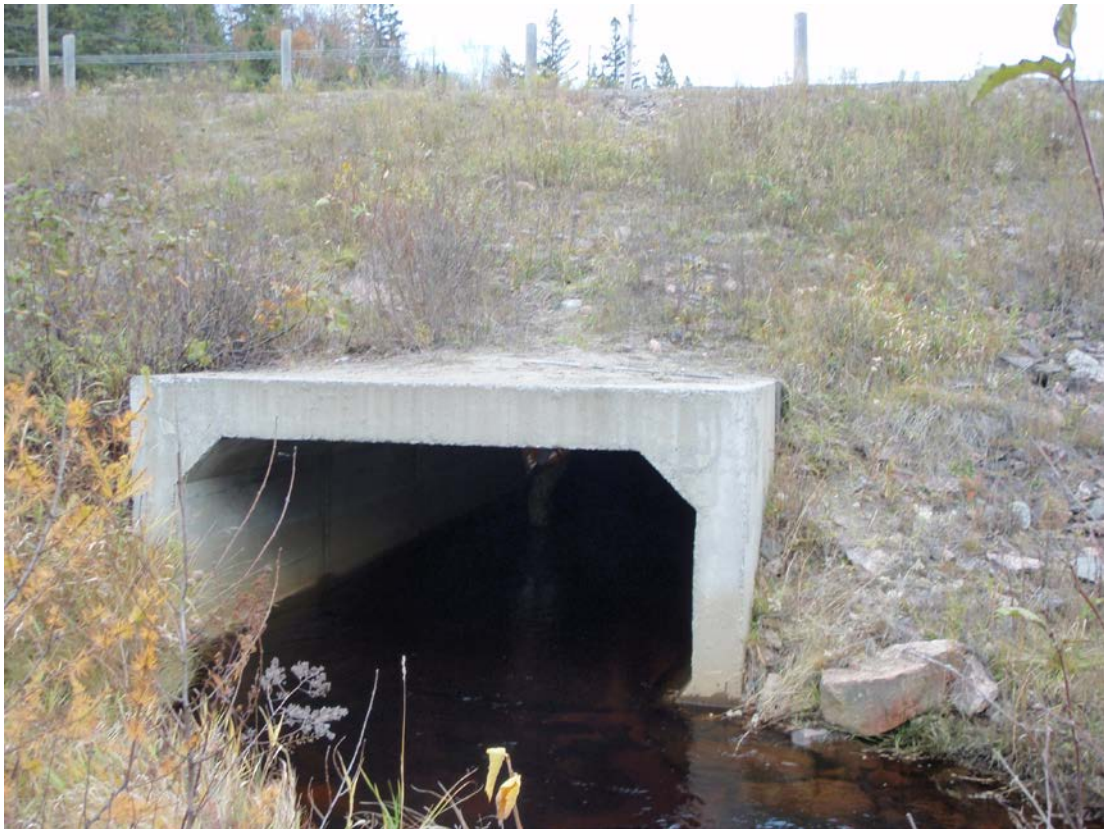
Photo No. 5: Culvert inlet, west side of Highway 11.

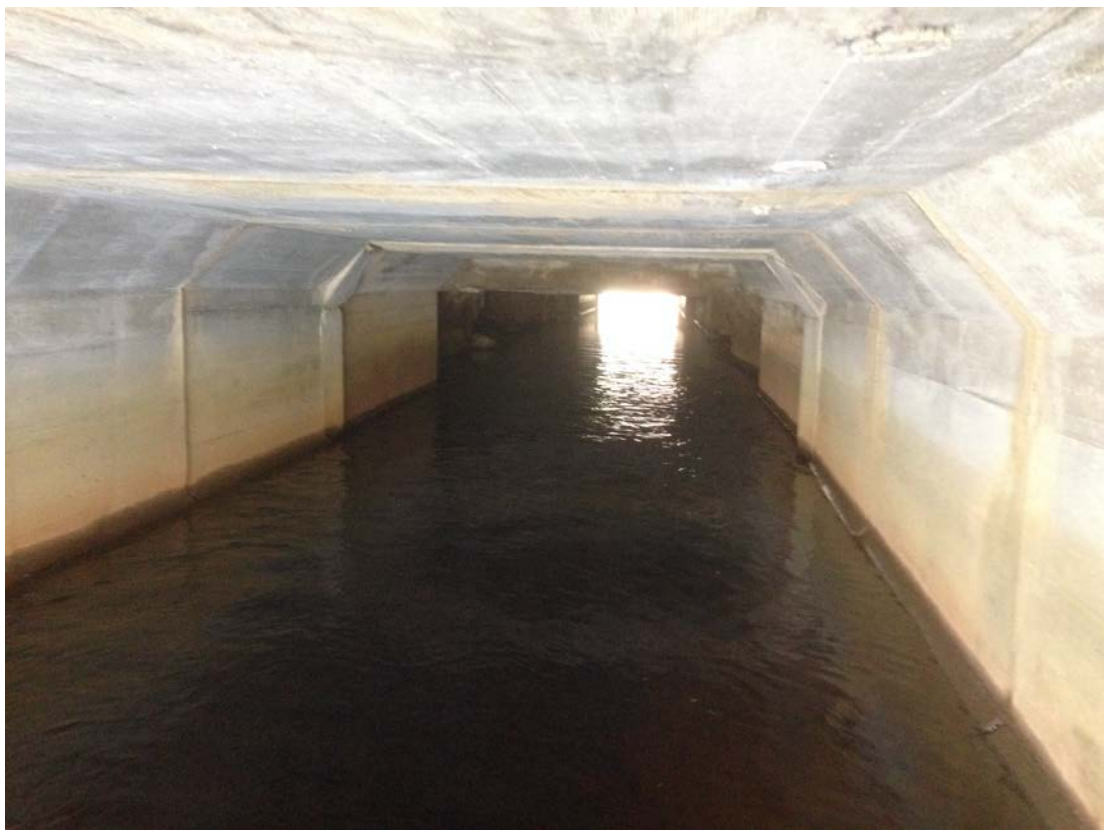
Photo No. 6: Interior of culvert looking east.

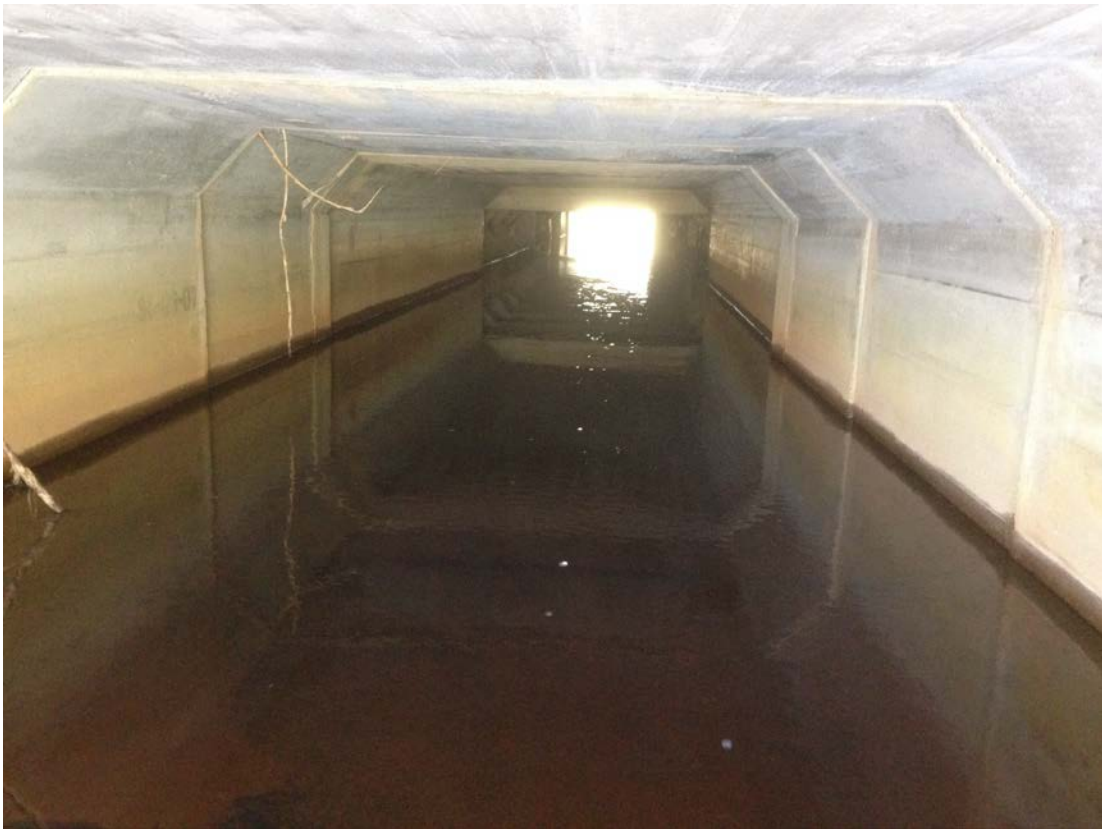
Photo No. 7: Interior of culvert looking west.

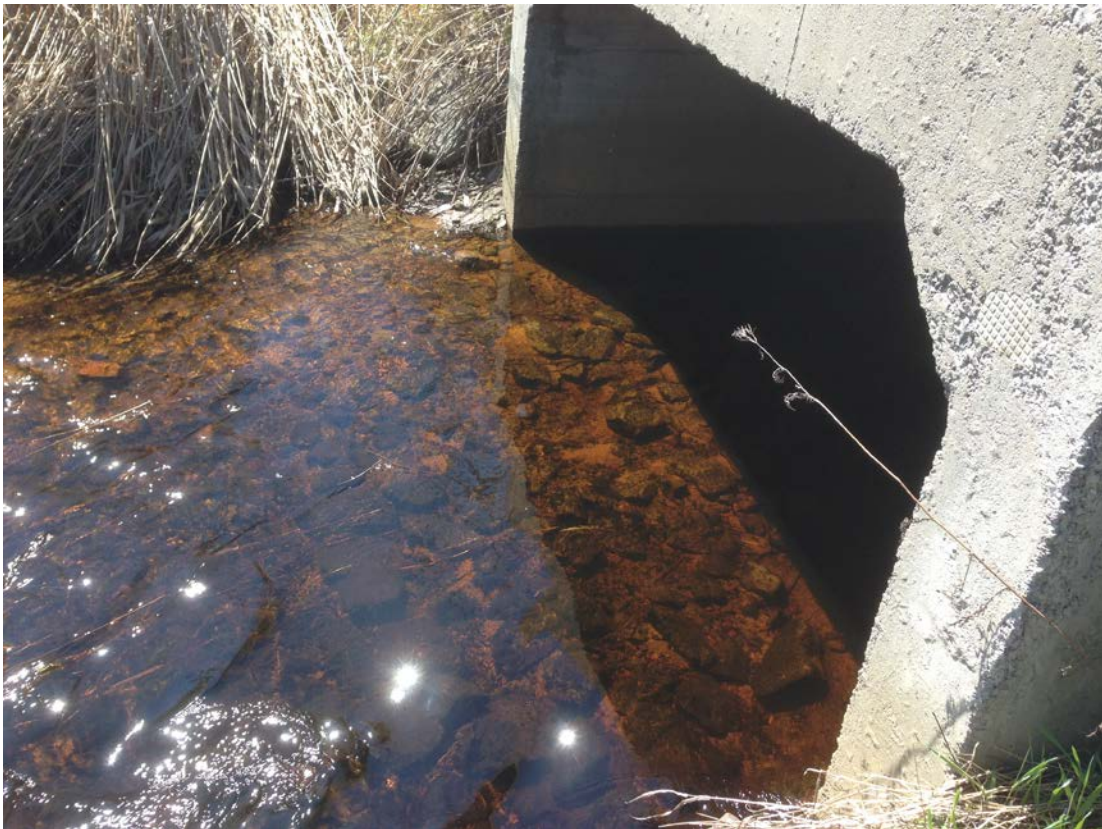
Photo No. 8: Culvert outlet, showing creek bed and sediment in culvert.

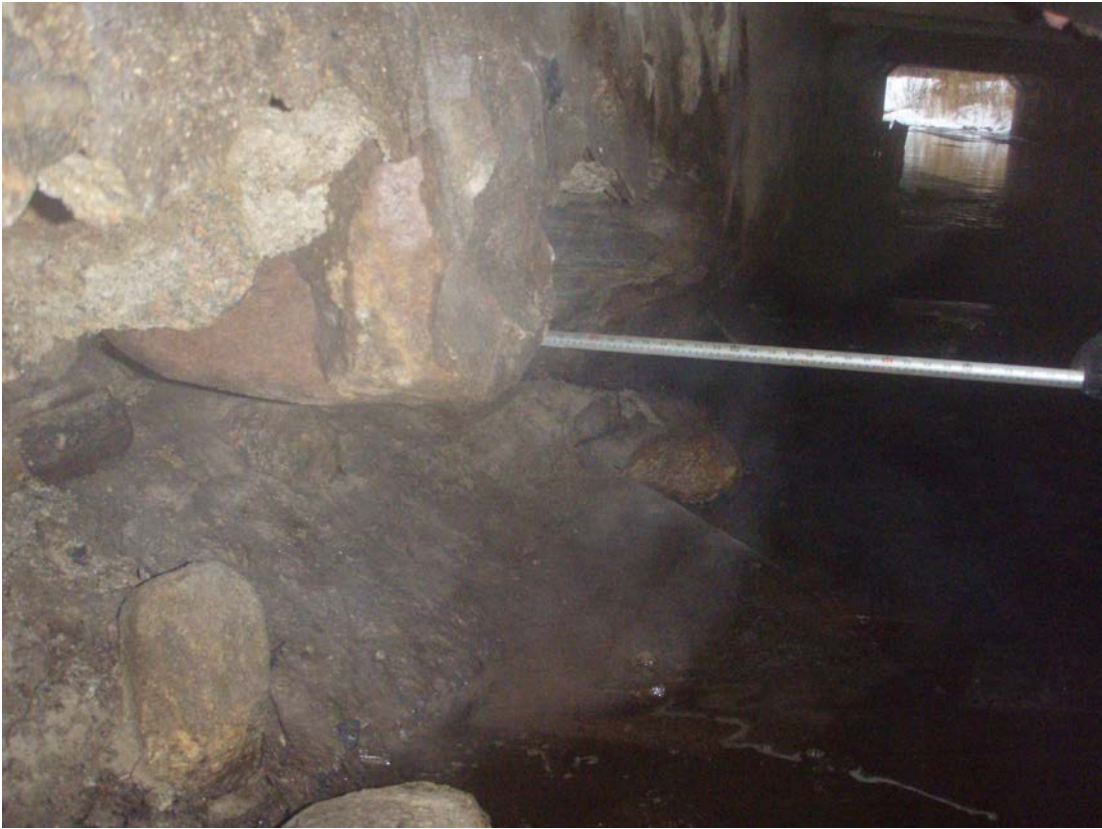
Photo No. 9: Deterioration of stone wall and concrete in middle-west section of culvert.

1. Install a concrete lining within the middle portion of the culvert to address the condition of the stone and mortar foundation walls
2. Provide a temporary support system to shore the top slab of the original middle portion of the culvert during construction
3. Repair deteriorated concrete for the remainder of the culvert
4. Install a concrete lining at the streambed within the open bottom portions of the culvert
5. Add stone walls at the inlet to improve efficiency of hydraulic performance
6. Provide rock protection at both ends of the culvert

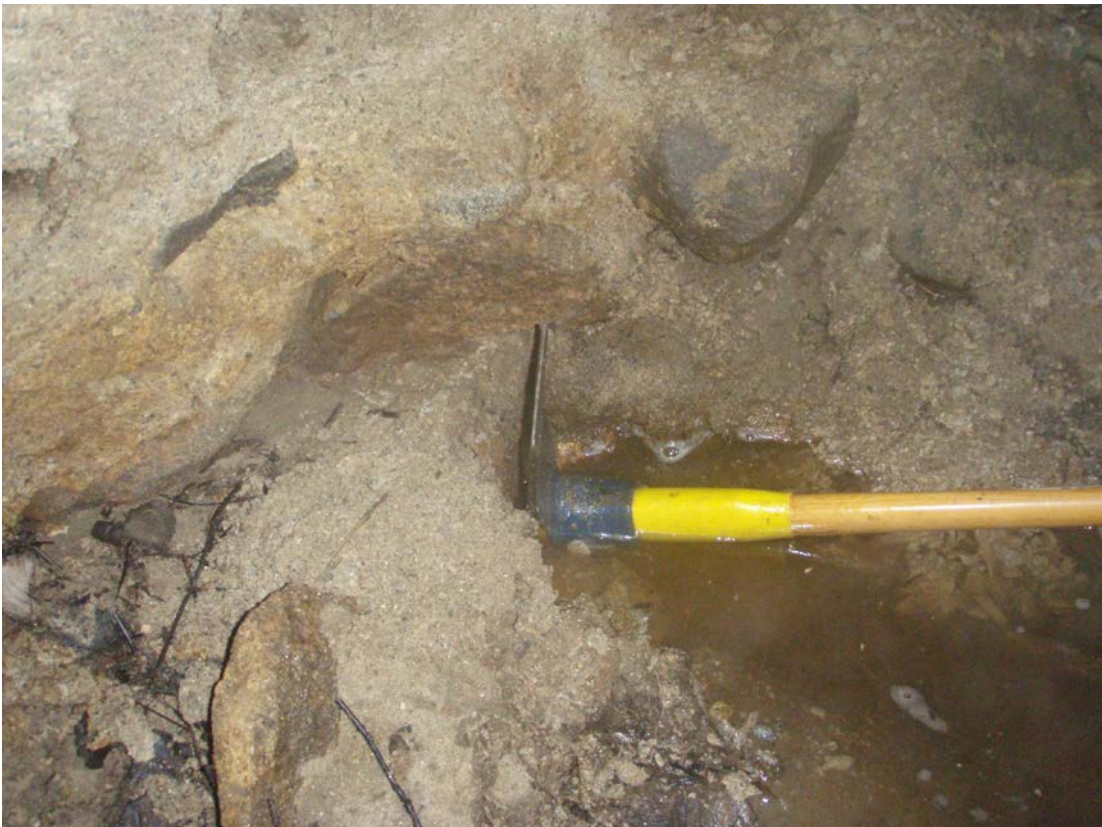
Photo No. 10: Deterioration of stone wall and concrete in middle-west section of culvert.

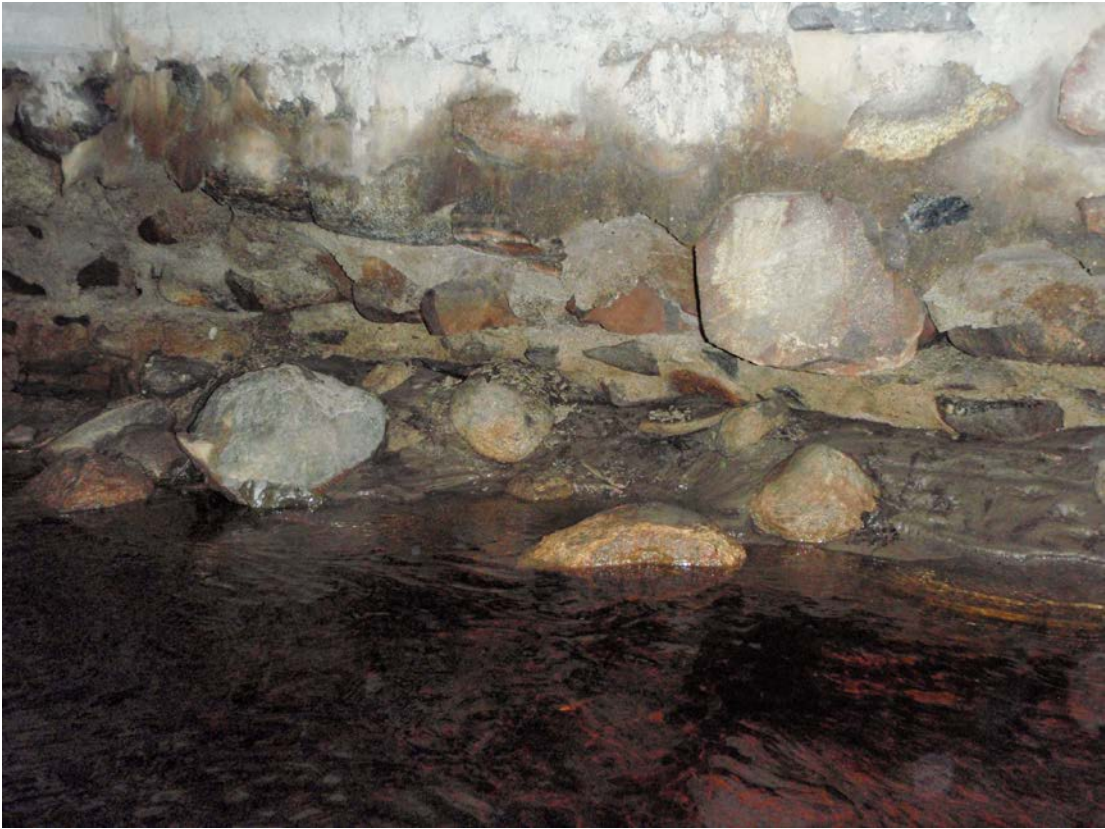
Photo No. 11: Deterioration of stone wall and concrete in middle-west section of culvert.
