FOUNDATION INVESTIGATION AND DESIGN REPORT

Proposed Non-Structural Culvert
Replacement,
Highway 48, 240 m South of
Stouffville Road/Main Street,
Town of Whitchurch-Stouffville,
Ontario

MINISTRY OF TRANSPORTATION (MTO)

WSP PROJECT NO.: 18M-01021-13
DATE: JUNE 26, 2020

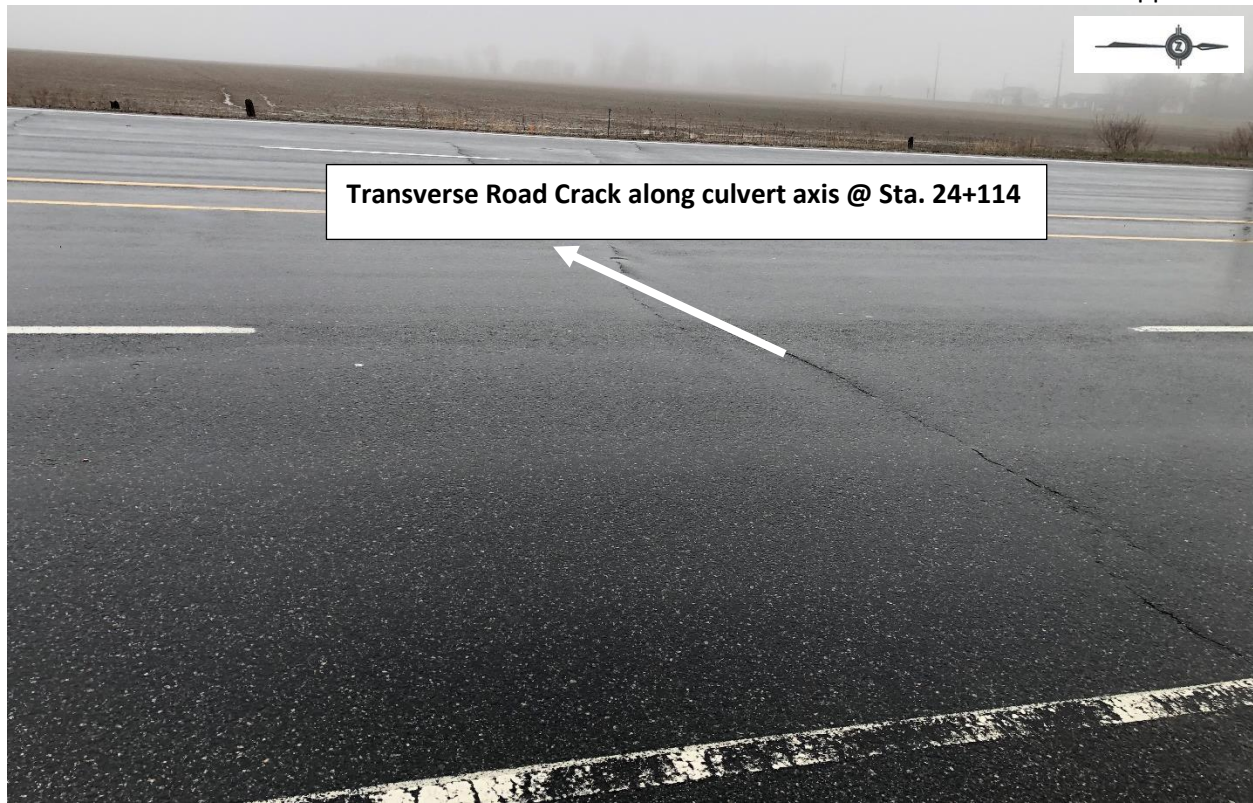
Photo C1-1: Looking towards West across Highway 48 at Culvert Sta. 24+114 (May 2019)

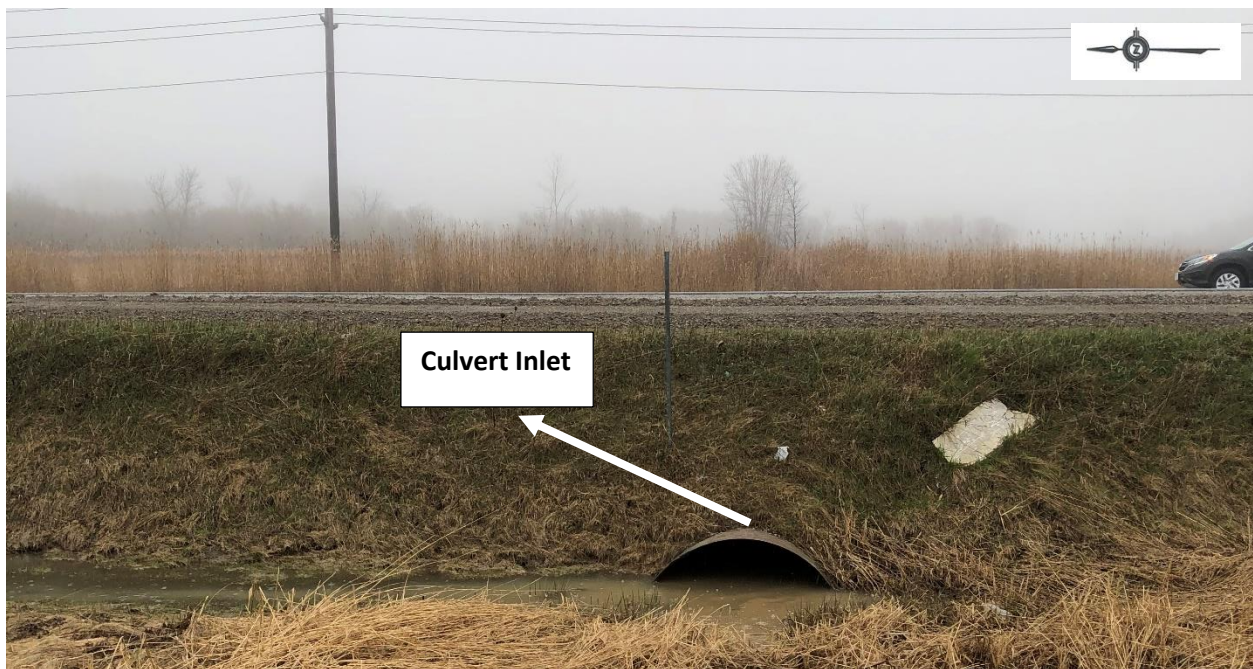
Photo C1-2: Looking towards East at culvert Inlet Sta. 24+114 (May 2019)

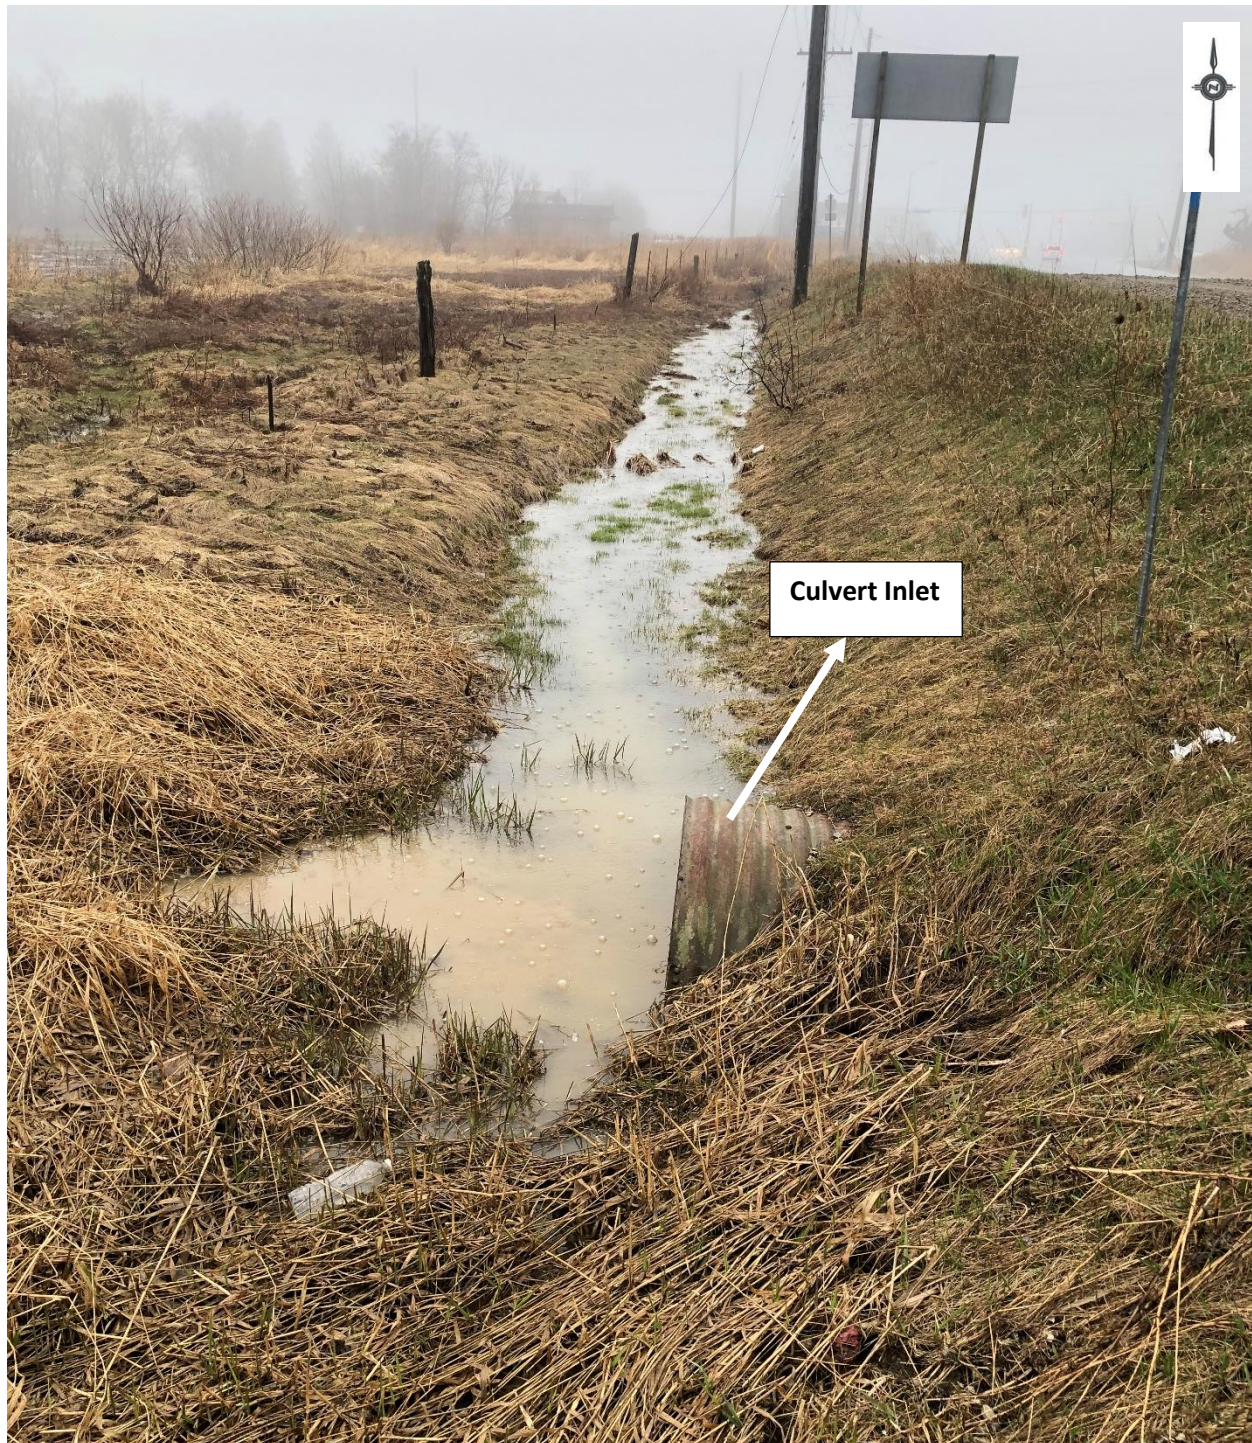
Photo C1-3: Looking towards North at culvert Inlet Sta. 24+114 (May 2019)

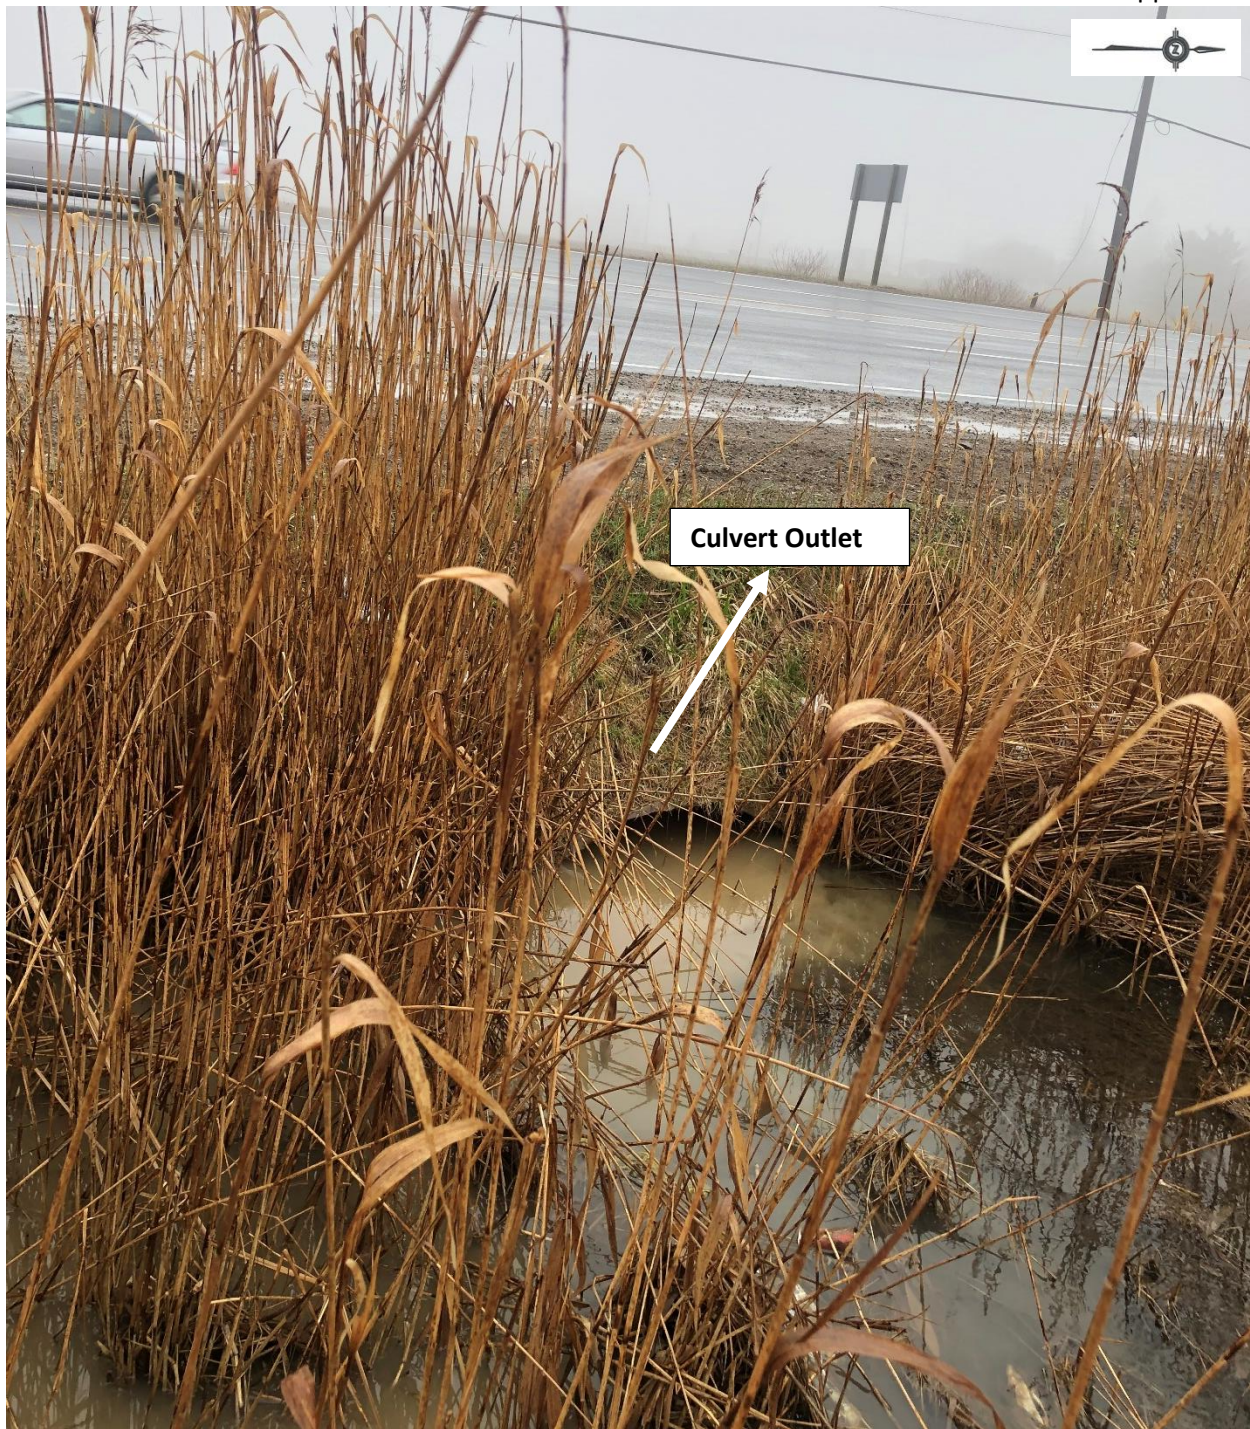
Photo C1-4: Looking towards West at culvert outlet Sta. 24+114 (May 2019)

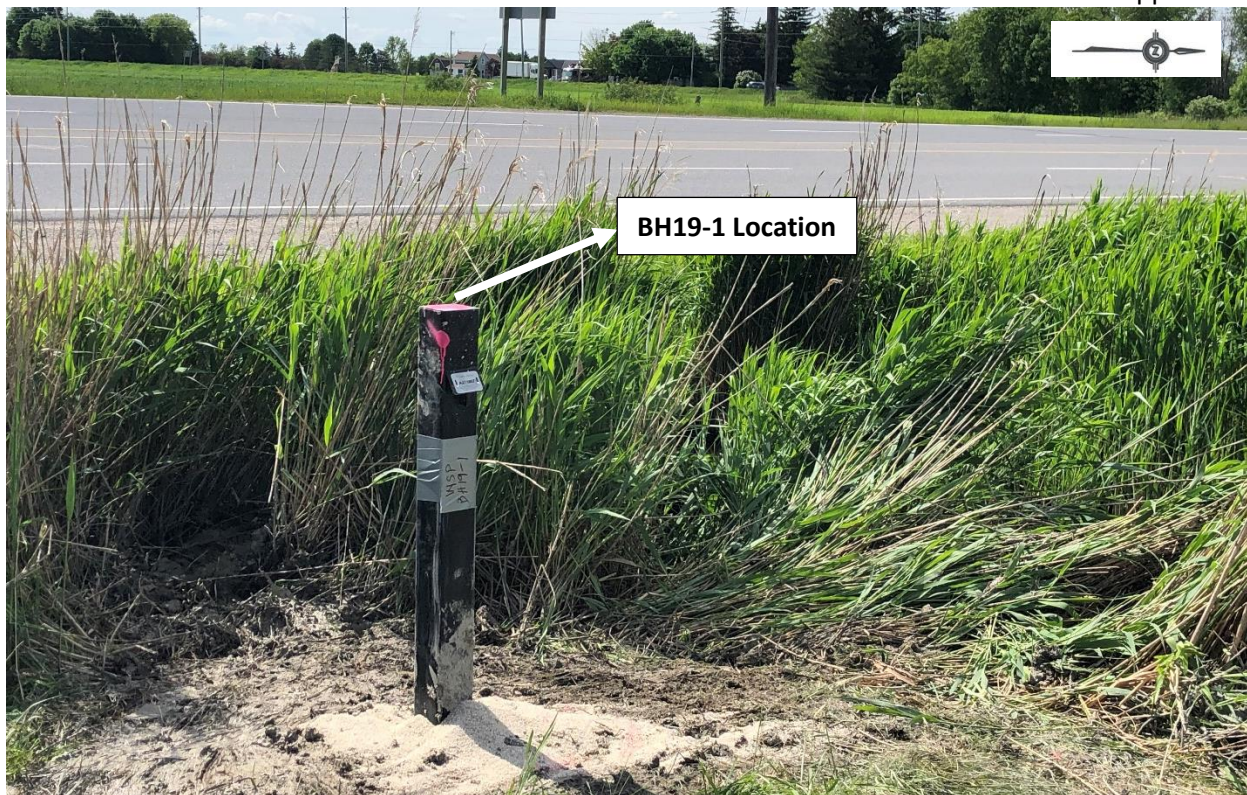
Photo C2-1: Looking towards West at culvert outlet location Sta. 24+114 (June 2019)

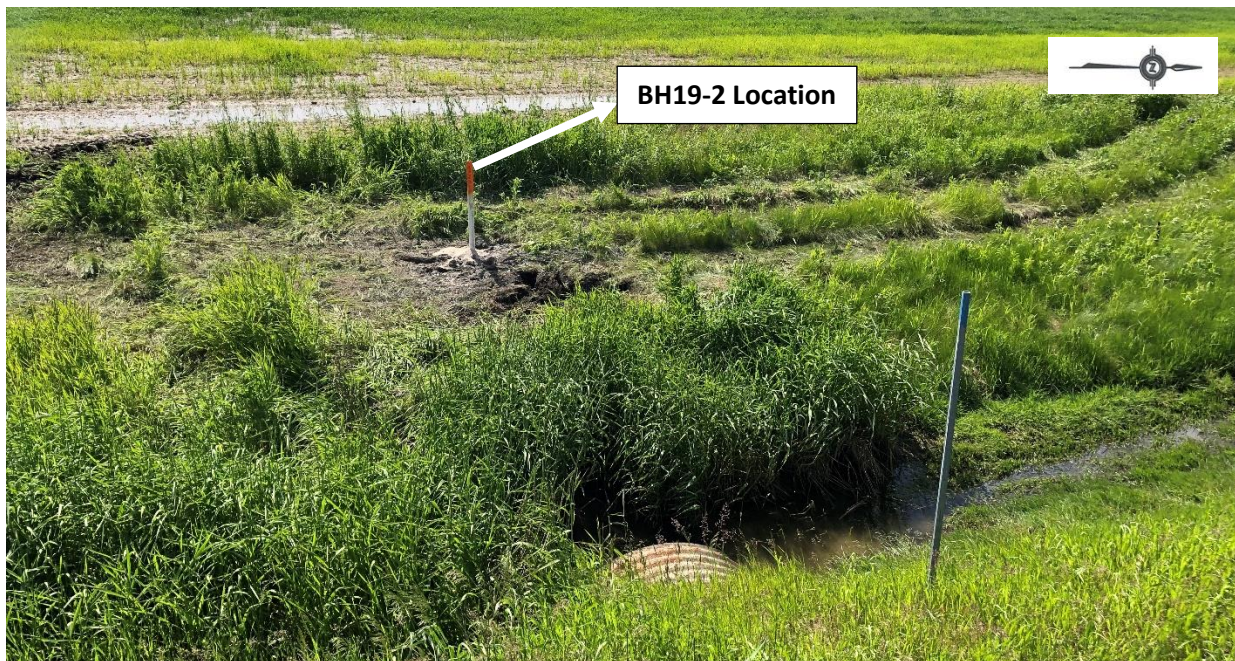
Photo C2-2: Looking towards West at culvert outlet location Sta. 24+114 (June 2019)

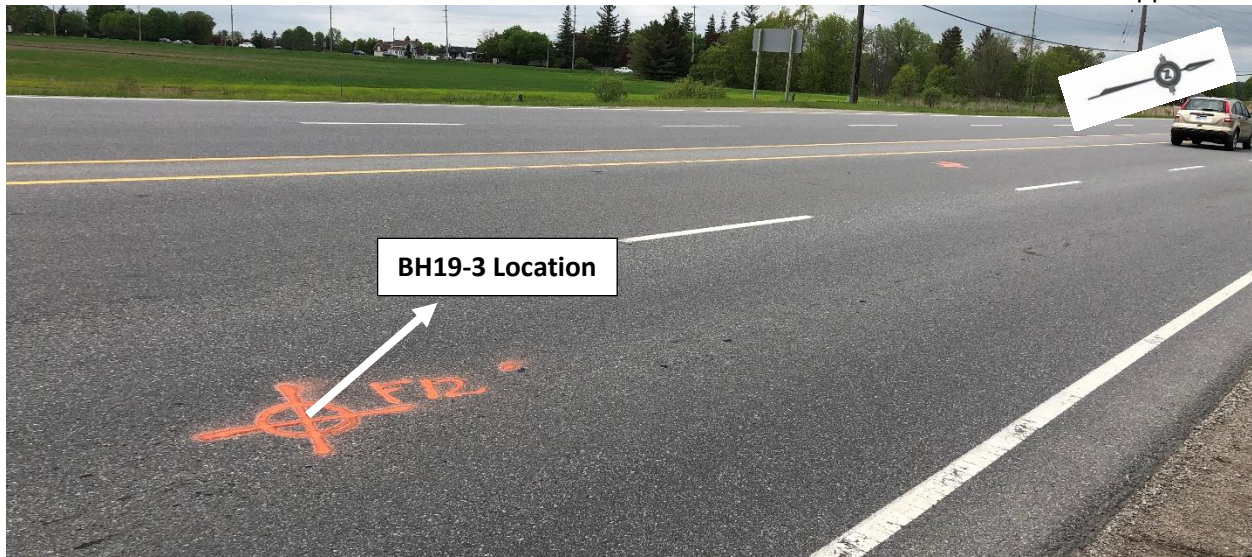
Photo C2-3: Looking towards North near culvert Sta. 24+114 (June 2019)

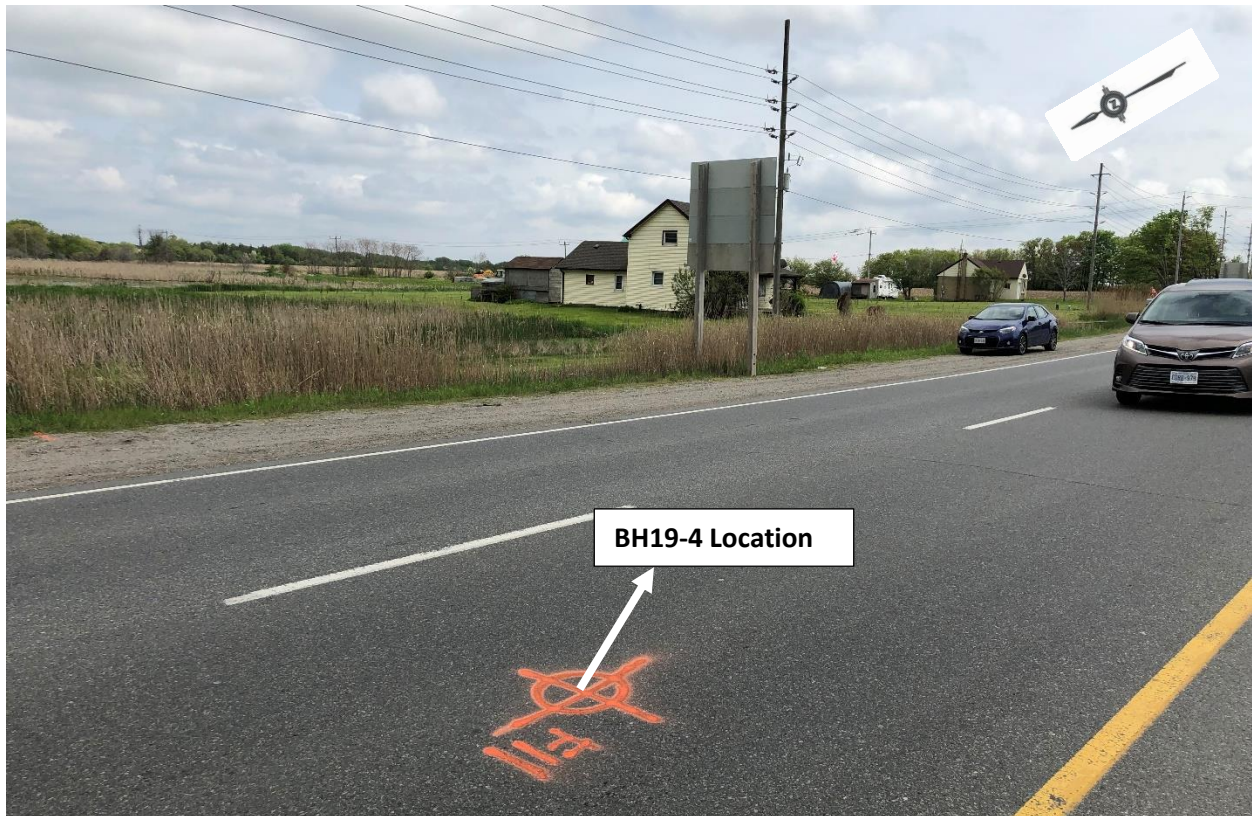
Photo C2-4: Looking towards South near culvert Sta. 24+114 (June 2019)

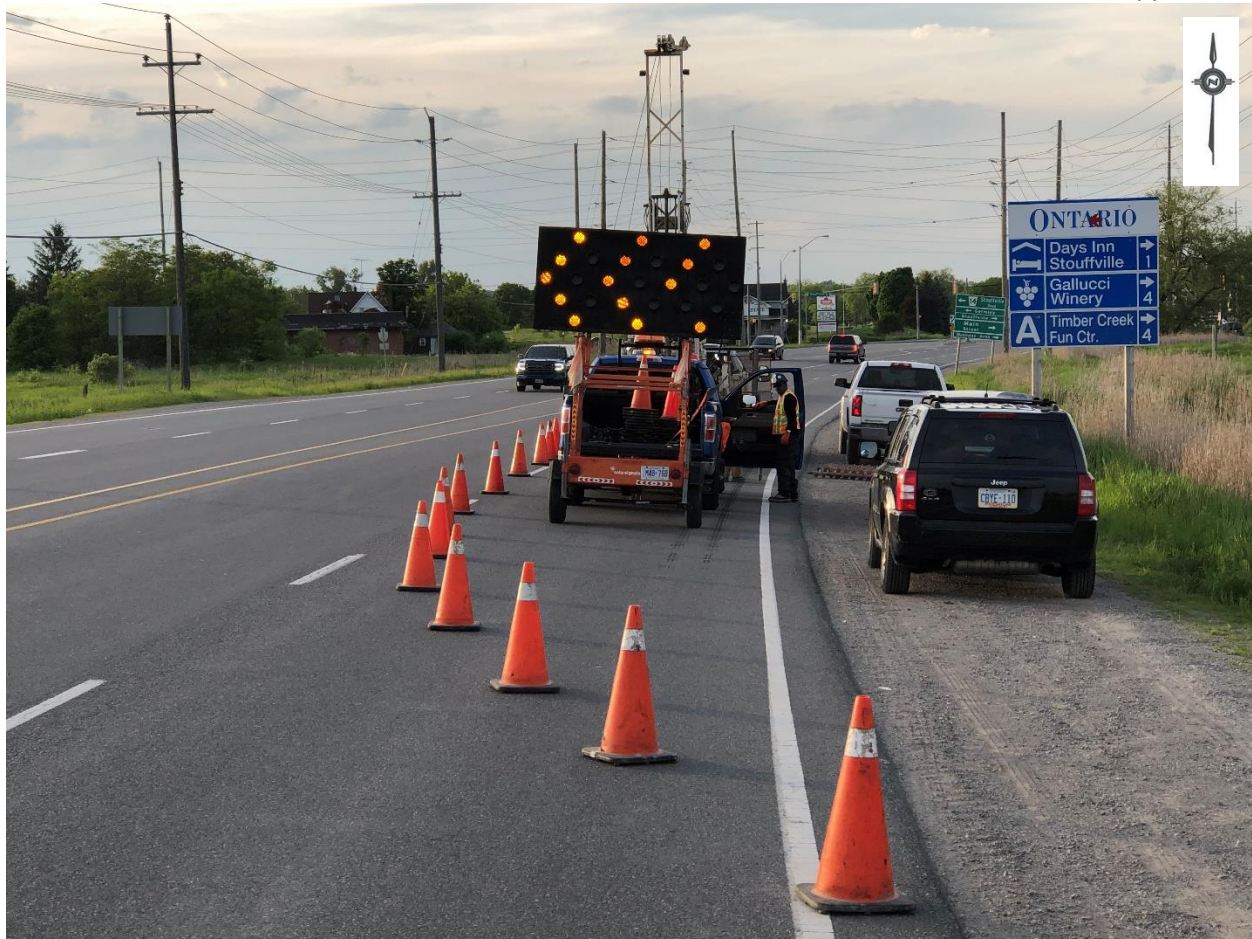
Photo C2-5: Looking towards North on Highway 48 at BH19-4 location (June 2019)
