**PRELIMINARY FOUNDATION INVESTIGATION AND DESIGN REPORT
HIGHWAY 401 WIDENING, HIGHWAY 16 TO MAITLAND ROAD
401W-416N RAMP CULVERT REHABILITATION, SITE NO. 16X-0259/C0
GWP 4024-20-00 / ASSIGNMENT NO. 4019-E-0010.2**

Geocres No.: 31B-102

January 2023
Thurber File No.: 29381

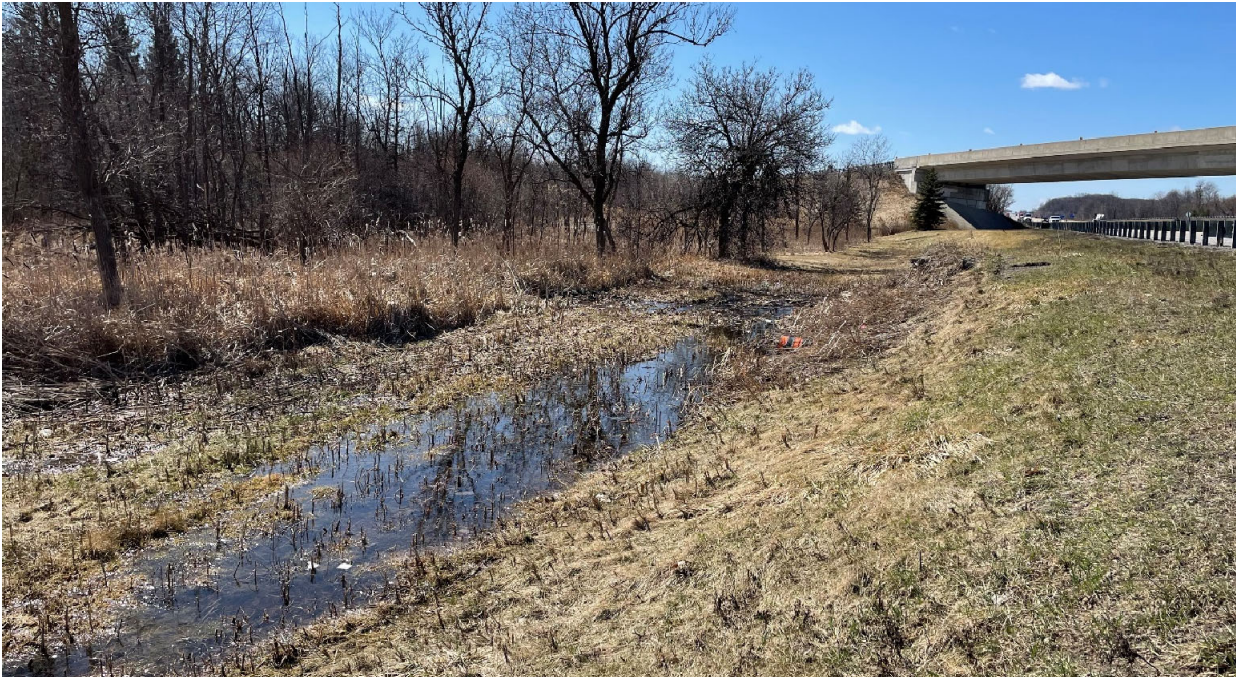
Photo 1. Looking southwest at the poorly drained ground and Hwy 401 Underpass of the W-N Ramp (2021/03/29).

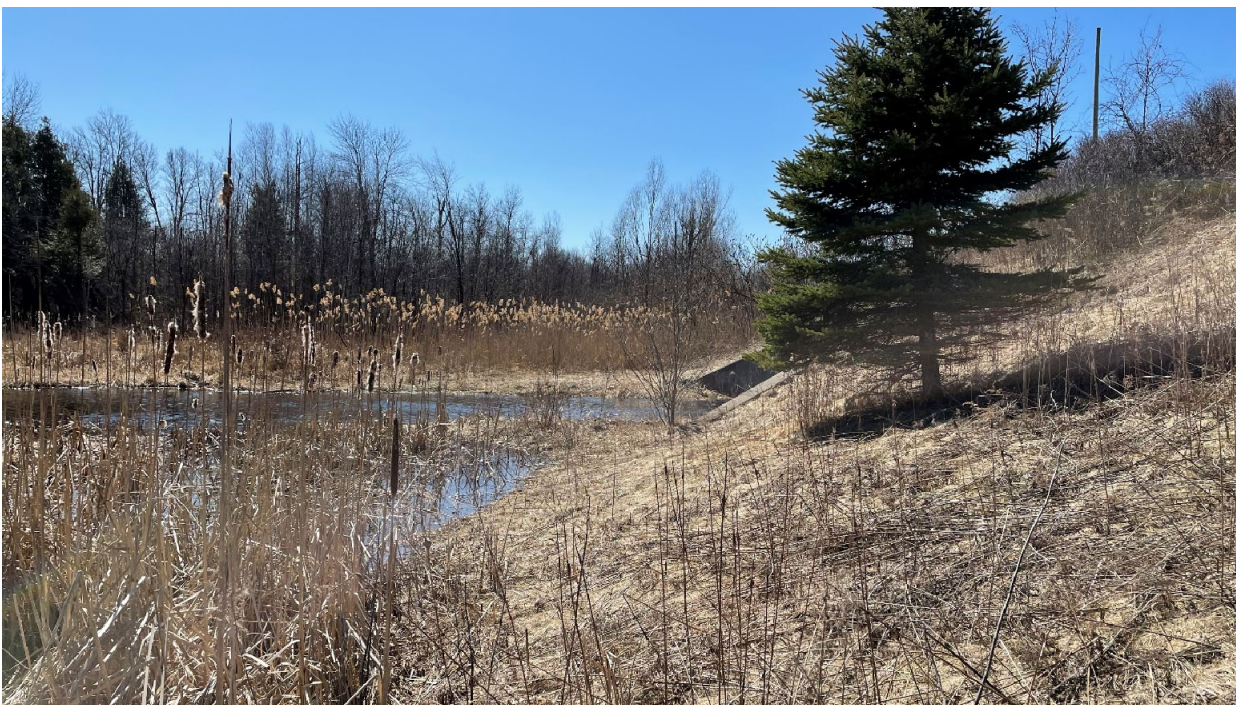
Photo 2. Looking south at east (outlet) culvert wingwalls (2021/03/29).

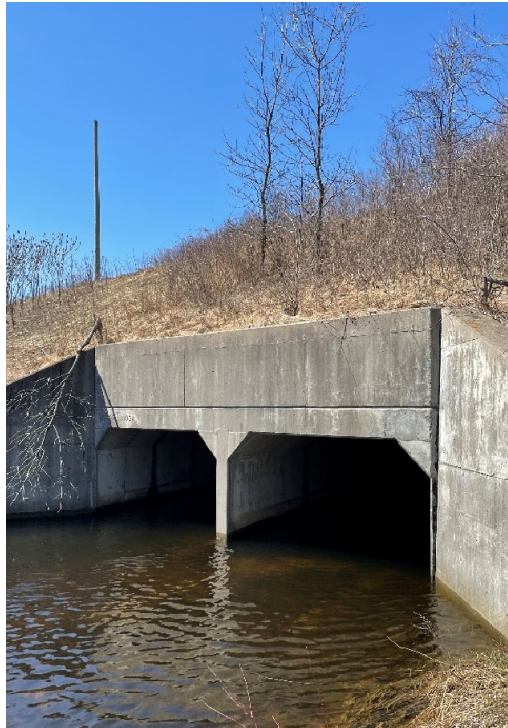
Photo 3. Looking west at east (outlet) culvert headwall (2021/03/29).

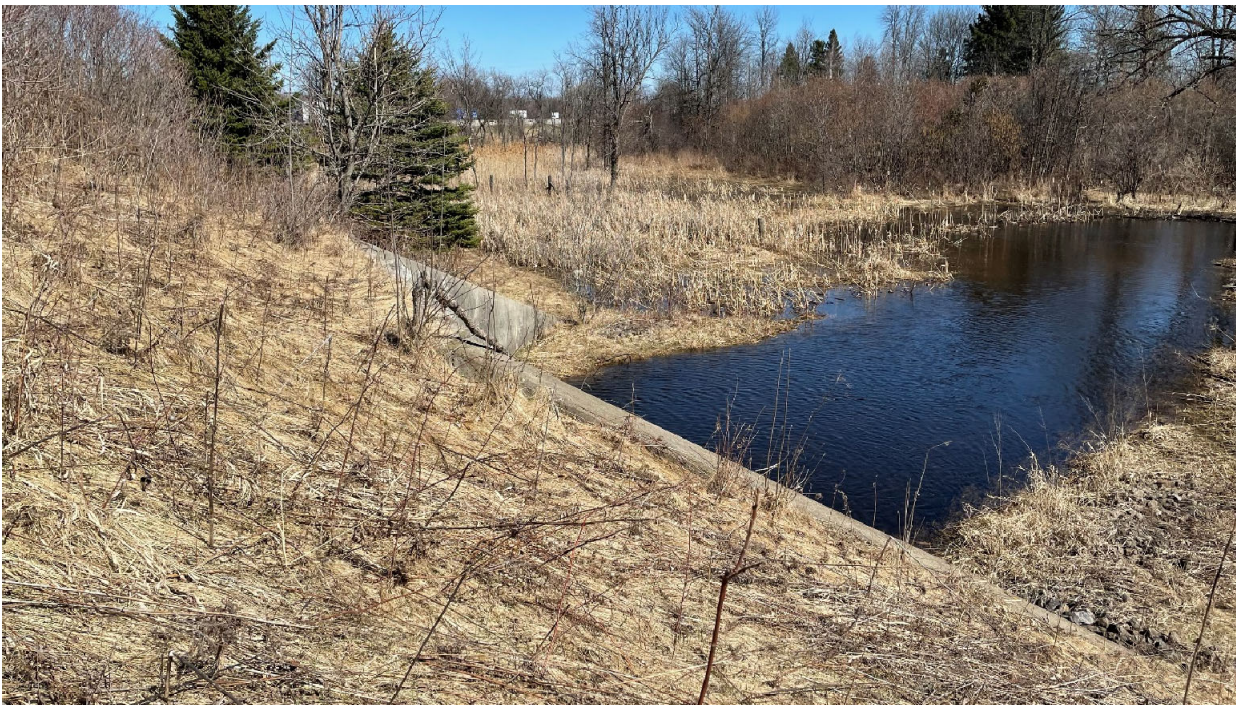
Photo 4. Looking north at east (outlet) culvert headwall (2021/03/29).

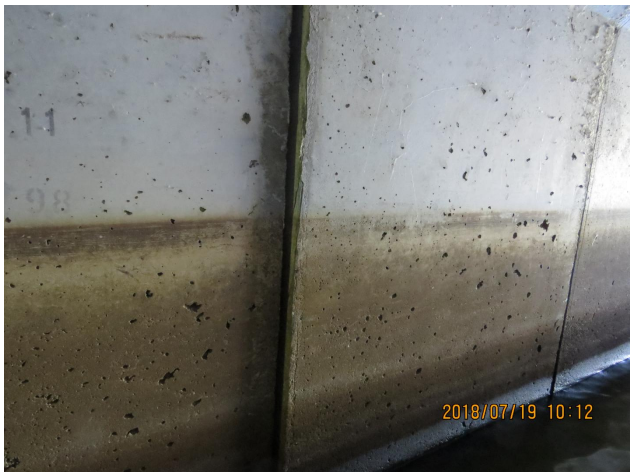
Photo #: 5

It is noted that the 2018 OSIM indicates that the precast units are poorly aligned and that there is evidence of leakage. This special note was first recorded in the 2016 inspection.

Differential culvert settlement has been considered as a cause for the poor alignment of the precast units and associated leakage reported in the 2018 OSIM. Typically, such movements would occur very soon after culvert and embankment placement; they most likely reflect poor subgrade preparation or construction practices (such as excess vibration from compaction or sheet pile extraction).

East Cell, Poor Alignment

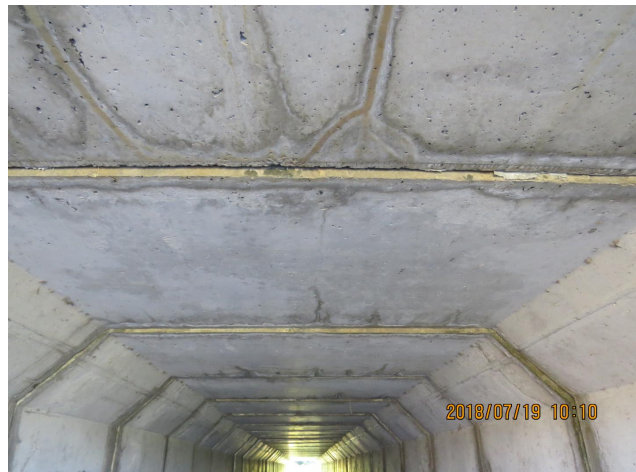
Photo #: 6

East Cell, Soffit Efflorescence

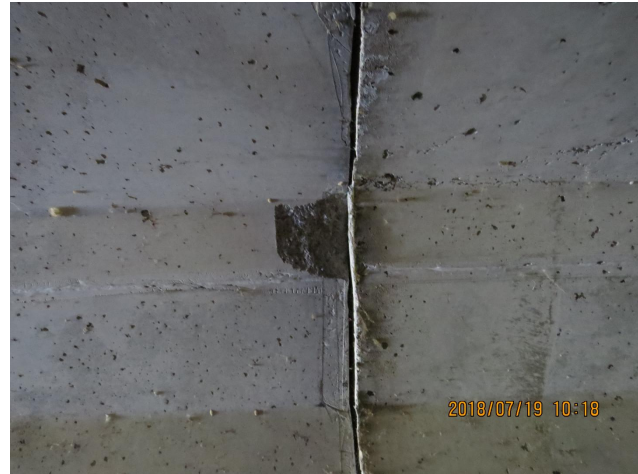
Photo #: 8

West Cell, East Wall, Shallow Spall

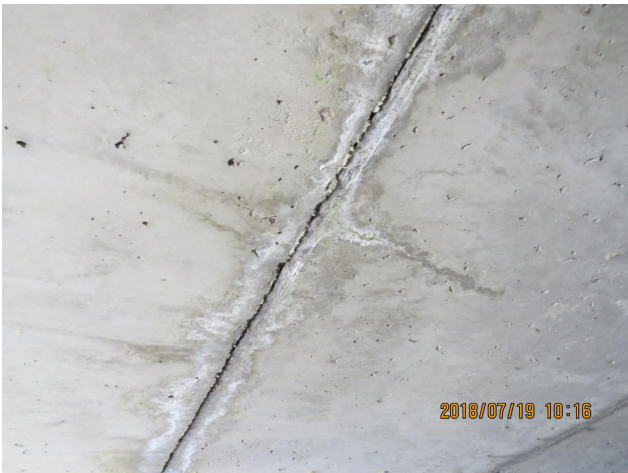
Photo #: 9

West Cell, Soffit, Efflorescence

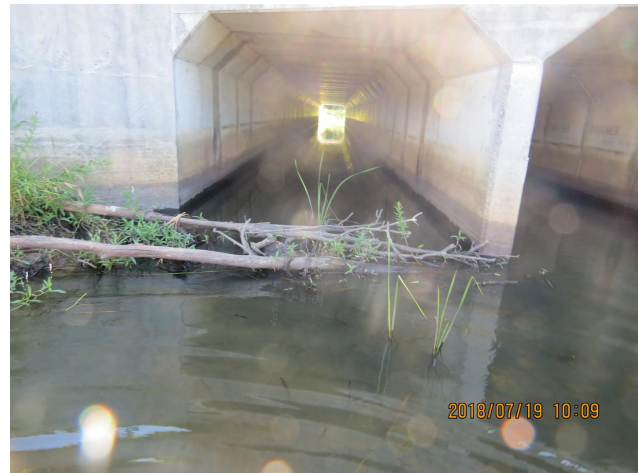
Photo #: 10

Debris at Inlet
