FOUNDATION INVESTIGATION REPORT

**Otasawian River Bridge, Highway 11 (Site No. 39W-002)
Township of Kohler – New Liskeard (Cochrane) Area, ON**

Project Name:
Otasawian River Bridge, Highway 11 (Site No. 39W-002)
Township of Kohler – New Liskeard (Cochrane) Area, ON
GEOCRES No. 42F-23

Project Number:
ADM-00201207-AO
THB-00011156-AG

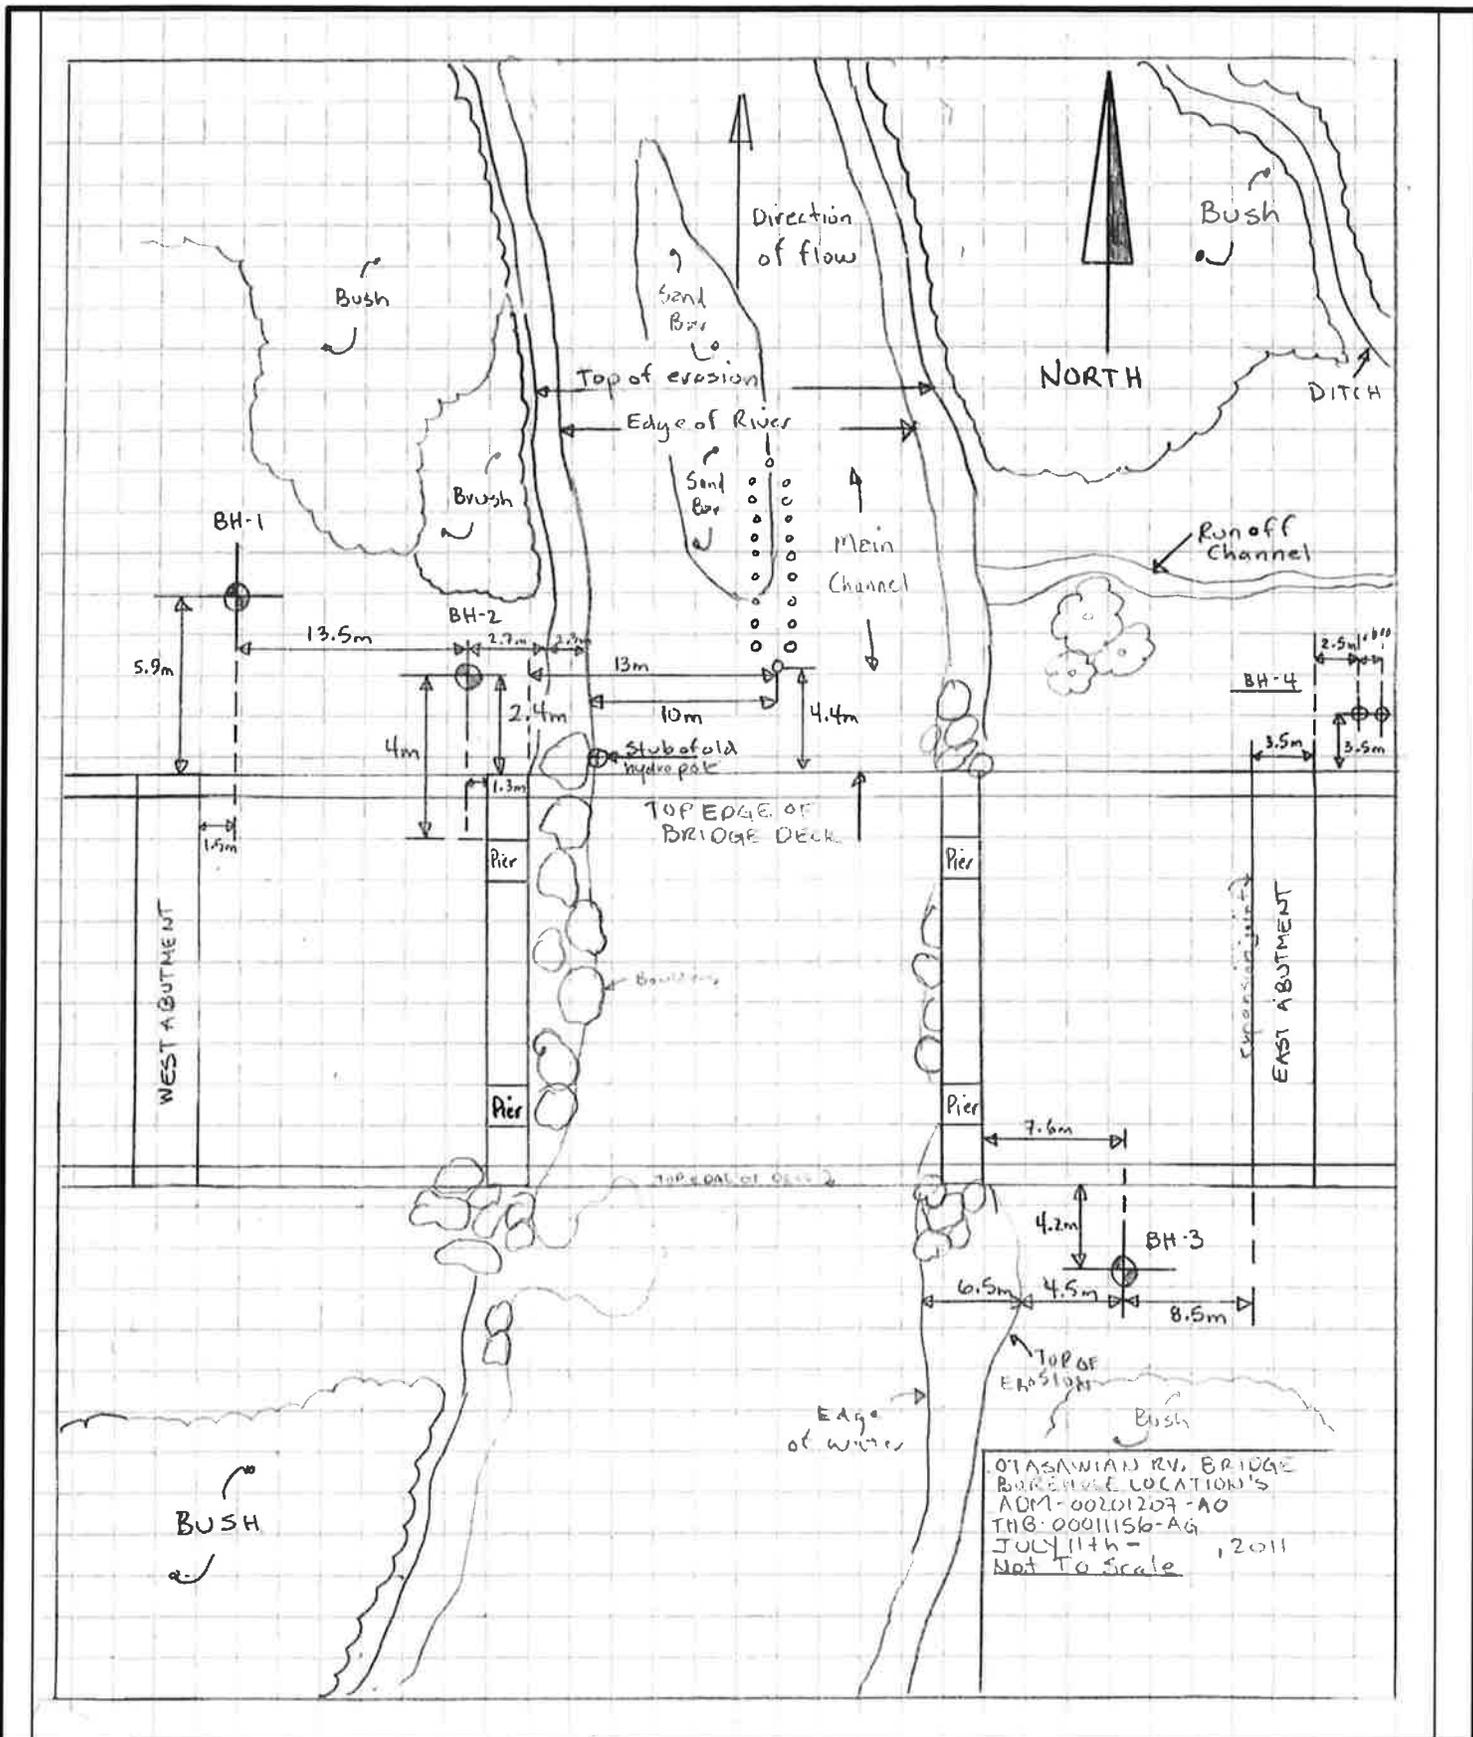
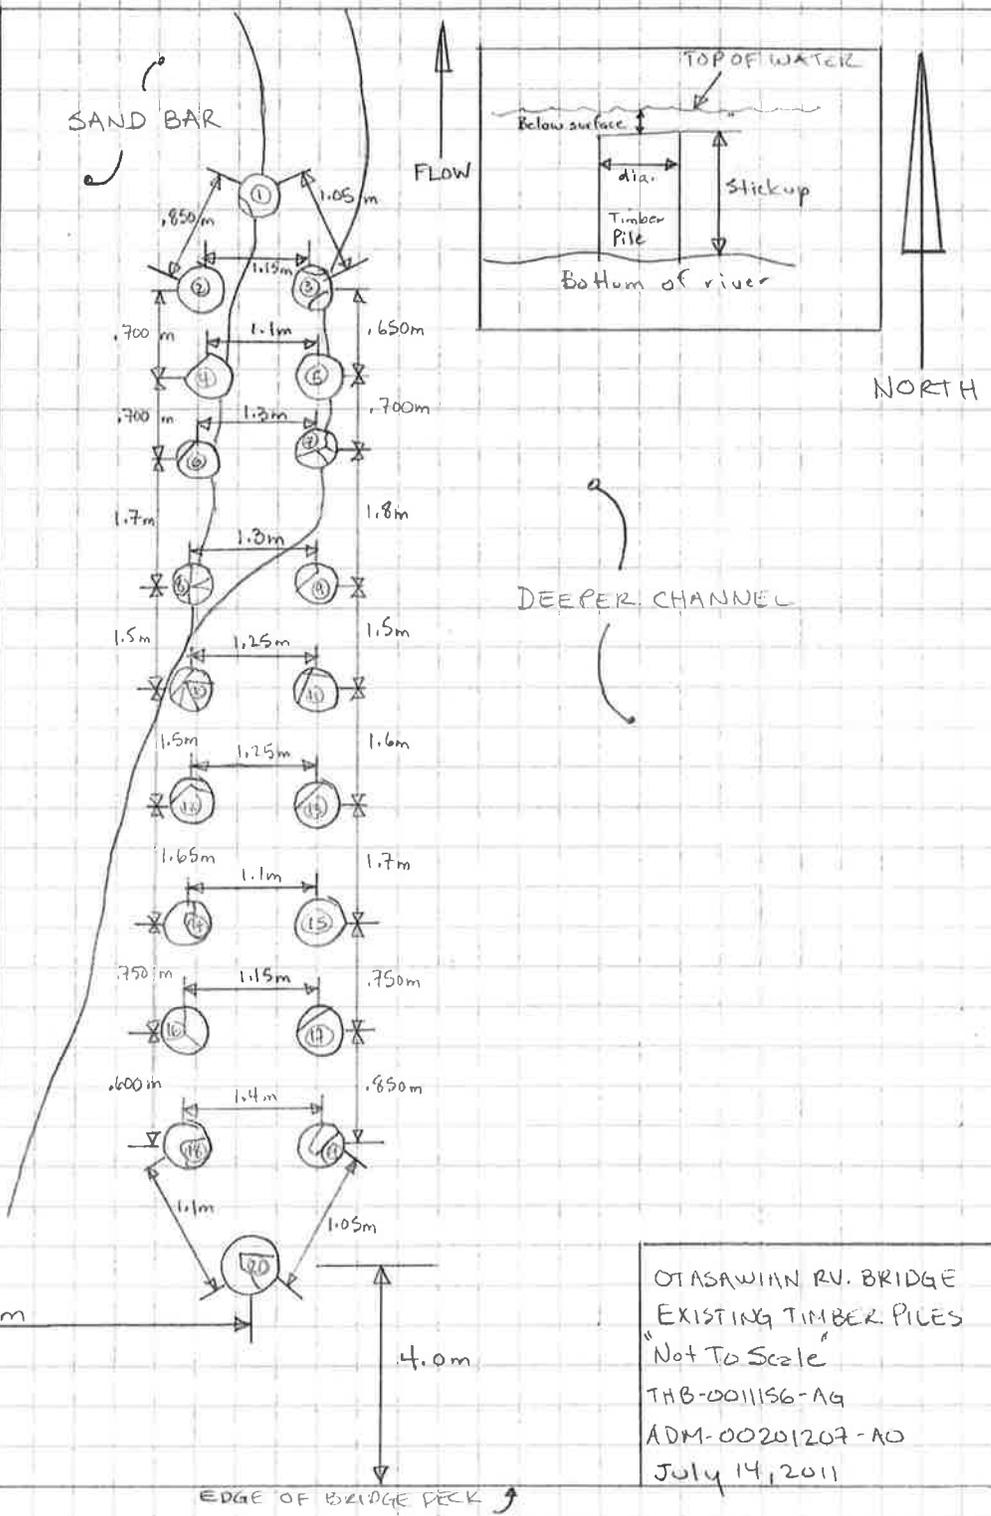
OTASAWIAN RV. BRIDGE ADM-00201207-AO THB-001156-A9
 July 14, 2011, EXISTING TIMBER PILE DETAILS

Existing timber piles (20) were noted in the river, north of the bridge. These are assumed to be from an abandoned pile bent at the time of original construction. The piles were located in two rows (i.e. pairs) in north / south direction and the lengths separating the piles in the east / west direction and north / south direction ranged between about 1.1 m and 1.4 m, and 0.6 m and 1.8 m, respectively. In addition, the pile located furthest north and furthest south were single piles (i.e. not paired). Details of the timber piles are shown on Figure 7 and are summarized in Table 1-3 below:

There were 20 timber piles noted and ranged in diameter between about 250 mm and 350 mm and the stick-ups ranged between about 300 mm and 950 mm above the river bottom.

TIMBER PILES	
①	.300 dia .070 below surface .350m Stickup
②	.350m dia .070 below surface .300m Stickup
③	.280m dia .060m below surface .650m Stickup
④	.350m dia .070m below surface .350m Stickup
⑤	.350m dia .050m below surface .750m Stickup
⑥	.350m dia .050 below surface .350m Stickup
⑦	.350m dia .050 below surface .800m Stickup
⑧	.300 dia .070 below surface .500m Stickup
⑨	.280 dia .050 below surface .850m Stickup
⑩	.350 dia .050 below surface .700m Stickup
⑪	.270 dia .070 below surface .850m Stickup
⑫	.350 dia .050 below surface .900m Stickup
⑬	.320 dia .050 below surface .900m Stickup
⑭	.290 dia .050 below surface .900m Stickup
⑮	.300 dia .030 below surface .900m Stickup
⑯	.300 dia .060 below surface .900m Stickup
⑰	.300 dia .050 below surface .950m Stickup
⑱	.300 dia .060 below surface .900m Stickup
⑲	.250 dia .050 below surface .950m Stickup
⑳	.250 dia .040 below surface .950m Stickup

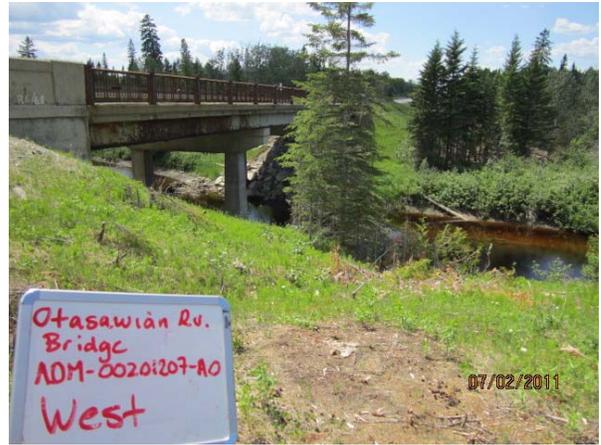
Photograph 1: Looking west at the bridge.
East pier shown.

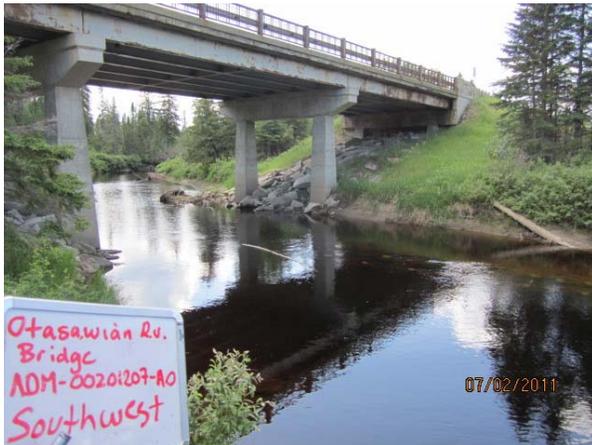
Photograph 2: Looking southwest under the
bridge. East and west piers shown. BH2
location is located across river on right side
(north) of bridge.

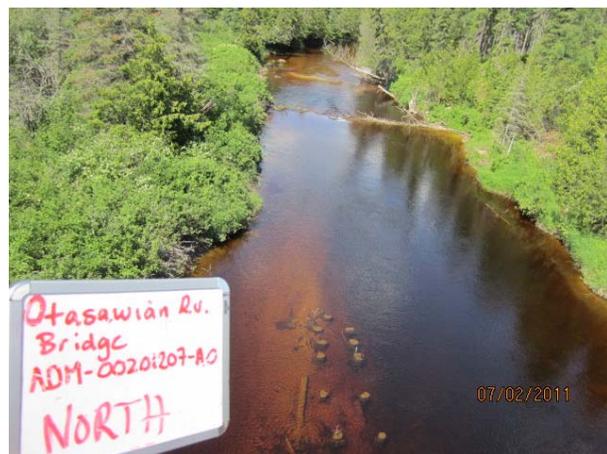
Photograph 3: Looking north from on top of
bridge. The existing timber piles (11 or 20) are
noted in river.
