**Final
FOUNDATION INVESTIGATION
REPORT
UNKNOWN CREEK # 5
CULVERT REPLACEMENT
HWY 540
TOWNSHIP OF HOWLAND
AGREEMENT NO.: 5010-E-0007
WP: 5057-07-01
GWP: 5057-07-00
GEOCRES NO.: 41G-12**

**January 4, 2012
GS-TB-012143**

**FOUNDATION INVESTIGATION AND DESIGN REPORT
UNKNOWN CREEK # 5 CULVERT REPLACEMENT
HIGHWAY 540
TOWNSHIP OF HOWLAND
AGREEMENT NO.: 5010-E-0007
WP: 5057-07-01
GWP: 5057-07-00
GEOCRES NO.: 41G-12**

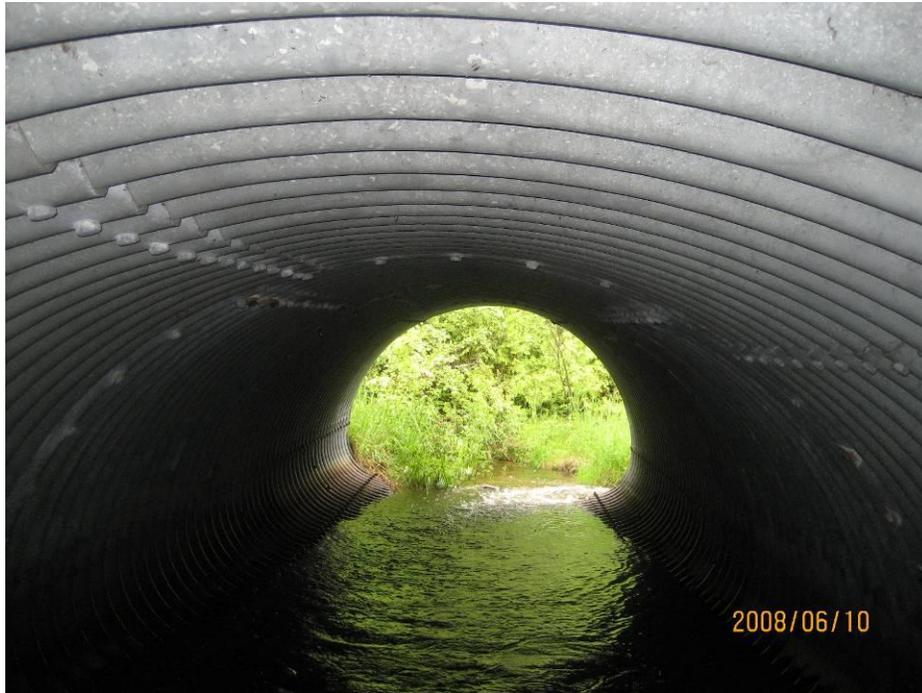
It is understood that the proposed replacement will involve the replacement of the existing corrugated steel pipe (CSP) culvert (Figure 2.1) which has approximately 0.5 m of cover with pre cast box structure. The existing steel ellipse culvert has dimensions of 3.0 m x 2.1 m x 24.7 m and was identified by MTO in the RFQ to be in fair to poor condition with a minor corrosion and deterioration of the barrel. Buckling was observed along the structure and some moderate flaking and section loss close to the inlet was also identified. Minor erosion and loss of embankment fill were identified around this the existing culvert at this site (Figure 2.2).

Figure 2.1 Corrugated Steel Pipe (CSP) culvert (looking south)

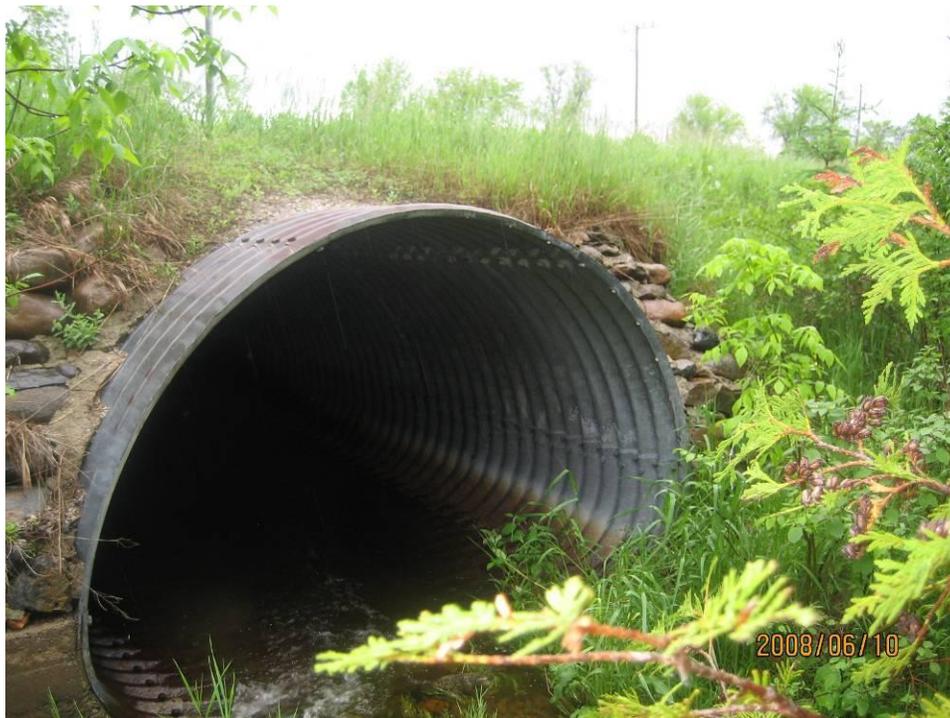
Figure 2.2 Minor erosion and loss of embankment (looking north)

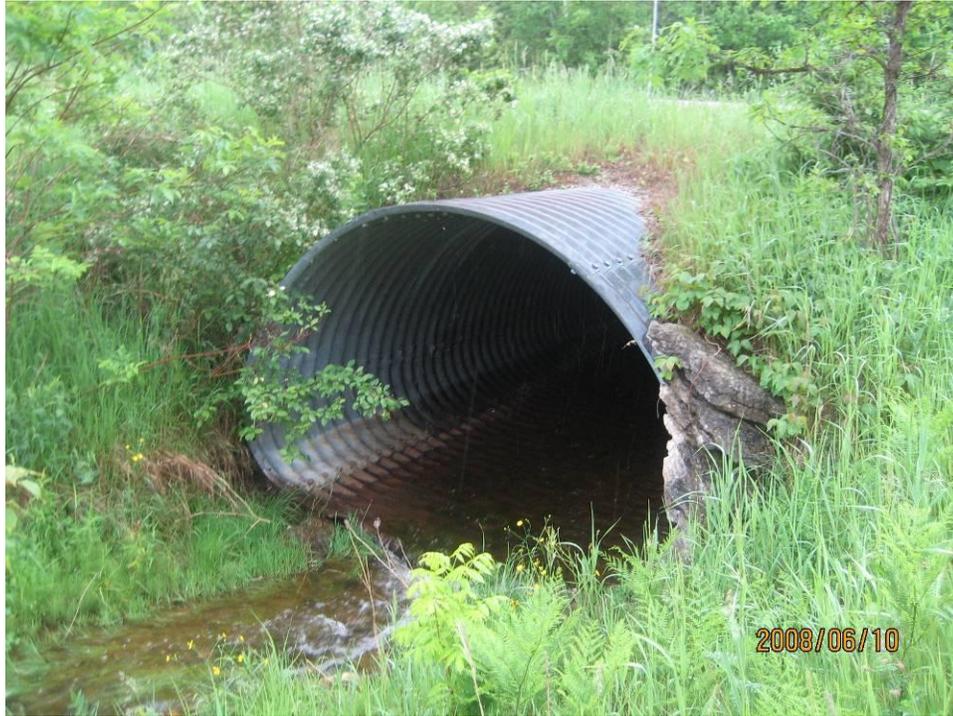
The outlet and inlet of the existing culvert are grassed and wooded (Figures 2.3 and 2.4). The embankment slopes at this location vary from 2H:1V to 3H:1V. The photographs shown in Figures 2.1 to 2.4 were taken by MTO.

Figure 2.3 Outlet of the existing culvert (looking west)

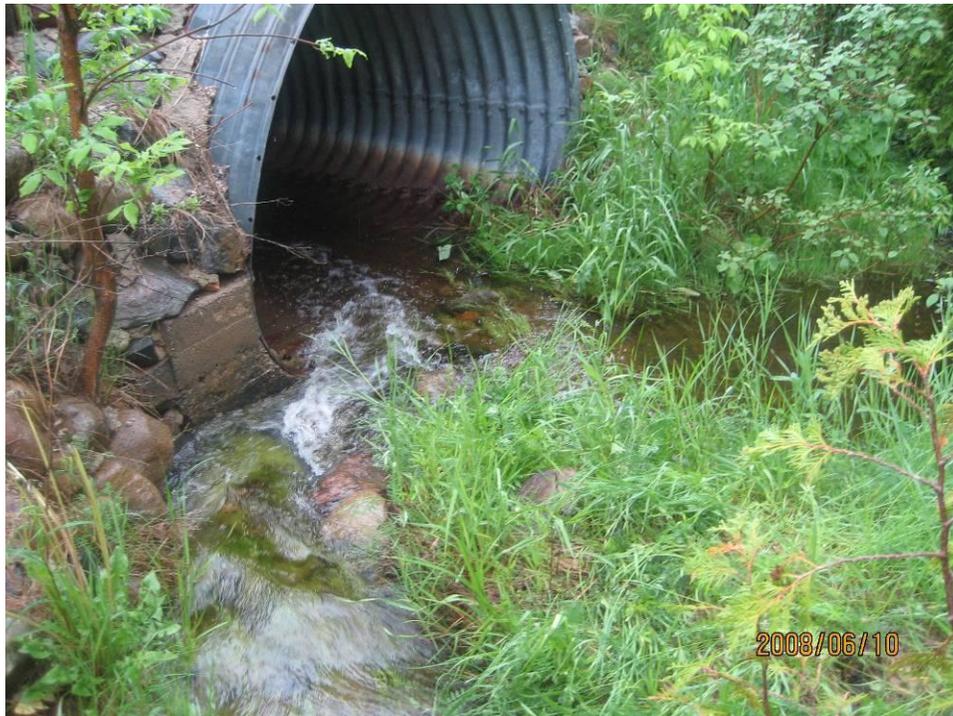
Figure 2.4 Inlet of the existing culvert (looking west)
