**PRELIMINARY
FEASIBILITY FOUNDATION INVESTIGATION
AND DESIGN REPORT FOR ROUTE
ALTERNATIVE STUDY
HIGHWAY 129 FROM 30.2 KM NORTH OF
HIGHWAY 554 NORTHERLY 20.8 KM AND
HIGHWAY 556 FROM HIGHWAY 129
WESTERLY 5.3 KM
DISTRICT OF ALGOMA, ONTARIO
G.W.P. 5670-04-00
GEOCRES 41J-75**

McCormick Rankin Corporation
Mississauga, ON

TRANETOB1200AA
June 2, 2011

Coffey Geotechnics Inc.
(Formerly Shaheen & Peaker Limited)

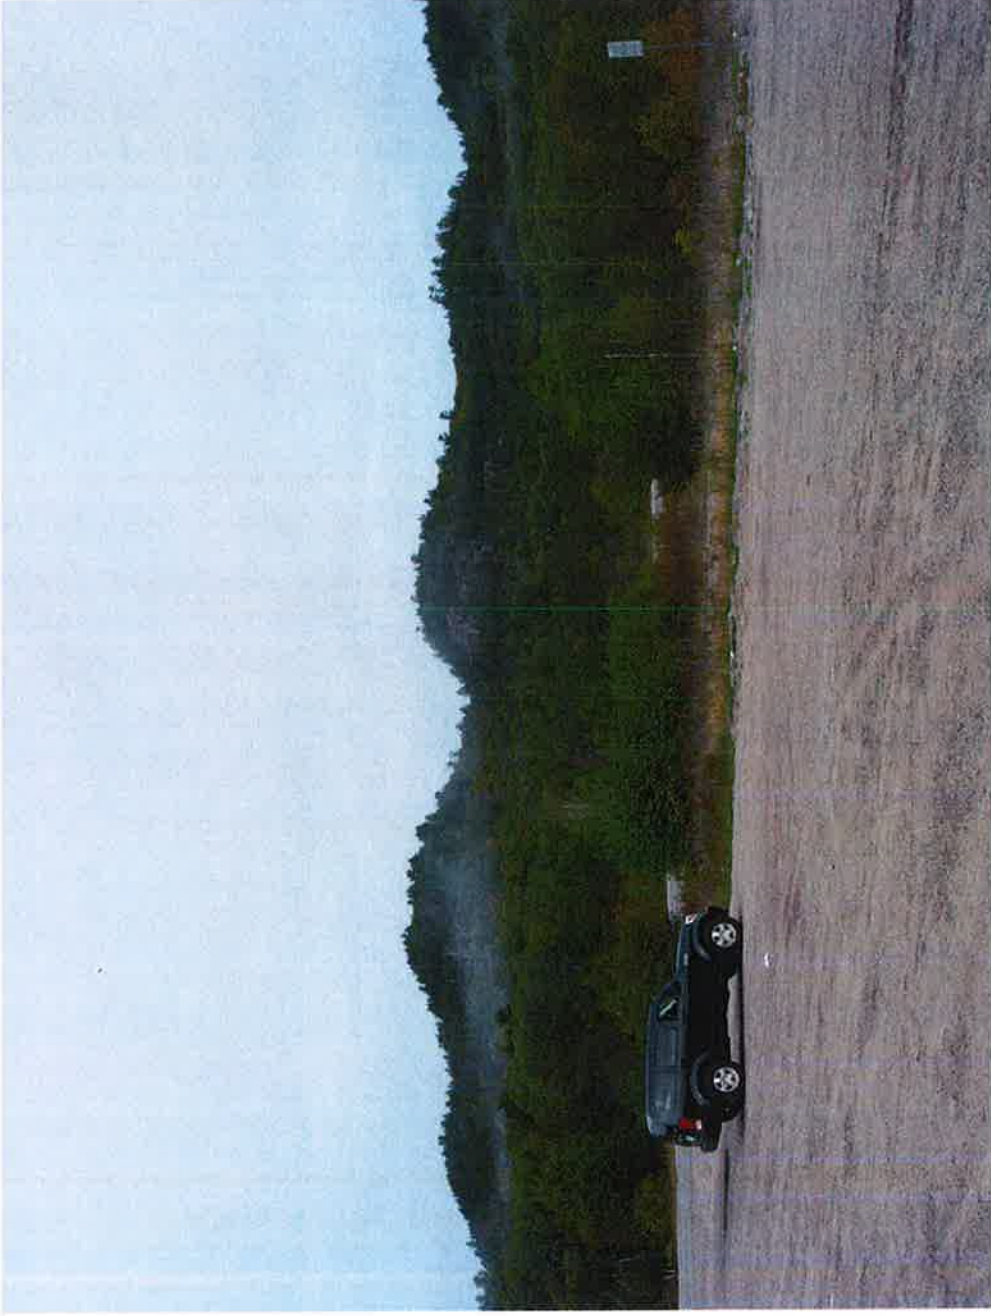
Photograph C-1 North bluff along Hwy 129

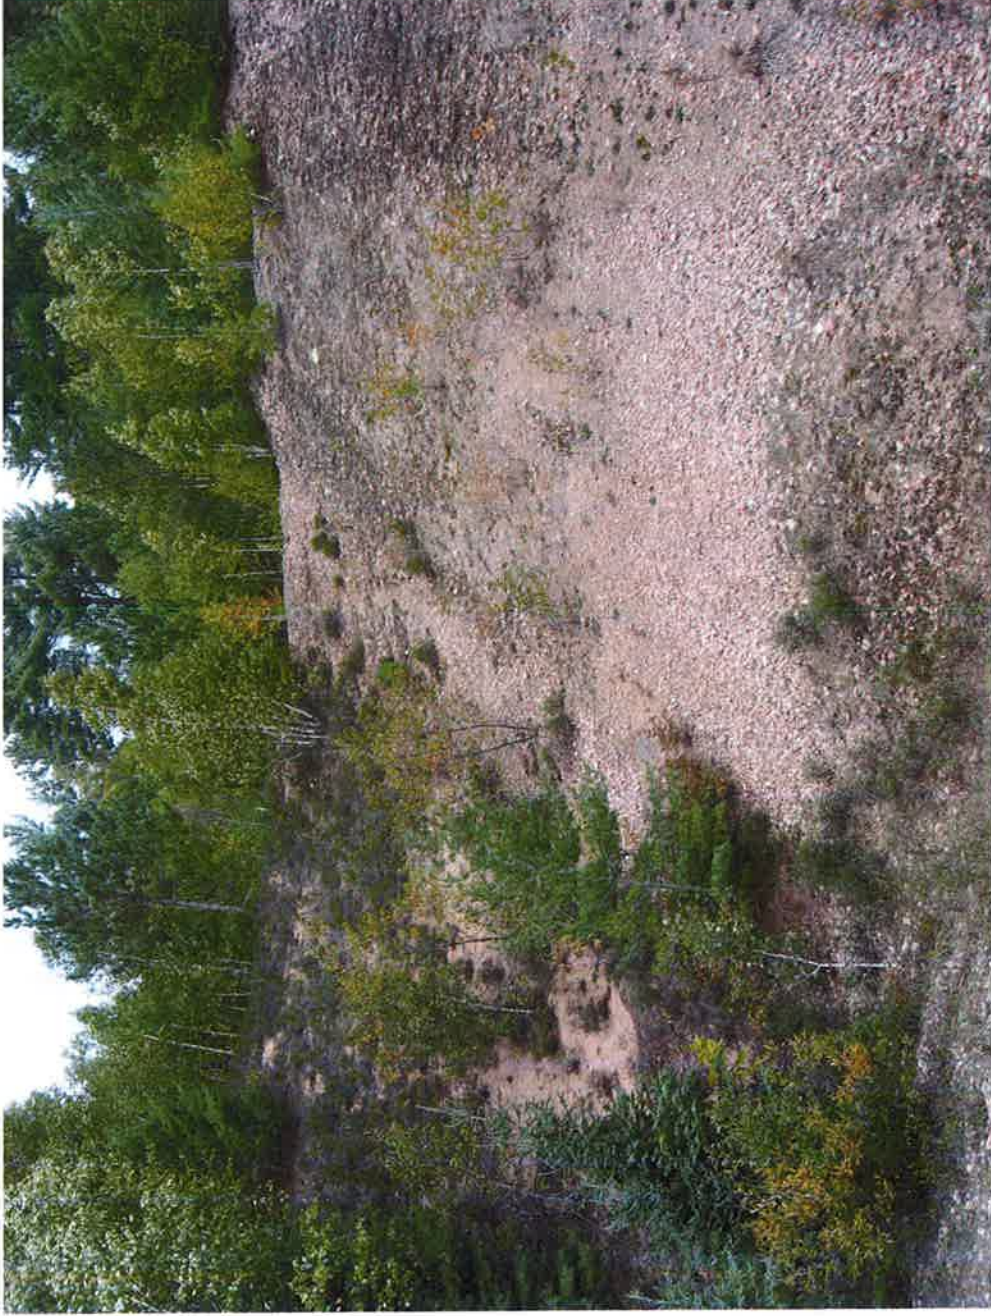
Photograph C-2 Shallow veneer of drift on the hill, Hwy 129

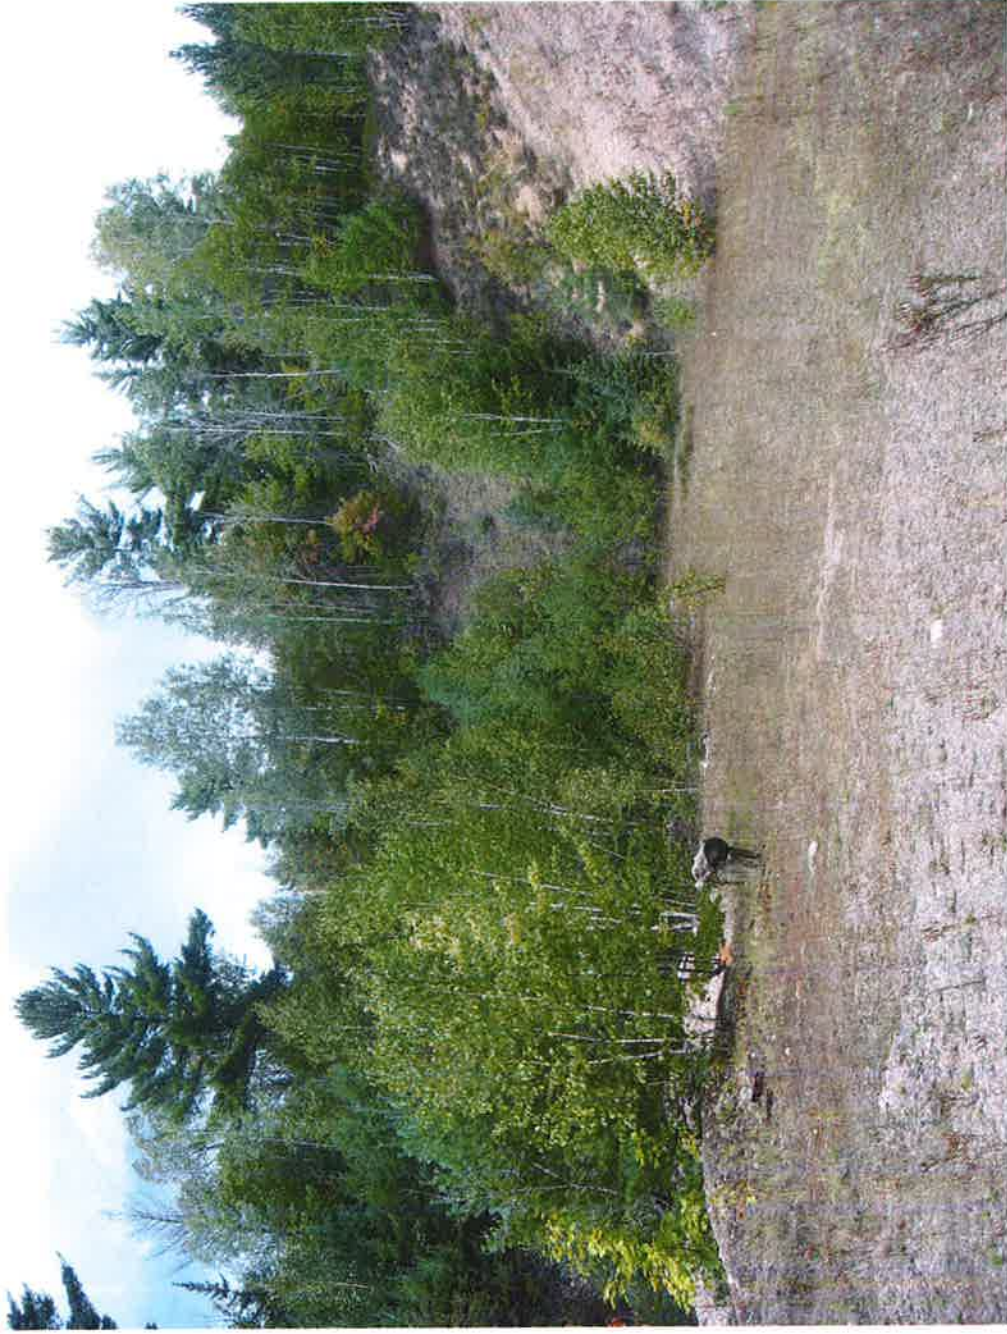
Photograph C-3 Possible swamp area (low lying area)

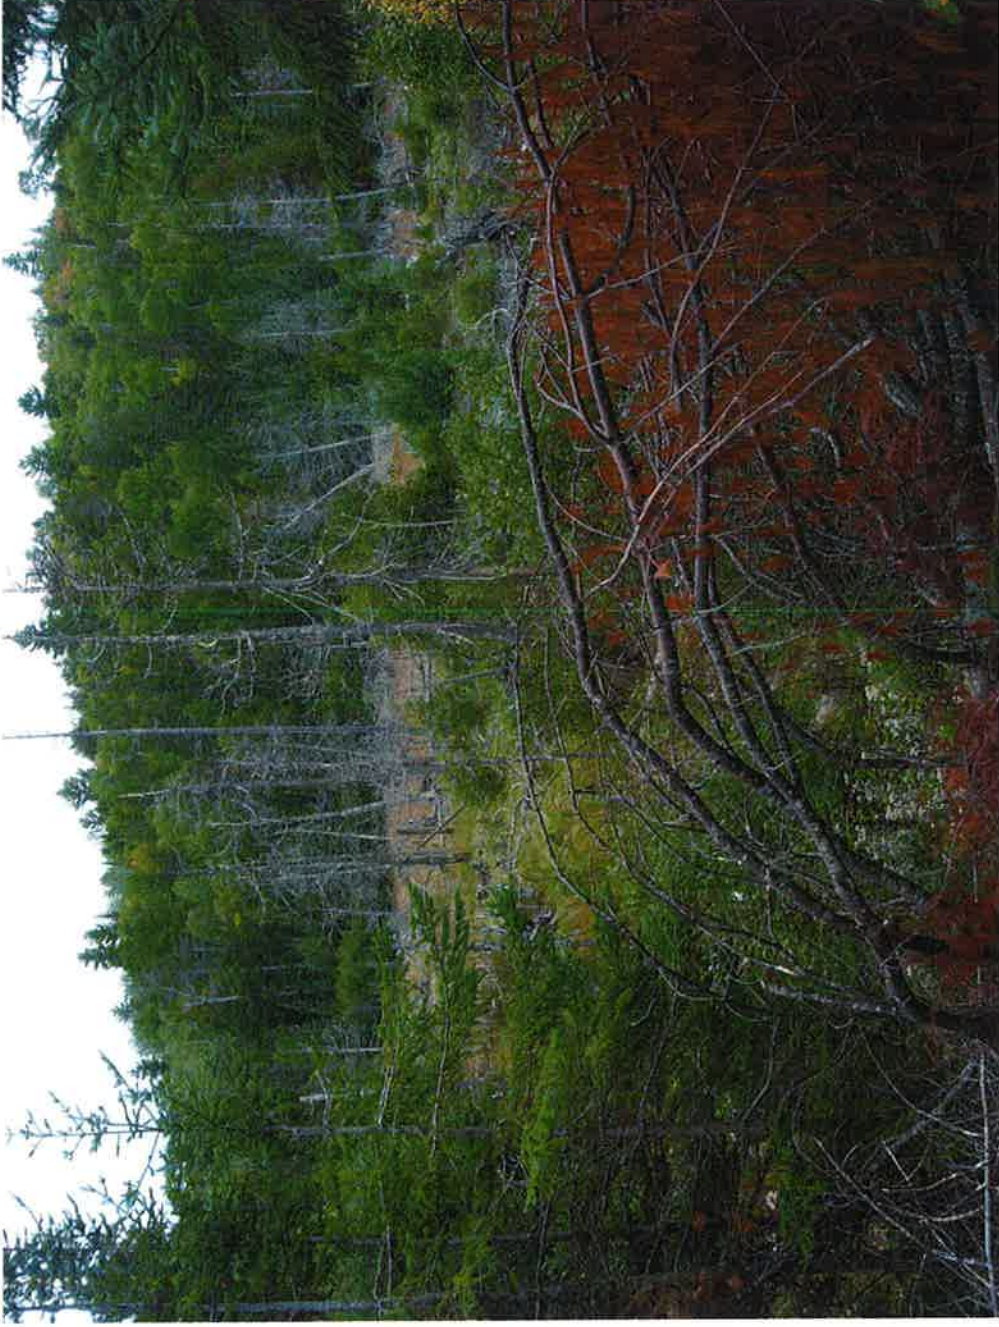
Photograph C-4 Wetland area at alternative 1 and 2, Hwy 129

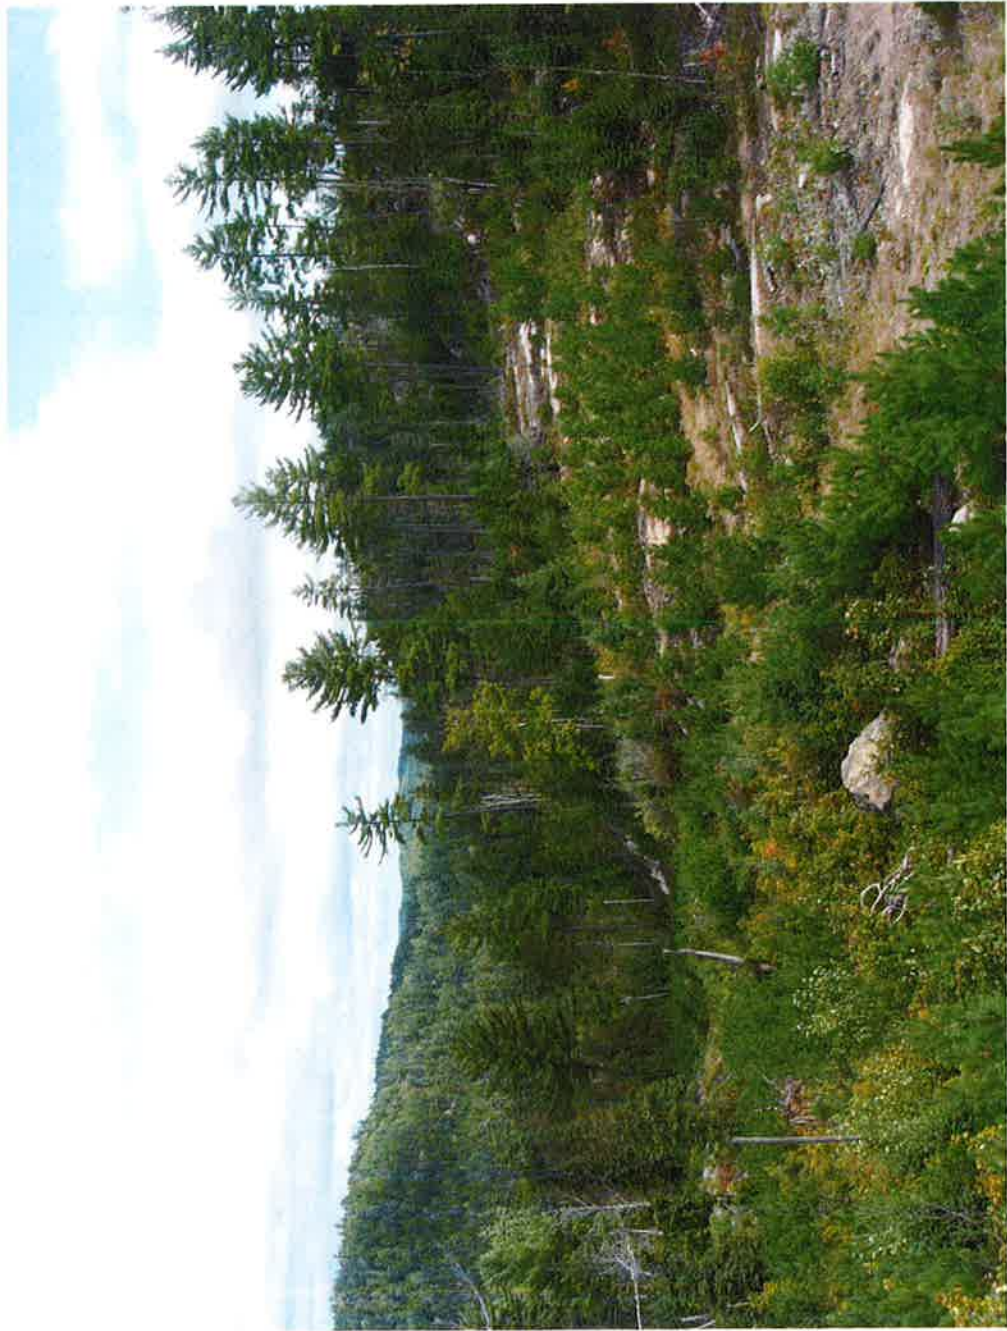
Photograph C-5 Surrounding area of Hwy 129

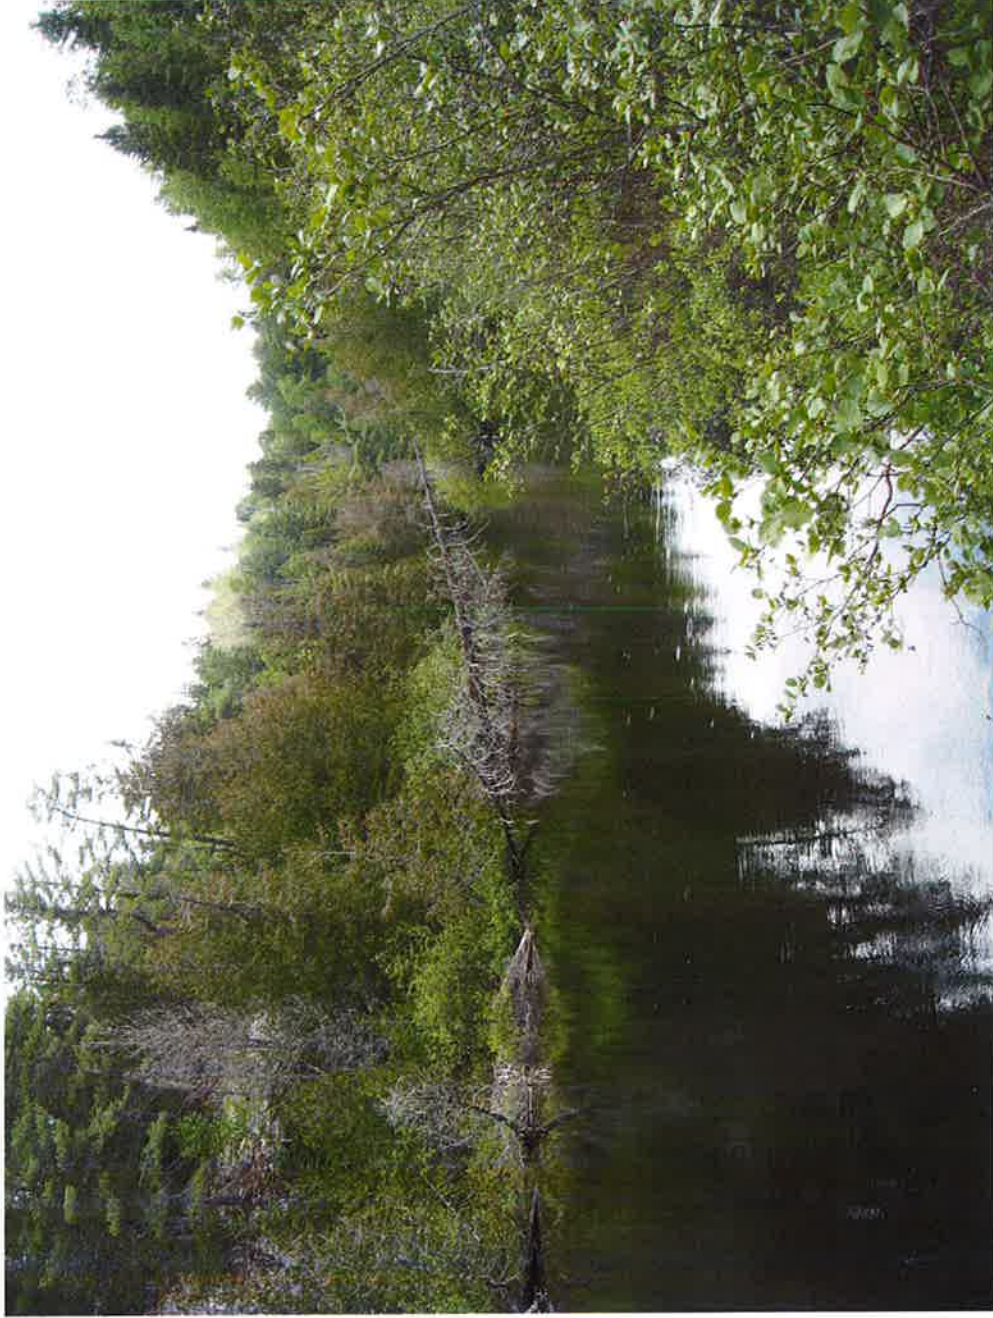
Photograph C-6 Lake in surrounding area of Hwy 129

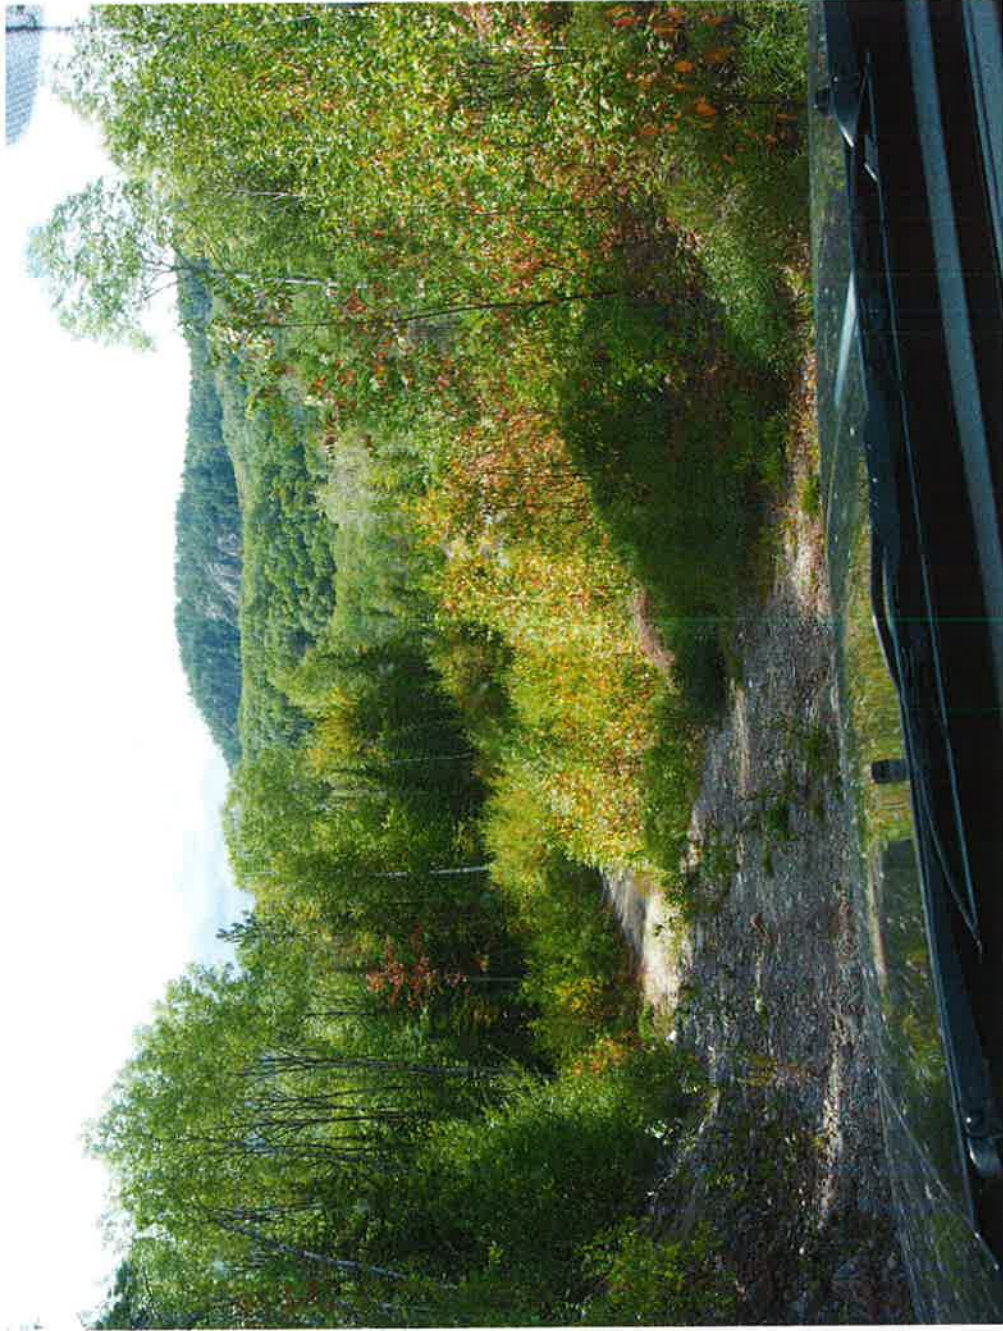
Photograph C-7 Surrounding area of Hwy 129

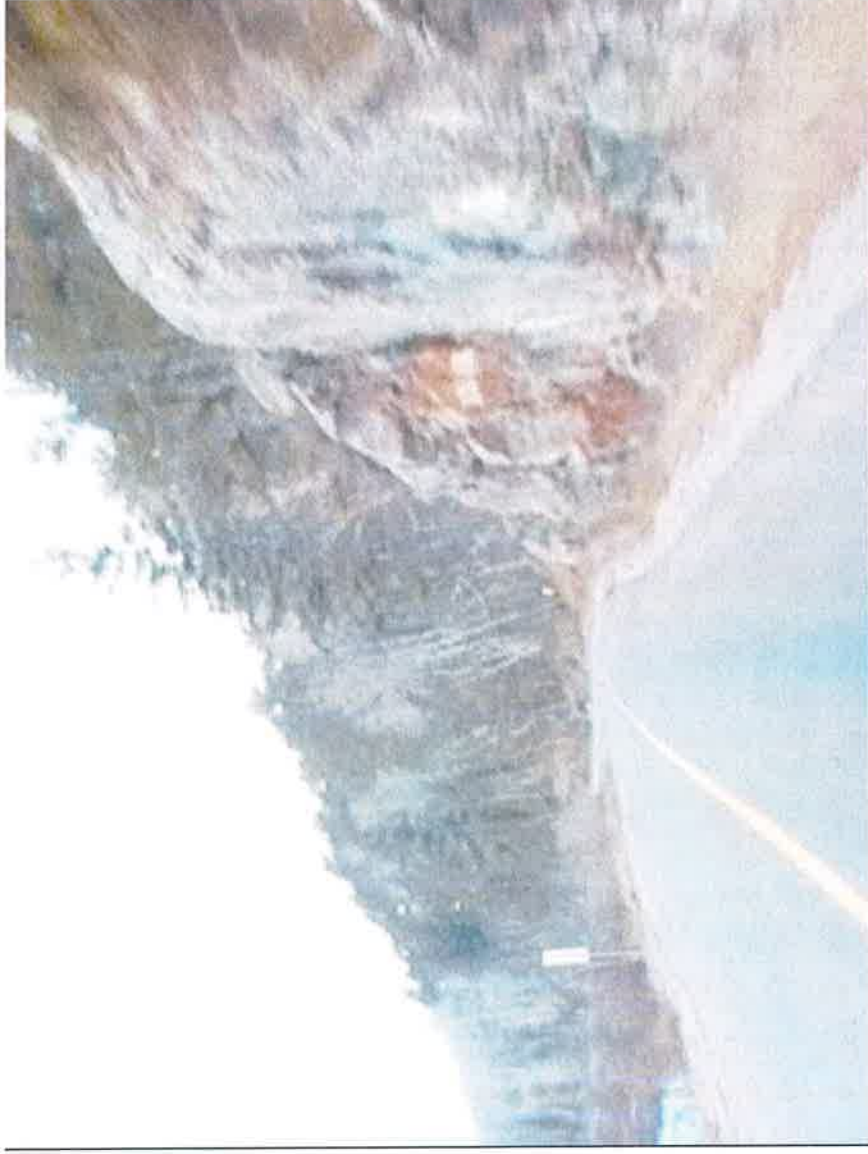
Photograph C-8 Hwy 129 adjacent to steep rock face

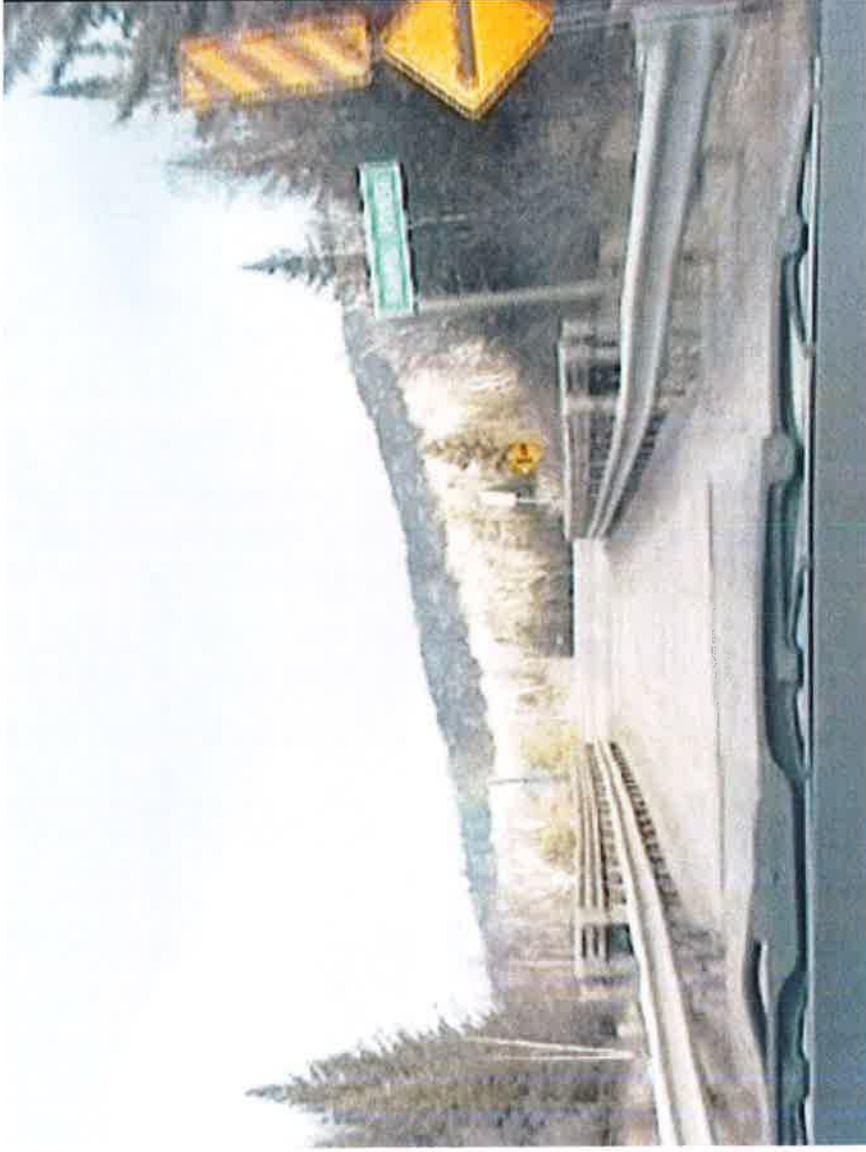
Photograph C-9 Single lane bailey bridge over Rapid River, Hwy 129

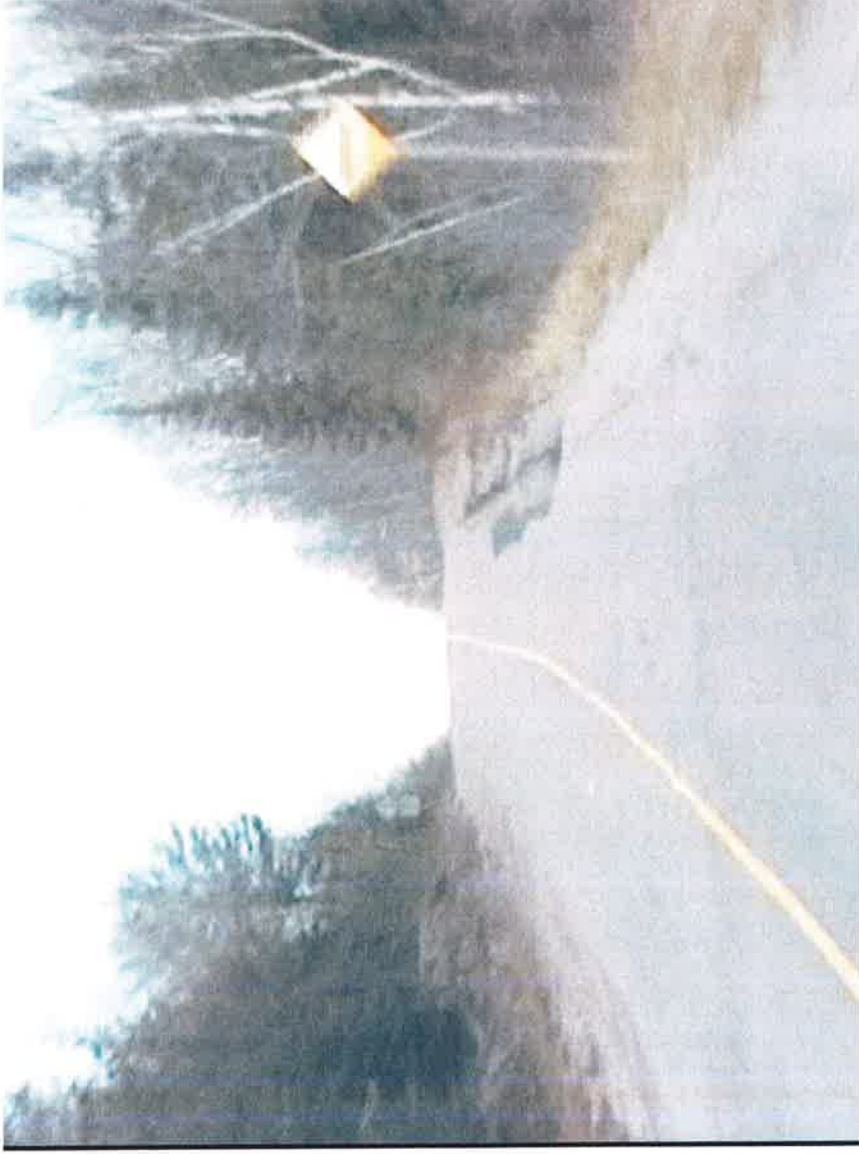
Photograph C-10 Drainage concerns, Hwy 129

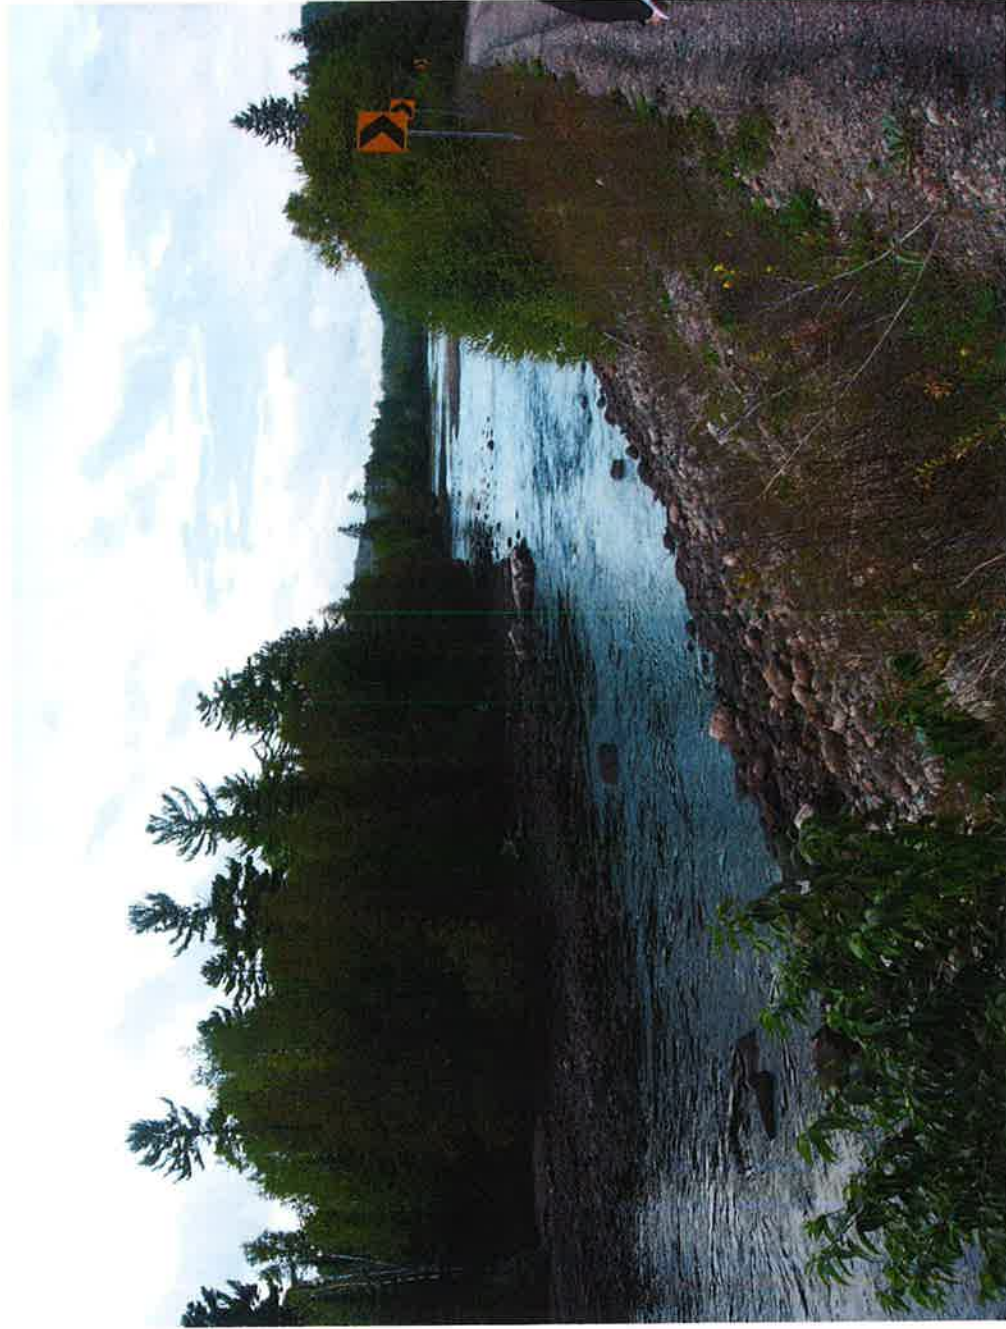
Photograph G-1 River bank, Hwy 556

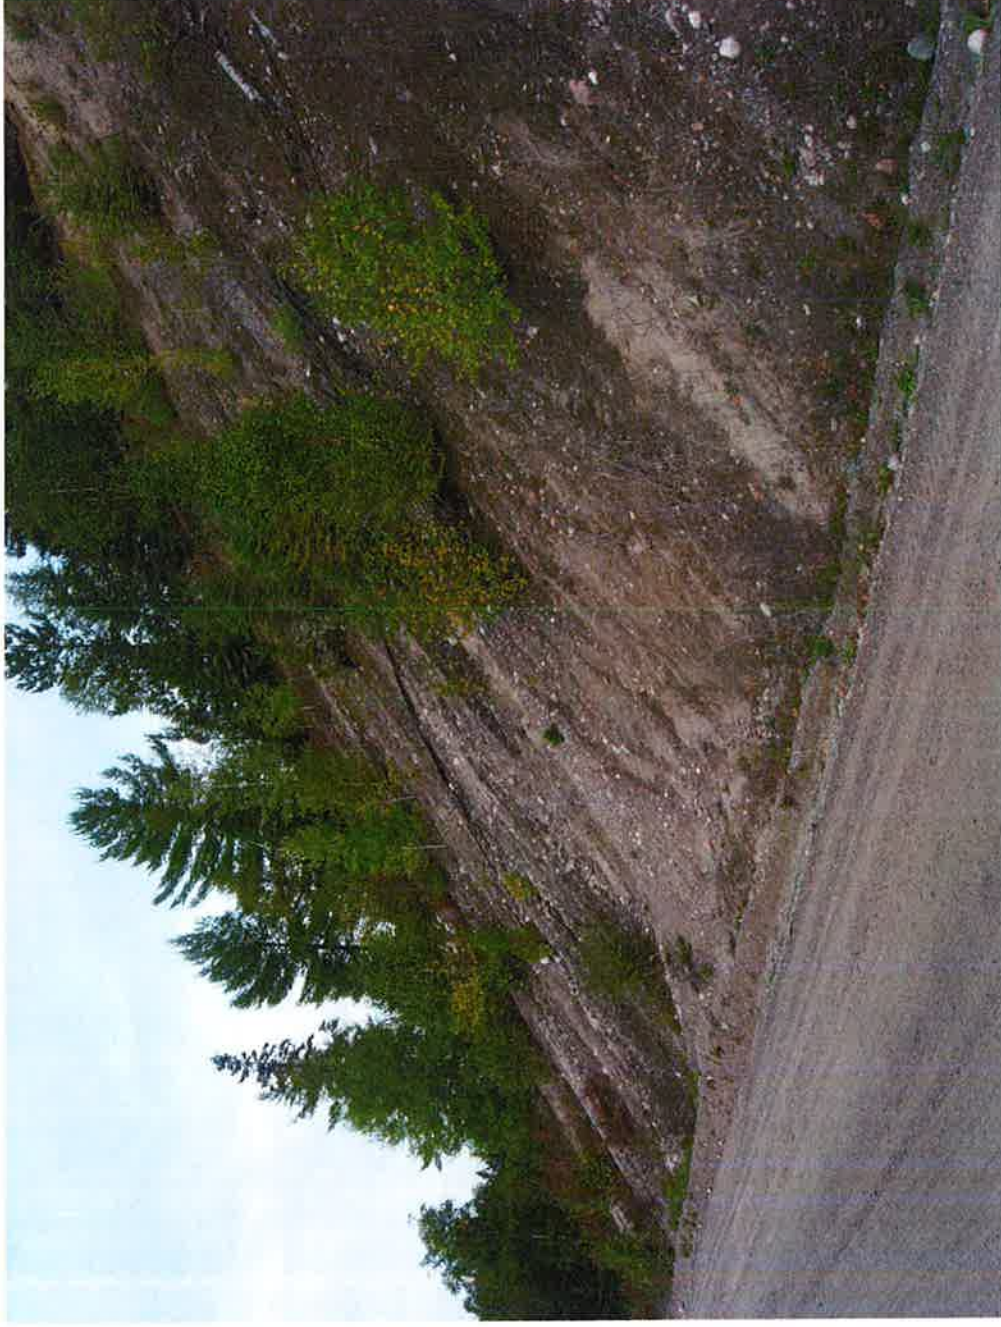
Photograph G-2 Slope, Hwy 556

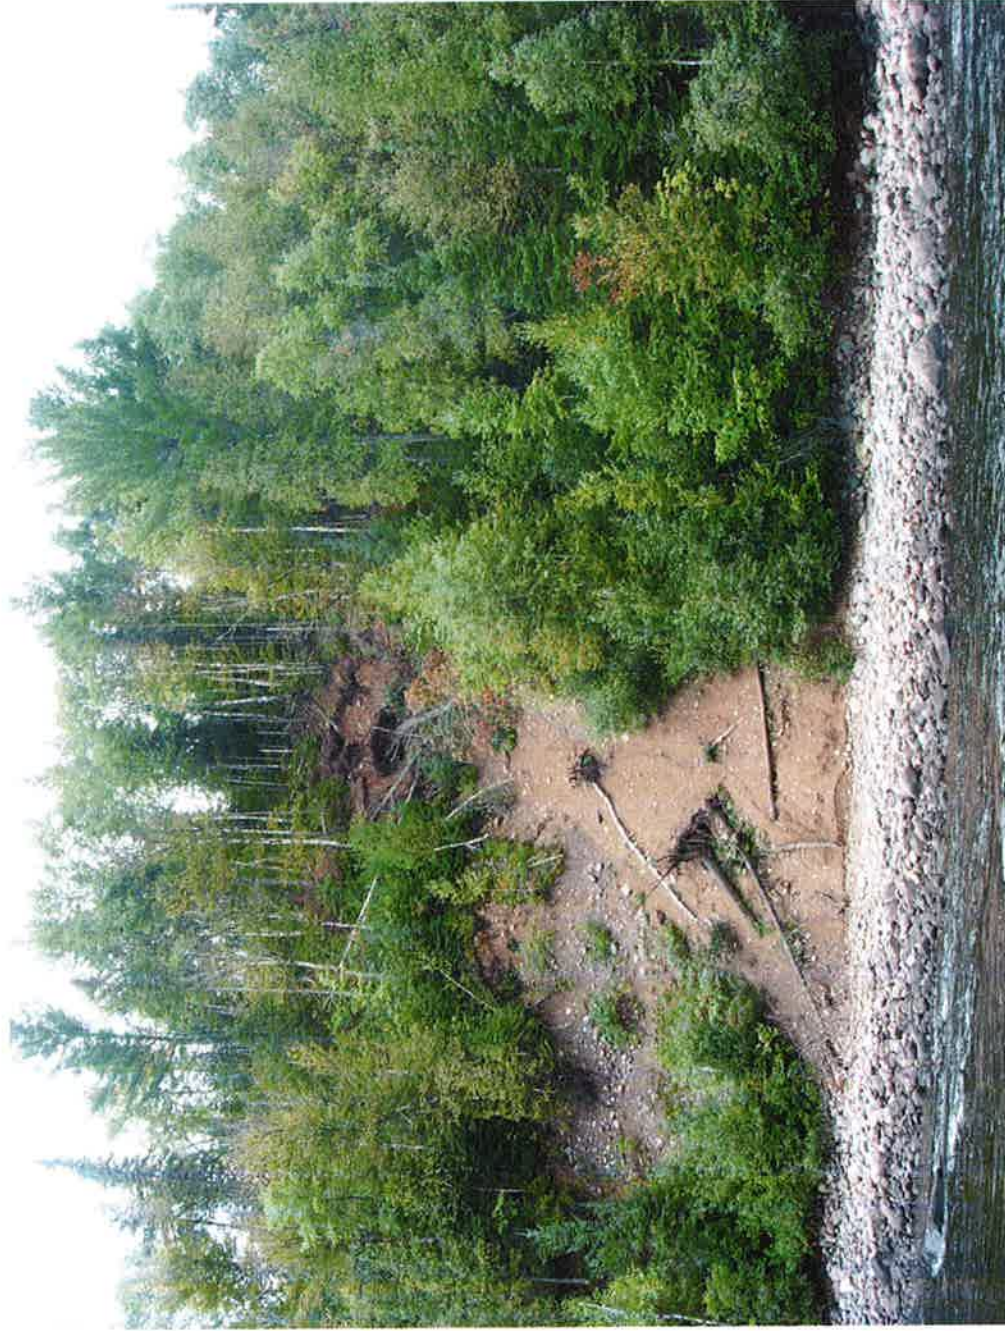
Photograph G-3 North bluff across the Mississagi River, Hwy 556

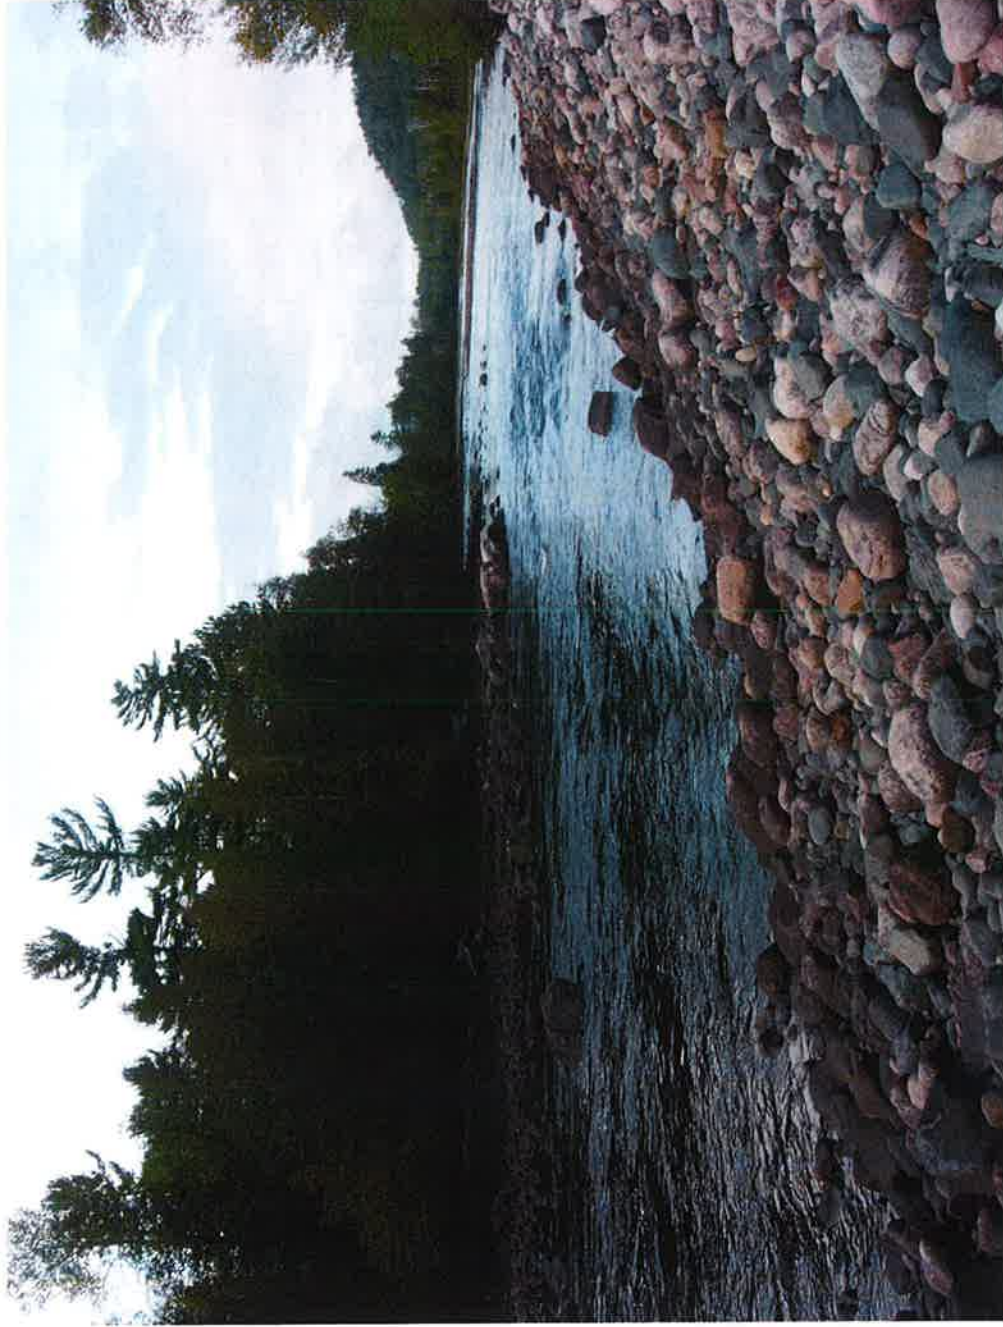
Photograph G-4 River bank, Hwy 556

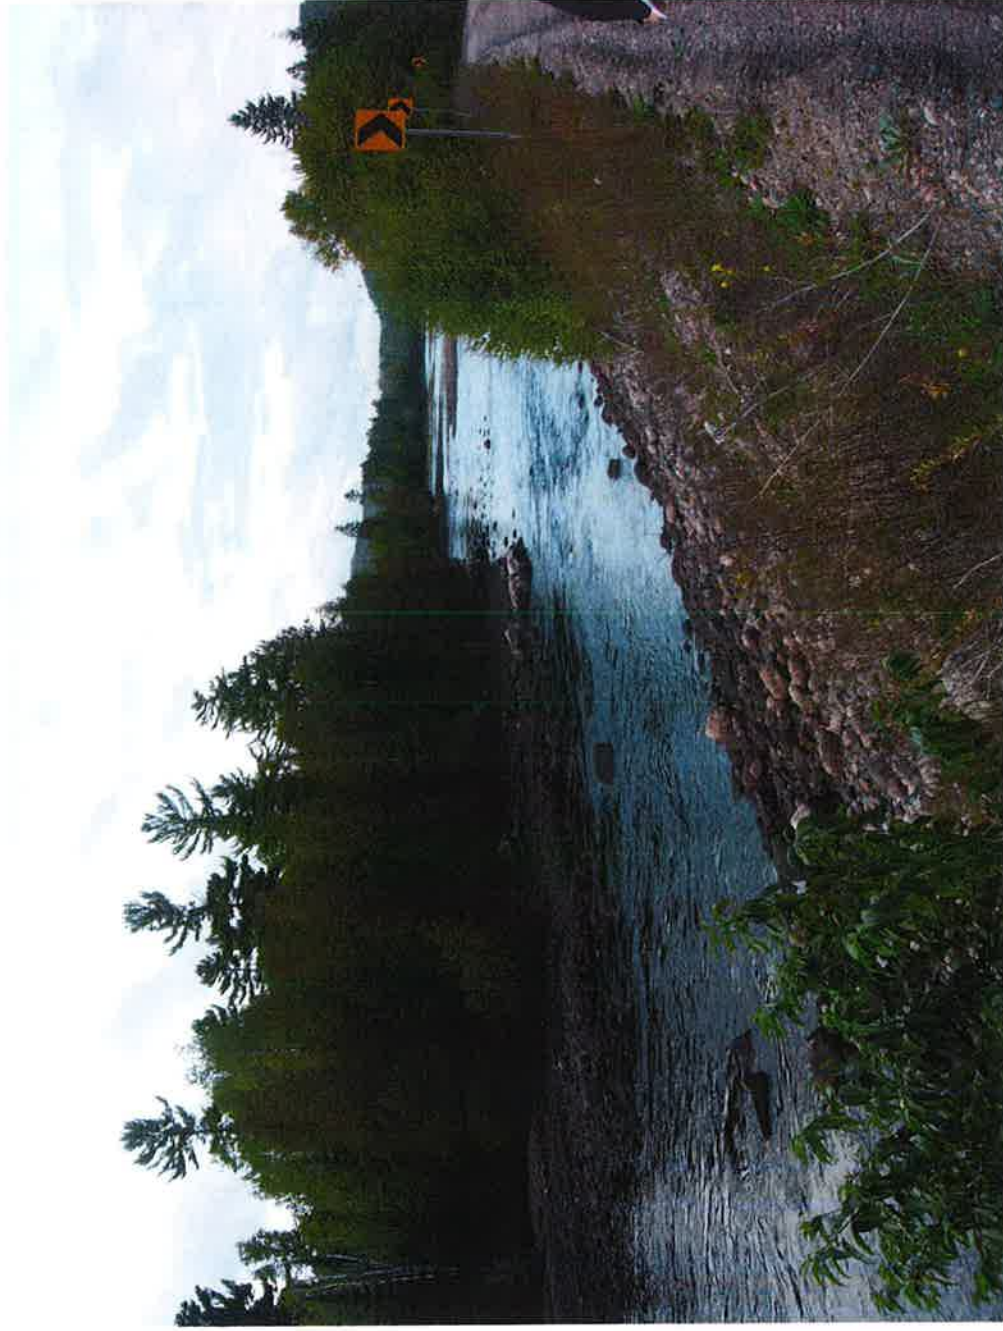
Photograph G-5 River bank, Hwy 556

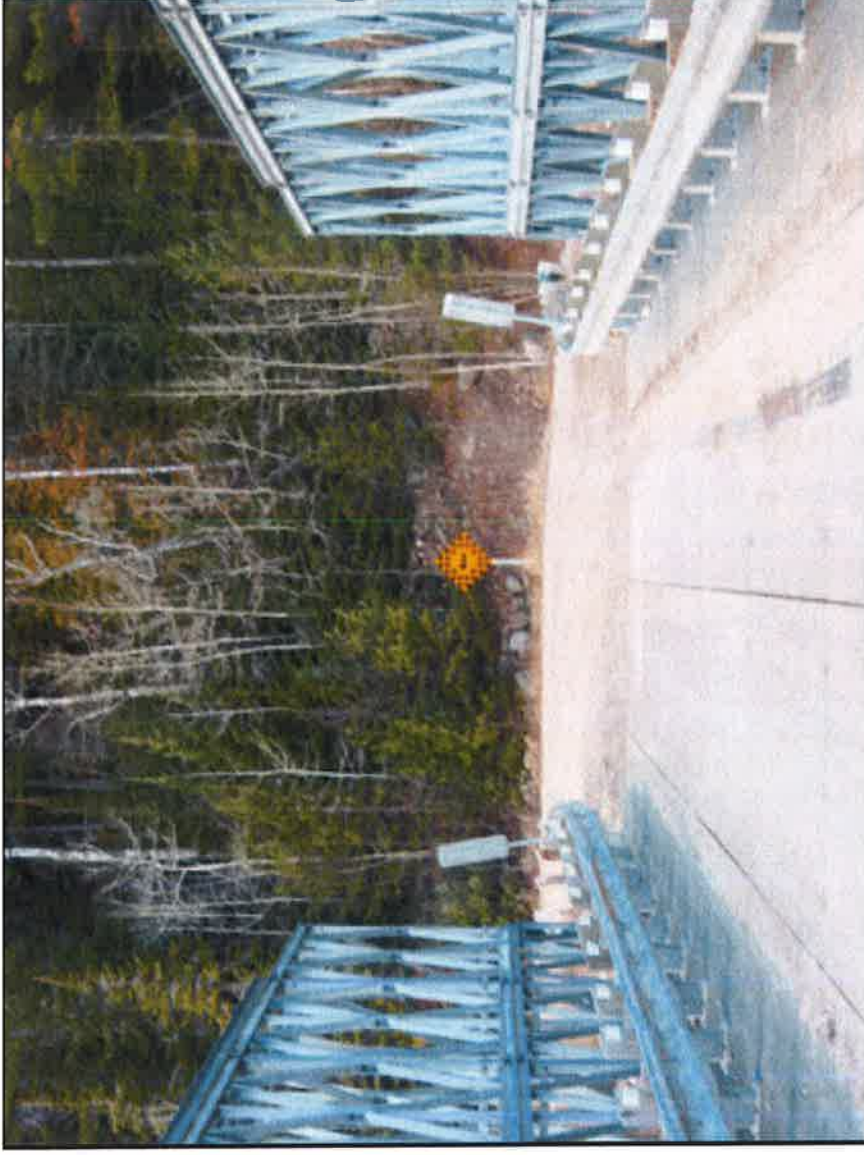
For Route Alternative 2, existing bridge needs to be improved to two lanes (i.e. a new bridge will be required to replace the existing one). More than 200 m long rock cut is required for less sharp west turn on the approach to the bridge than existing condition. Similar to Route Alternative 3, this route alternative merges with Highway 129 westerly after the river crossing. This route alternative is also rated as 'less favorable' due to this difficult rock cut section, as well as an even shaper approach to the bridge, but less sharp than existing alignment.

Photograph G-6 Sharp curve on the west approach to the bridge, Hwy 556

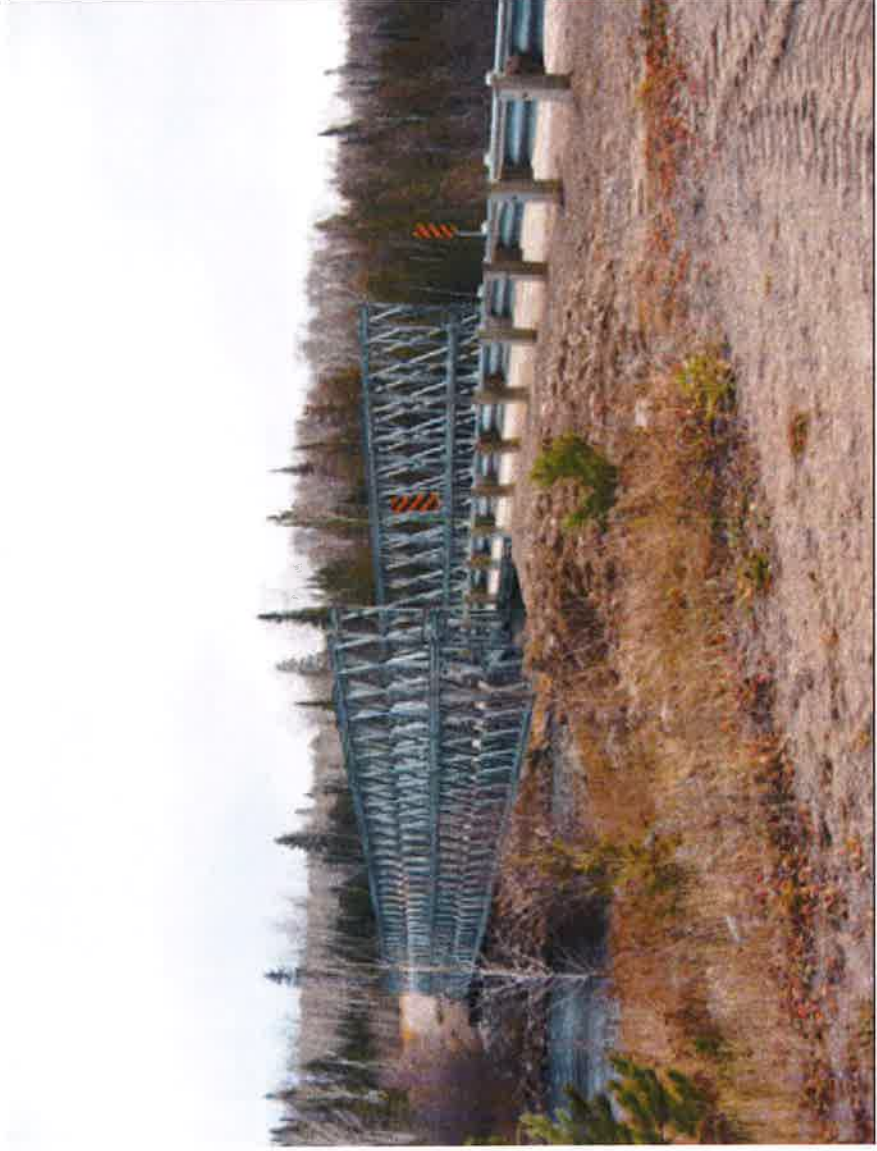
Photograph G-7 Sharp curve on the west approach to the bridge, Hwy 556
