**PHASE II
GEOTECHNICAL INVESTIGATION
AND SLOPE STABILITY
ANALYSIS REPORT
HIGHWAY 602, 0.2 KM SOUTH
OF BONE ROAD
TOWNSHIP OF CROZIER
AGREEMENT No.: 6009-E-0007
GWP: 6093-10-00
GEOCRES NO.: 52C-23**

September 2011

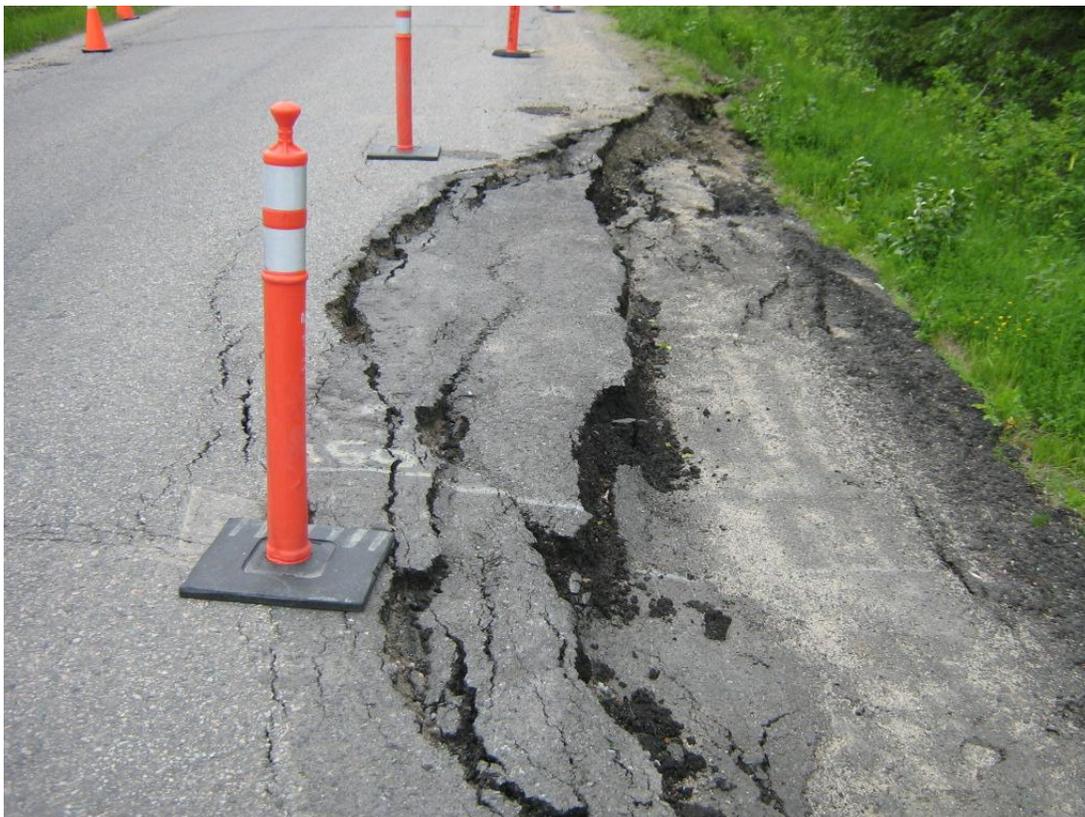
Figure 2.1 Slope Failure (looking north)

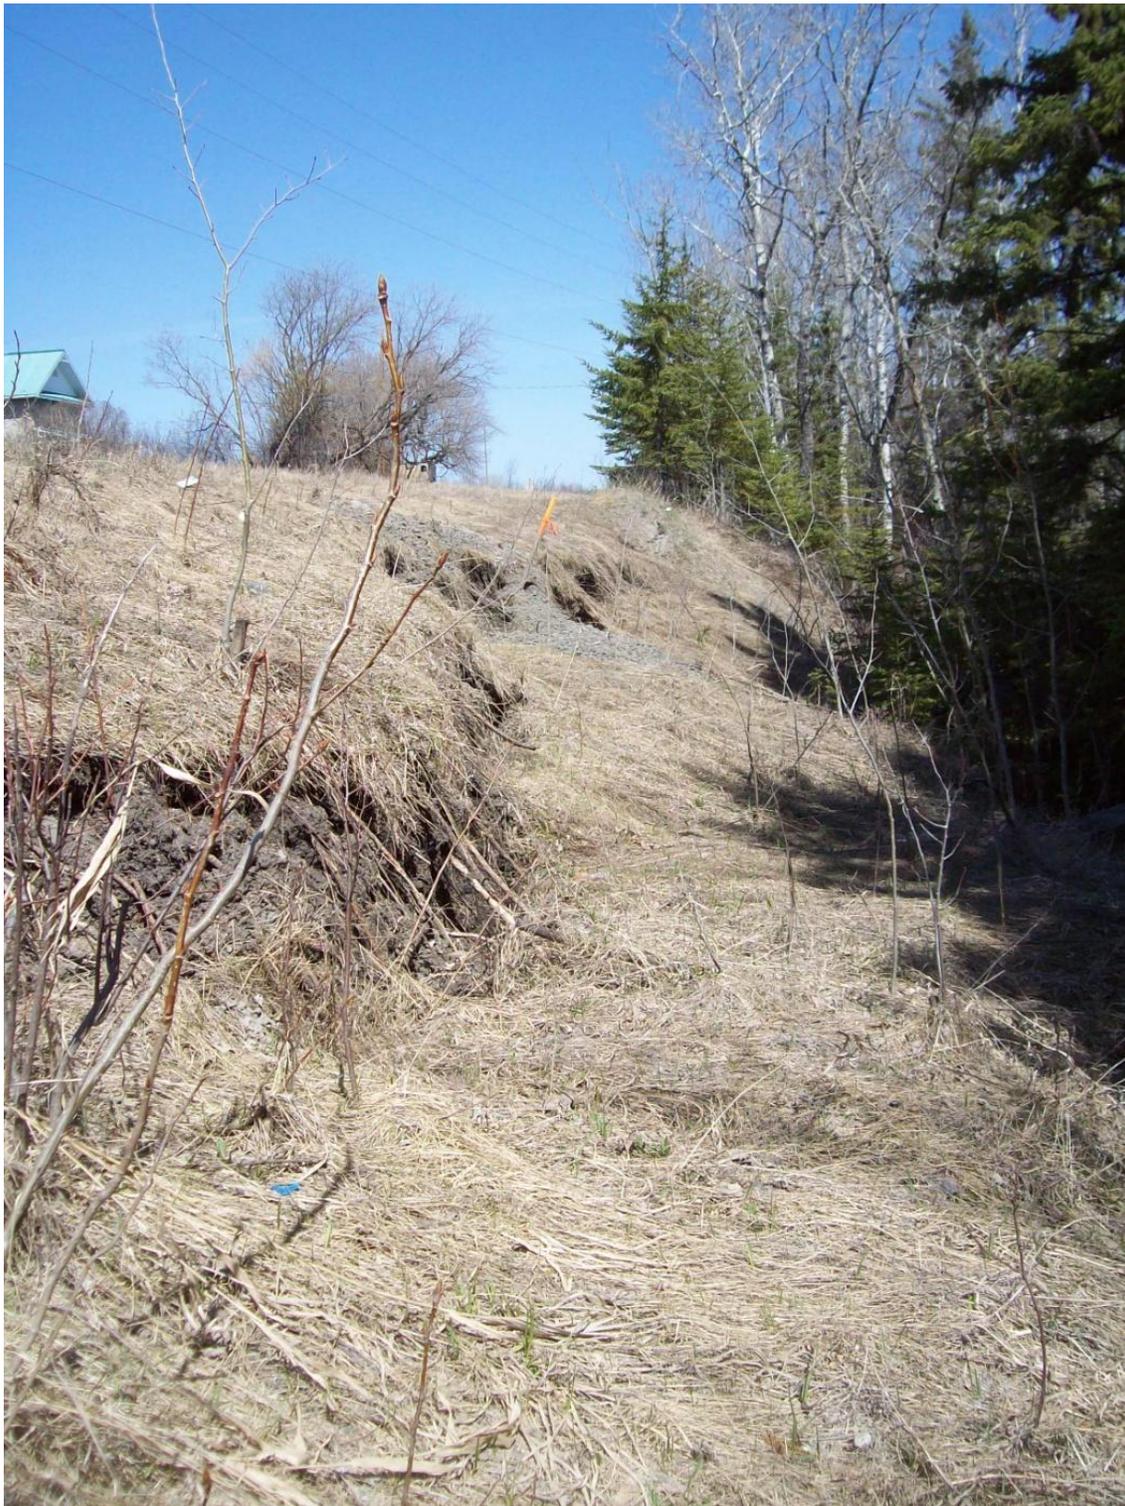
Figure 2.2 Failed slope vegetation (looking north)

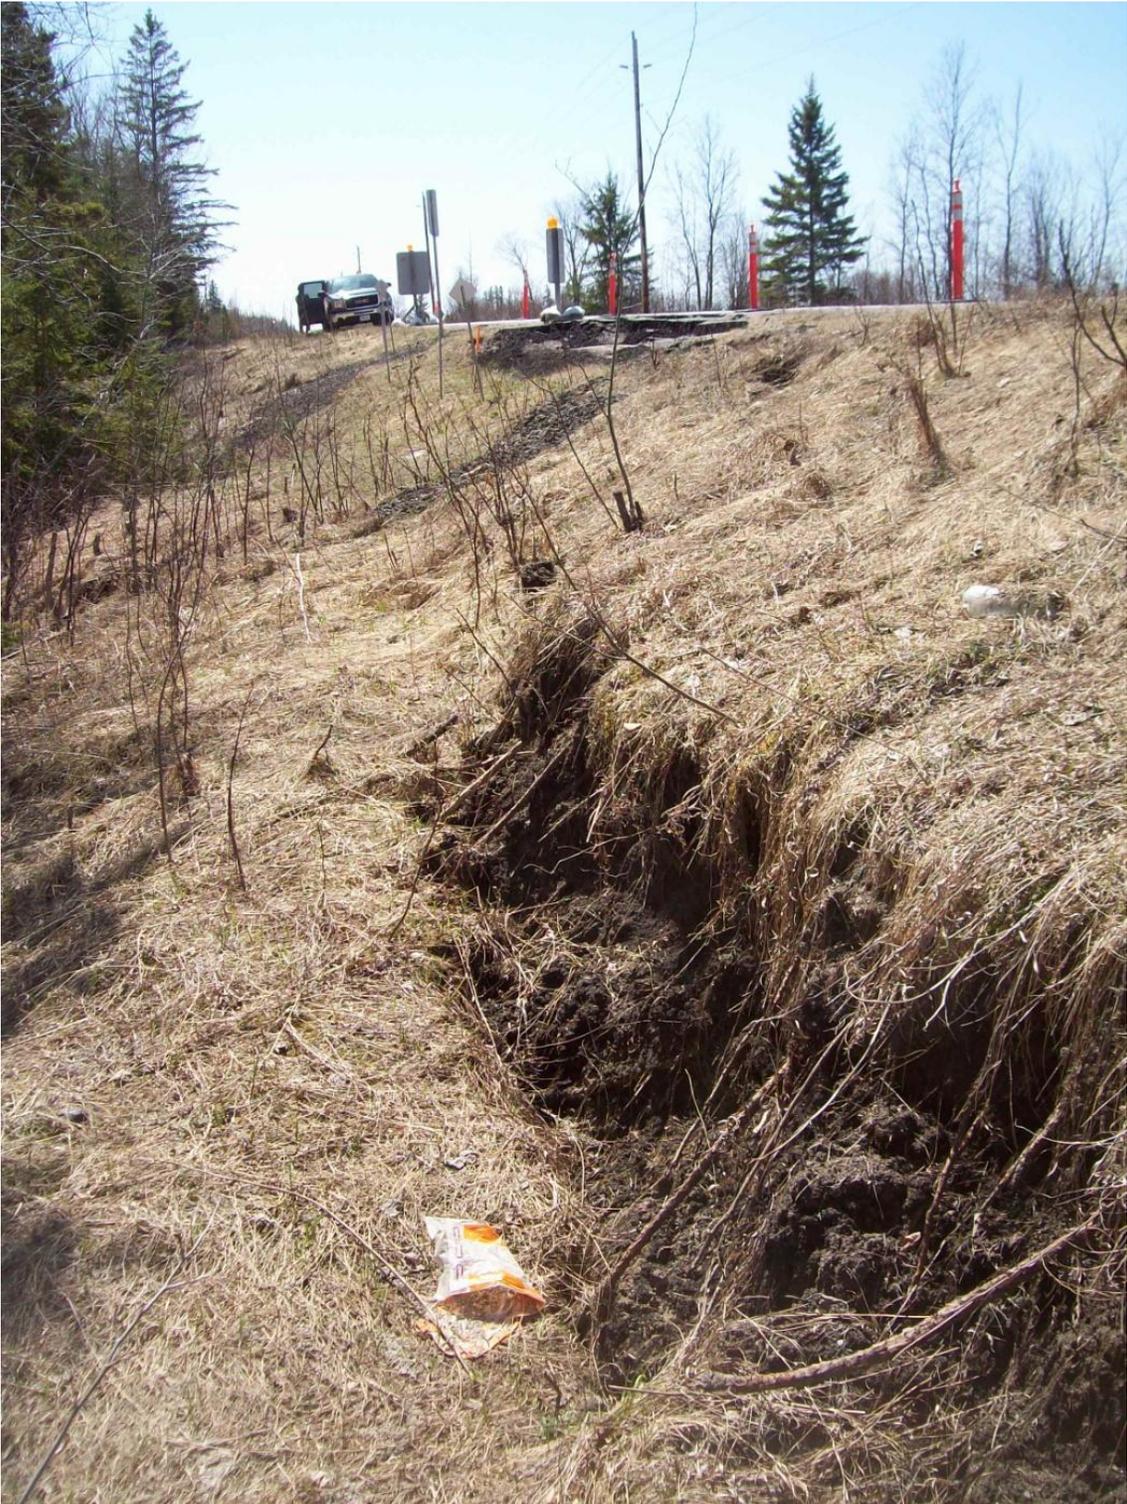
Figure 2.3 Failed slope vegetation (looking south)

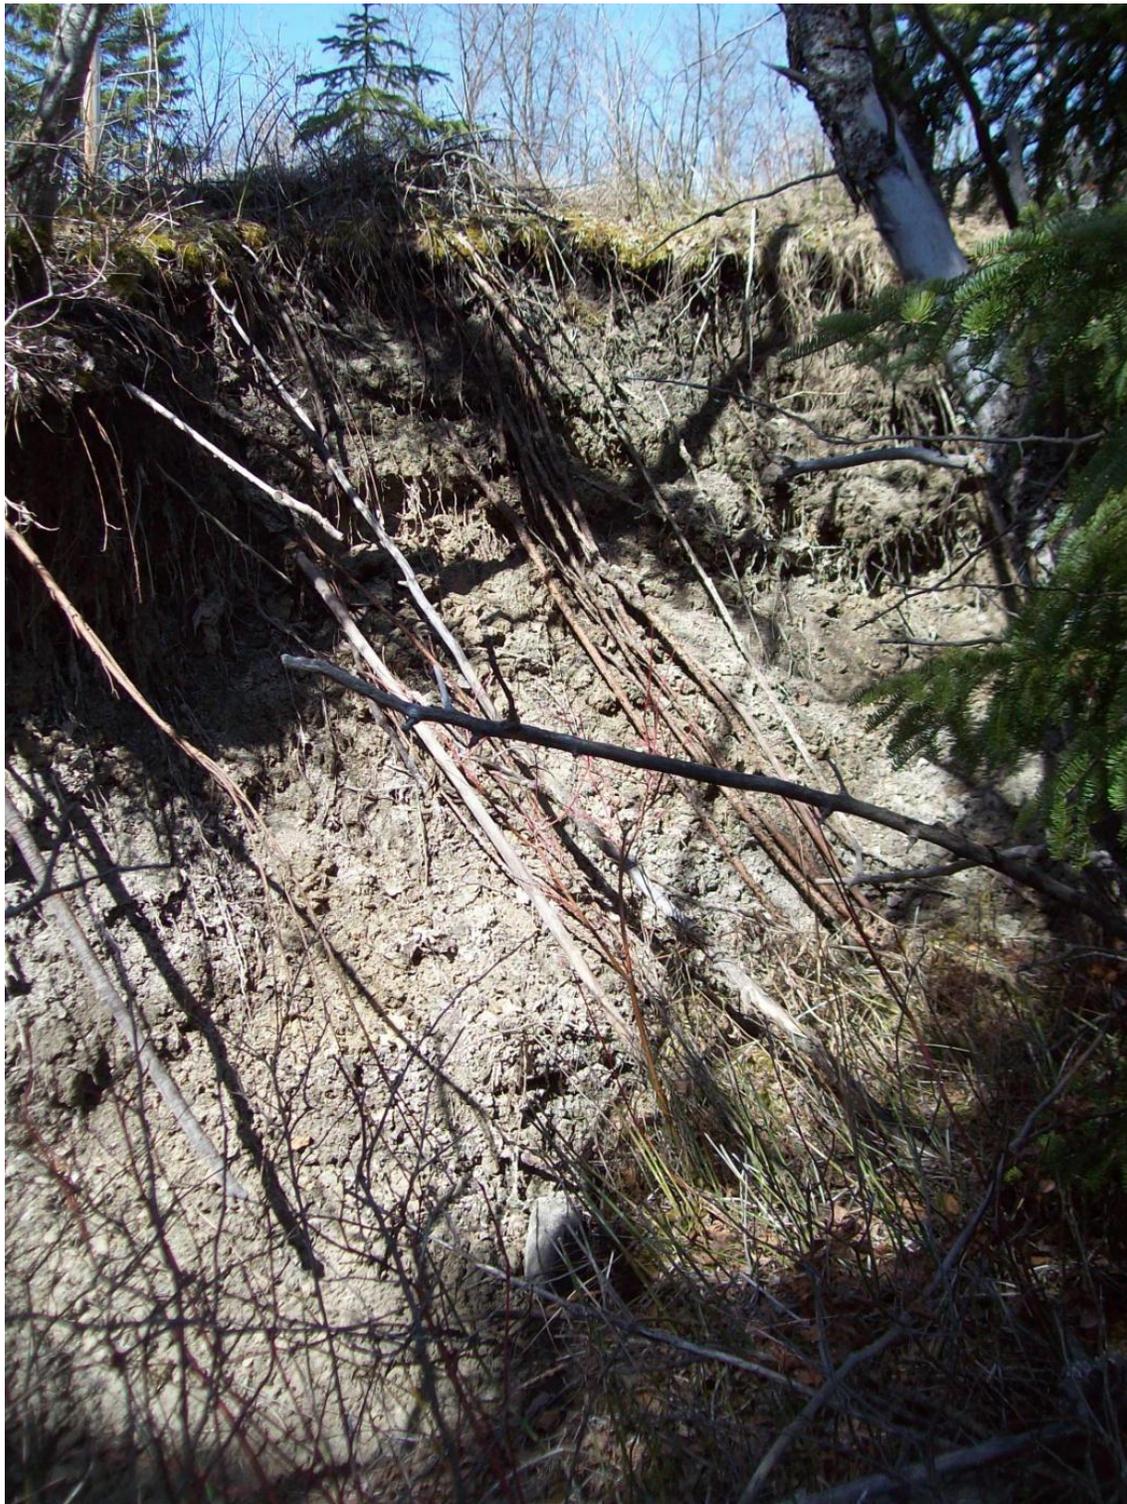
Figure 2.4 Approximately 2 m exposed slope face

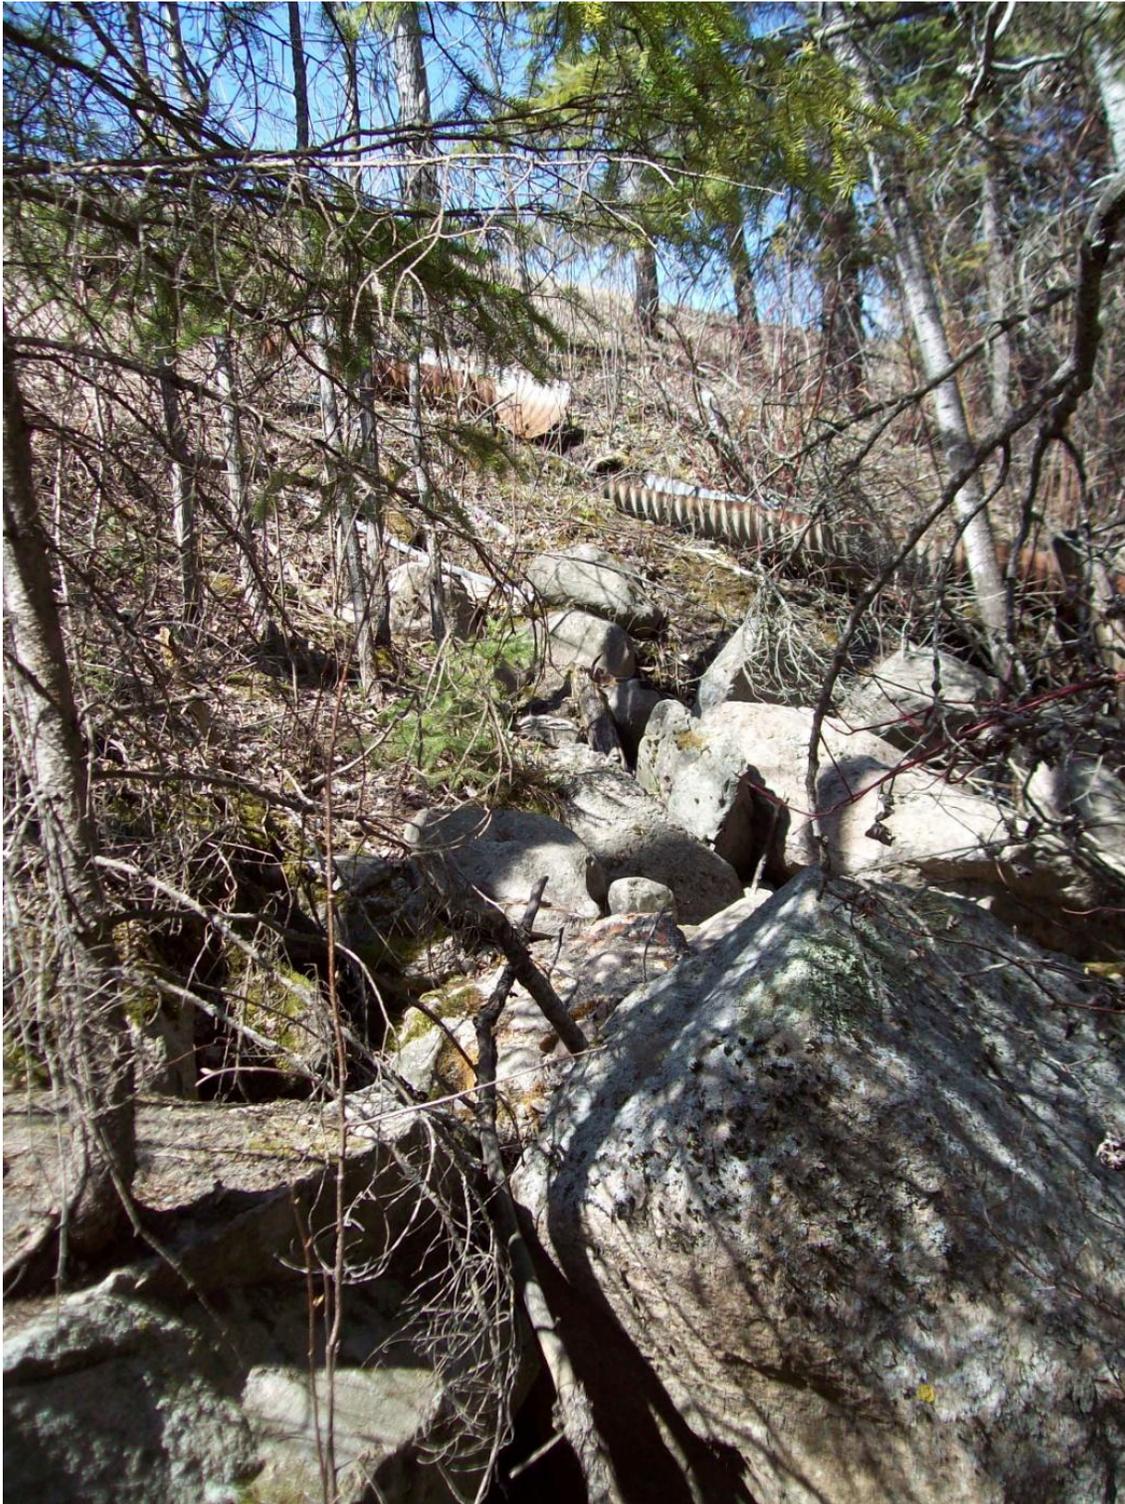
Figure 2.5 Cobble and boulder fill on foreslope (looking northwest)

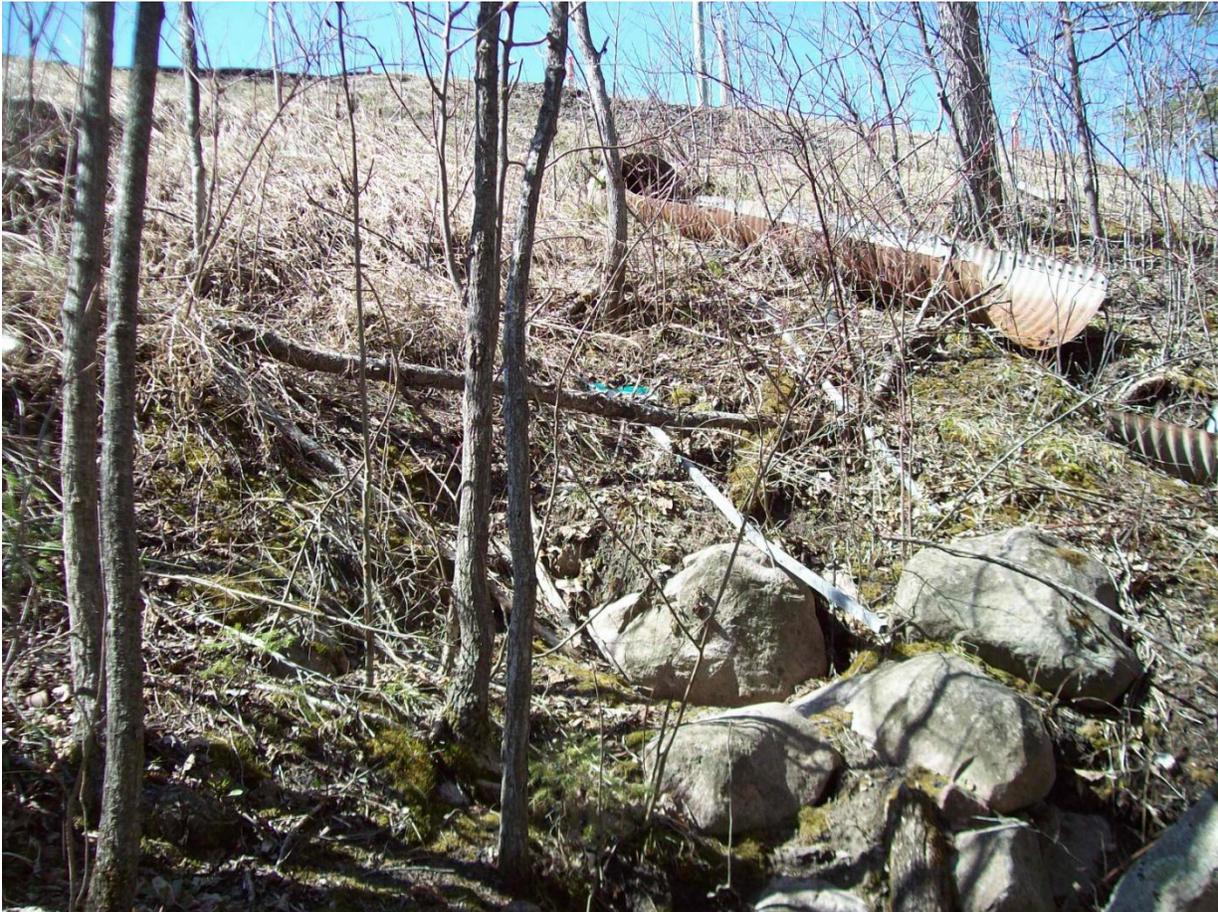
Figure 2.6 Cobble and boulder fill on foreslope (looking west)

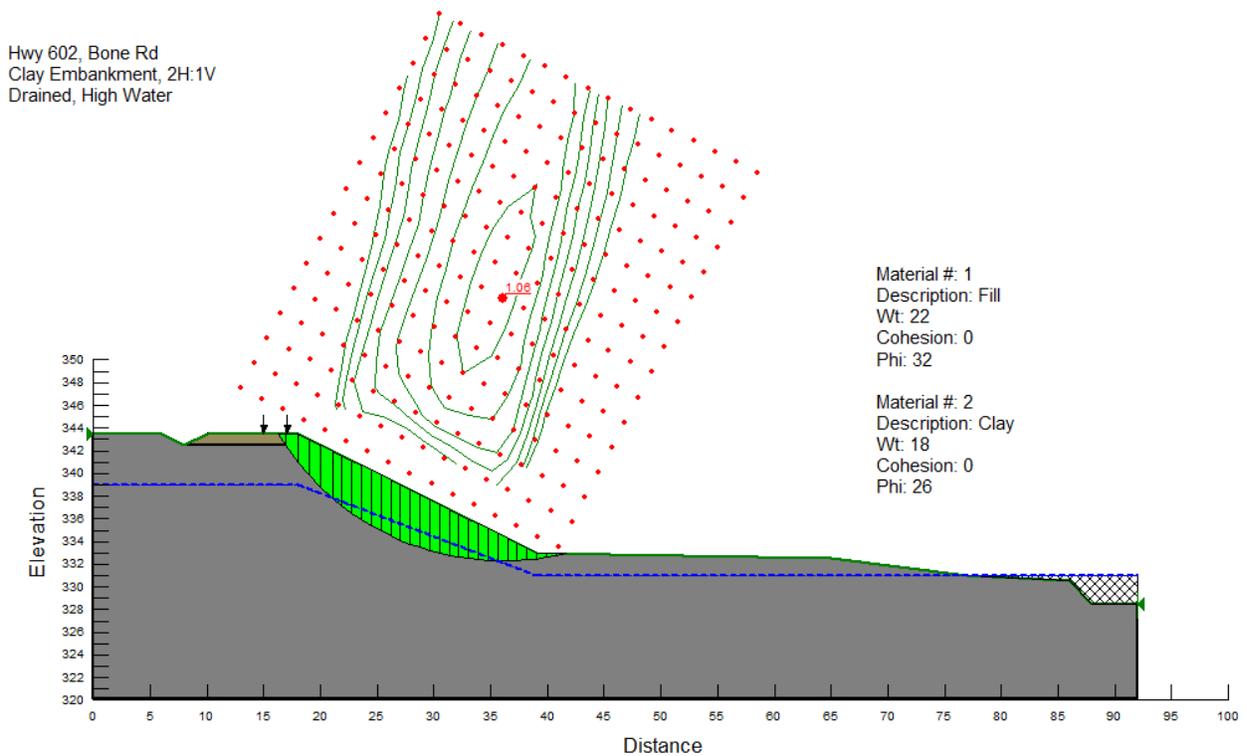
As can be seen above, the factor of safety for the existing slope under drained conditions is close to unity under conditions of both high and low groundwater and indicates unfavourable slope stability. The failure at the site is likely occurring as the result of a gradually steepening slope due to erosion, the undermining of the road from inadequate drainage as well as reoccurring smaller slope failures. Inadequate drainage significantly increases the potential for elevating the groundwater level during the spring thaw and heavy rainfall events due to the increased retention of water at the top of the slope which further reduces the factor of safety of the slope. The current conditions at the site (localized failure in northbound lane) are likely a precursor to a larger future slope failure.

Figure 1 Clay embankment 2H:1V, drained condition with high water

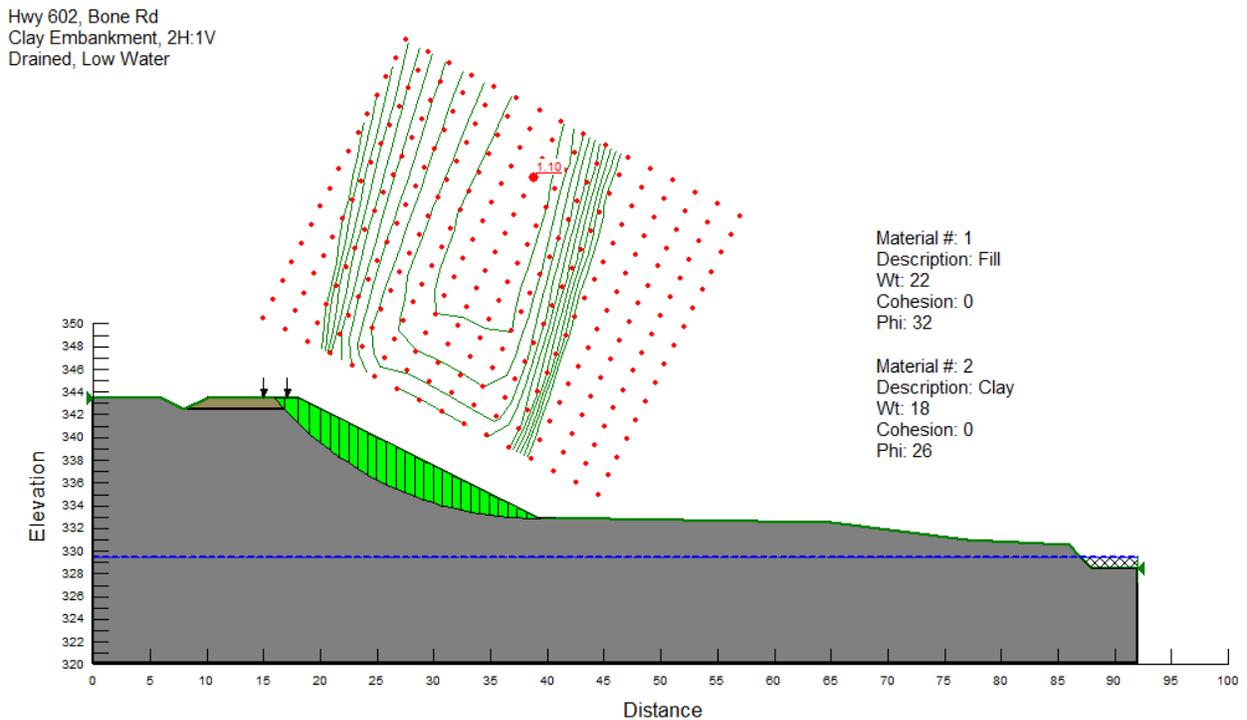
Figure 2 Clay embankment 2H:1V, drained condition with low water
