Final Foundation Investigation Report (FIR)

Highway 61 Culvert Replacement

Station 19+250, Township of Blake

GWP 6176-15-00

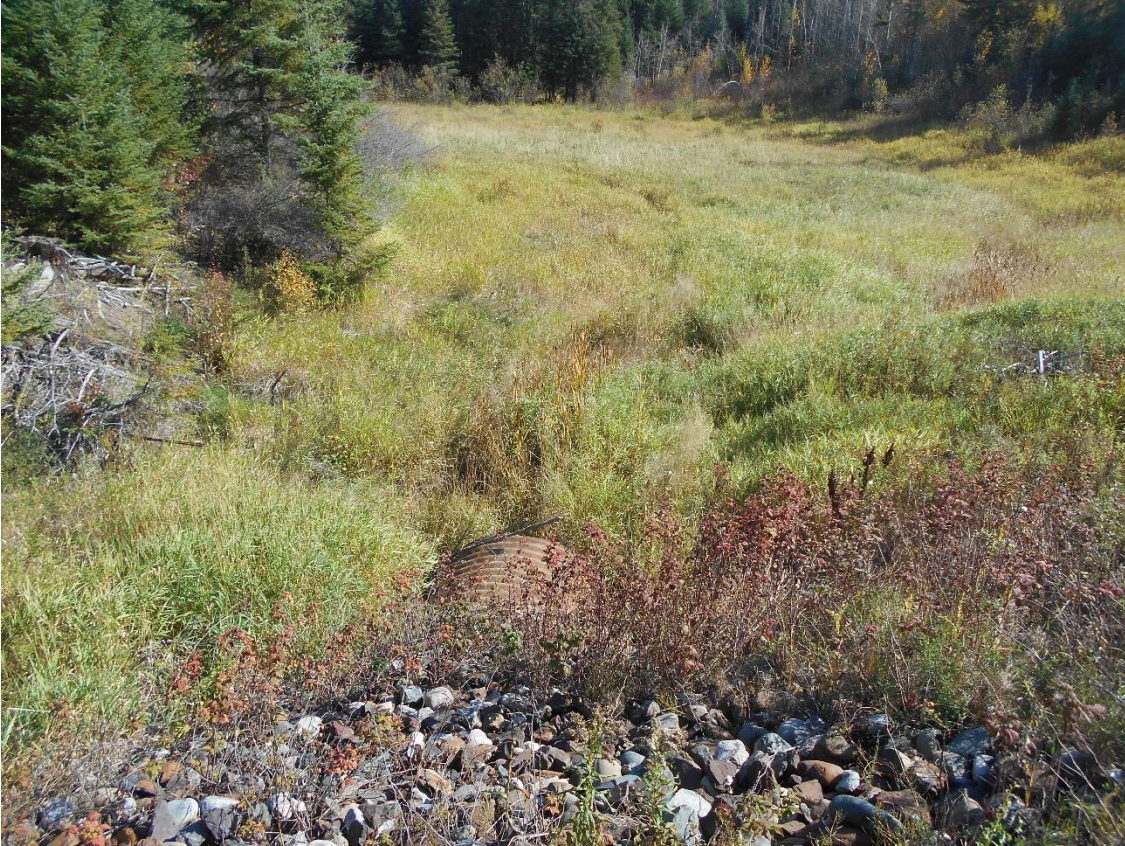
C11A - #1 – Upstream Channel Conditions

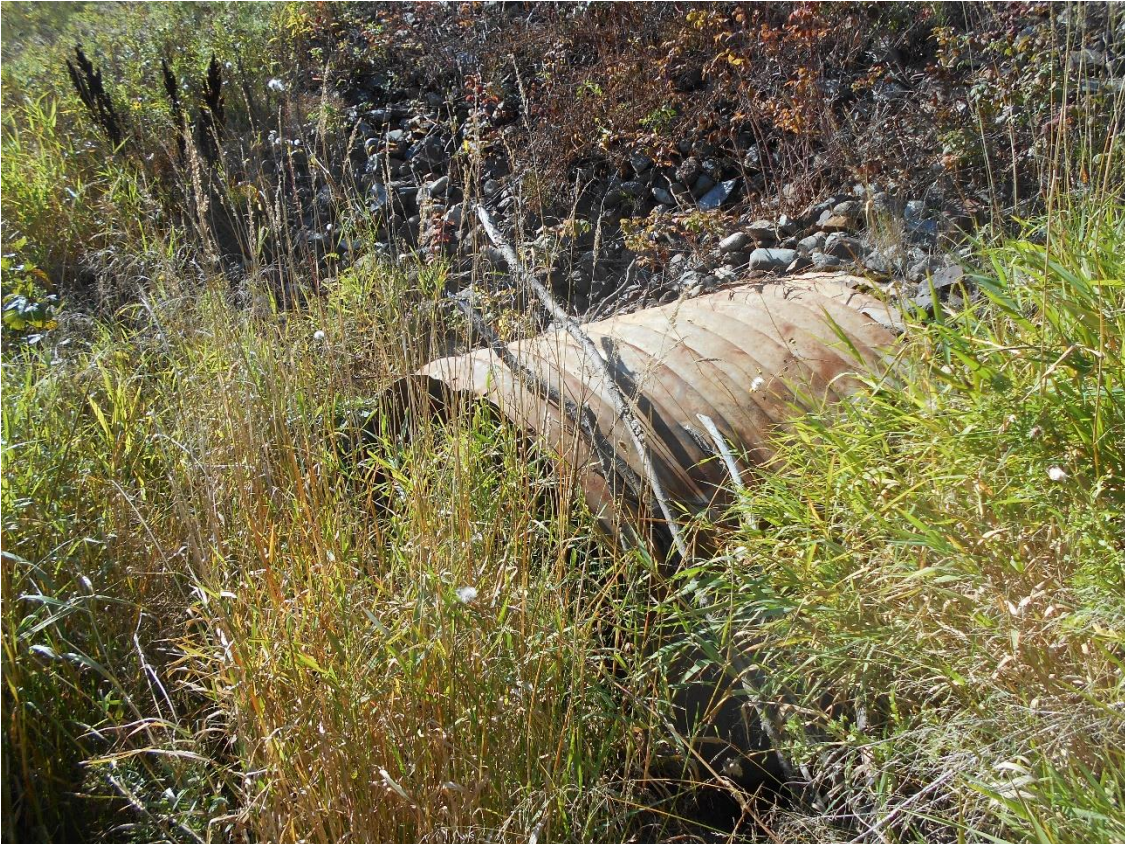
C11A - #2 – Upstream Face of the Culvert

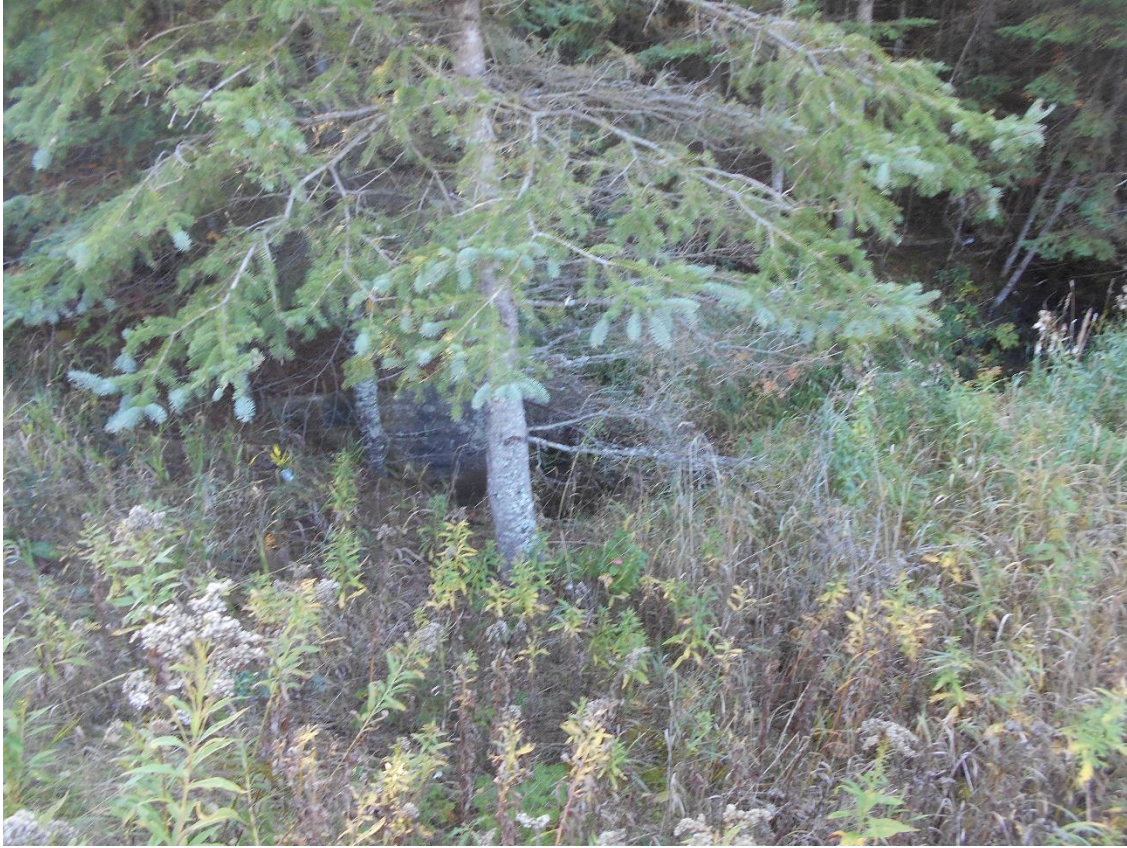
C11A - #3 – Downstream Channel Conditions

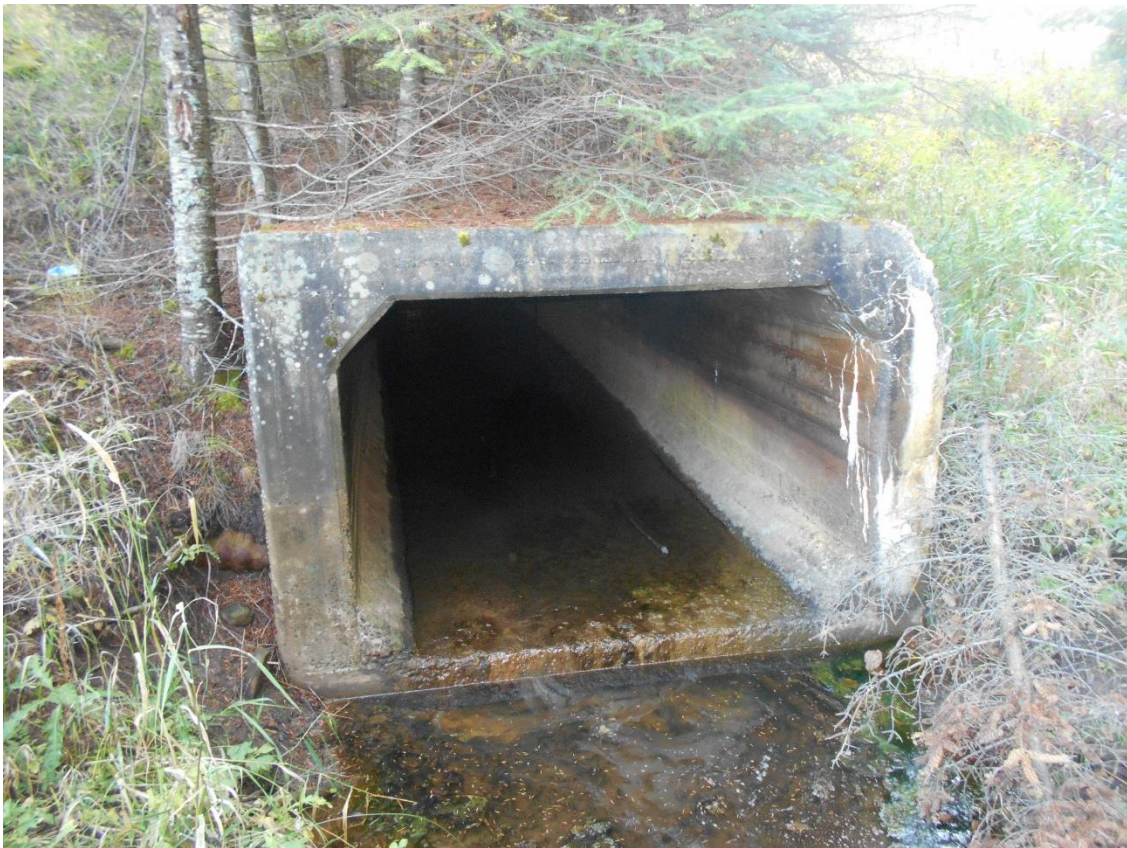
C11A - #4 – Downstream Face of the Culvert
