**FINAL
GEOTECHNICAL INVESTIGATION
AND DESIGN REPORT
HIGHWAY 61, 0.4 KM NORTH
OF CLOUD RIVER ROAD
TOWNSHIP OF CROOKS
STATION 23 + 075 TO 23 + 150 RT
MTO GEOCRE NO.: 52A-153
GWP NO.: 6210-10-00**

**MARCH 2014
GS-TB-016596**

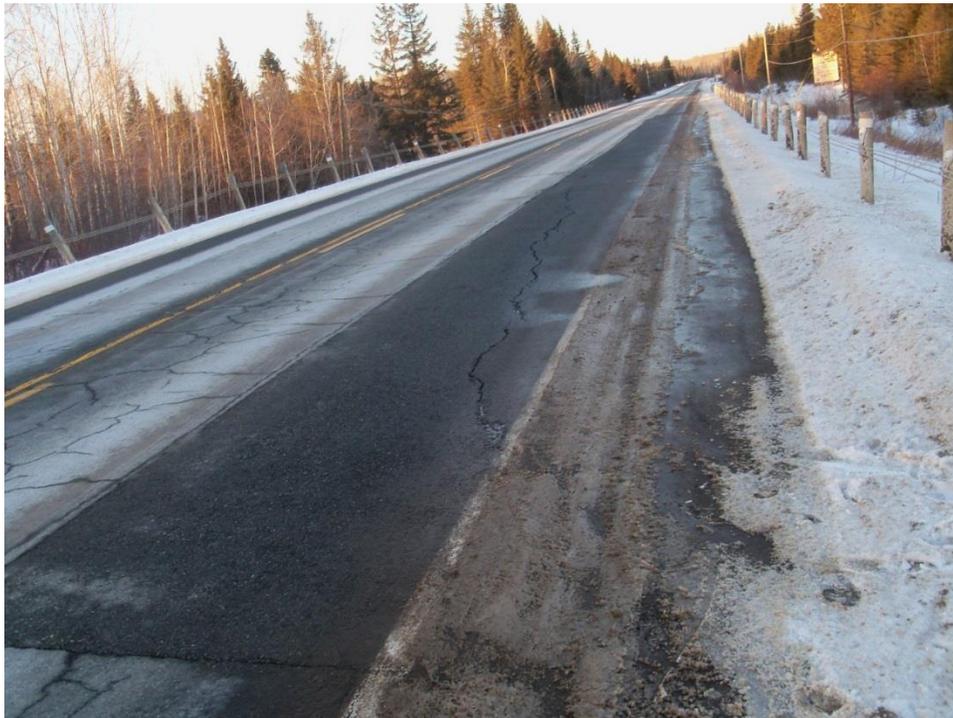
An indication of embankment movement was found on the northbound lane. A crack on the asphalt paving surface was observed at a section approximately 2 m wide x 50 m long (Figure 2.1). The total height of the existing road embankment and natural valley is approximately 8.0 m and the overall slope of the embankment is at an approximate gradient of 2.3H:1.0V (Figure 2.4). A ditch beside the northbound lane of the highway has a lower elevation than the ditch beside the southbound lane. A culvert exists at the northern extent of the investigated embankment and drains water from the west to the east side of the embankment.

Figure 2.1 Investigated embankment along Hwy 61 (looking northbound)

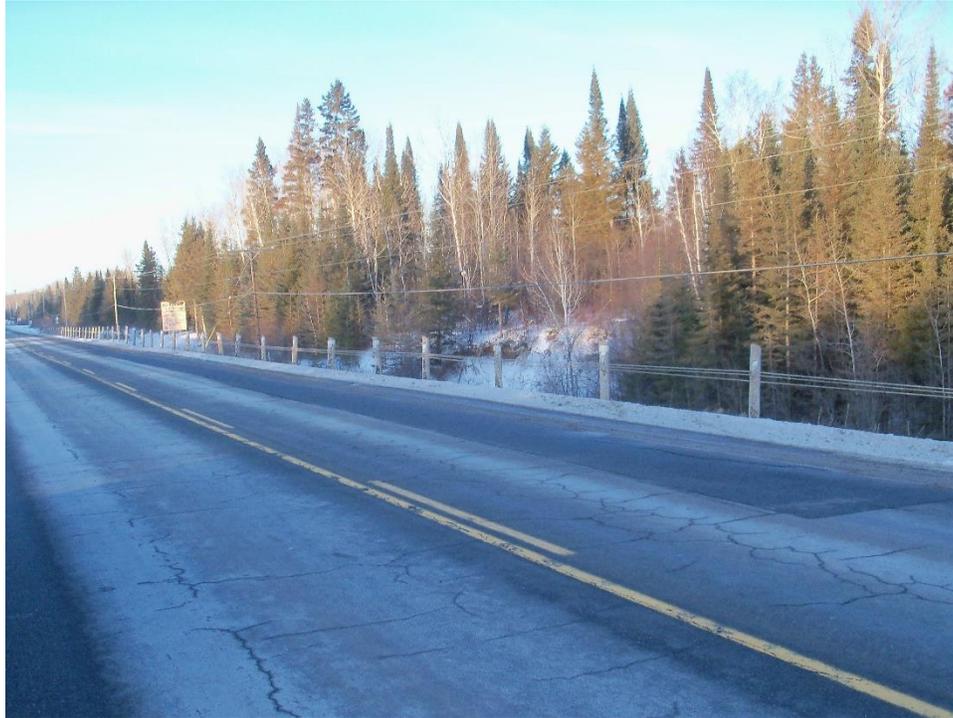
Figure 2.2 Investigated embankment northbound lane along Hwy 61 (looking northbound)

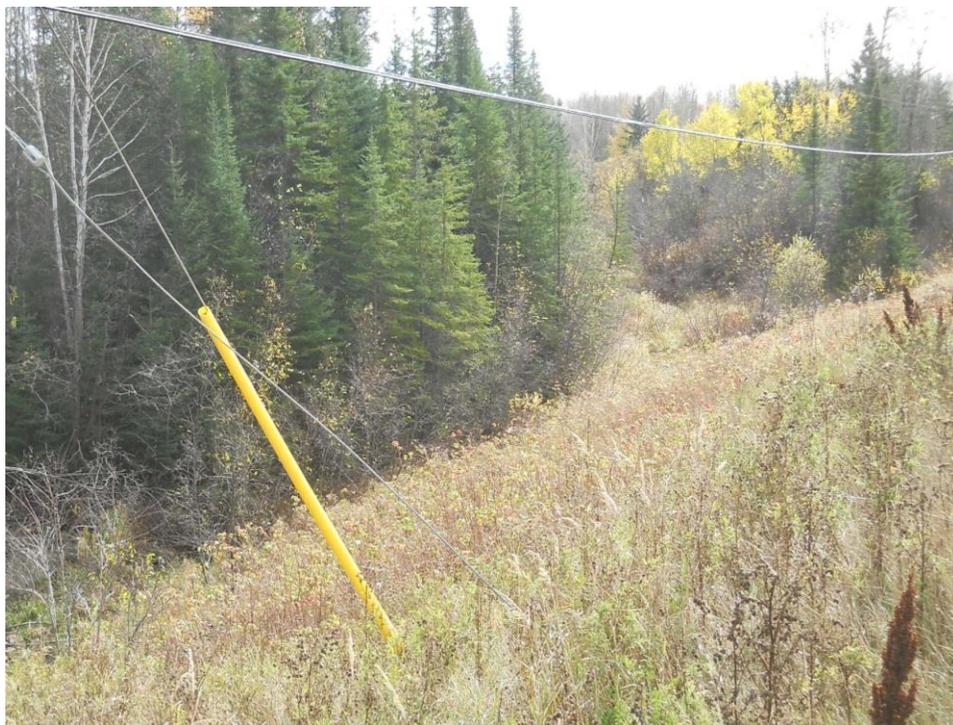
Figure 2.3 Investigated embankment along Hwy 61 (looking southbound)

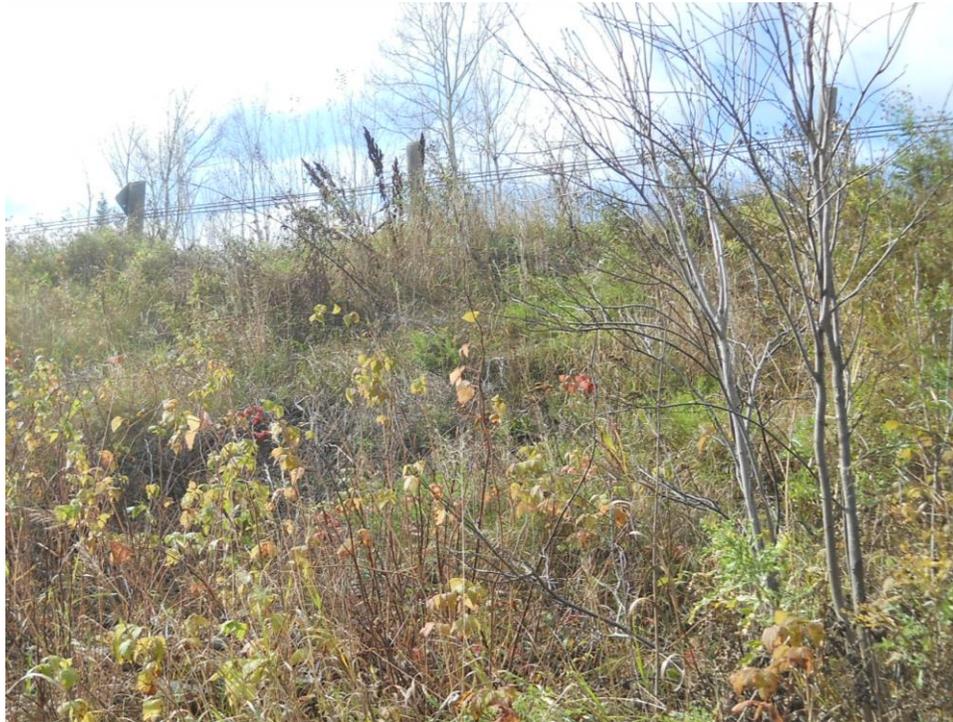
Figure 2.4 Embankment slope northbound lane (looking west)

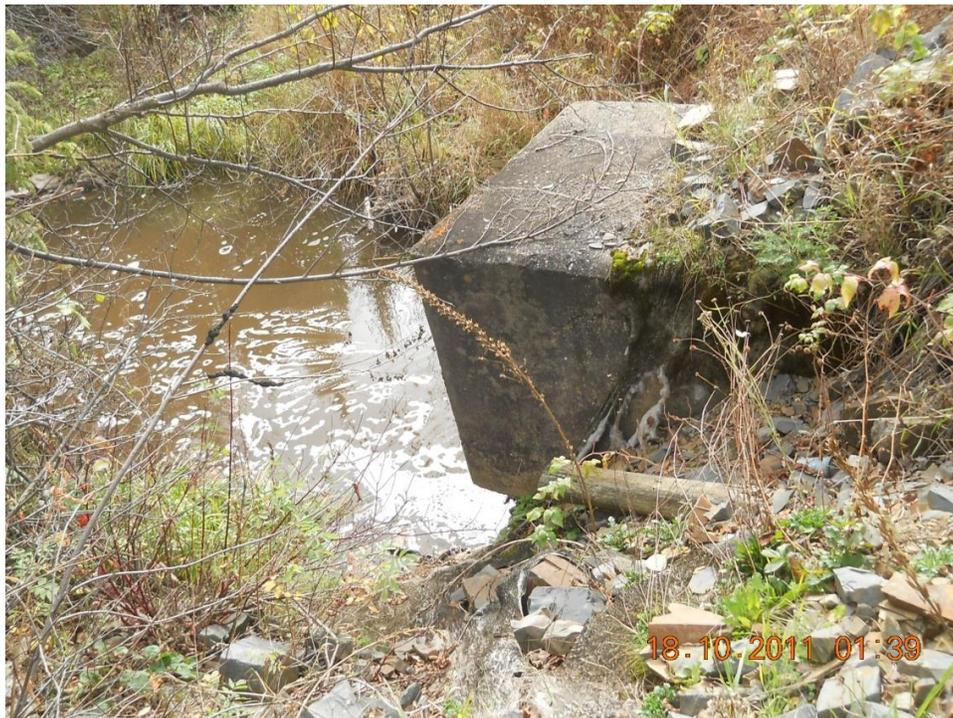
Figure 2.5 Concrete culvert outlet at northbound lane (looking south).

During the site inspection on 18 October 2011, DST noticed that water is flowing underneath the existing culvert (see Figure 2.6). This may cause internal erosion below the existing culvert in the long run and should be prevented. A clay seal or alternative should be used upstream to prevent the movement of fine material.

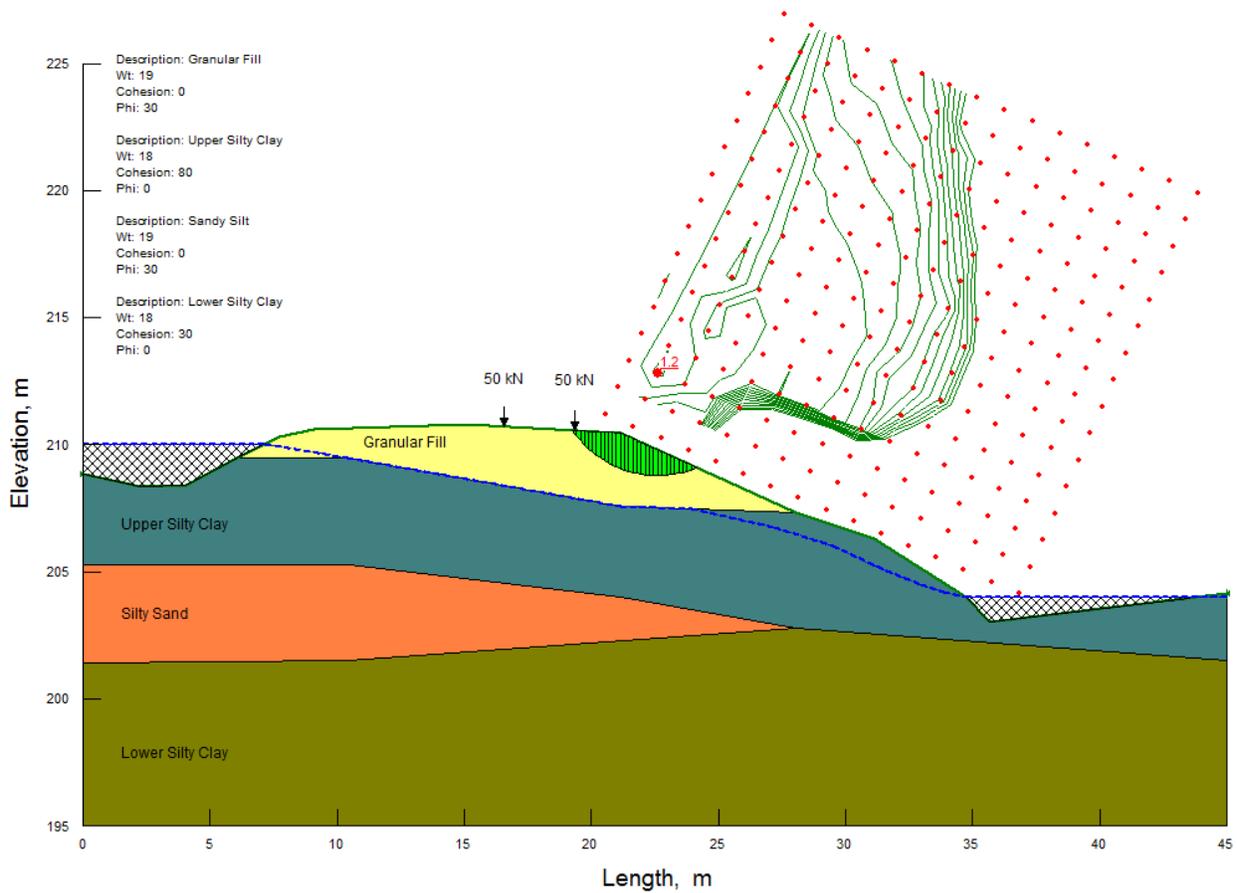
Stability analyses of the existing embankment profile and present soil parameters, estimated from the recent site investigation, shows a factor of safety of 1.2 for the total stress condition analysis. However, stability analysis with effective stress condition resulted in a factor of safety close to unity.

Figure C.2 Existing embankment, total stress analysis with high water

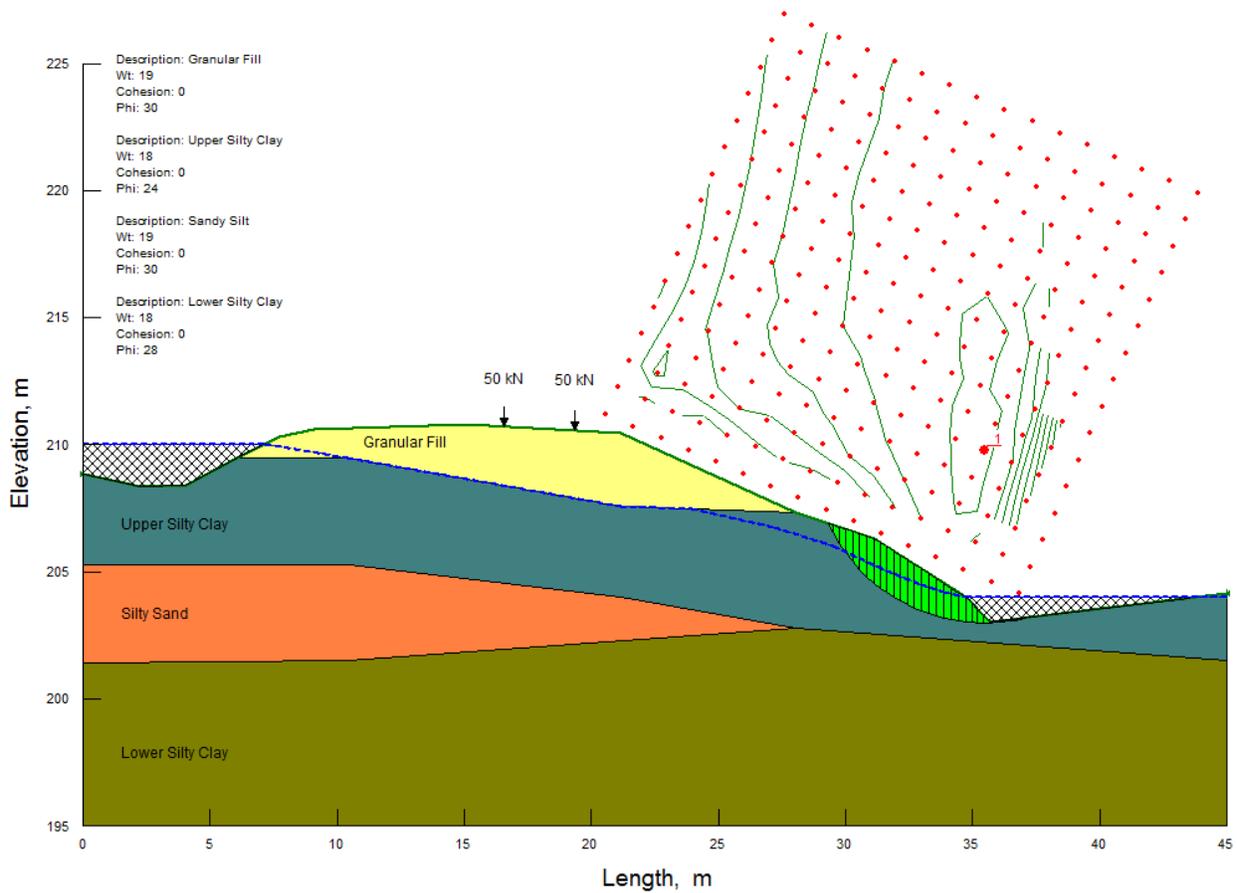
This indicates that the embankment has a reasonable factor of safety for total stress condition. However, this is not the case for the effective stress condition which reflects long term conditions.

The long term condition only has a factor of safety of unity. This indicates that the embankment has a long term instability problem. This also indicates that the input parameters used in the slope stability analyses reasonably represent the average overall strength parameters of the in situ soil mass and the parameters are very close to the critical state soil parameters. Therefore, stabilization measures are required to maintain long term embankment stability.

Figure C.3 Existing embankment, effective stress analysis with high water

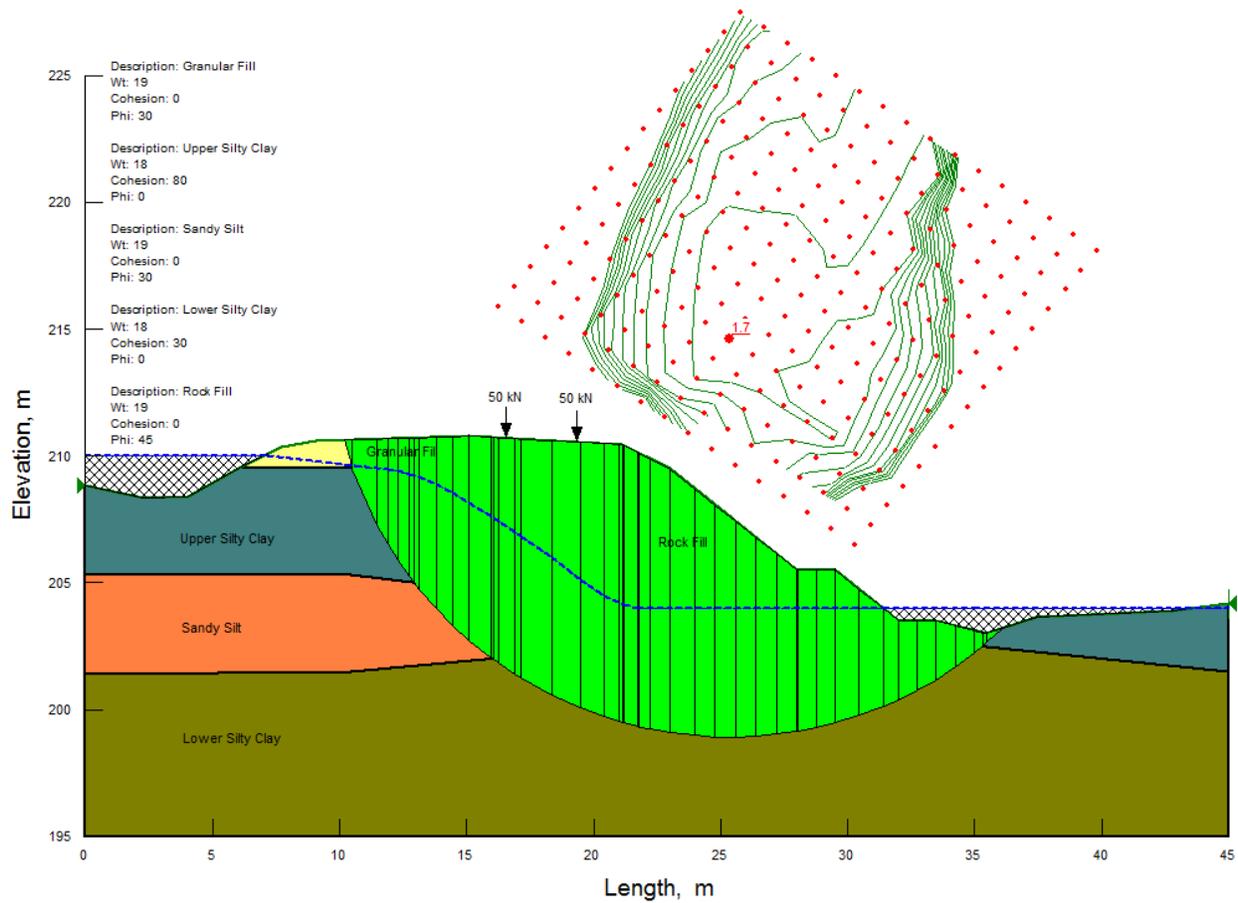
This option resulted in acceptable factors of safety of greater than or equal to 1.3. For these analyses, the total stress and effective stress parameters were used. The following table shows factors of safety of the selected cases under total stress and effective stress conditions. Examples of slope stability analysis outputs can be found in Appendix C, Figures C.4 through C.6. Plan view and cross sections of the proposed remedial methods are provided in Appendix B, Drawing 4.

Figure C.5 Steepened rock fill embankment with counterweight berm, total stress analysis with high water

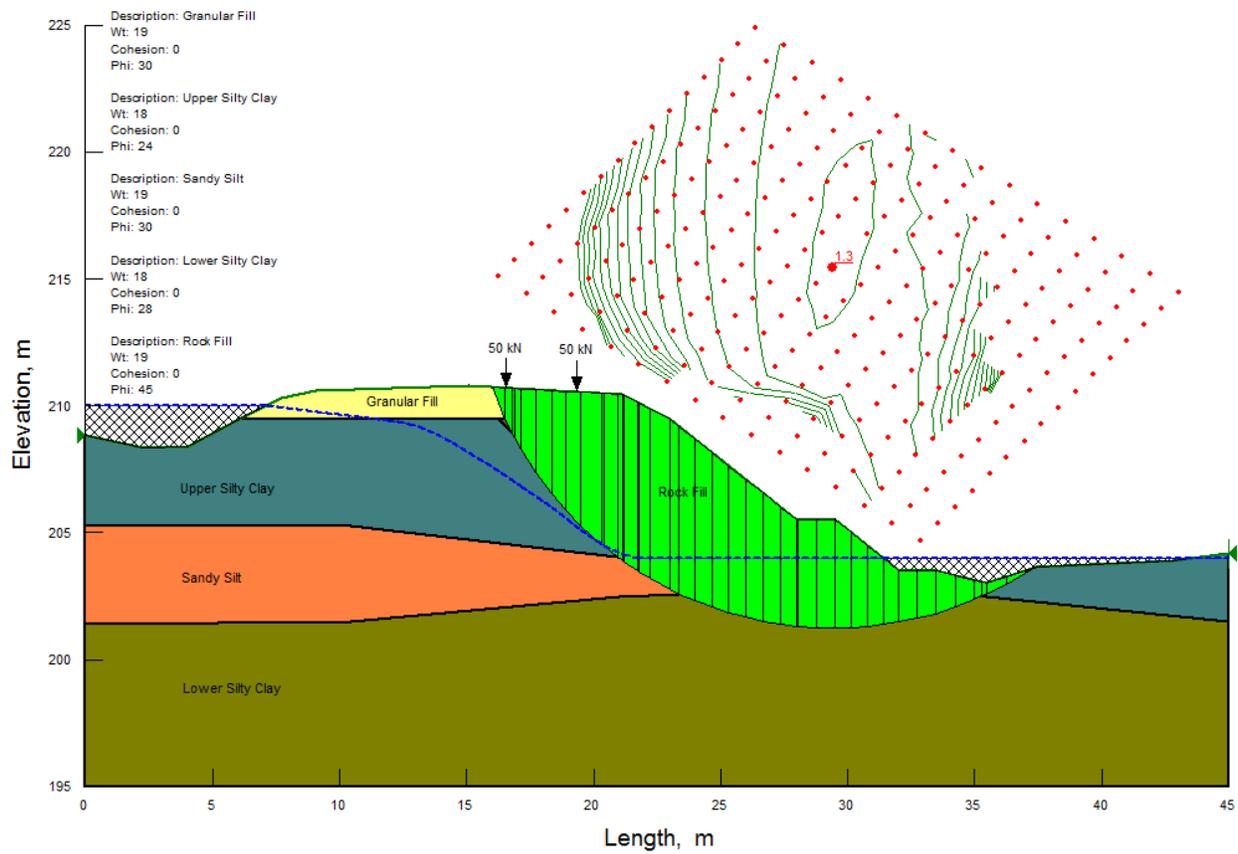
Figure C.6 Steepened rock fill embankment with counterweight berm, effective stress analysis with high water

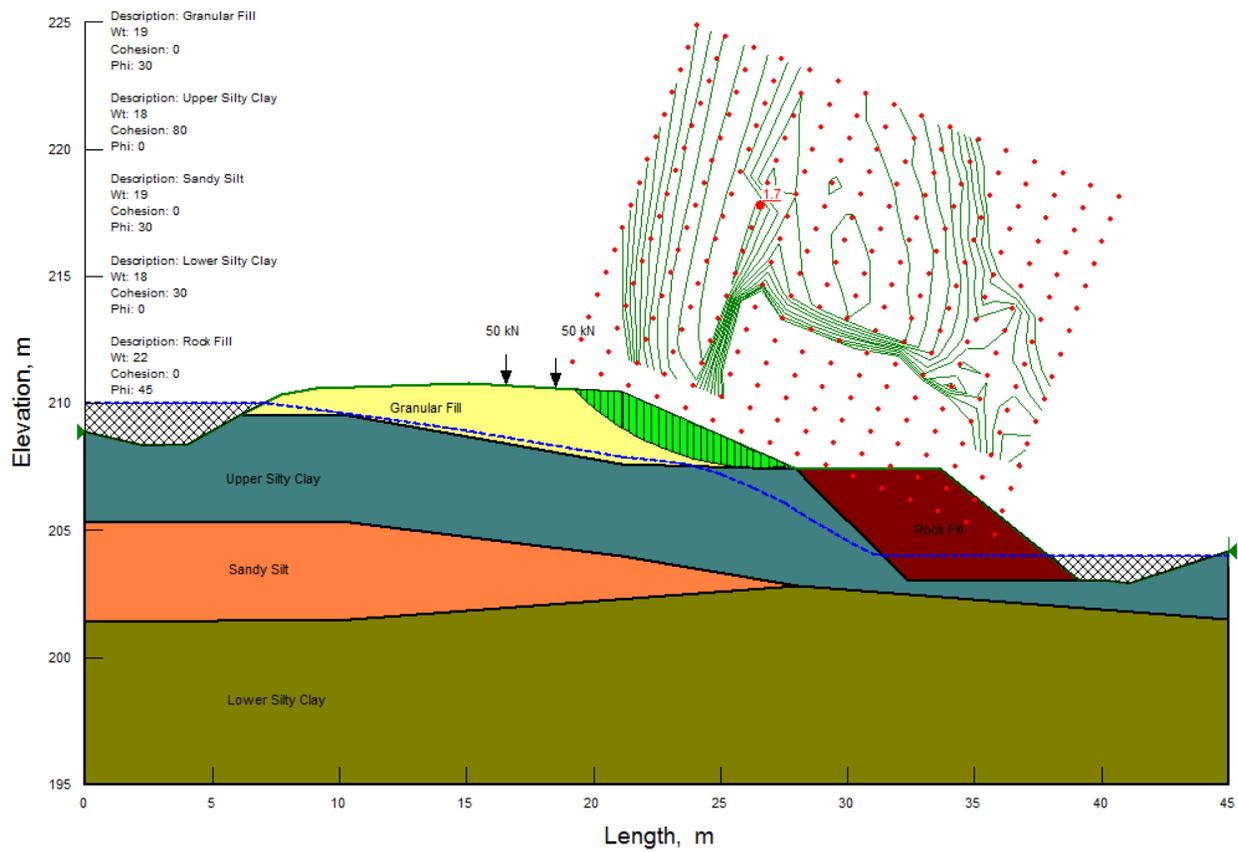
The existing embankment with granular fill foreslopes of 2H: 1V and with rock fill counterweight berm side slope of 1.25H: 1V, a bench elevation at 207.5 m and width of 5.5 m was considered.. This option resulted in acceptable factors of safety of greater than or equal to 1.3. For these analyses, the total stress and effective stress parameters were used. The following table shows factors of safety of the selected cases under total stress and effective stress conditions. Examples of slope stability analysis outputs can be found in Appendix C, Figures C.7 through C.9. Plan view and cross sections of the proposed remedial methods are provided in Appendix B, Drawing 5.

Figure C.8 Existing embankment with counterweight berm, total stress analysis with high water

DST is of the opinion that the best suited remedial option is the construction of a rock fill counterweight berm while maintaining much of the existing embankment geometry and materials. This option is recommended as it combines a high degree of certainty in effectiveness while potentially allowing for the continuation of traffic flow.

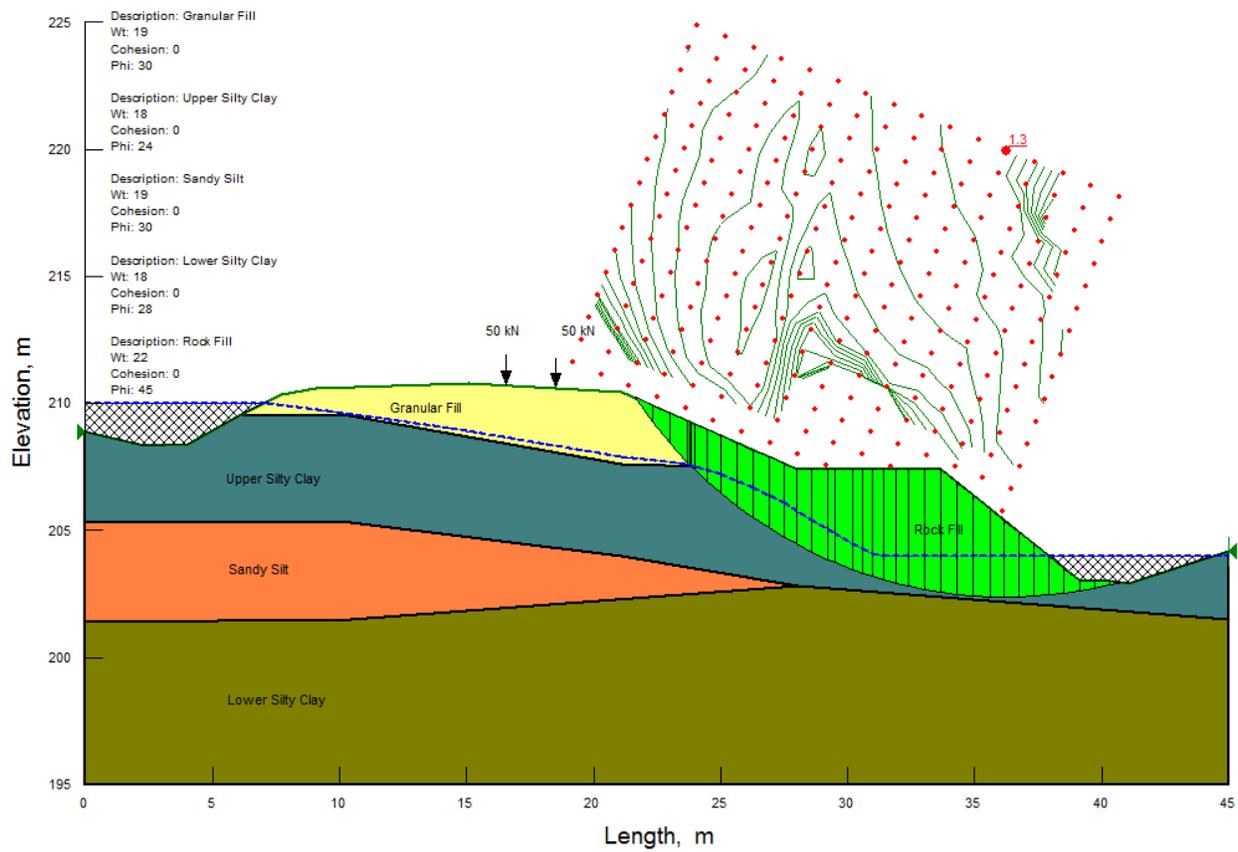
Figure C.9 Existing embankment with counterweight berm, effective stress analysis with high water
