**FOUNDATION INVESTIGATION  
AND DESIGN REPORT  
FARLEY CREEK CULVERT  
REPLACEMENT  
HIGHWAY 124  
TOWNSHIP OF HAGERMAN  
AGREEMENT NO.: 5010-E-0007  
WP: 5424-06-01  
GWP: 5424-06-00  
GEOCRES NO.: 31E-306**

**March 28, 2011  
GS-TB-012413**

**Prepared for:  
Ministry of Transportation of Ontario  
Northeastern Region Office  
447 McKeown Avenue, Suite 301  
North Bay, ON P1B 9S9**

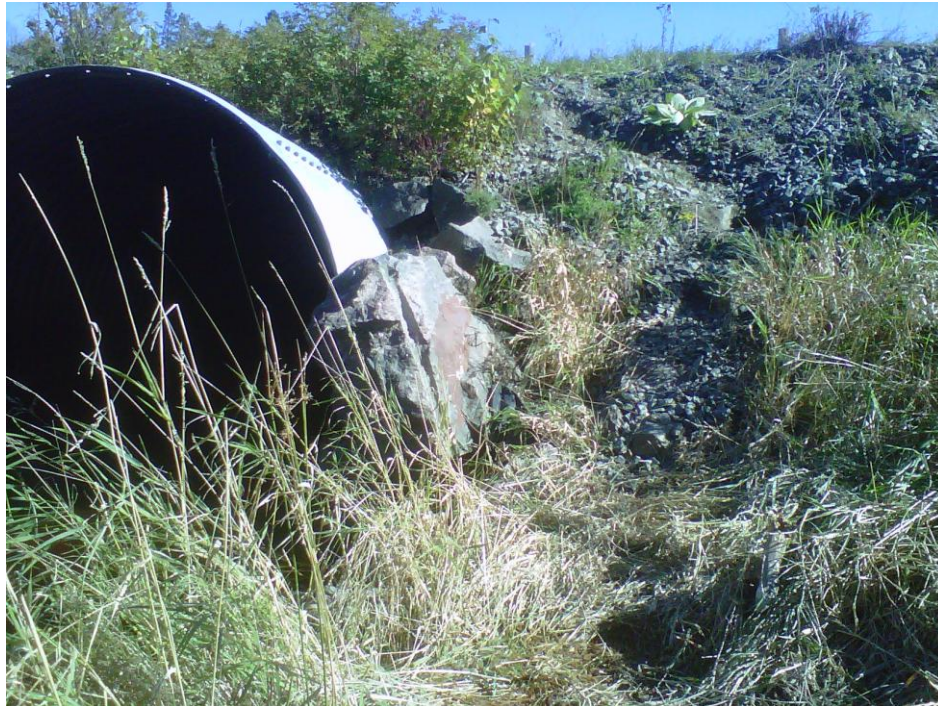
The existing culvert is a 3000 mm x 30 m corrugated steel pipe (CSP) culvert with approximately 1.6 m of cover (Figure 2.1). It was determined to be in poor condition with severe corrosion, flaking below the waterline, few perforations and cracks at the bolt locations as well as some deformation of the culvert shape. It is understood that the existing structure will be replaced by a 3.0 x 2.1 x 29.4 m precast box culvert.

Figure 2.1 Corrugated Steel Pipe (CSP) culvert (looking south)

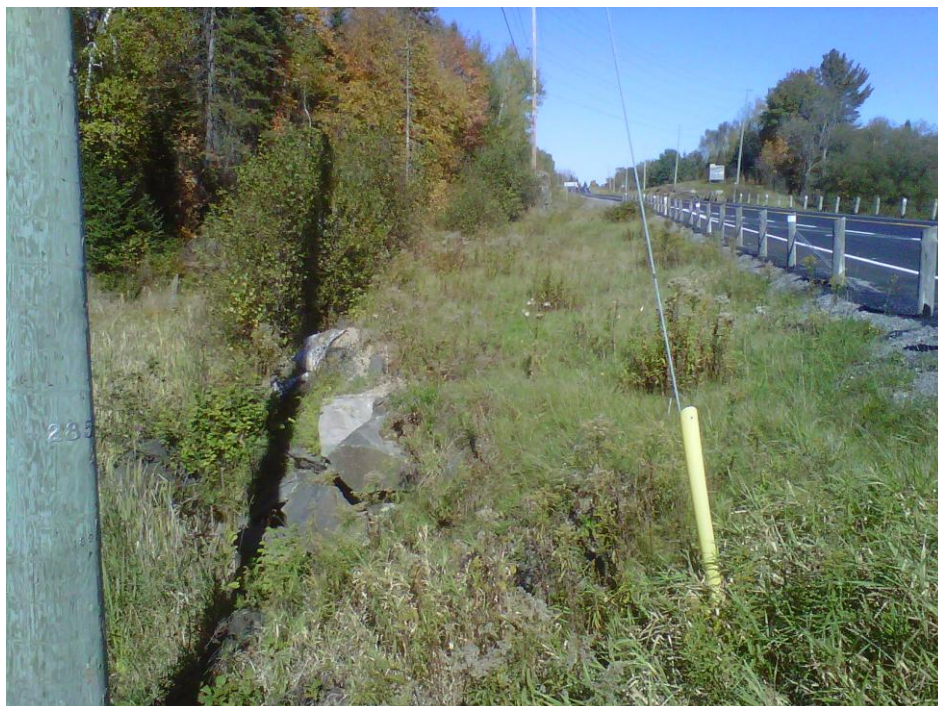
Figure 2.2 Rockfill along the embankment (looking north)

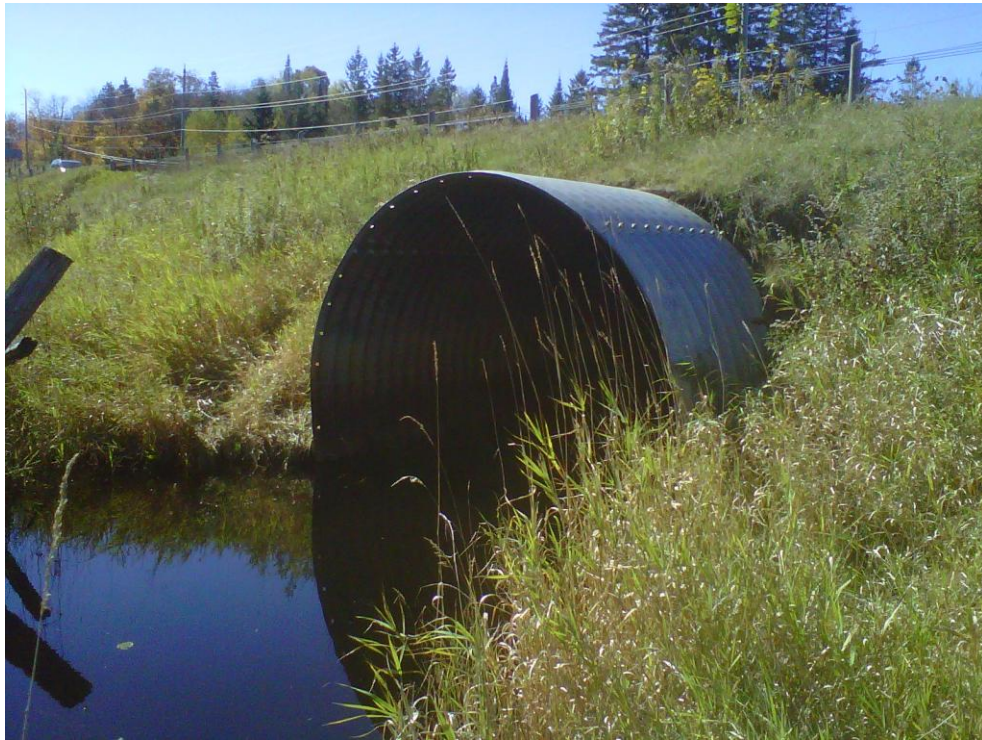
Figure 2.3 Outlet of the existing culvert (looking west)

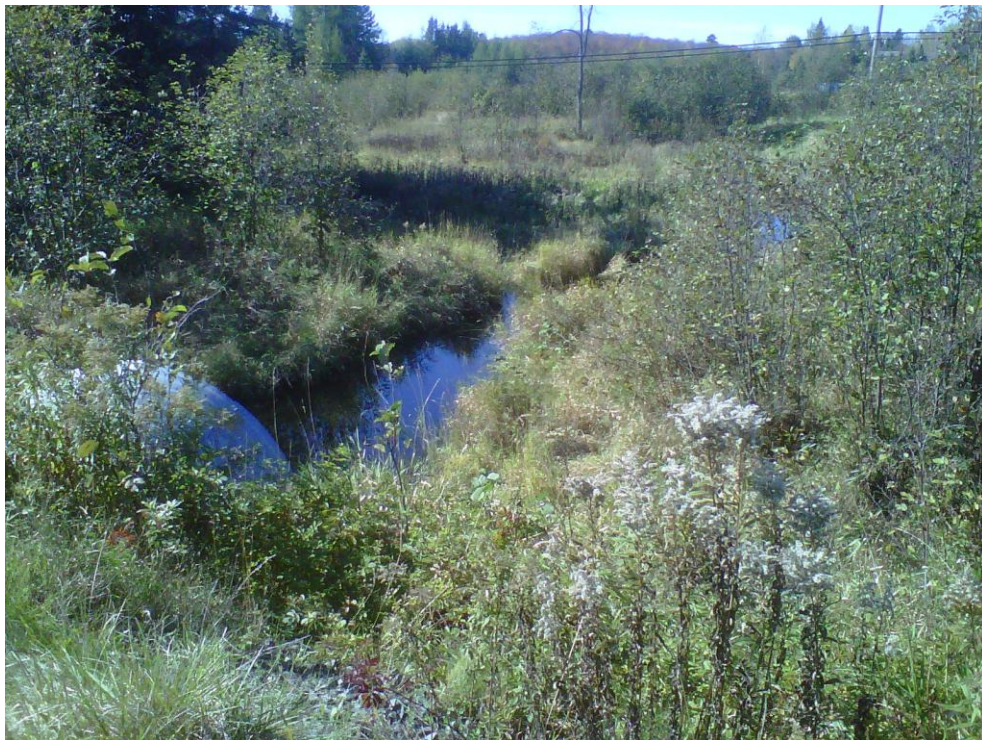
Figure 2.4 Inlet of the existing culvert (looking west)

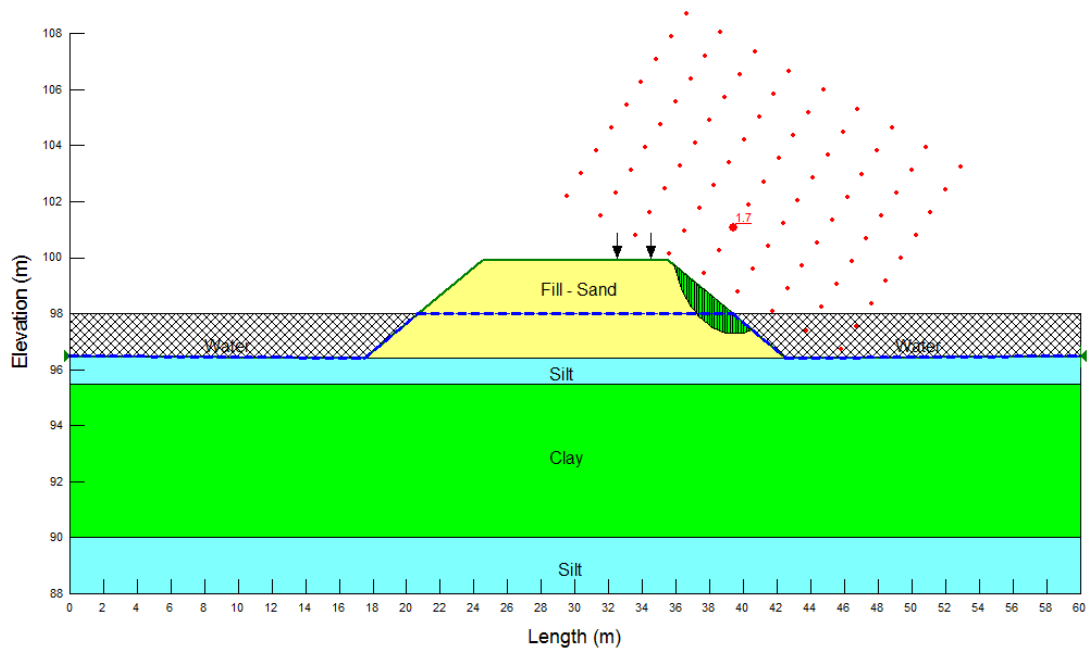
Slope Condition	Foreslope Gradient	Drained or Undrained Analyses	Factor of Safety
Reinstated Embankment with Granular Fill	2H : 1V	Drained	1.7
		Undrained	1.7
Reinstated Embankment with Rock Fill	1.5H : 1V	Drained	1.3
		Undrained	1.4
Temporary Embankment with Rock Fill	1.25H : 1V	Drained	1.3
		Undrained	1.3

Figure 5.1 Slope stability analysis of reinstated embankment with 2H:1V granular fill foreslopes in an undrained condition

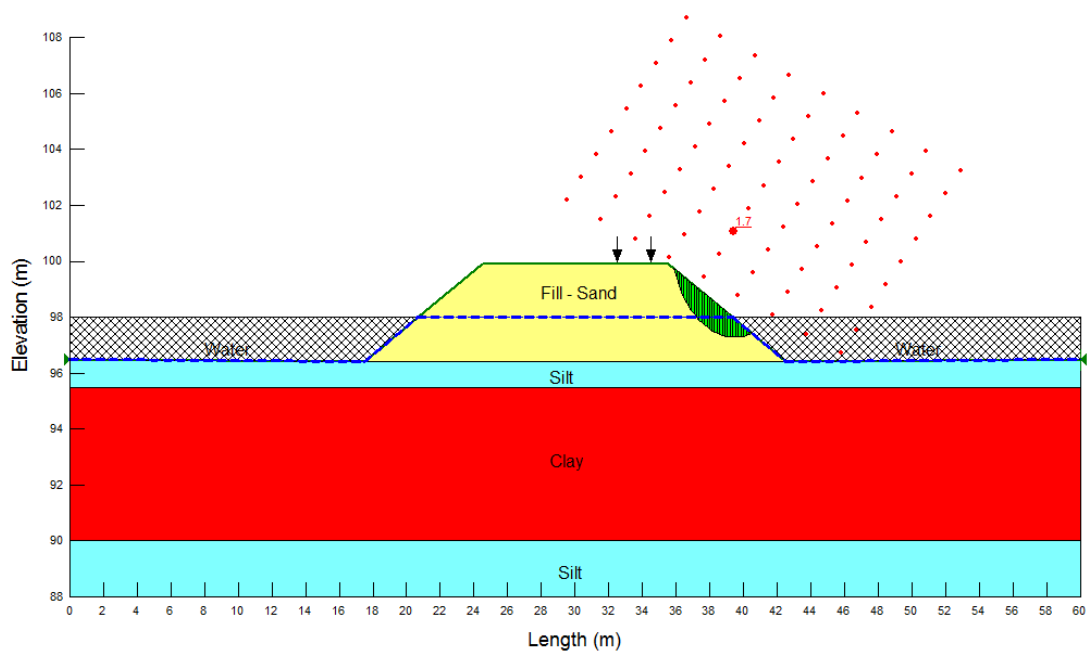
Figure 5.2 Slope stability analysis of reinstated embankment with 2H:1V granular fill foreslopes in a drained condition

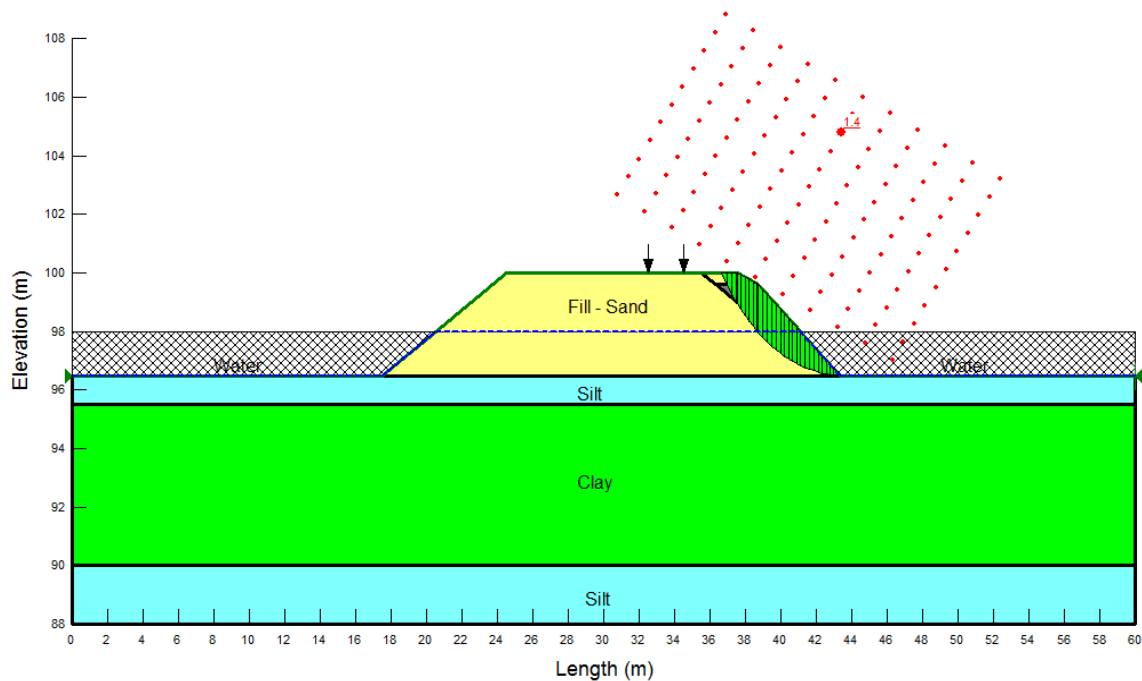
Figure 5.3 Slope stability analysis of reinstated embankment with 1.5H:1V rock fill foreslopes in an undrained condition

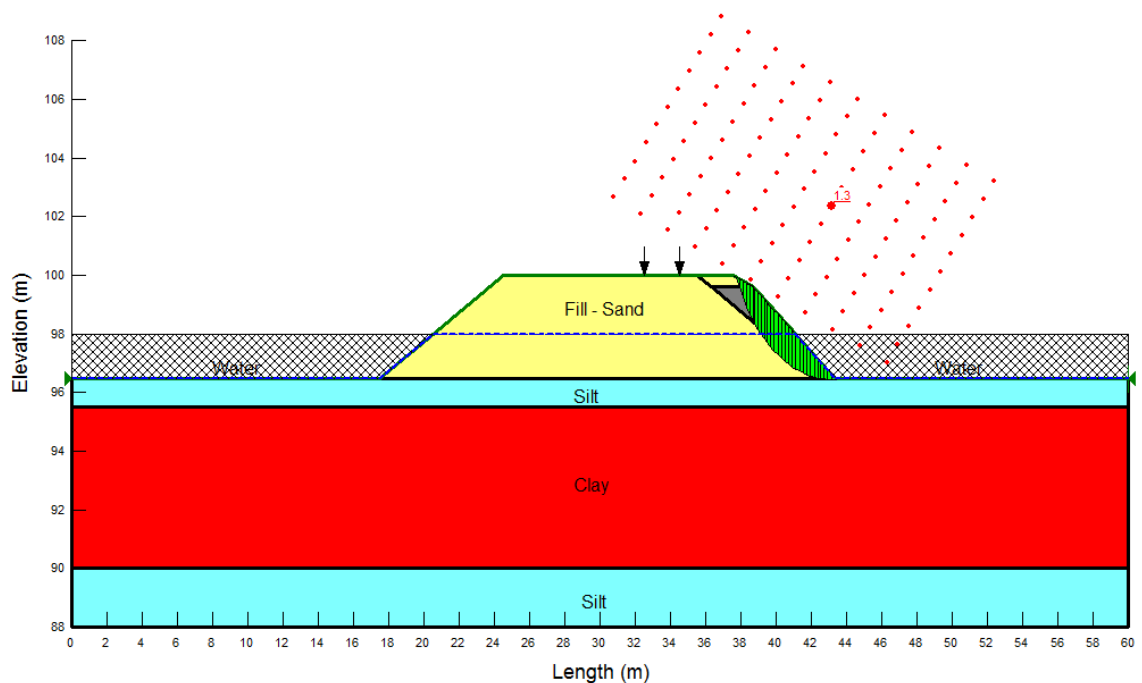
Figure 5.4 Slope stability analysis of reinstated embankment with 1.5H:1V rock fill foreslopes in a drained condition

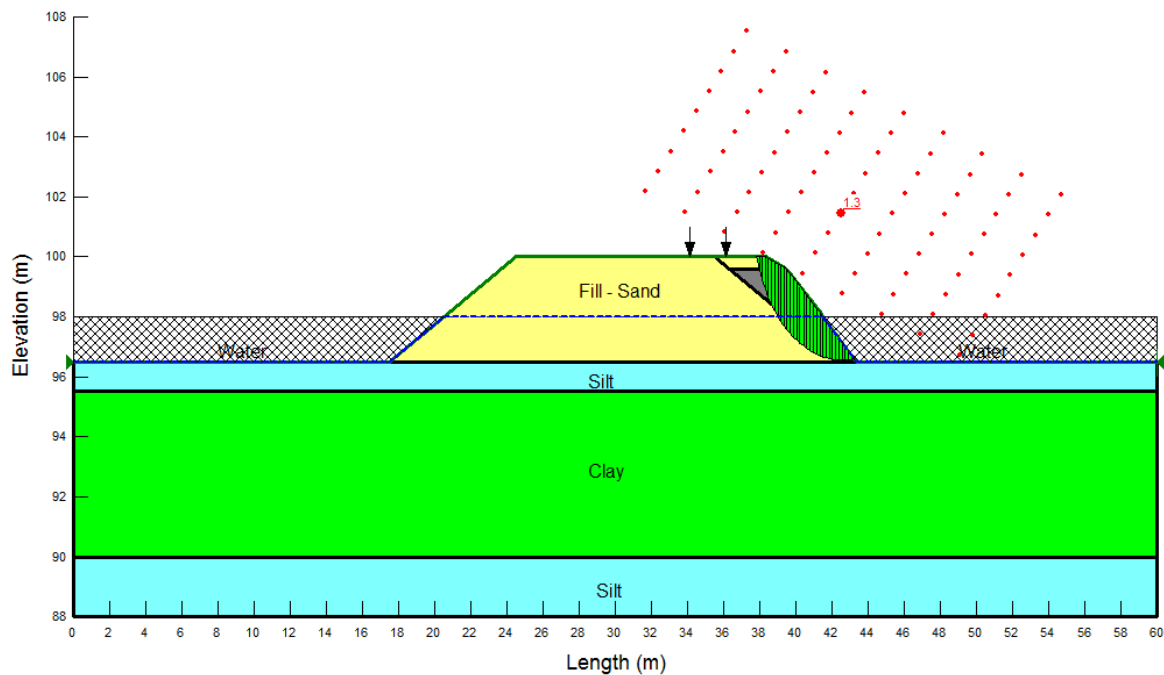
Figure 5.5 Slope stability analysis of temporary embankment with 1.25H:1V rock fill foreslopes in an undrained condition

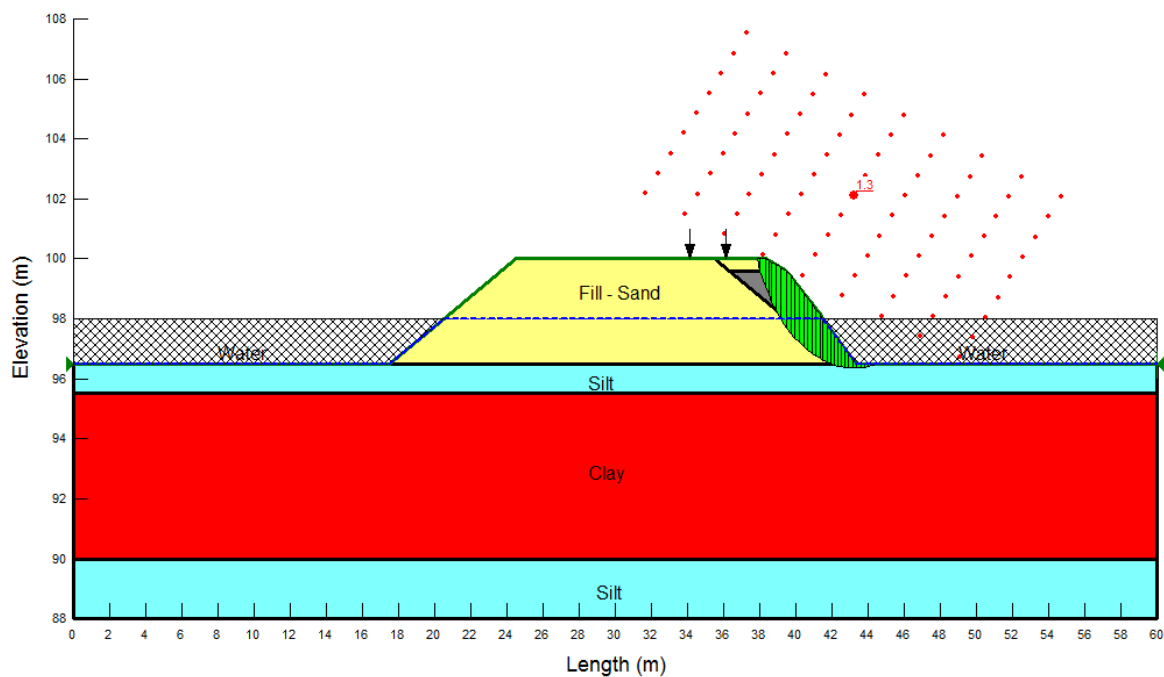
Figure 5.6 Slope stability analysis of temporary embankment with 1.25H:1V rock fill foreslopes in a drained condition
