To: Ministry of Transportation, Ontario      Date: October 4, 2023

**HIGHWAY 400 VOID DETECTION MEMORANDUM  
NORTH OF 5<sup>TH</sup> LINE INTERCHANGE  
BRADFORD, ONTARIO, CENTRAL REGION  
RETAINER ASSIGNMENT NO. 2020-E-0049, ASSIGNMENT NO. 8**

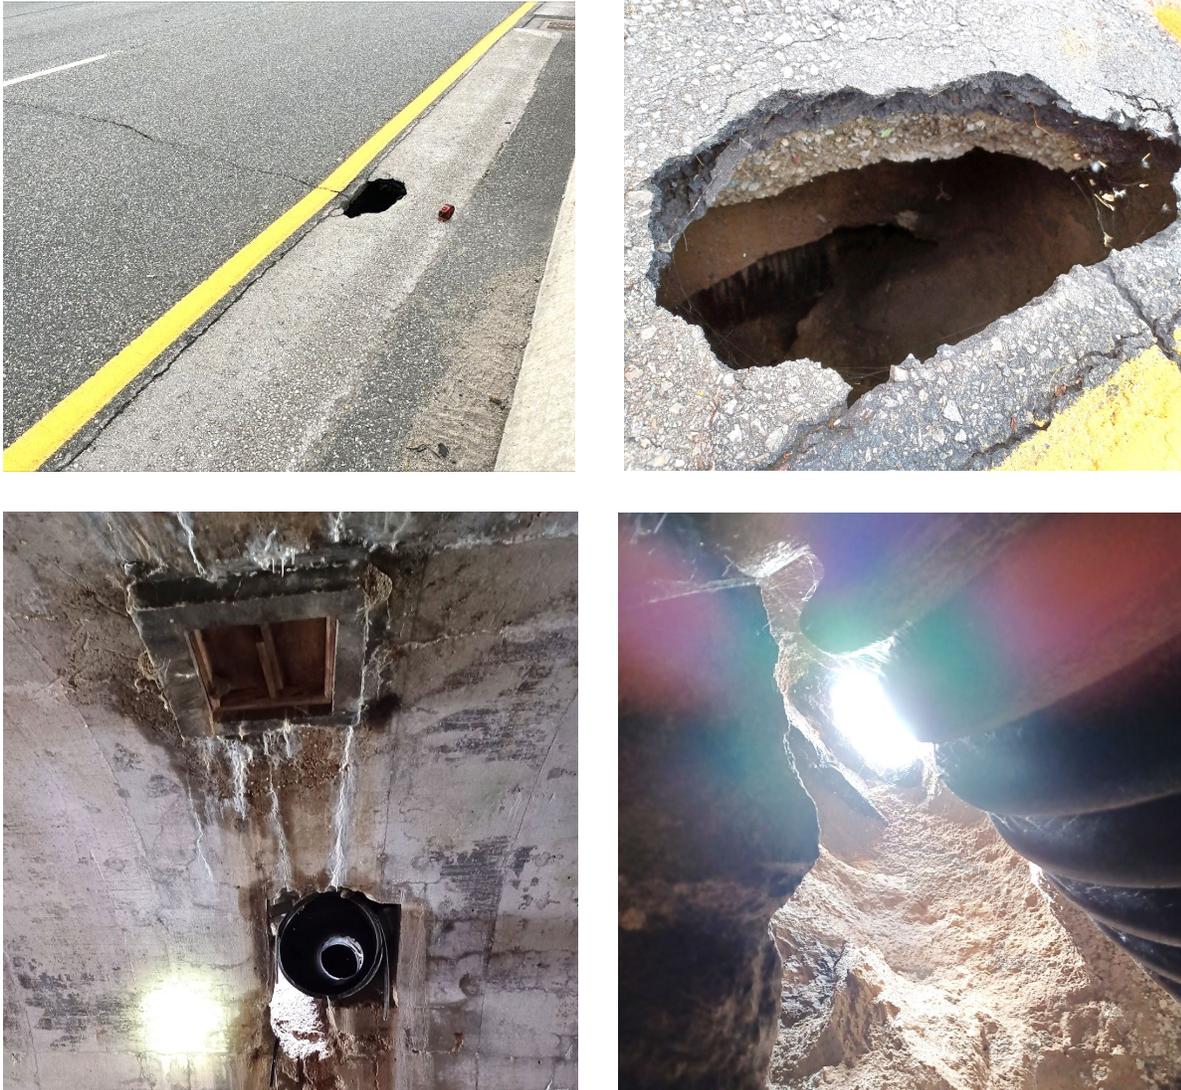
***Figure 1.1: Void Cavity Beneath Highway 400 SB Inside Shoulder***

It is understood that a sinkhole was observed in the southbound left (median) lane and shoulder on Highway 400, approximately 360 m north of 5<sup>th</sup> Line on August 7, 2023. Further examination of the sinkhole indicated that this sinkhole formed directly above an existing arch culvert (Culvert #30-400/C) carrying sucker creek under Highway 400, where a storm sewer pipe was connected to the culvert without sealing the perimeter of the pipe. Over the years, backfill and granular material continued to migrate through the opening around the sewer pipe and into the culvert, creating a large cavity that extended to the pavement surface.

The sinkhole was subsequently repaired on August 9, 2023, with the patching of the sewer pipe and filling of the void with unshrinkable fill (U-fill) material. Photographs of the surface void, void cavity, and culvert connection within the sinkhole area are provided in Figure 1.1.

It is also important to note that the GPR survey at this location was completed within 3 weeks of the repair to fill the observed sinkhole. It is understood that subsequent visits by MTO staff to this area observed continued seepage of water into the culvert from the perimeter of the sewer pipe. Furthermore, an inspection of the catchbasins observed water and granular material entering the storm sewer system through failed connections. This loss of material was also confirmed by a CCTV inspection of the storm sewer system, as areas with considerable granular material accumulation were observed. These assessments completed after the GPR indicate that possible void development may be continuing. Consideration should be given to further assessment of these possible void development areas, as well as the development of an appropriate strategy to repair the failed sewer connections that are causing backfill erosion and formation of voids.

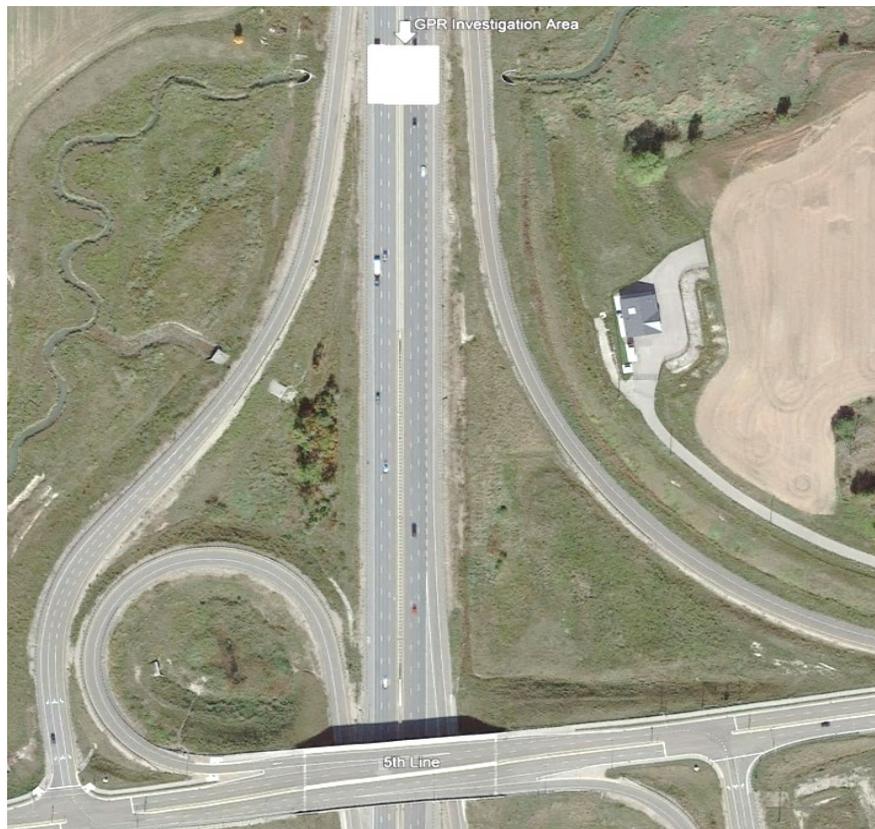
**Figure 2.1: GPR Survey investigation Area**

The GPR survey was completed August 27 to 30, 2023, using a Noggin 500 MHz antenna, supported by a manually operated SmartCart system. The GPR survey was completed in a grid pattern with individual scans on 500 mm intervals. The GPR grid survey was completed after filling of the sinkhole and extended across the highway platform (NB and SB lanes and shoulders) along the length of the arch-culvert, with the scanning extending approximately 15 m north and south of the culvert edges. The grid scanning commenced 0.5 m from the concrete barrier in the median and extended across the highway platform and ended 0.5 m from the guardrails at the edge of the outside shoulders. In consideration of the large area to be scanned, the scan area was divided into four (4) individual grid scans, completed under separate traffic control closures.

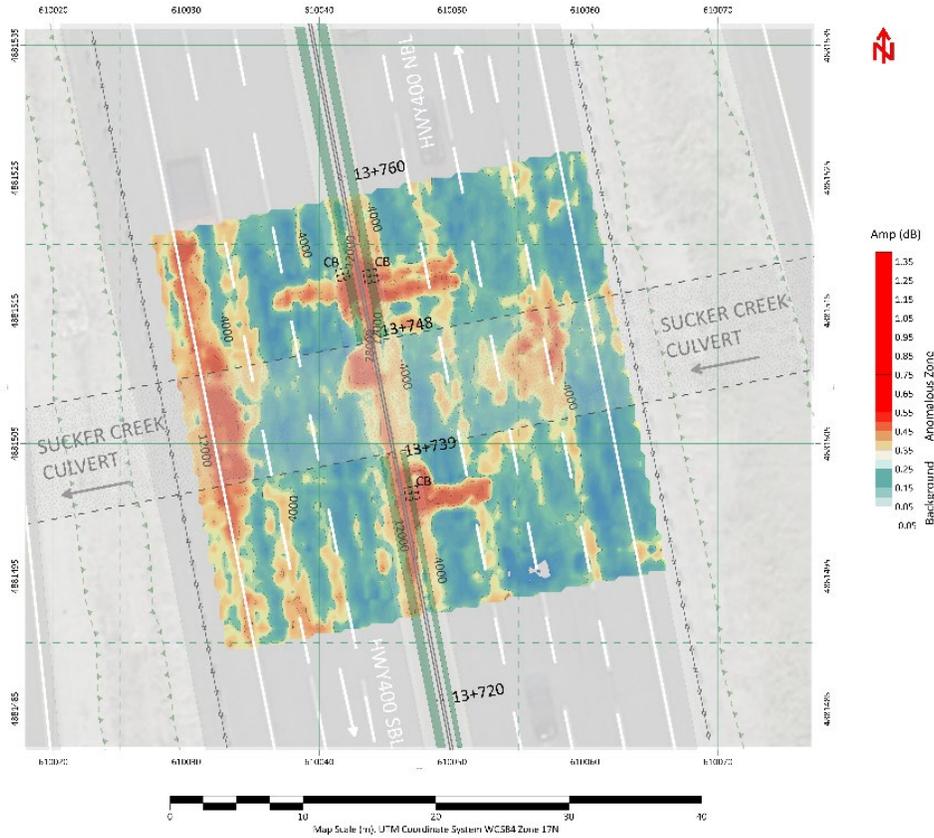
**Figure 5.1: GHM GPR Survey Results**

The results of the GPR survey completed by GHM is provided in the figure below, that identify similar results to the areas of interest described above. The only notable difference includes areas of anomalies extending transversely into the travel lane from each of the catchbasin locations. The depth of these anomaly zones are estimated to be near 800 mm, with each of these areas extending partly into Lane 2.

It is recommended that the survey results of the pavement surface focus in these areas to assess whether any settlement is observed, as a result of potential void development or material densification. Should settlements be verified in these areas, consideration should be given to advancing boreholes to confirm subsurface conditions.

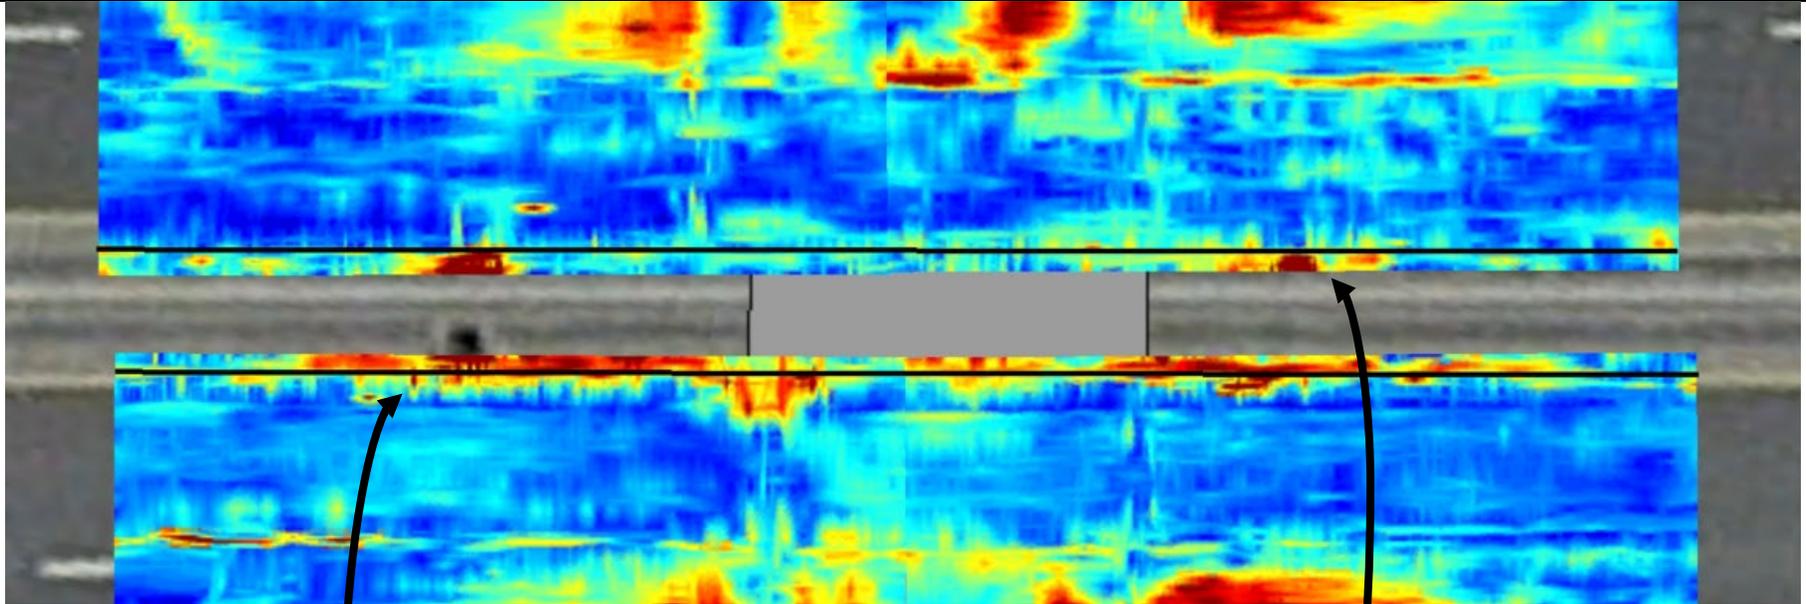
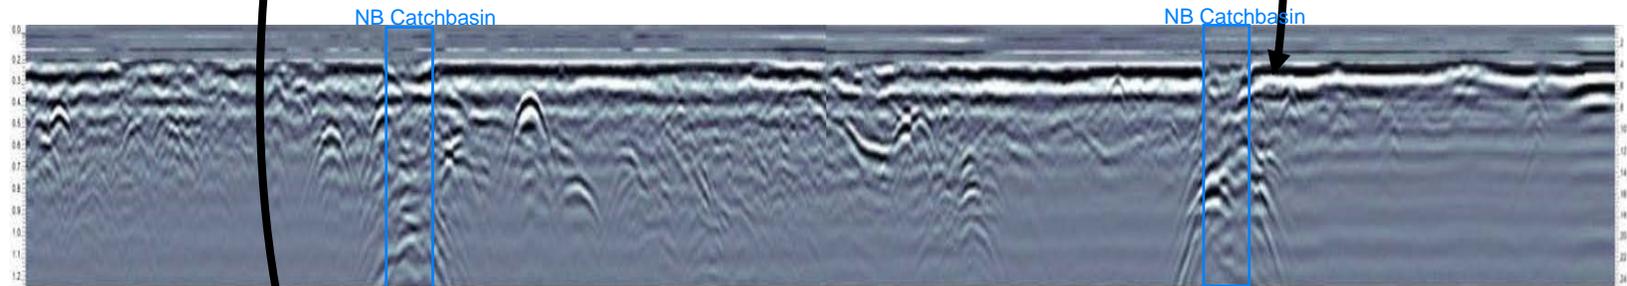
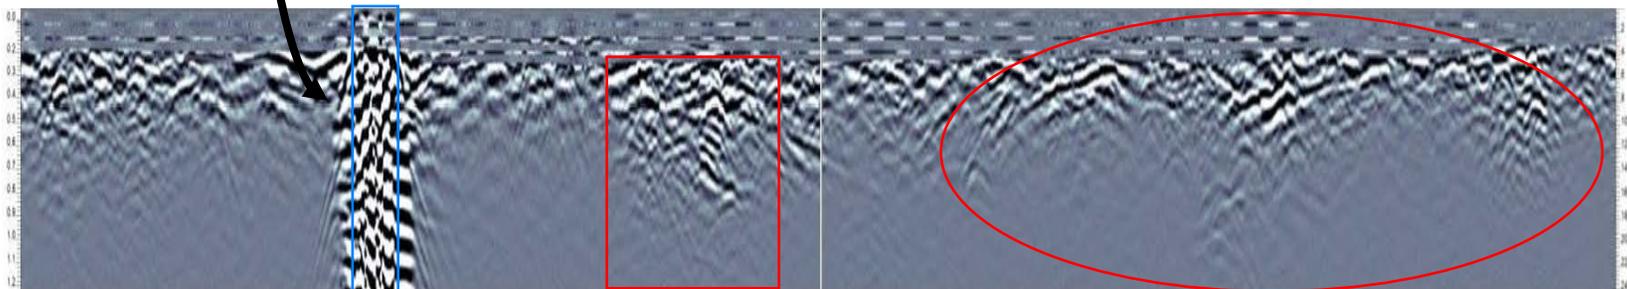
## Area of Interest 1: NB/SB ISH (250 - 300 mm)

The first area of interest was located along the median concrete barrier wall, in both direction of travel. These locations were selected for further analysis because of the strong signal intensity in the SB direction. From the individual line scans, the locations of both catchbasins in the NB median shoulder could be identified, as well as the catchbasin in the SB median shoulder, north of the culvert. In addition to the catchbasin locations, an area of deeper disturbance was identified, which may represent the repair area of the observed sinkhole. Each of these features are noted on the line-scan image.

In comparing the results of the line scans in each direction, the subsurface strata along the NB median shoulder appear to be more consistent (with less irregular signal patterns) than the comparable SB plot. It is the irregular signal pattern along the SB median shoulder that seems to be the zone of observed anomalies in this area, which seems to extend to depths of 1.2 m in the area adjacent to the NB catchbasin south of the culvert.

SB Catchbasin

Sinkhole Repair  
Area

Area of Disturbance

It is recommended that the anomalies and areas of disturbance along the concrete barrier wall and in the SB shoulder near the NB catchbasin south of the culvert be further investigated and assessed.

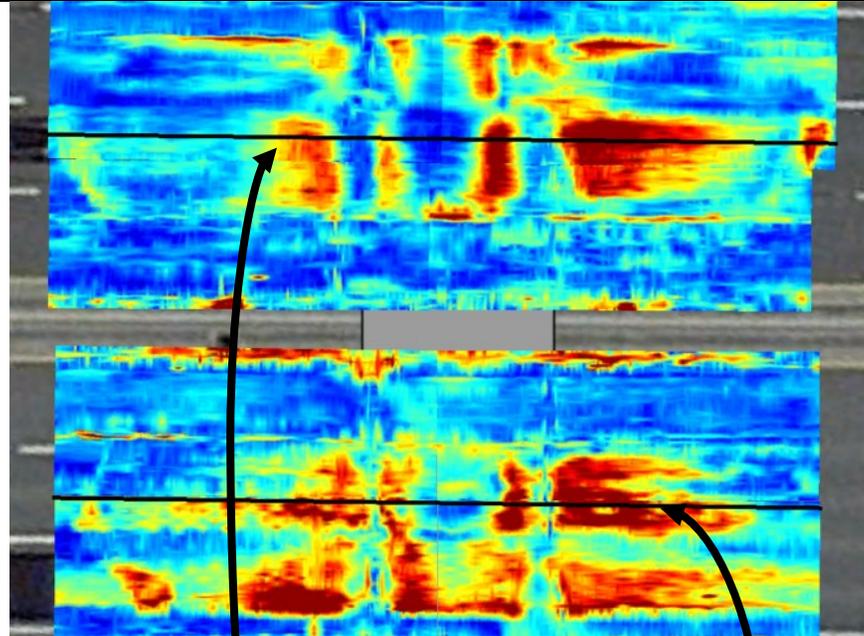
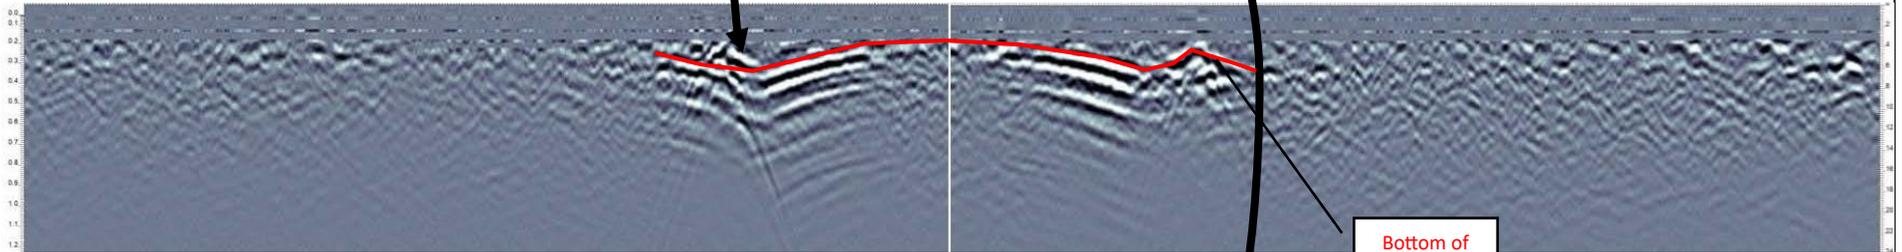
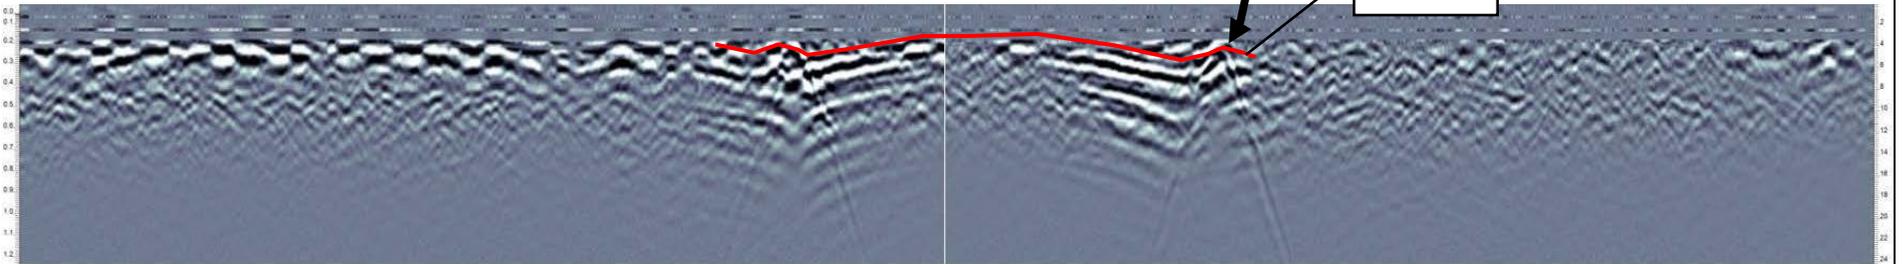
## Area of Interest 2: NB/SB Lanes 2 and 3 (300 - 350 mm)

A second area of interest was identified along the edges of the culvert in lanes 2 and 3 in both directions. The results of the GPR analysis indicate anomaly areas in this location with high intensity signals at a depth between 250 and 400 mm. Although the colour contour images appear to indicate an area of possible anomaly in this area, a secondary analysis of the individual line scan indicate the asphalt thickness in this area may be increased as a result of historical settlement of the culvert backfill. The reflection of the GPR signal within the granular base/subbase appear to follow the outline of the arch culvert, which may indicate material movement at the edges of the culvert. The movement of the granular also matches the assumed interface at the bottom of asphalt. With the increase in asphalt thickness and no observed distortions visible, the observed movement of the granular material are assumed to be historical that have since been addressed.

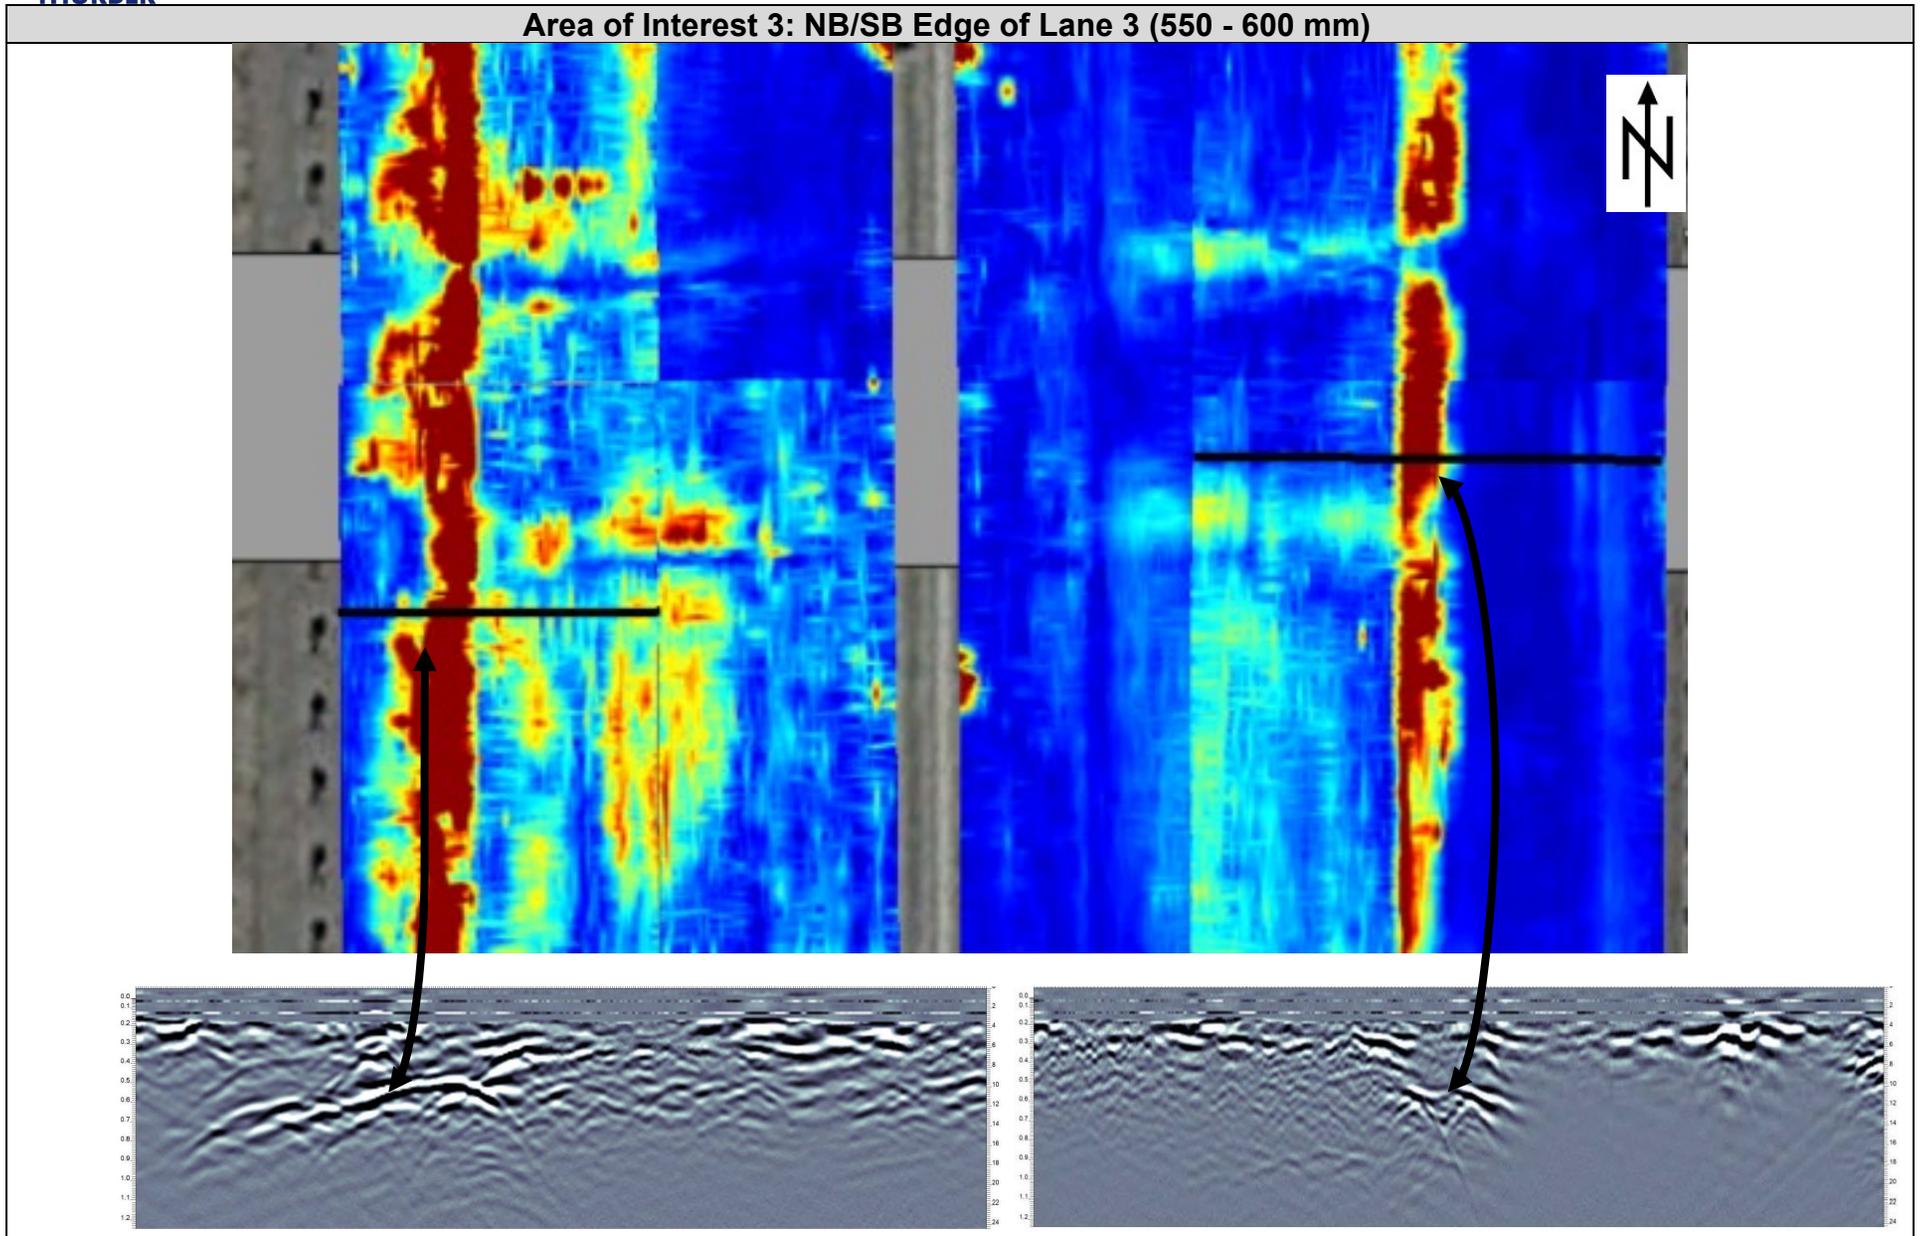
Area of Interest 3: NB/SB Edge of Lane 3 (550 - 600 mm)

The third area of interesting anomalies was located along the edge of the outside travel lane in both directions. In the NB direction, this anomaly zone was located between the outside travel lane and the speed change lane constructed as part of the 5<sup>th</sup> Line interchange, while in the SB direction, the area of interest was located along the outside travel lane and the outside shoulder.

In this area, a strong GPR signal was visible along the outside edges of Lane 3 (in both directions) at a depth ranging from 500 mm to almost 1.0 m. Visual assessment of a transverse line scan indicate an area of disturbance at the pavement edges that do not extend beyond the travel lane. In consideration of the location and the depth of disturbance, it is suspected that this disturbance is not void cavity, but rather associated with increased moisture conditions from impeded subsurface pavement drainage.

Investigations along the Highway 400 corridor have identified several areas where the outside shoulders have reduced pavement thickness, as compared with the outside travel lane; however, boreholes would be required to confirm these conditions exist in this specific area. Although the impeded drainage conditions may lead to premature pavement deterioration in the outside travel lane, the increased moisture conditions would not be related to potential void developed at this culvert location.
