memorandum

August 30, 2012

From: David F. Wood. P.Eng., David F. Wood Consulting Ltd.

Re: Rockfall, Hwy 403, Ancaster, 13 March 2012

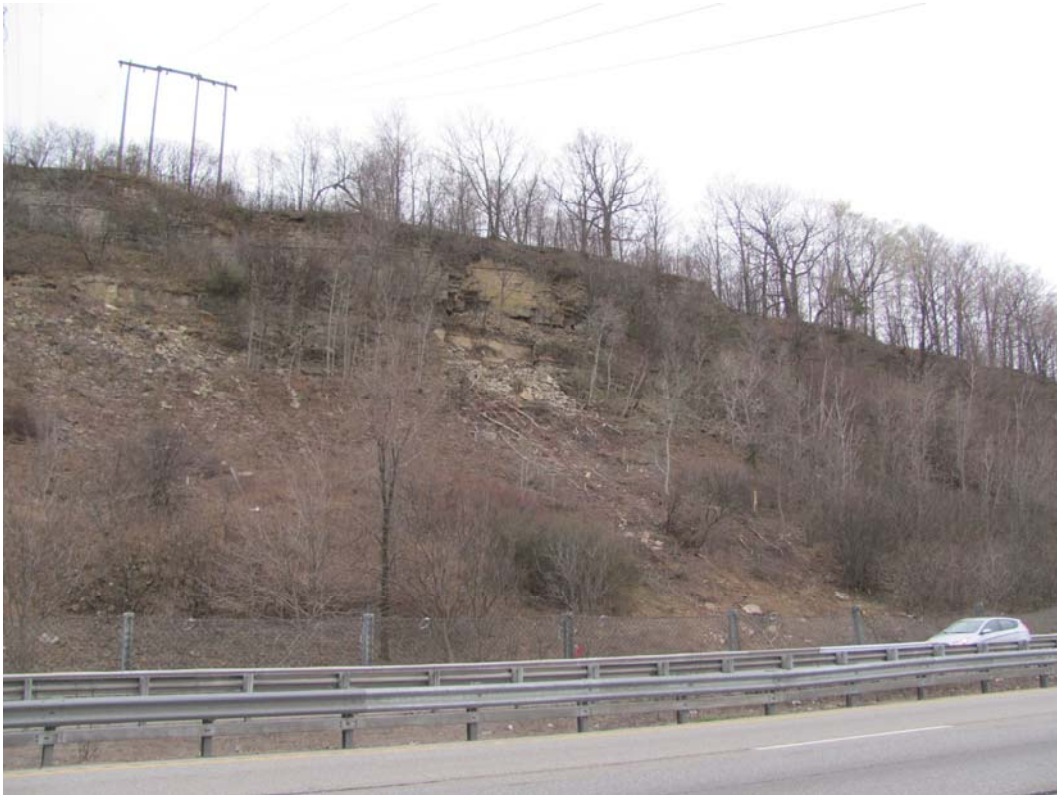
Images 1 through 6 show the 13 Mar 2012 event (Poles # 20 to 22 on the catchment fence) and the area at the crest as well as the slope and the ditch area. Image 3, for example, shows where an air bag would likely be used. A total of about 15 cubic metres of rock could be removed from this area. Images 7 through 12 show the 20 Mar 2012 event (Poles #48 to 50) immediately south of "The Cascades" (about Pole #53). A further 5 to 10 cubic metres could be removed from this area, including the large rock block 'stuck' on the slope shown in Image 9. Images 13 through 17 show crest conditions between Pole #50 and 20, and represent small areas where local manual scaling and air bag removal would be considered appropriate. An estimated 4 to 6 cubic metres of rock could be removed at each such location. Image 18 shows voids immediately to the south of the 13 Mar 2012 event which could be addressed with air bag technology, while Image 19 shows the damaged slope where one of the larger rocks rolled and tumbled to the ditch. This block moved with its long axis parallel to the slope and each time it rolled over, the edge marked the damp ground.

Image 1. View of source of 13 Mar 2012 rockfall event from below crest of Niagara Escarpment. (Image date – 29 March 2012)

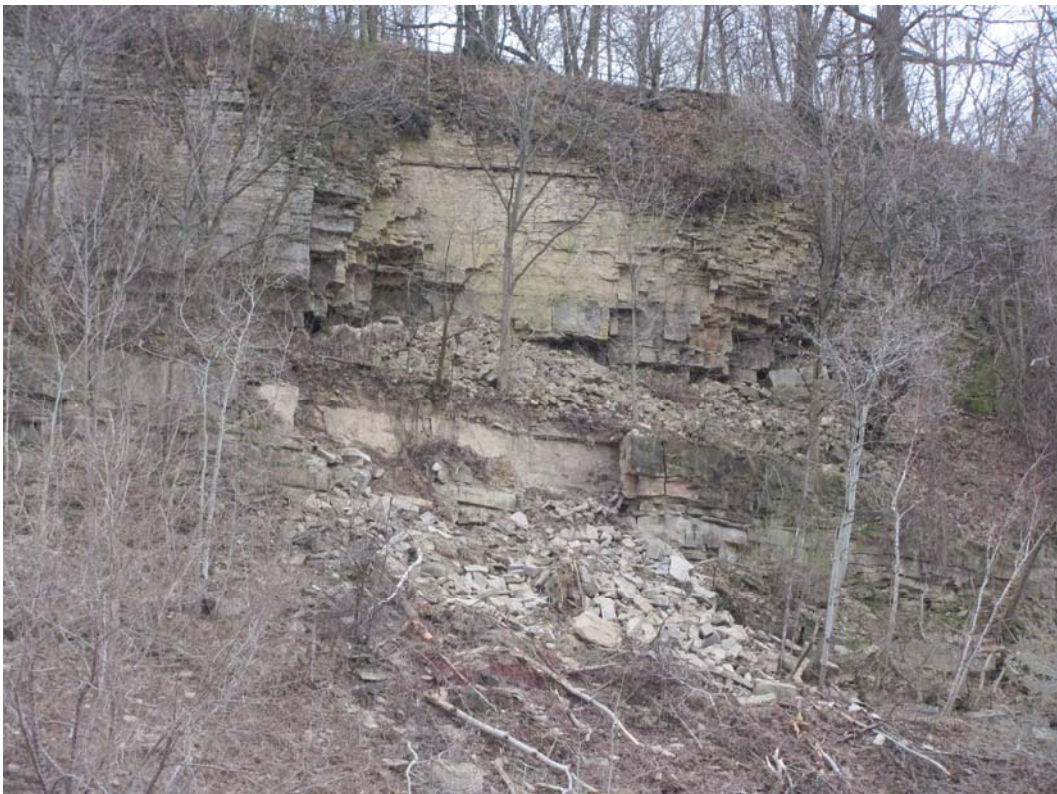
Image 2. Close up image of source area. Rockfall came predominantly from intact band of rock in lower middle of image. Piles of rock above do not appear to have been involved. (Image date – 29 March 2012)

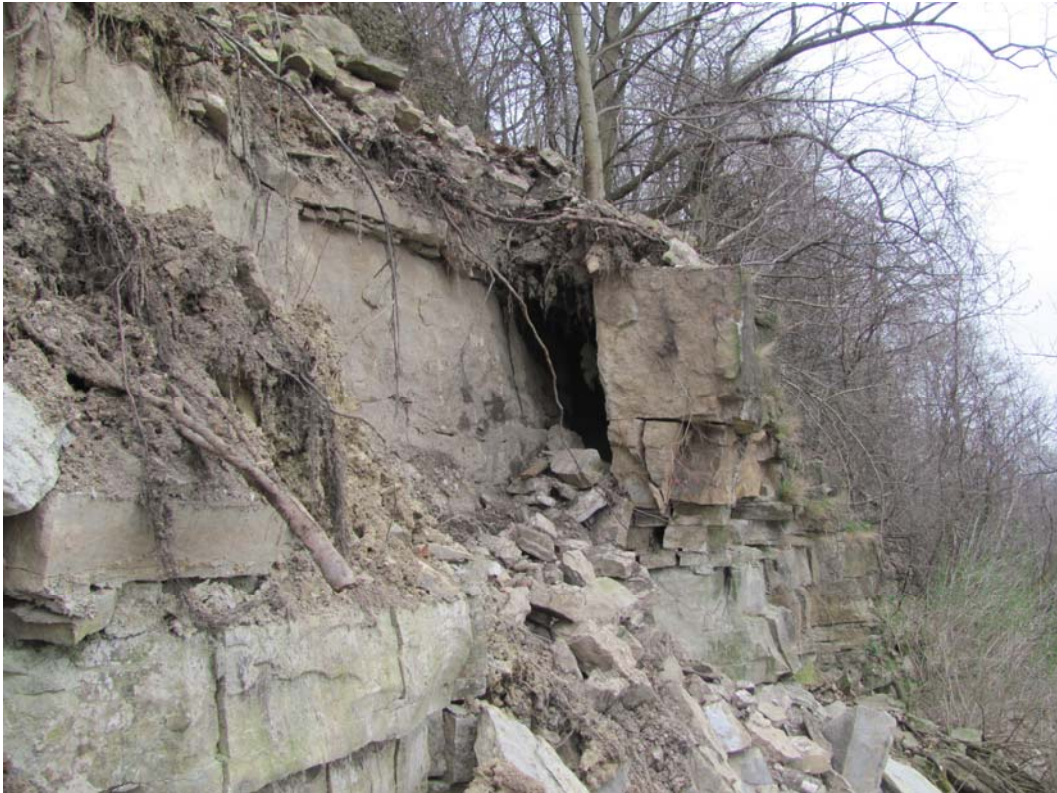
It is likely that the largest mass of rock to be removed will be at the west end of the first rockfall event, and it appears that there could well be a further 15 cubic metres (40 tonnes) of rock that could be brought down. This will require a full closure of Hwy 403 – in both directions.

Image 3. Void to right of source area in Image 2, isolates approximately 7 cubic metres of loose rock. Approximate total rock to be removed in this area is 15 cubic metres.

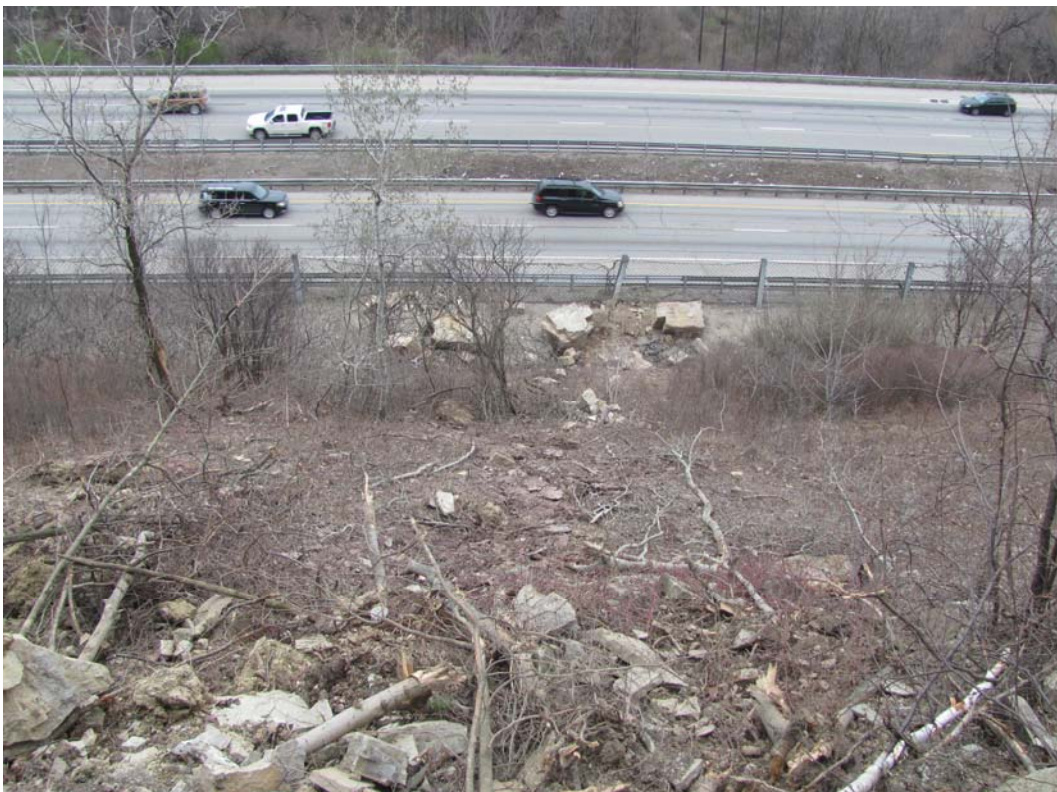
Image 4. View towards highway from source of main rockfall event 13 March 2012.
(Image date – 29 March 2012)

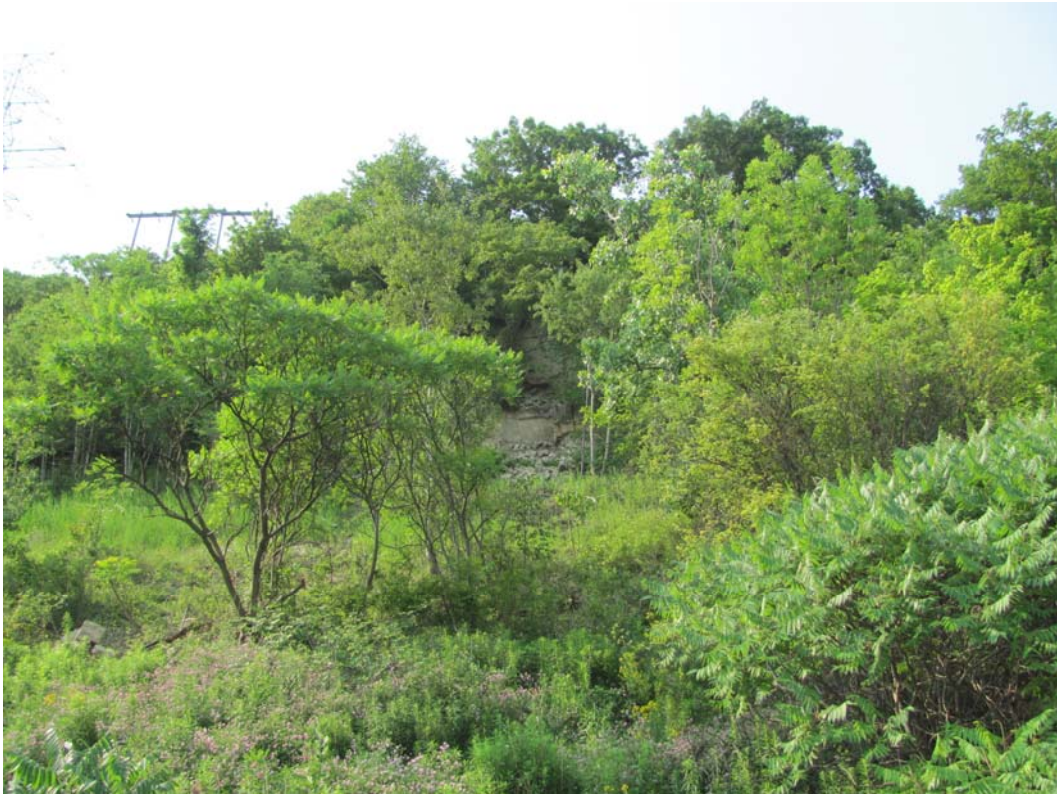
Image 5. Appearance of slope in late June, in full vegetation. (Image date – 28 June 2012)

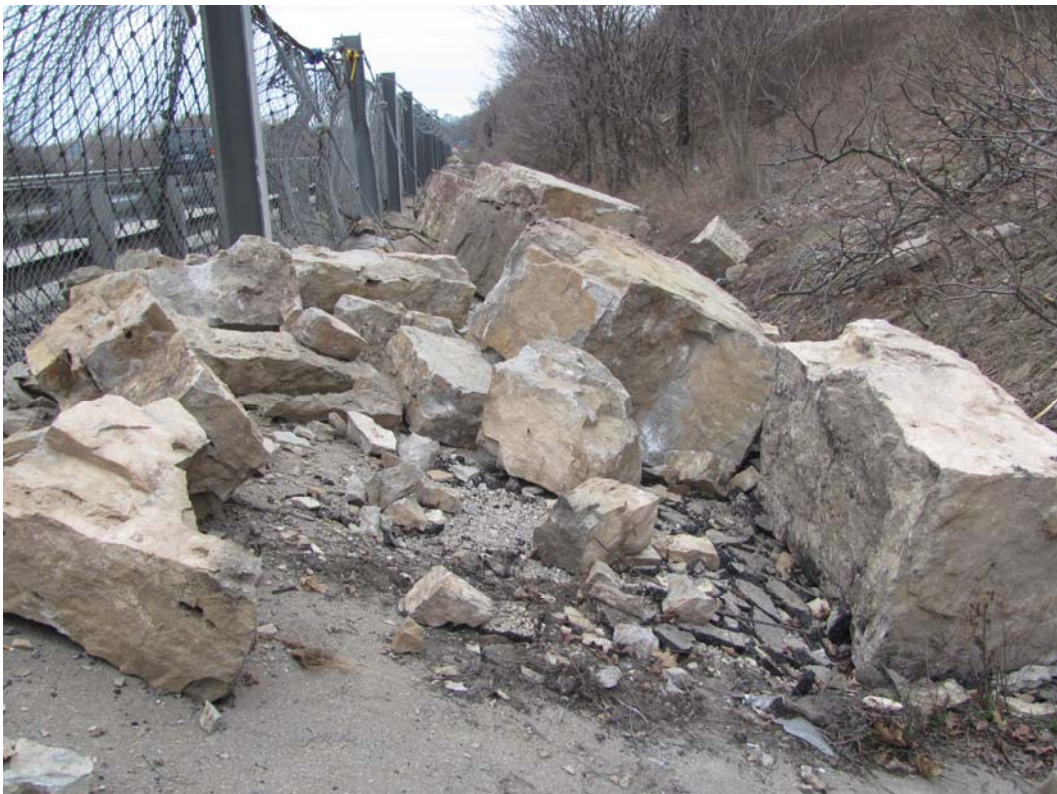
Image 6. Accumulated rockfall material from main event, 13 March 2012. (Image date – 29 March 2012)

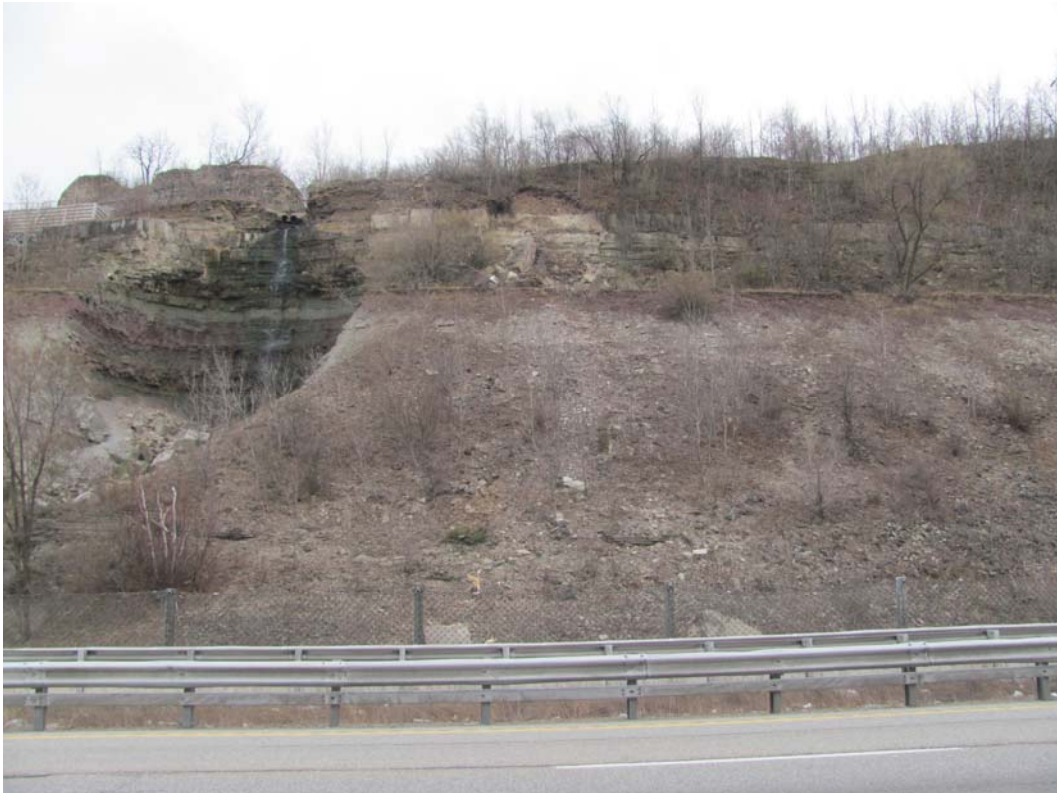
Image 7. Overview of second rockfall event, 20 March 2012 to just west of “The Cascades”. (Image date – 29 March 2012)

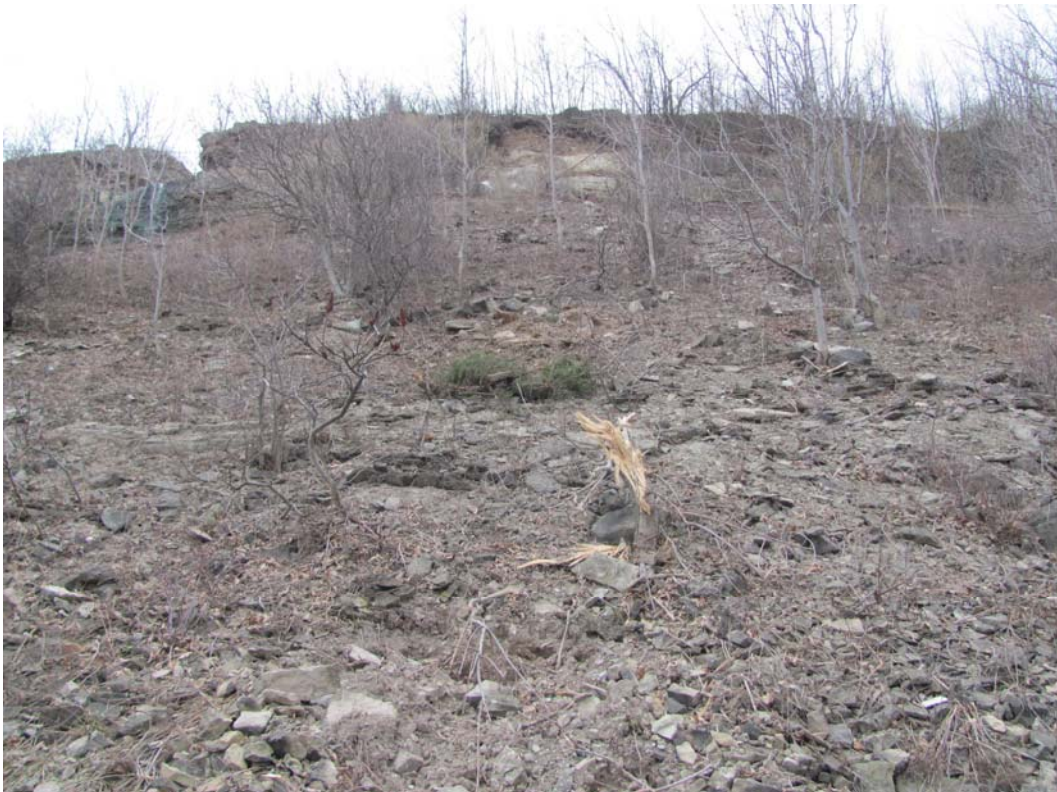
Image 8. Looking upslope from highway ditch to second rockfall source. (Image date – 29 March 2012)

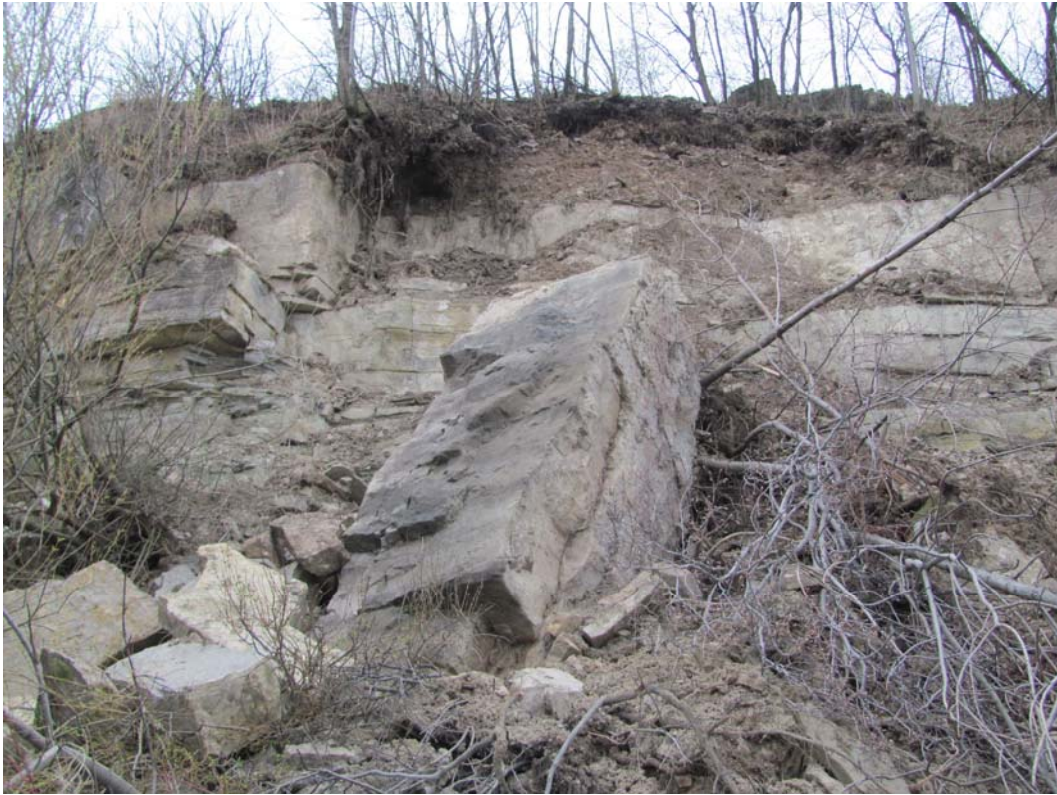
Image 9. Close-up of second source area, note failed material still on slope. (Image date – 29 March 2012)

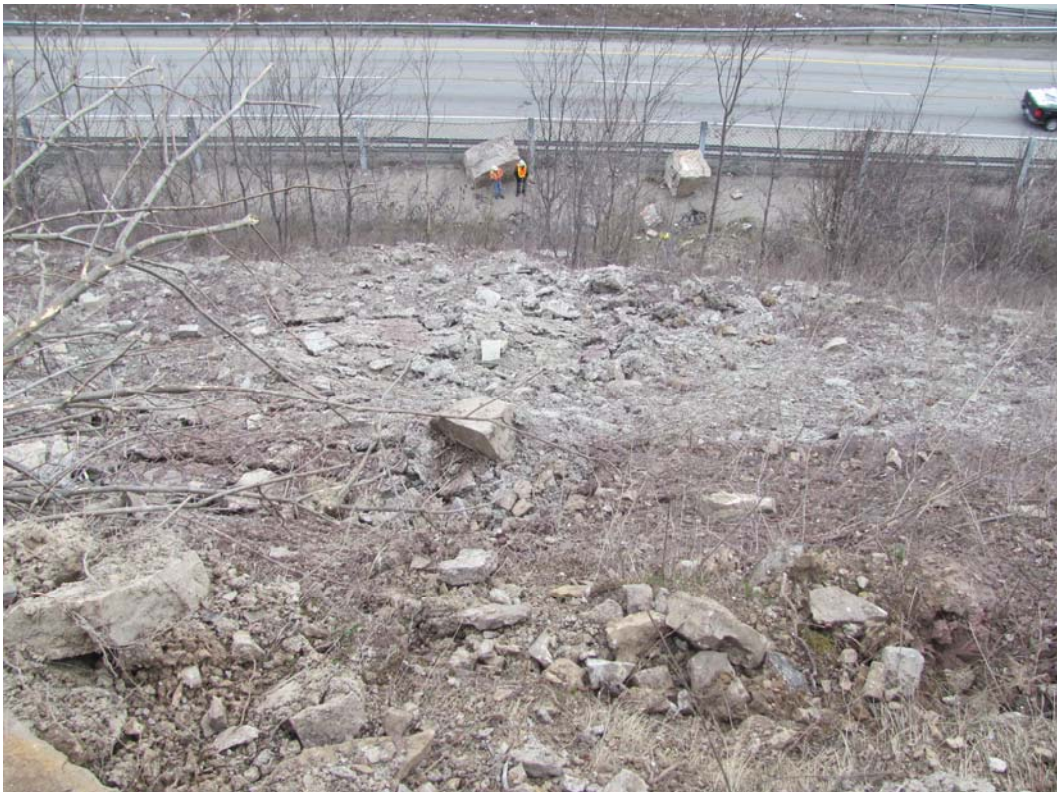
Image 10. View of highway from source of second rockfall event, 20 March 2012. (Image date – 29 March 2012)

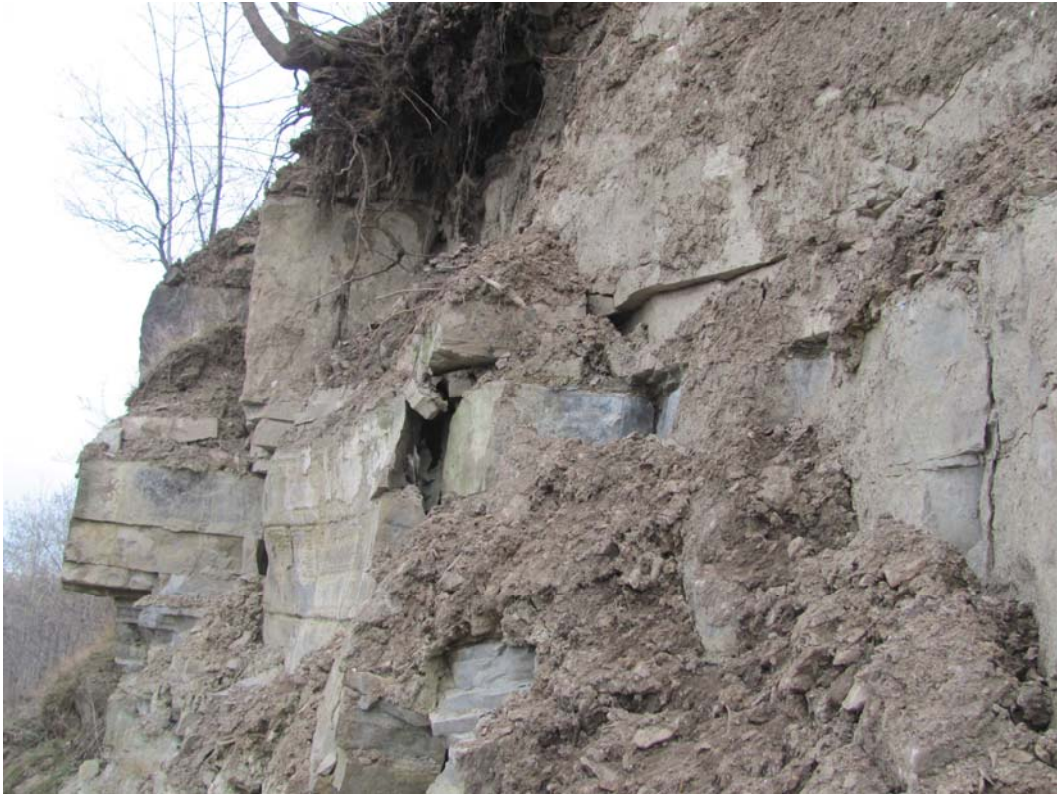
Image 11. Close-up of crest of failed area, upper left in Image 9. (Image date – 29 March 2012)

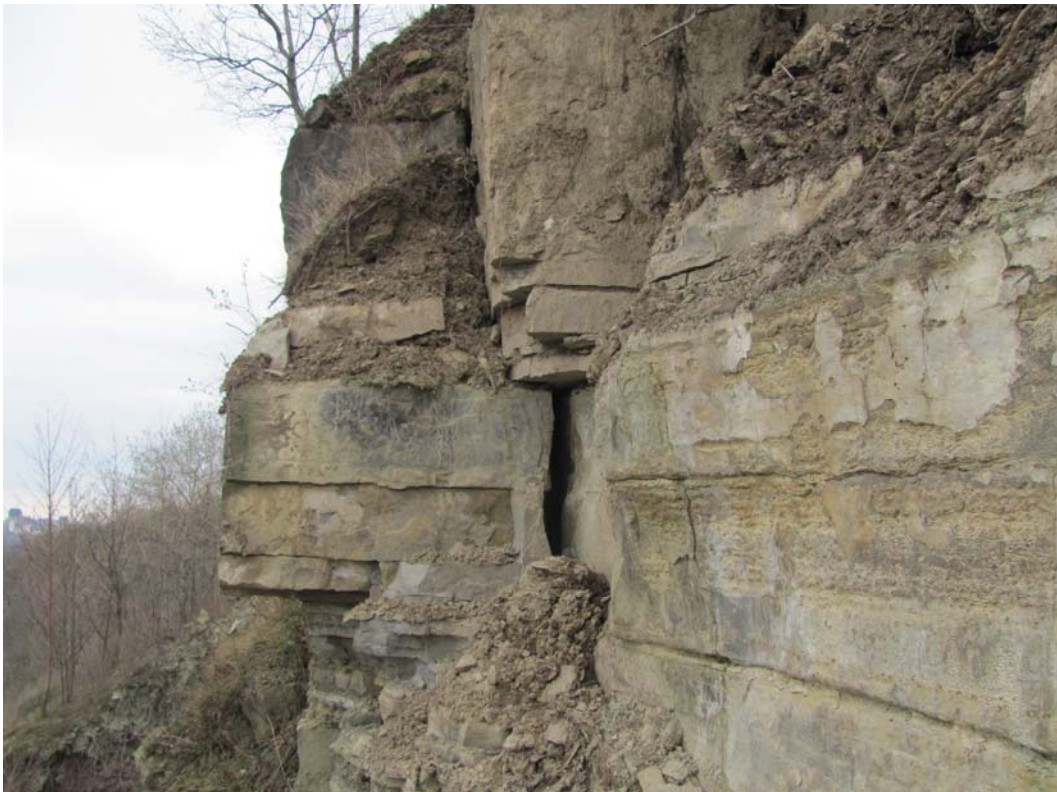
Image 12. Typical crest conditions in rock formation that failed, adjacent to second event. (Image date – 29 March 2012)

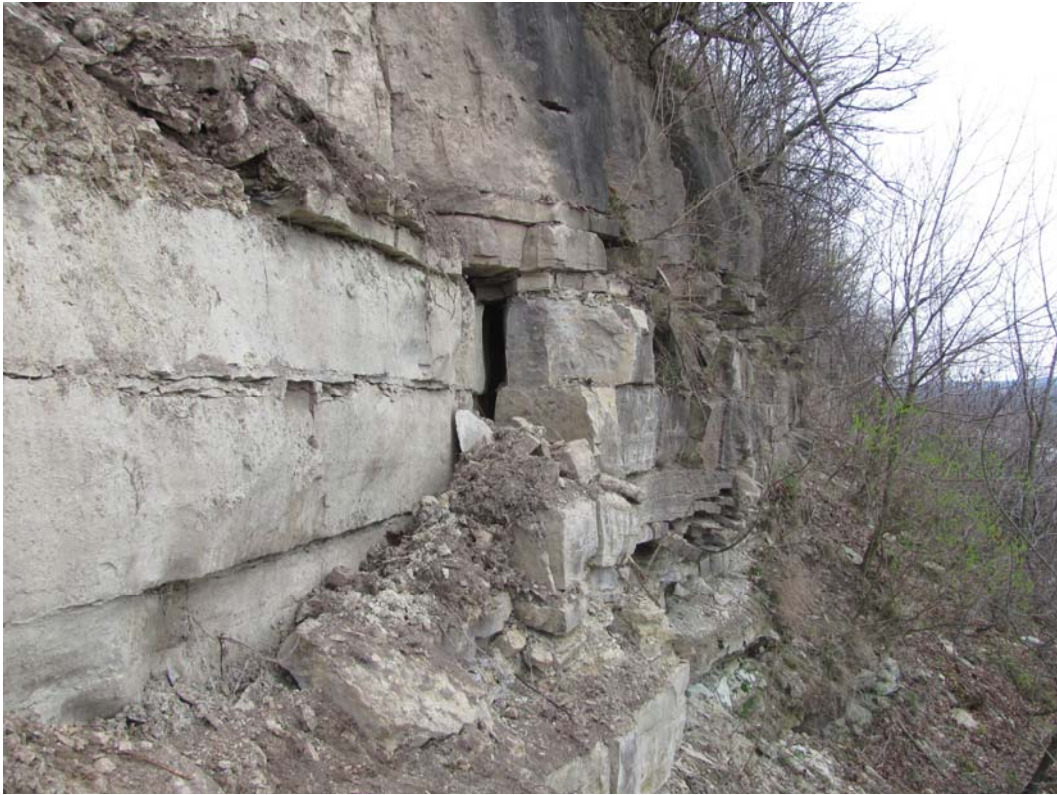
Image 13. Similar cracking seen to west of second failure area. Same geological formation. (Image date – 29 March 2012)

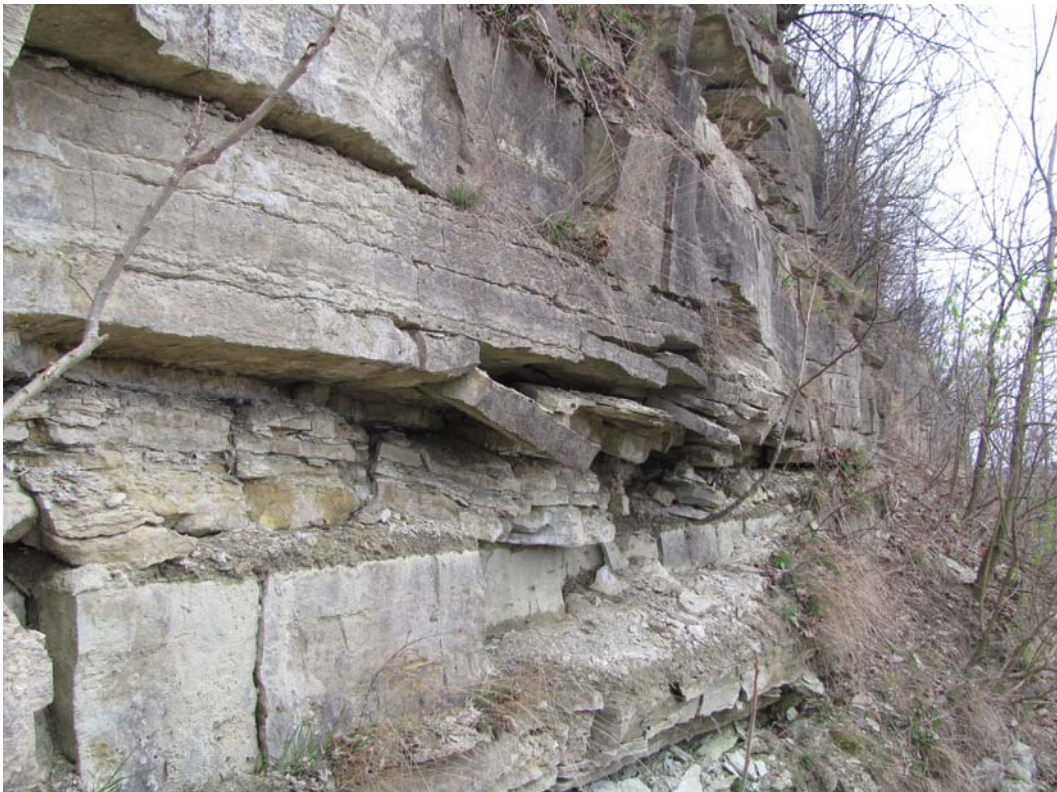
Image 14. Friable inter-bed allows more competent overlying rock mass to fail. (Image date – 29 March 2012)

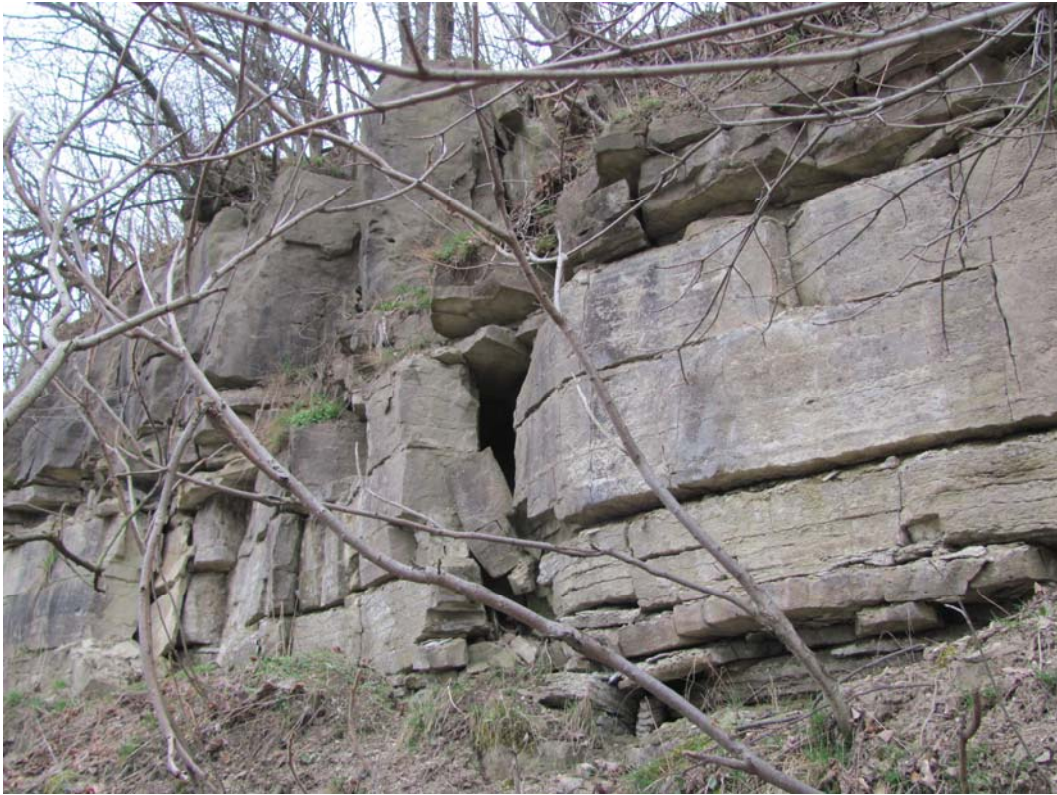
Image 15. Same geological sequence to west with similar failure style to Image 13. (Image date – 29 March 2012)

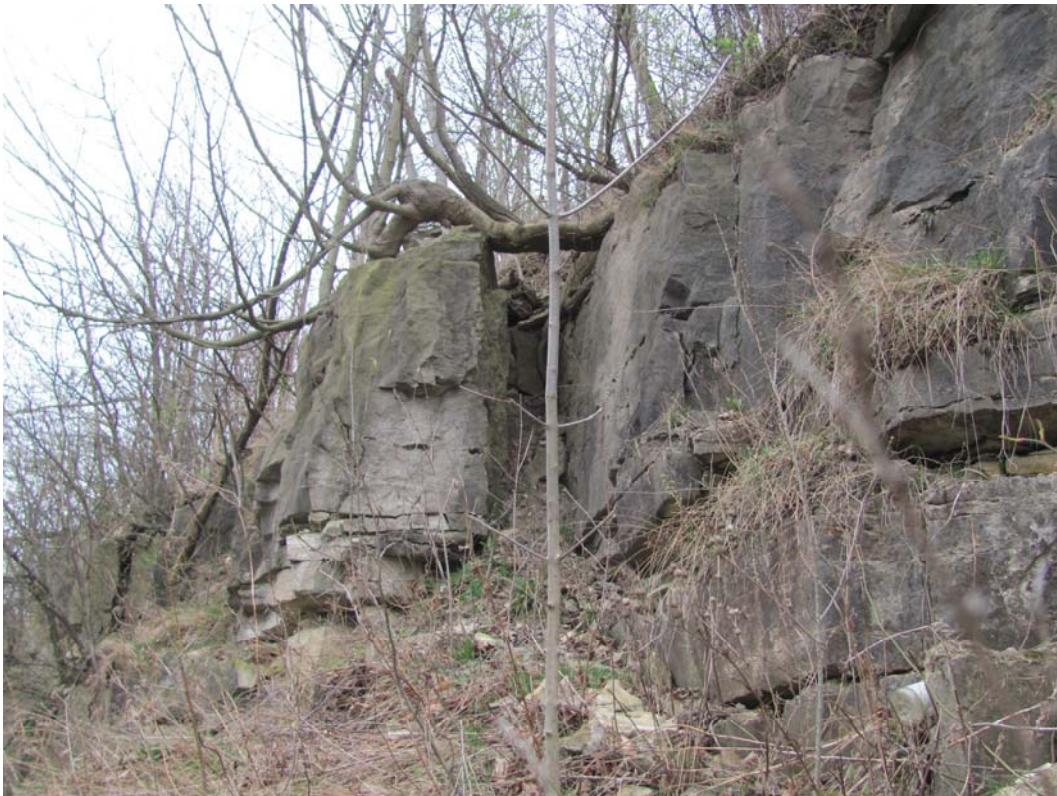
Image 16. Displaced block near crest that appears to be relatively stable! (Image date – 29 March 2012)

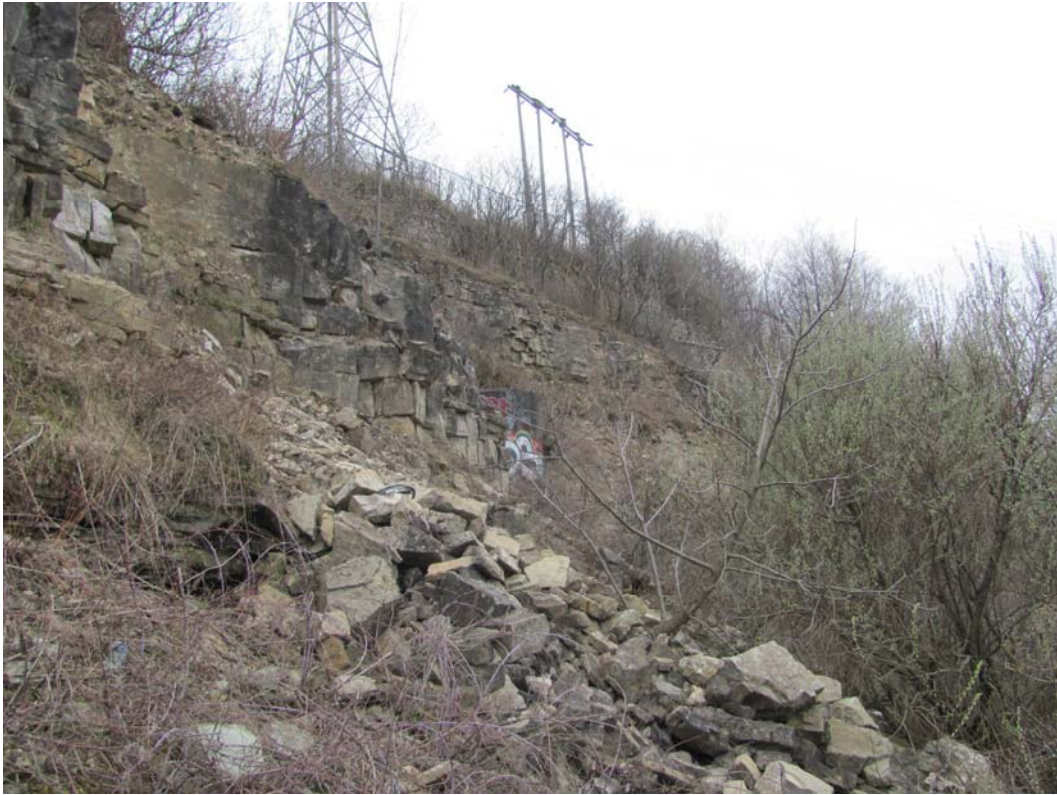
Image 17. Fresh looking talus pile below failed rock just to east of power lines. (Image date – 29 March 2012)

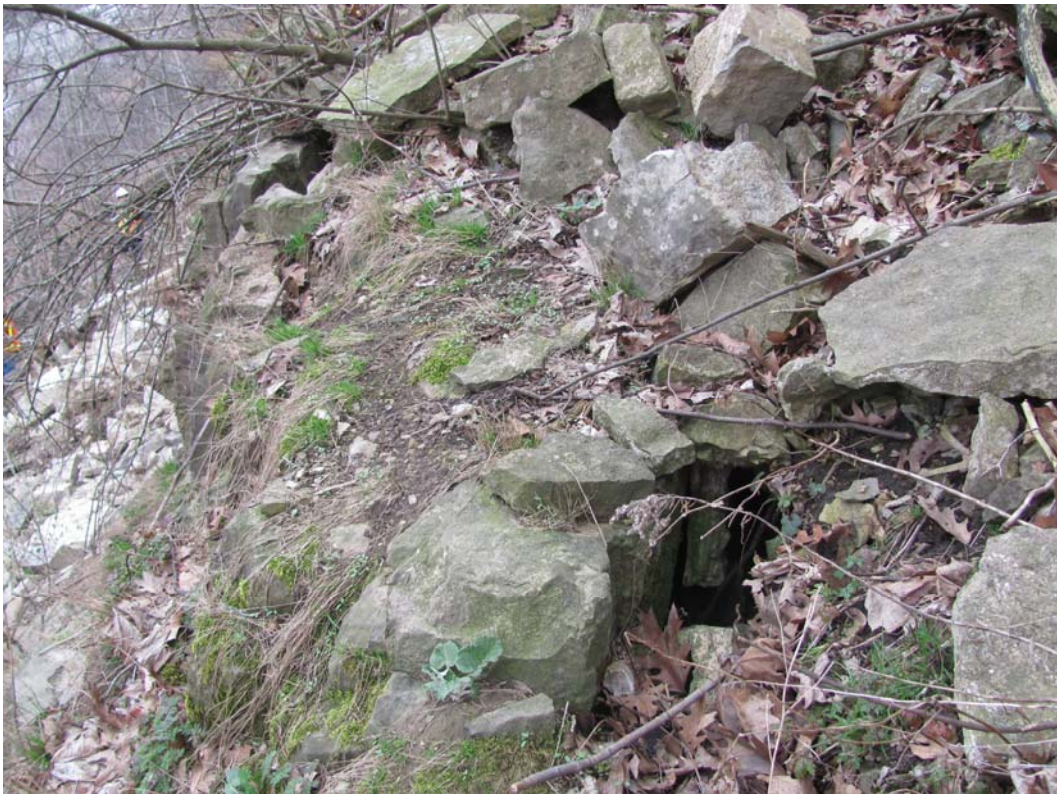
Image 18. Voids in rock mass immediately adjacent to first rockfall event. (Image date – 29 March 2012)

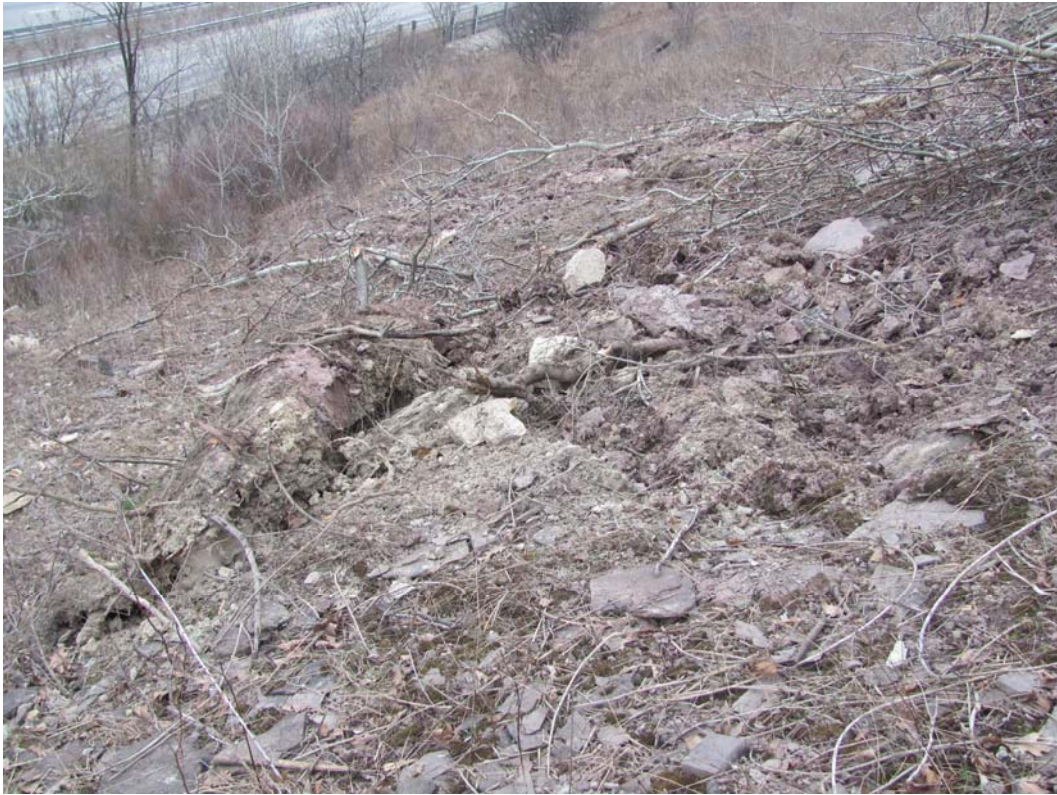
Image 19. Strike mark on slope below main failure, indicating that the long axis of the block was parallel to the slope and that the slope materials were saturated at the time of failure. (Image date – 29 March 2012)
