MEMORANDUM

Re: WO: 2012 – 11037

Assessment and remedial measure recommendations for slope instabilities at east side of the north approach at QEW/Ridgemount Rd Underpass, Welland, Ontario

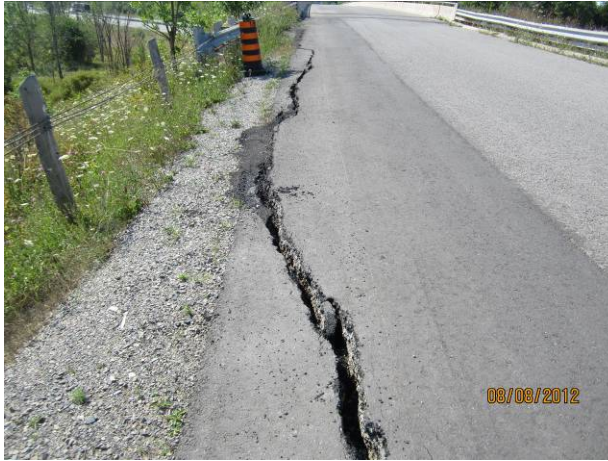
- At the east side of the north approach, there are two sections of tension cracks at the crest of the slope. The crack at the north section is approximately 2.4 m long and it's width various from 25 mm to 50 mm. The crack at the south section is about 12 m in length and 25 mm to 75 mm in width. The depths of the cracks are about 20 cm (Figure 2 and 3)

Figure 2: Tension crack at the edge of pavement

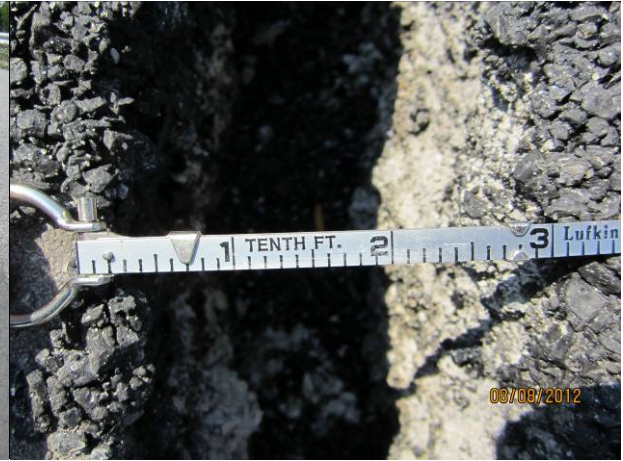
Figure 3: Width of the tension crack

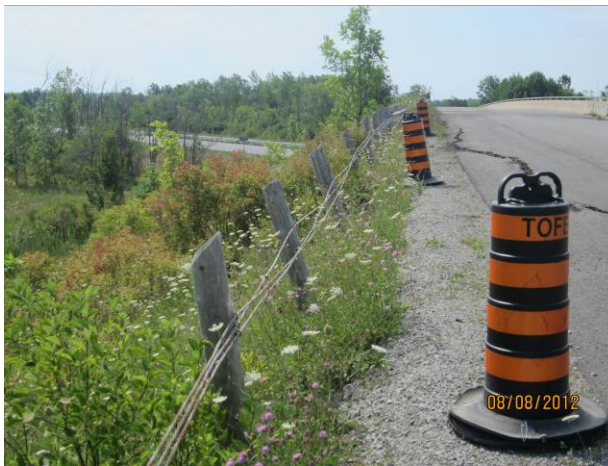
- The underpass embankment slope is 2.4H:1V and the embankment height is approximately 6 m
- Distress of the guide rail (in the form of tilting) was also evident in area where tension crack appears to be the widest (Figure 4)

Figure 4: Distress of the guide rail

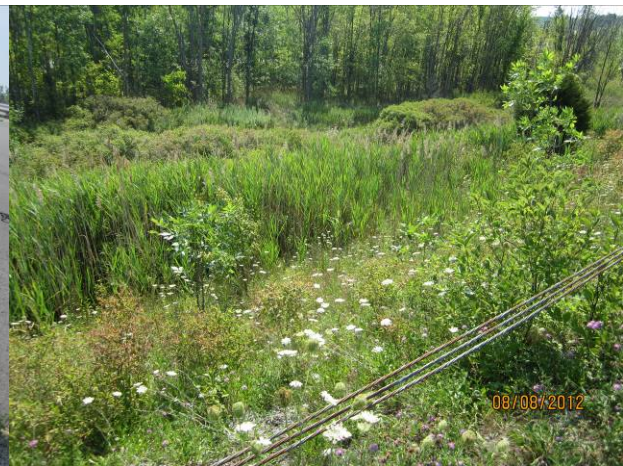
- The slope is well vegetated with shrubs and small trees (Figure 5)
- Granular fill material was present on the slope faces, near the highest parts of the embankment.

Figure 5: Vegetation on the slope

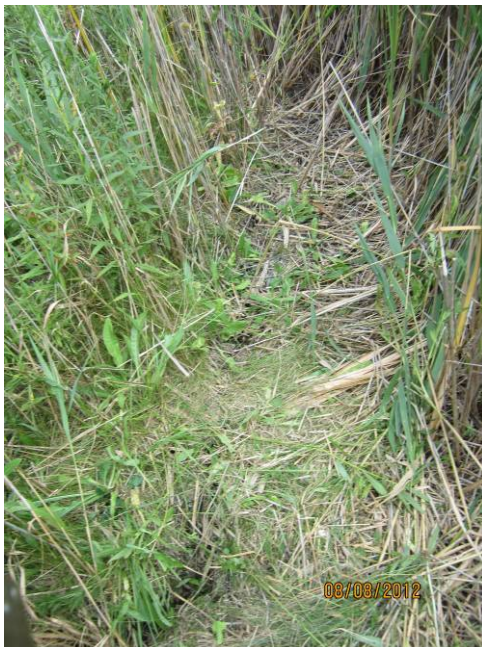
- There is a tension crack along the toe of the slope running parallel to the road. However, the level ground beyond the toe of the slope does not bulge (Figure 6 and 7)

Figure 6: Tension crack along the slope toe

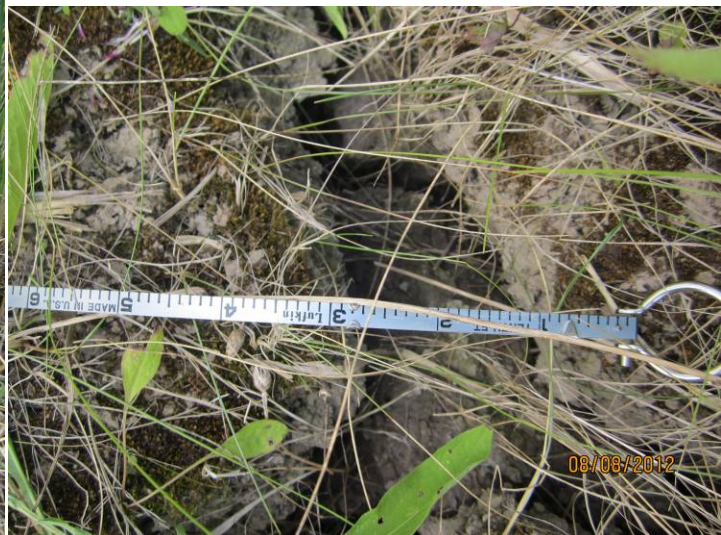
Figure 7: Width of the tension crack at the slope toe
