**Ministry of Transportation**

## Memorandum Report

**Subject:** Short-Term Remedial Measures for Embankment Instabilities  
600m North of Innisfil Beach Road/ Hwy 400  
W.O. 2011-11021  
GEOCRES No. 31D-523

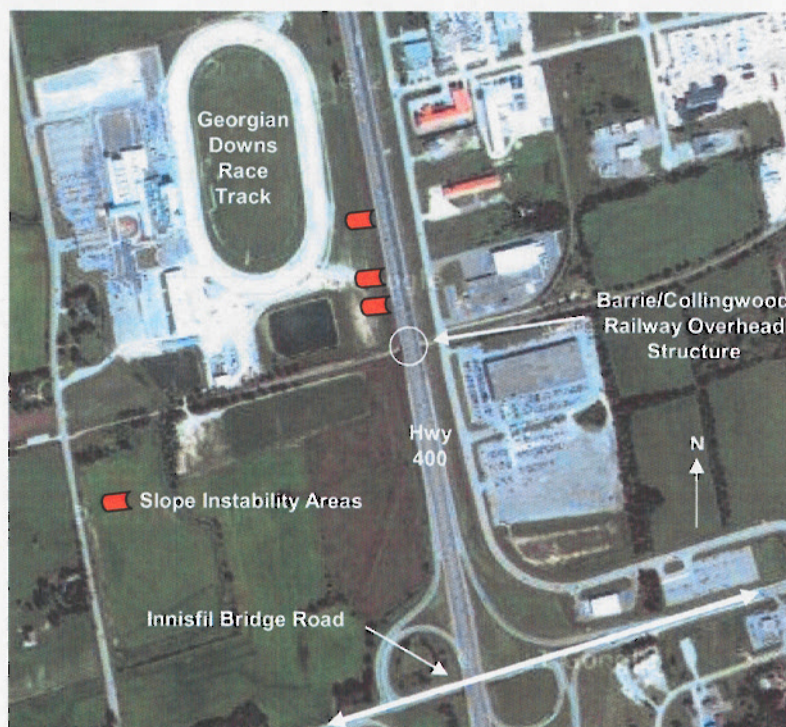
CR Geotechnical Section indicated that there are three separate slope instabilities areas along the southbound embankment, facing the Georgian Downs Race Track (See Figure 1) and that this condition was noticed and informed by personnel from Georgian Downs in mid-October 2011 after consecutive rainy days.

**Figure 1: Location of Slope Instability Areas**

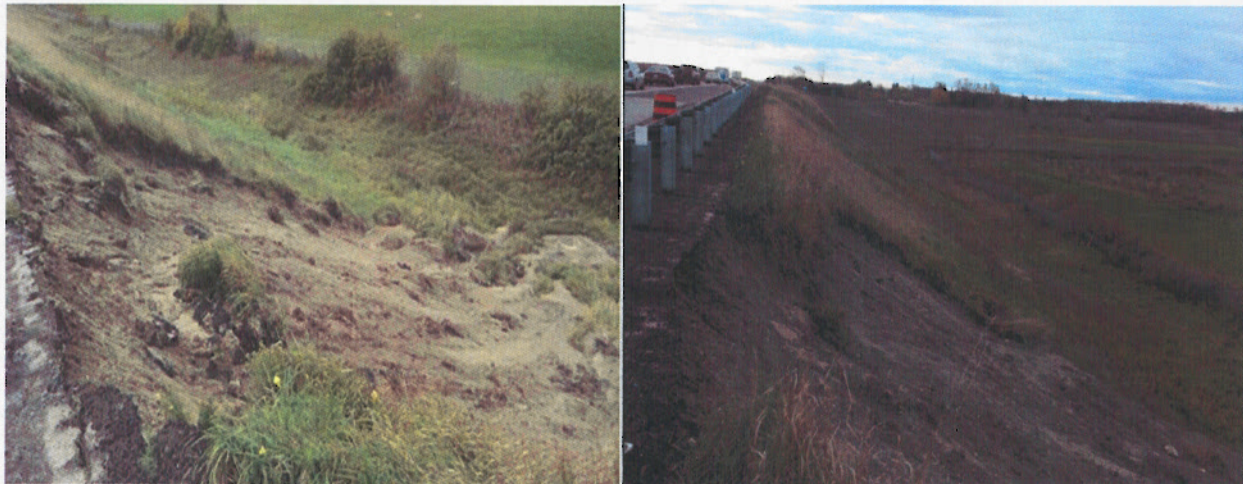
The three slope instability areas are located along the Hwy 400 southbound lanes, approximately 75m, 110m, and 175m north of the north abutment of the railway overhead structure, respectively. A 15m long asphalt pavement crack, located 145m north of the abutment, was also observed behind the SBGR. The spacing between slope instability areas and cracks is about 35m. Figure 2 illustrates features of the slope instability areas. The widths of these instability areas are about 16m, 8m, and 12m, respectively. The start of the slides varies from 0.3m to 0.5m behind the SBGR, which is also the edge of the asphalt shoulder treatment. The top 200mm thickness (approximately) of the slope material (including vegetation and topsoil) has slid to the bottom of the slope leaving exposed earth fill material. The features of the instabilities are typified by a deep scarp at the top of the slope and a mass of sloughing and debris at the bottom of the slope.

**Figure 2: Pictures of the Slope Instability Areas**

Based on the site observations and information received from CR, the instabilities are surficial failures of the embankment slopes, as opposed to deep-seated failures through the natural subsoil below the base of the embankment. These failures were triggered by the loss of soil strength due to the slope material being saturated with water from the consecutive rainfall in mid October 2011.

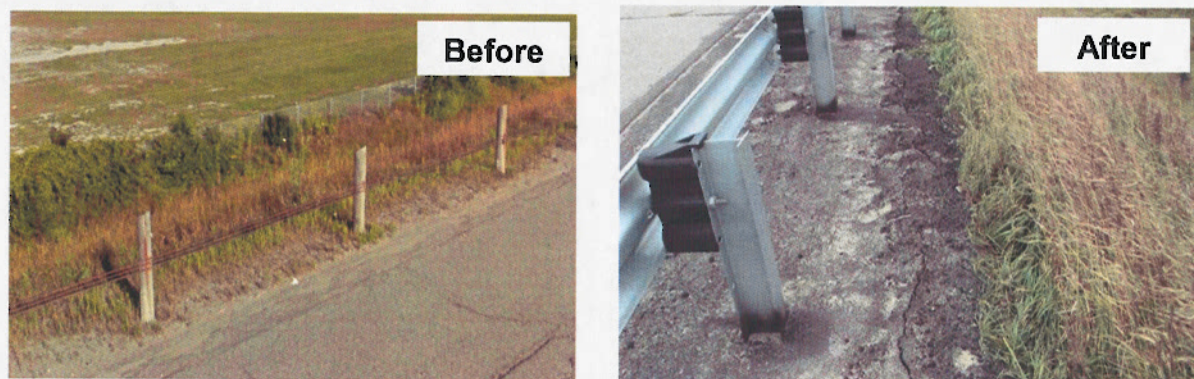
Since there were no reports of slope instabilities at this site prior to the newly installed SBGR, and since the before and after installation photos confirm the timing of instabilities, it is concluded that the installation of SBGR and asphalt shoulder treatment contributed to the surficial instabilities probably by accelerating the surface runoff. Figure 3 illustrates that vegetation was in place behind the guide rail before construction of the SBGR and the asphalt shoulder treatment. This vegetation would have provided a permeable surface for the surface runoff to slow down and be absorbed along the vegetated slope. However, the asphalt shoulder treatment behind the newly installed SBGR created an impermeable surface condition that may have increased the surface runoff volume and velocity to the slope and caused instability and erosion of the slope.

**Figure 3: Before and After Steel Beam Guide Rail and Asphalt Shoulder Treatment Installation**

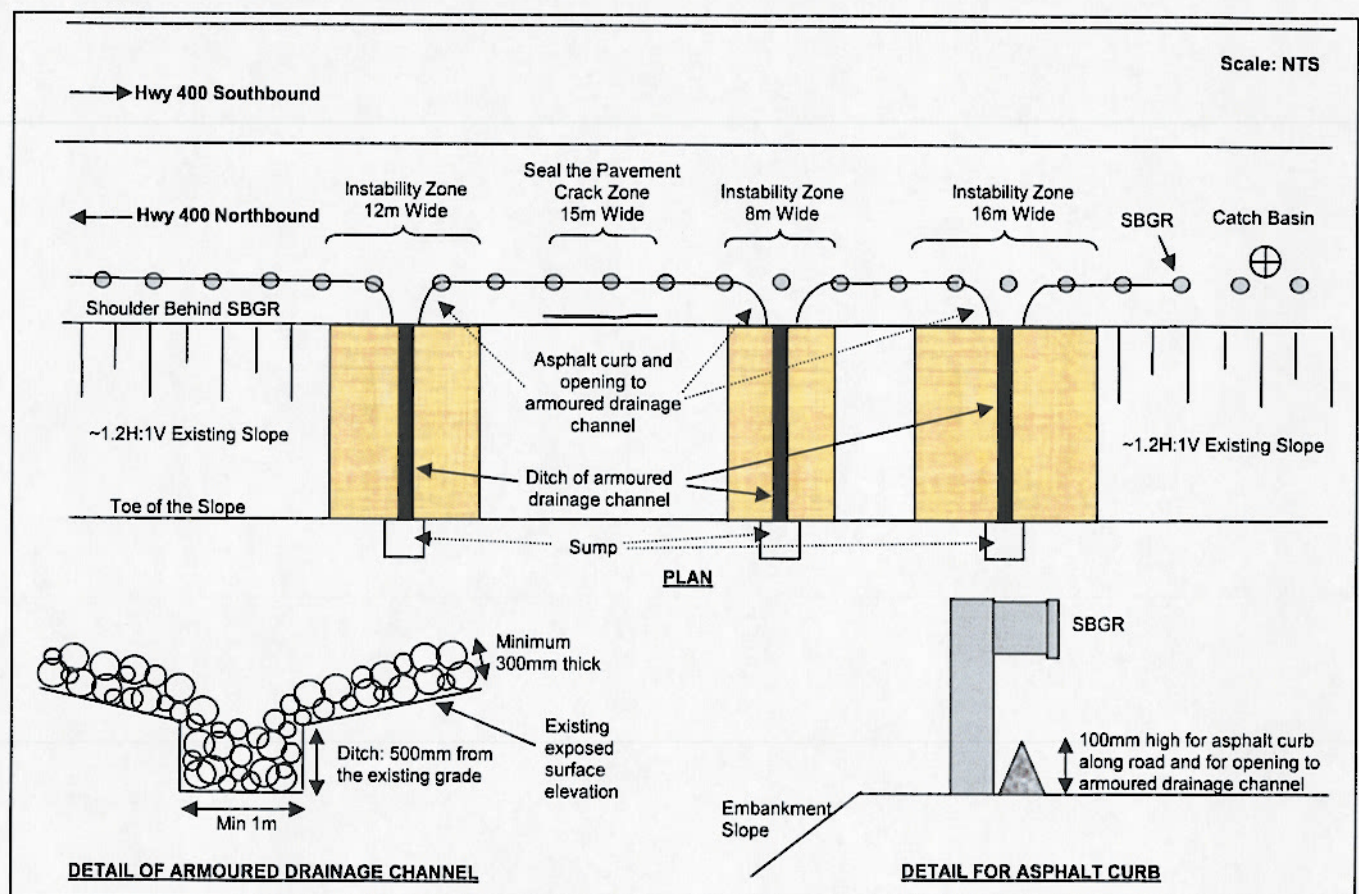
**Figure 4: Short-Term Remedial Measures**

- See Figure 4 for illustration.
- Remove slope instability debris at the bottom of the slope.
- Construct a ditch at the centre of each identified instability slope area and sump area as described. The depth of the ditch shall be 500 mm deep from the existing exposed grade and a minimum of 1m wide.
- Fill the entire ditch (to form an armoured drainage channel) and the rest of the instability area with Rip-Rap R-10 grading aggregates. No additional excavation is required outside the ditch for the armoured drainage channel. The minimum thickness of the Rip-Rap R-10 grading aggregate fill shall be 300mm. The armoured drainage channel

should outlet into a 0.5m deep 2m x 2m area sump at the toe of the slope, centred on the armoured drainage channel. The sump shall be filled with Rip-Rap R-10 grading aggregates. All Rip-Rap R-10 grading aggregates shall be placed using rock protection construction method from the bottom up (i.e. machine place and random manner and without geotextile separator). Refer to the following Ontario Provincial Standard Specifications for construction method and material selection:

- OPSS 511: Construction Specification for Rip Rap, Rock Protection and Gravel Sheeting
- OPSS 1004: Material Specification for Aggregates - Miscellaneous
- Construct an approximately 100mm high asphalt curb and with opening to direct surface runoff to the armoured drainage channels along the slope. The preferred location for the asphalt curb is immediately in front of the SBGR.
- Seal the pavement cracks behind the SBGR to prevent water seepage and movement.
