MEMORANDUM

File: 19-4406-20

PRELIMINARY FOUNDATION INVESTIGATION AND DESIGN SILVER CREEK CULVERT (SITE 15-165/BC)

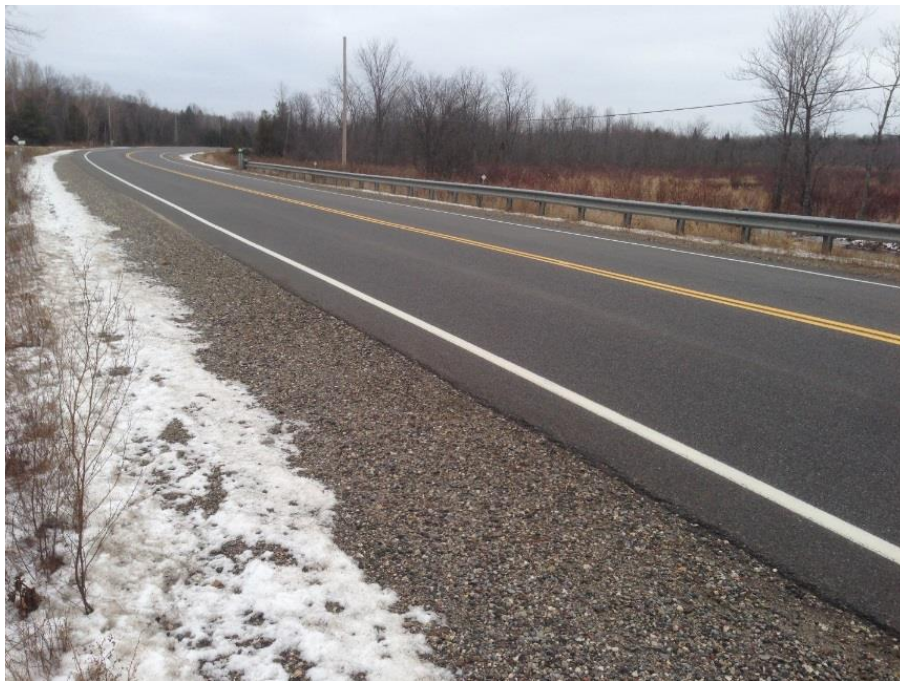
Photo 2 Top of Highway Embankment Looking East (repaved surface)

There were no obvious signs of settlement or distress in the foundations. It appears that the pavement in the vicinity of the culvert has recently been resurfaced.
