**THURBER** ENGINEERING LTD.

## MEMORANDUM

Date: March 9, 2017

### PRELIMINARY FOUNDATION ASSESSMENT SAWERS CREEK BRIDGE (SITE 26-040) GEOCRES NO. 31D-650

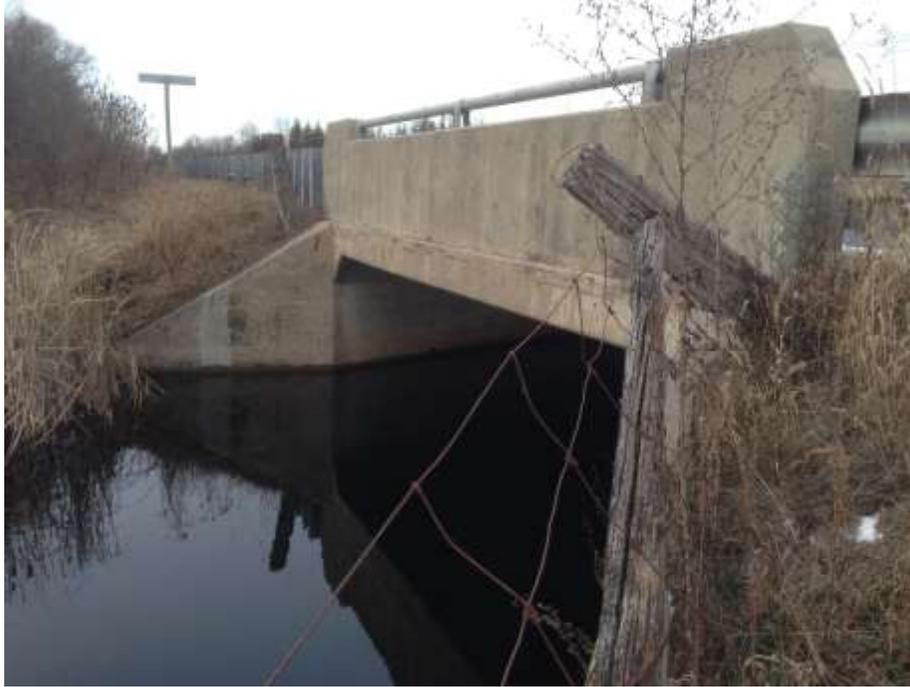
**Photo 1 View Looking North Showing Culvert Inlet Area**

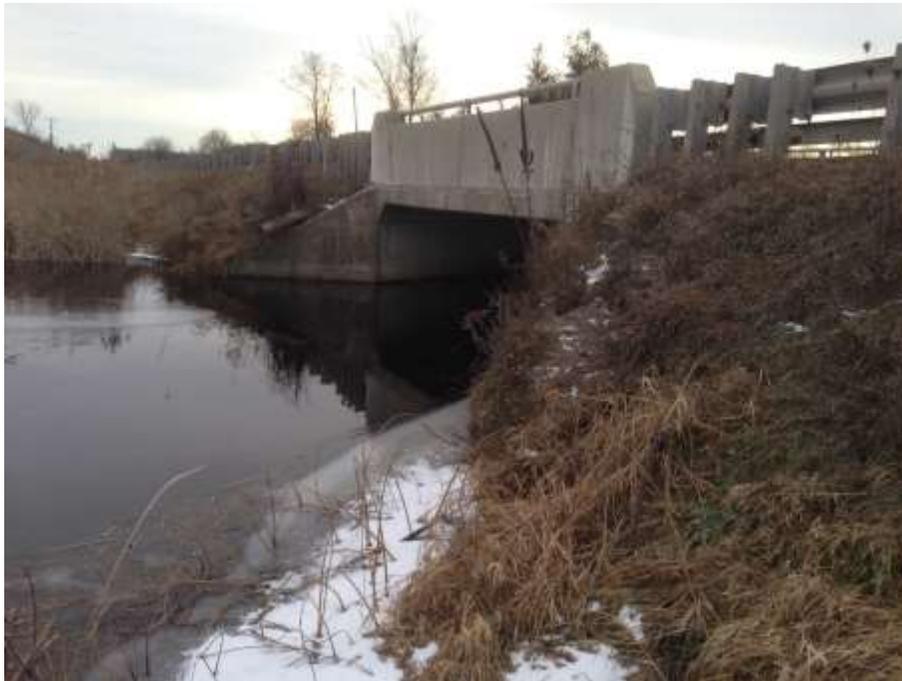
**Photo 2 View Looking South Showing Culvert Outlet Area**

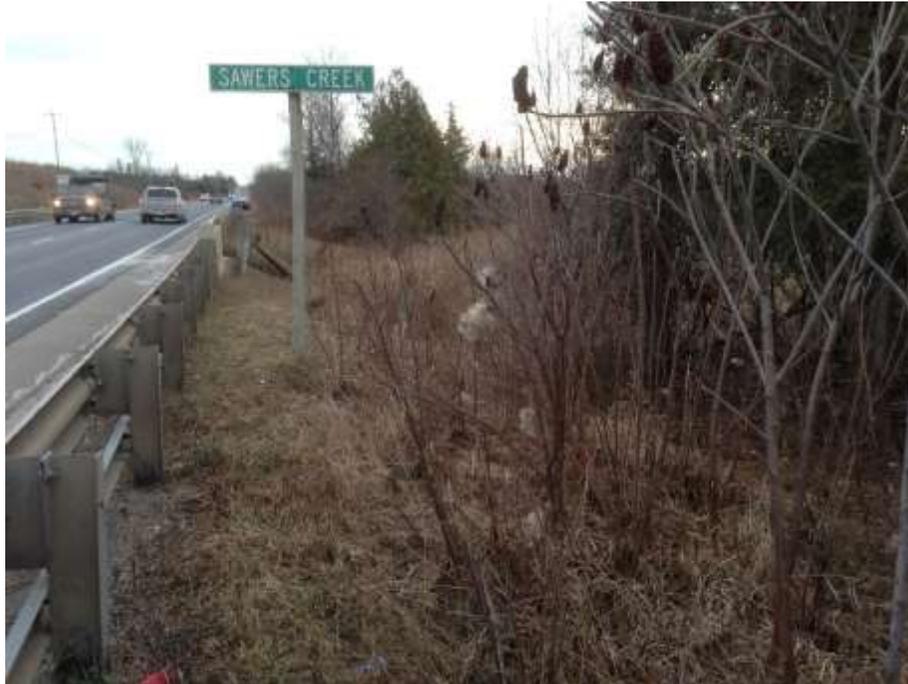
The approach embankments appeared to be stable with no obvious signs of instability. There was some indication of erosion behind the wingwall at the southeast abutment.

**Photo 3 View Looking South Showing Highway Embankment**

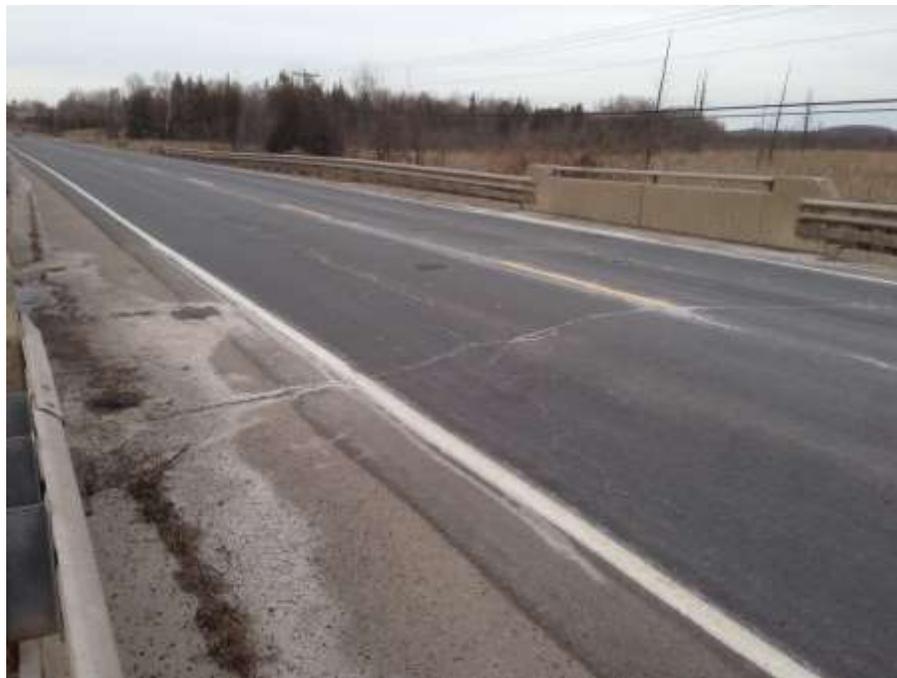
Pavement distress in the form of transverse and longitudinal cracks was noted. There was no visible settlement at the approaches, except for a shallow depression located on the highway shoulder near the northwest quadrant.

**Photo 4 View Looking North Showing Pavement Distress Near Culvert**
