**FOUNDATION INVESTIGATION AND DESIGN REPORT
STONE CREEK CULVERT FOOTING REHABILITATION
NEW LISKEARD DISTRICT, ONTARIO
GWP 5407-15-00 – HWY 112**

Geocres Number: 41P-66

March 10, 2016
File: 10098

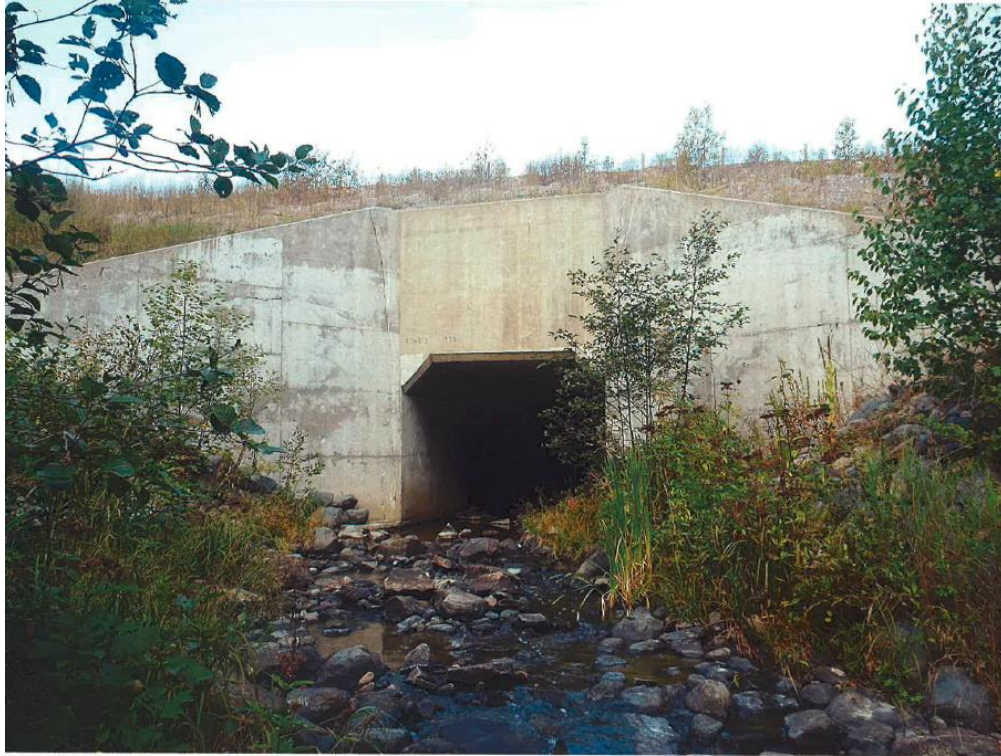
Photo 1 – Looking West at Culvert Outlet

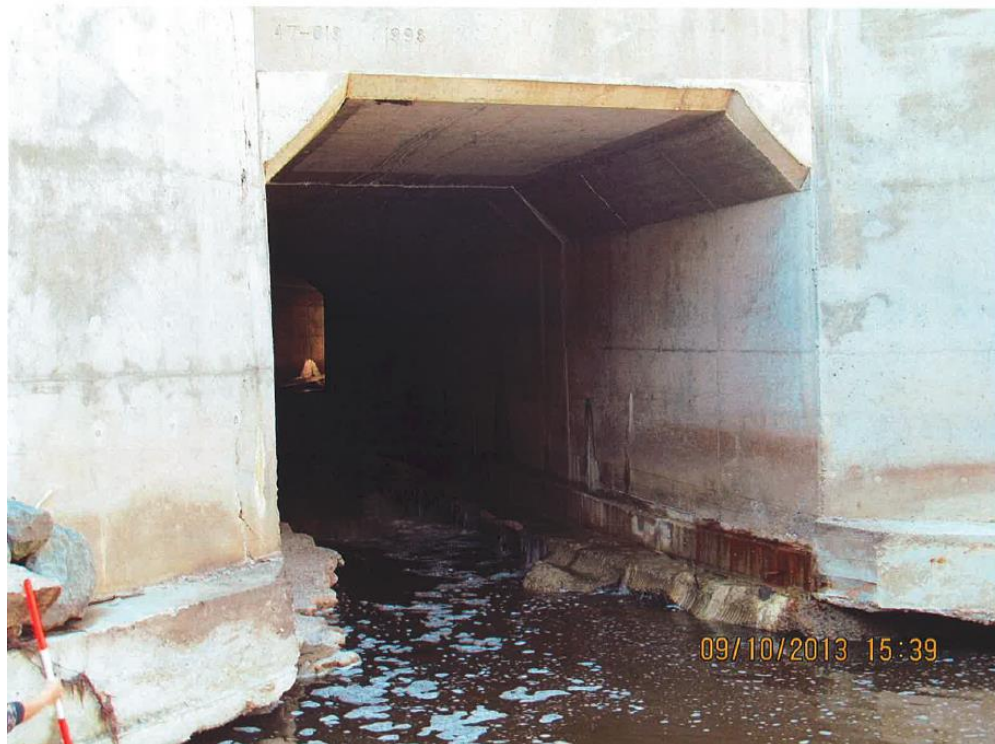
Significant erosion has occurred at the culvert outlet, which has resulted in undermining of the foundations. Depth of undermining was estimated to be in the order of 0.5 to 1.0 m below the underside of the footings. The undermining due to erosion has rendered a segment of east end of the culvert footings and both outlet wingwall footings partially or completely unsupported. A vertical crack was visible adjacent to the east headwall throughout the entire height of the southeast wingwall behind which a sizeable sinkhole is present in the retained highway embankment slope.

Photo 2 – Unsupported Wingwall Footings at Culvert Outlet

At the same time, it is not considered to be advisable to attempt to excavate below the undermined footings in order to remove the loosened cobbles and boulders and consideration should be given to in-place stabilization. One possible method of stabilization would be to pump cementitious grout into the voids between the cobbles and boulders in an attempt to prevent future movement within this layer. If acceptable by other disciplines, the grouting could be carried out across the width of the creek bed and to some distance downstream of the culvert as a method of reducing scour.

After the streambed has been stabilized, temporary formwork could be erected in front of the footings and flowable concrete could be pumped in to underpin the footings. It is very difficult to estimate geotechnical resistances for the layer of cobbles and boulders. However, from a practical point of view, the scouring action has probably removed most of the fine material and left the cobbles and boulders in hard contact with each other. If this array of cobbles and boulders is stabilized by grouting, it seems reasonable that it will provide adequate support for the foundations.

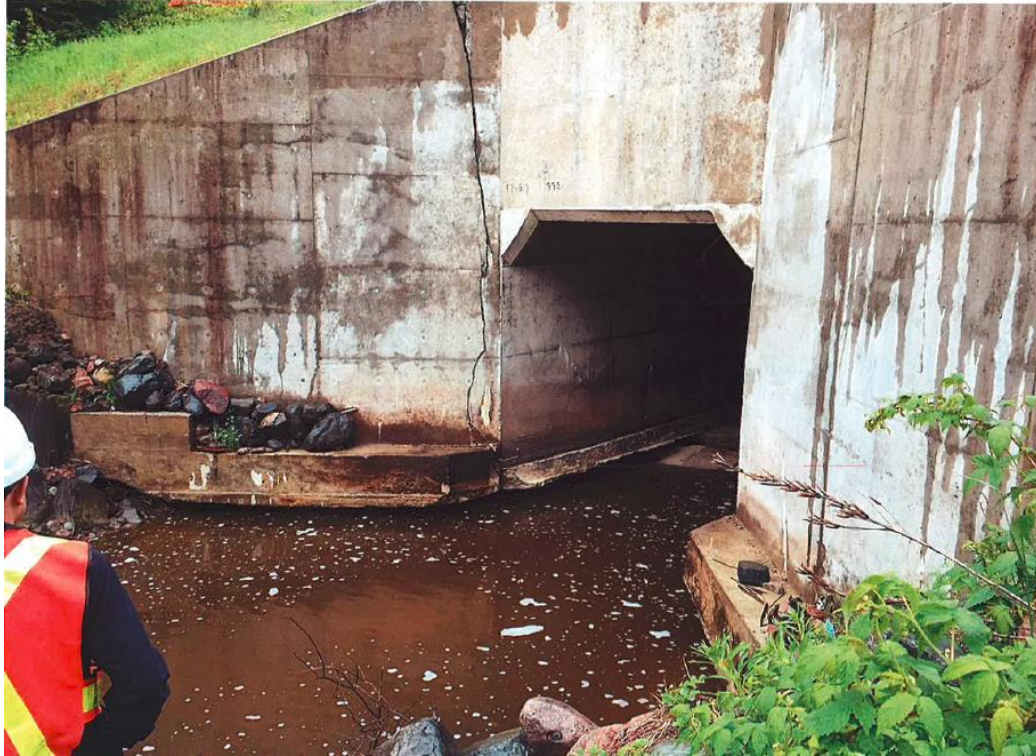
The project site is located approximately 2.5 km south of Round Lake. The culvert is generally surrounded by wooded lands with sporadic residential properties located approximately 300 m to the north and south. The existing culvert carries the easterly meandering Stoney Creek through the highway embankment in a west-to-east direction. Photographs of the culvert and surrounding area presented in Appendix C show the partially unsupported footing bases and wingwalls, at least one of which has cracked.

Photo 3 – Unsupported South Footing and Cracked Wingwall

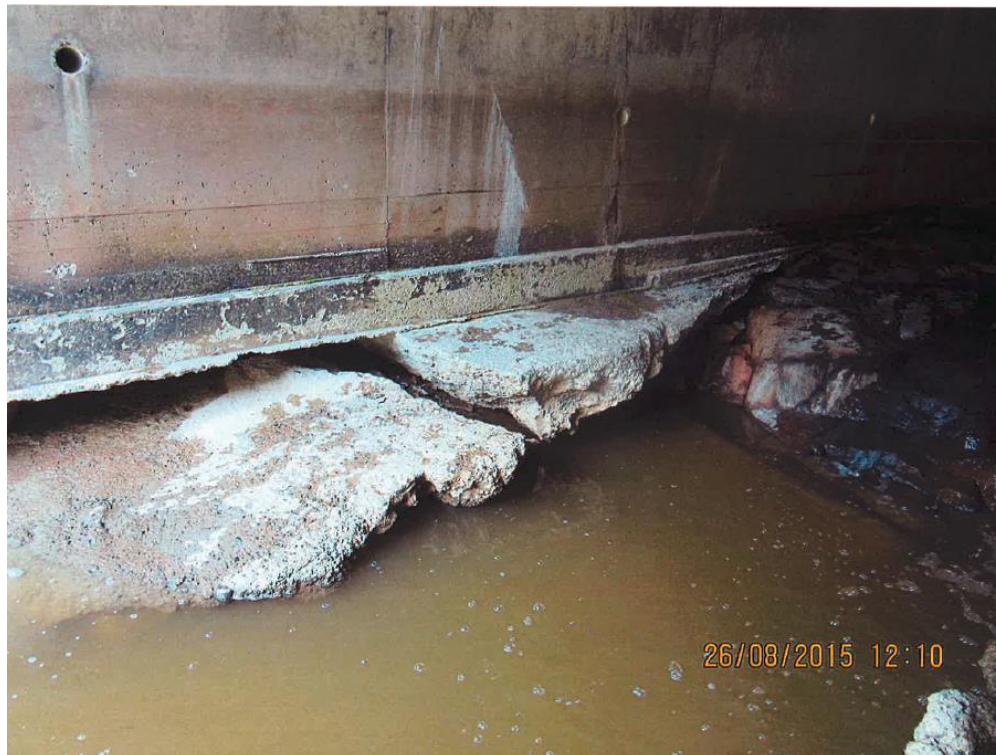
Photo 4 – Partially Supported South Footing

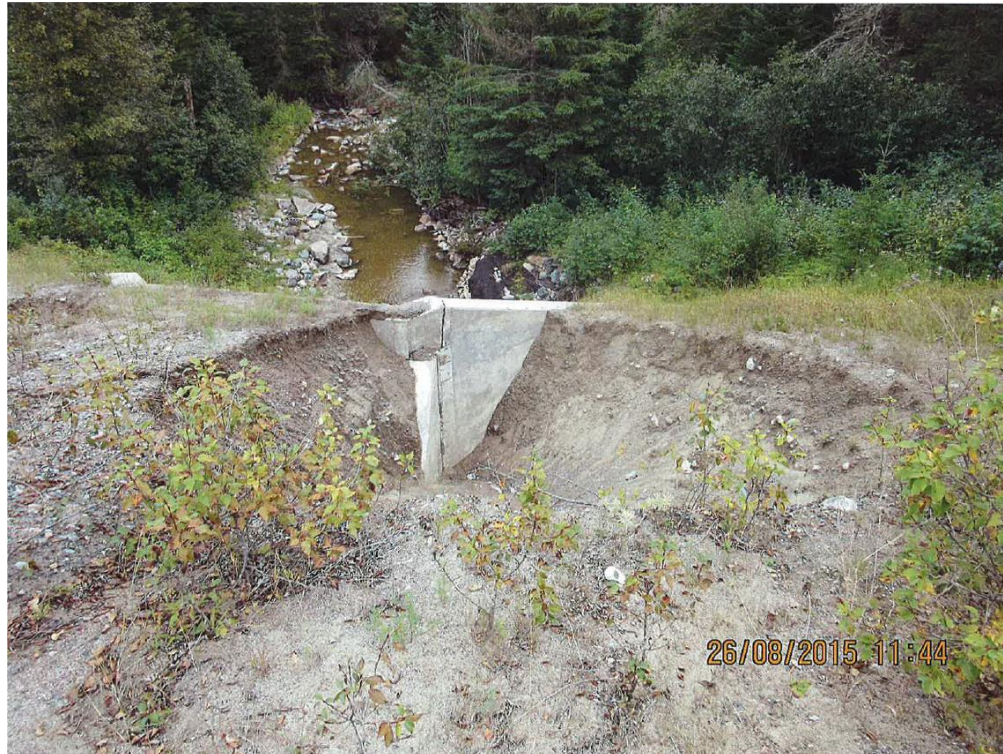
The existing rigid frame open footing culvert on Highway 112 is located approximately 0.4 km north of the Highway 11 and Highway 112 intersection. Significant erosion was noted beneath the footings at the culvert outlet (east end) which caused the footings to be partially unsupported and now requires footing rehabilitation. A sinkhole has developed behind the southeast wingwall as shown on Site Photos 5 and 6 in Appendix C.

Photo 5 – Sinkhole behind Southeast Wingwall (Looking Downstream)

After the foundations have been stabilized, the sinkhole may be backfilled. Before this is done, a structural engineer must analyse the ability of the wingwalls to retain the backfill and implement such structural remediation as may be required.

Depending on the results of the structural analysis, granular backfill in conjunction with tie-backs to deadman anchors could be considered for remediation of the sinkhole.

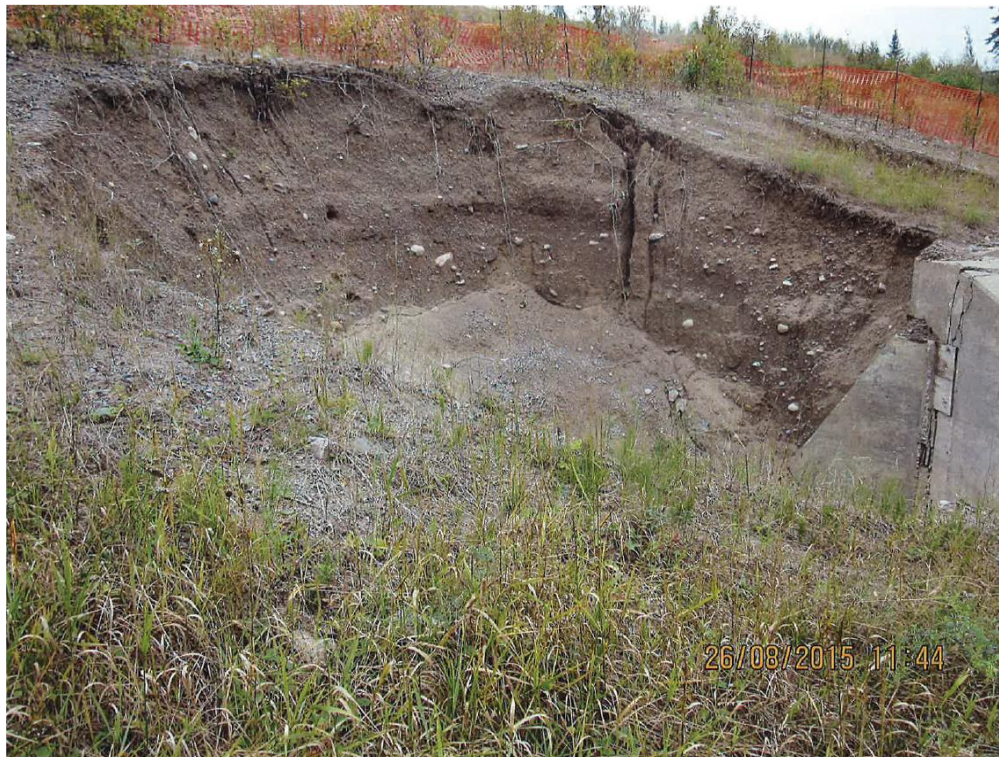
Photo 6 – Sinkhole behind Southeast Wingwall (Looking Upslope)
